# Scientific Studies on Conservation for Üzümlü Church and its wall paintings in Cappadocia, Turkey

**Vol. 2 (Report on the activities in 2015-2016)**

University of Tsukuba  
2017

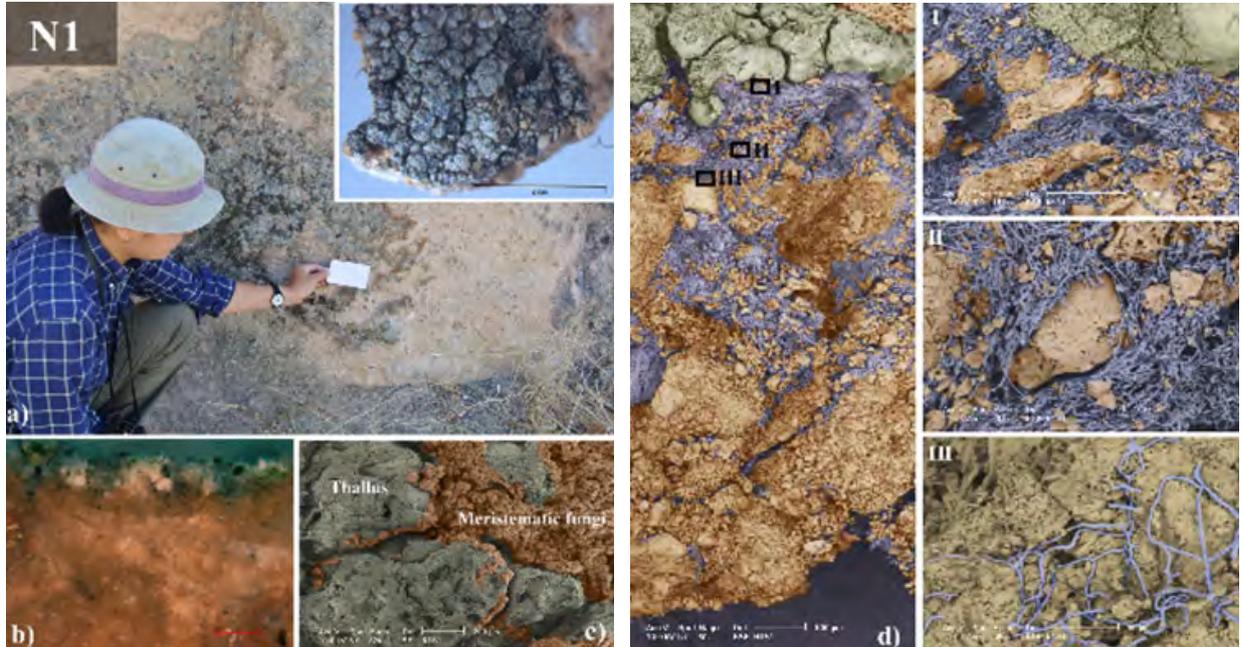
In the fragment N1 has been observed the crustose lichen *Aspicilia*; the thallus is whitish- to leaden grey and appear cracked-areolate with the surface of each areole warted (Fig 3 a). In addition, the OM and SEM observation (Fig. b, c) showed the presence of black meristematic fungi over the surface.

The SEM observation of the entire fractured sample highlights the dense networks of fungal hyphae inside the rock. The images also indicate that a relatively greater portion of the rock shows evidence of fragmentation and crumbling. In fact, as shown by Figs. 3 I and II, mineral grains are completely embedded in the interior of the hyphae networks. The abundance of hyphae decreases with the depth, and only a few hyphae can be seen in the bottom part.

Figure. 2.3 Biological colonization in north exposures a) Sampling point (N1) and picture under the stereomicroscope; b) Microphotograph of the sample in polished cross sections; c) SEM image in false colour of the fragment surface; d) SEM image in false colour of the fragment.

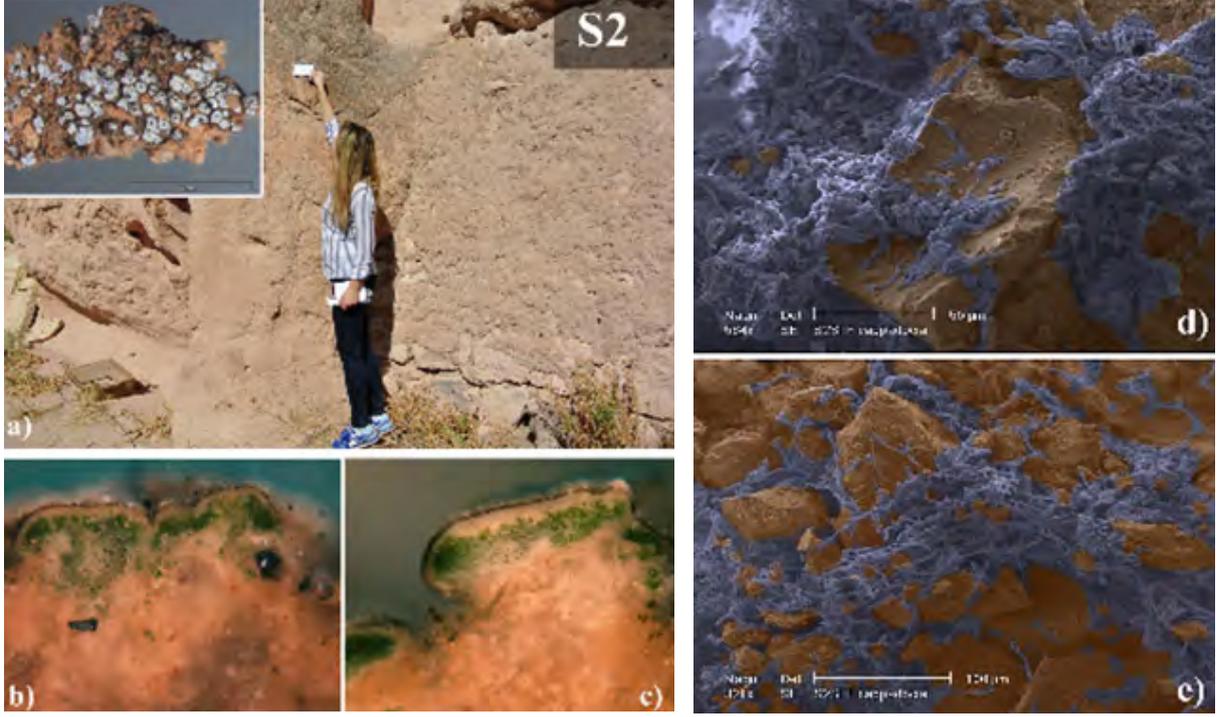
In the fragment S2 has been observed the crustose lichen *Acarospora*; the thallus is white and appear with the areoles more rounded (Fig. 11 a). The SEM details of the fractured sample show mineral grains completely embedded in the hyphae networks (Figs. 11 d, e).

Figure. 2.11 Biological colonization in south exposures a) Sampling point (S2) and picture under the stereomicroscope; b), c) Microphotograph of the sample in polished cross section; d), e), SEM image in false colour of details observed in the sample  
Şekil 2.11 Kilsenin güney cephesinde biyolojik kolonizasyon a) Alınan örneğin (S2) kilise yüzeyinde seçilen noktası ve stereomikroskop altındaki resmi ; b), c) Cilalı kesitte alınan örneğin mikroskopografisi ; d), e) Örnek parçasının tamamının detaylı olduğu renkli SEM görüntüsü

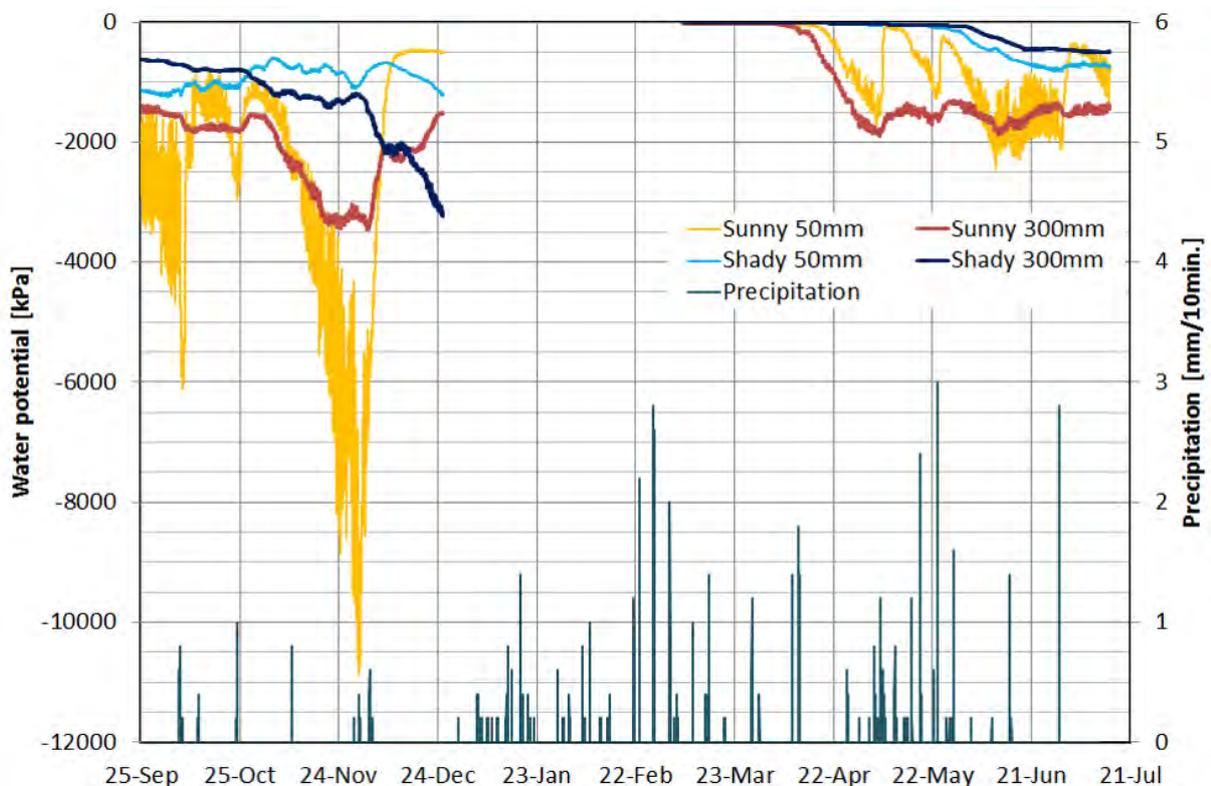
Figure 4.11. From Sep. 25, 2015 to Jul. 21, 2016 (300 days) Ground soil moisture data near Üzümlü Church

After rainfall in early December, underground water potential near the surface was higher than that in deeper zones. Therefore, the rock structure did not absorb significant amounts of groundwater. This tendency was same as that of the previous season. A few intervals of rainfall were observed in this area. The ground water potential seemed close to saturation until the end of March.

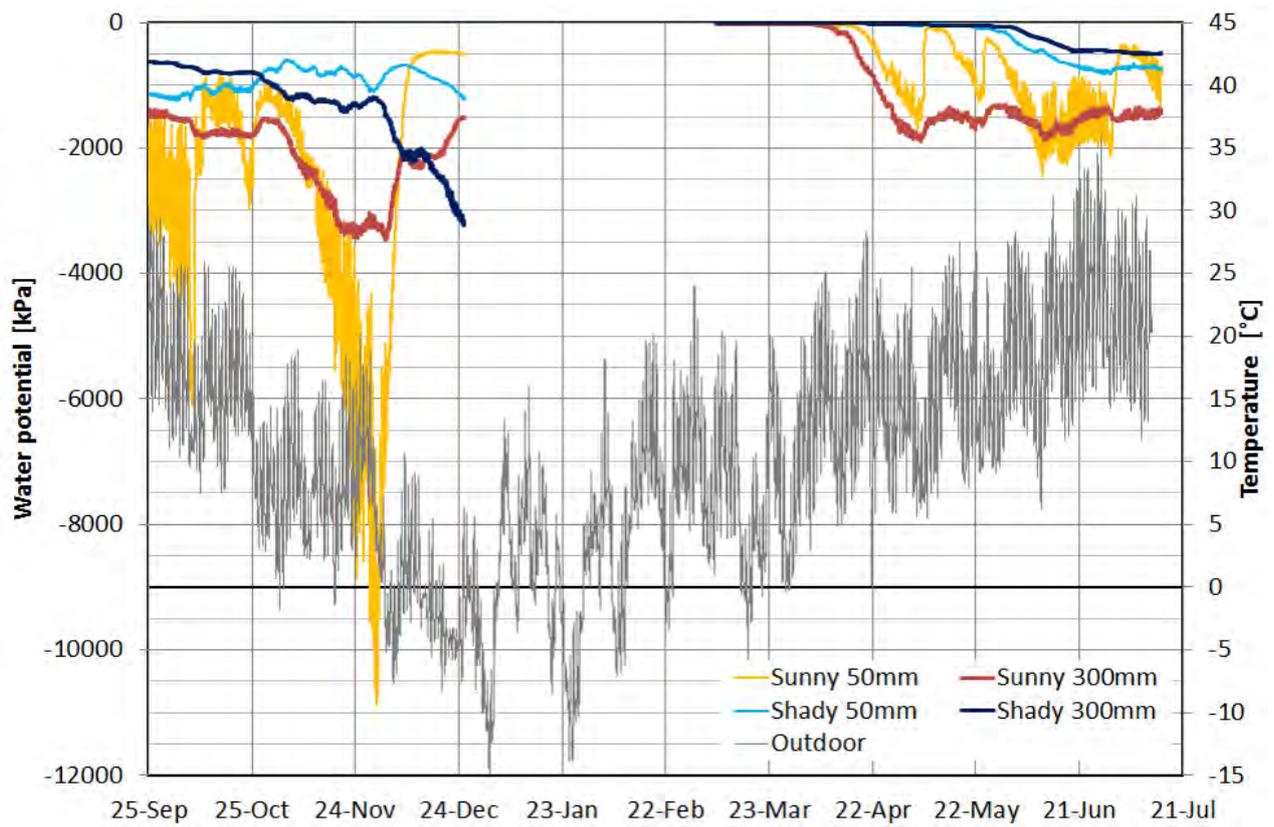
Figure 4.12. From Sep. 25, 2015 to Jul. 21, 2016 (300days) Ground soil moisture data near Üzümlü Church

It is likely that the freeze-thaw cycle will occur frequently in the immediate vicinity of the ground surface when the ground water potential remains high, because the ground surface temperature tends to drop lower than that of the outdoor air due to nocturnal radiation.

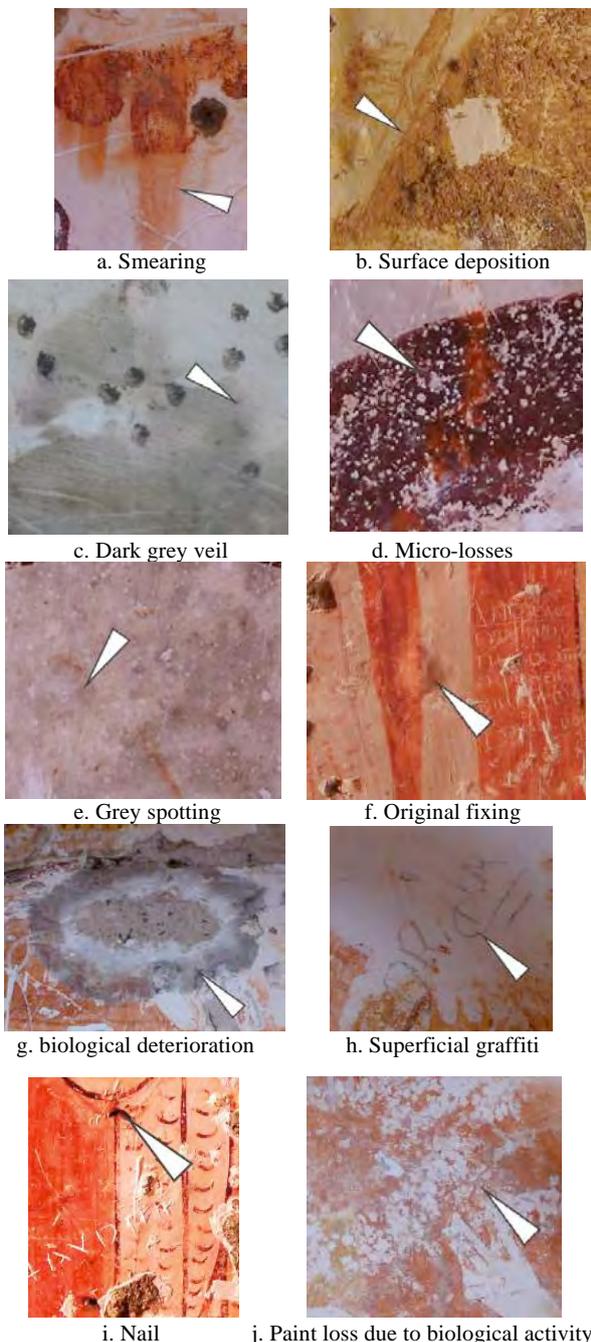
rounded losses of the paint layer generally on the order of 0.5-1 mm Ø. Grey spotting is the faint, circular grey spots, 0.5-3 mm Ø, on the surface of the painting. Original fixing is the trace of fixing that may be carried out almost at the same period of mural painting depicted because the colors of this part and around area of that are almost the same. Biological deterioration is discoloration, generally dark gray, of certain areas of painting due to animal inhabitation. Superficial graffiti is the graffiti applied to the surface of the painting using a medium such as paint, ink or graphite. Nail is the part of nail on the paint layer. Paint layer loss due to biological activity is loss of the paint layer due to the former presence of birds' nests primarily which, when separated from the painting surface, removed part of the paint layer.

Figure 14. Photos of paint layer deterioration

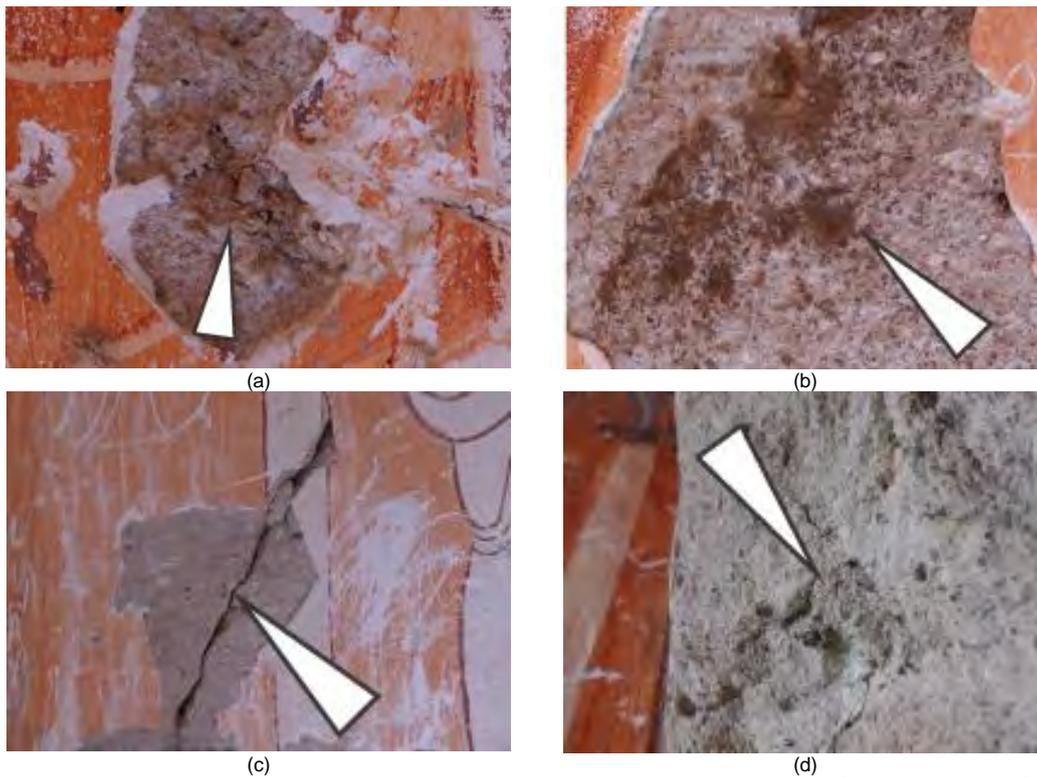
**Figure 13:** Photos of rock layer deterioration: a) Biological activity; b) Deposition of dark material; c) Structural cracks; d) Spalling.

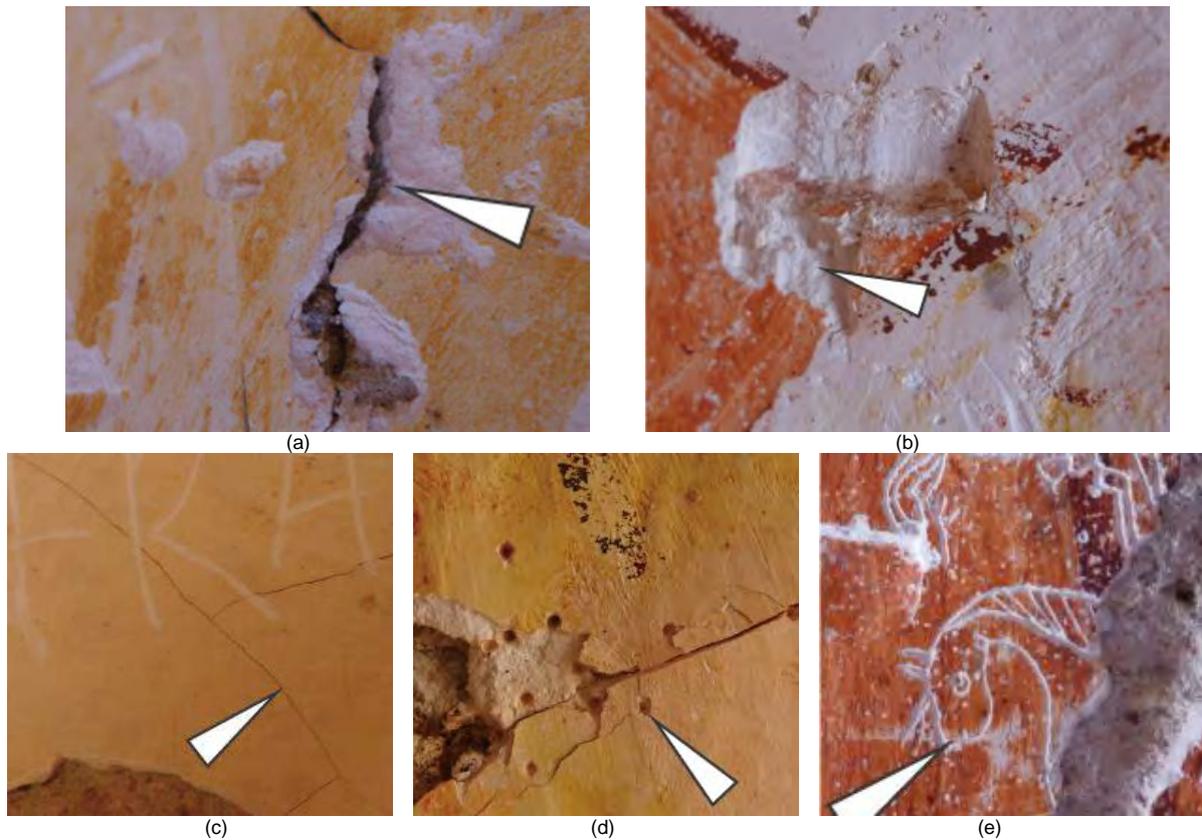
Plaster layer deterioration was identified on the basis of five factors: detachment of the lower plaster layer (Fig. 13a), mechanical damage (Fig. 13b), cracking (Fig. 13c), holes (Fig. 13d) and incised graffiti (Fig. 13e). Detachment of the lower plaster layer is the loss of adhesion between the lower plaster layer and a rock substrate, as assessed by visual evidence alone. Mechanical damage refers to the rupture in painting stratigraphy caused by human or animal activity. This type of damage causes a variety of other harmful effects, such as loss of entire stratigraphy; revealing an underlying rock substrate; loss of the paint layer, ground and part of the lower plaster layer, thus leaving the interior of the lower plaster layer exposed; loss of only the upper plaster ground, which leaves the surface of the lower plaster layer intact; and deformation of painting stratigraphy, which otherwise remains intact. Cracking occurs on a plaster layer most often because of the cracking of the rock structure and mechanical damage, although other factors may cause such damage. Holes are small highly circular holes of approximately 5 mm in diameter; these penetrate into a plaster layer but generally do not reach a substrate. Incised graffiti are inscriptions and drawings inscribed onto the surface of a painting, thus affecting the paint, ground and plaster layers.

**Figure 14:** Photos of plaster layer deterioration: a) Detachment of lower plaster layer; b) Mechanical damage; c) Cracking; d) Holes; e) Incised graffiti.

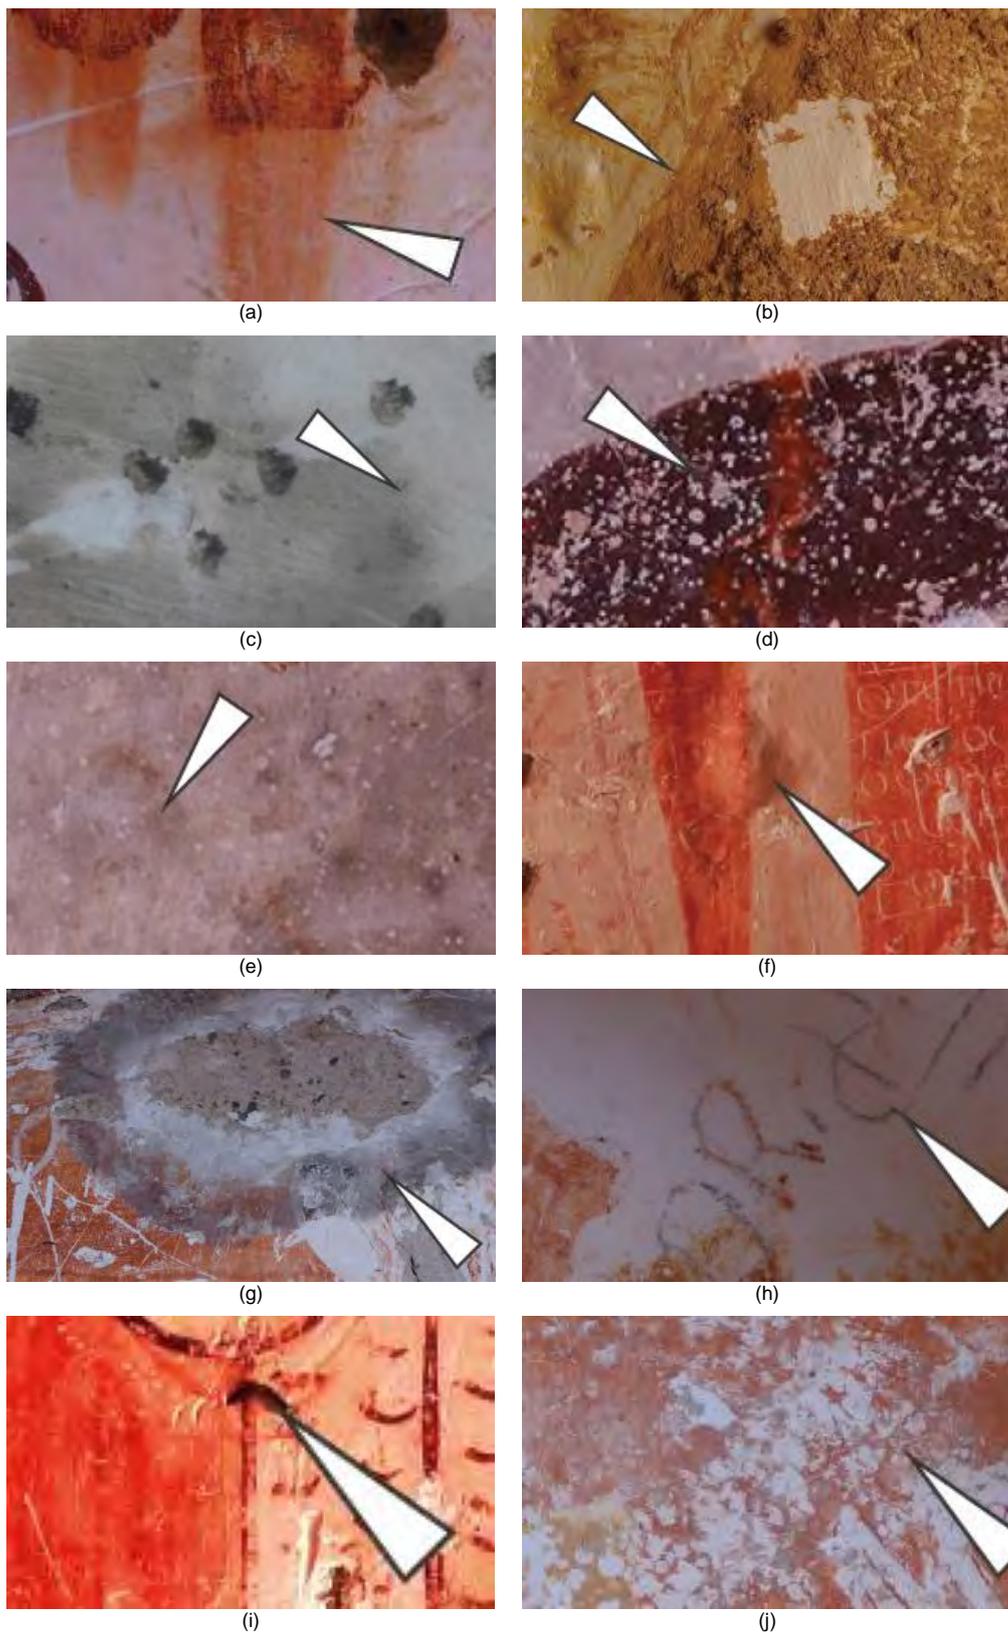
**Figure 15:** Photographs of paint layer deterioration: a) Smearing; b) Surface deposition; c) Dark grey veiling; d) Micro-losses; e) Grey spotting; f) Original fixing; g) Biological deterioration; h) Superficial graffiti; i) Nail; j) Paint loss due to biological activity.

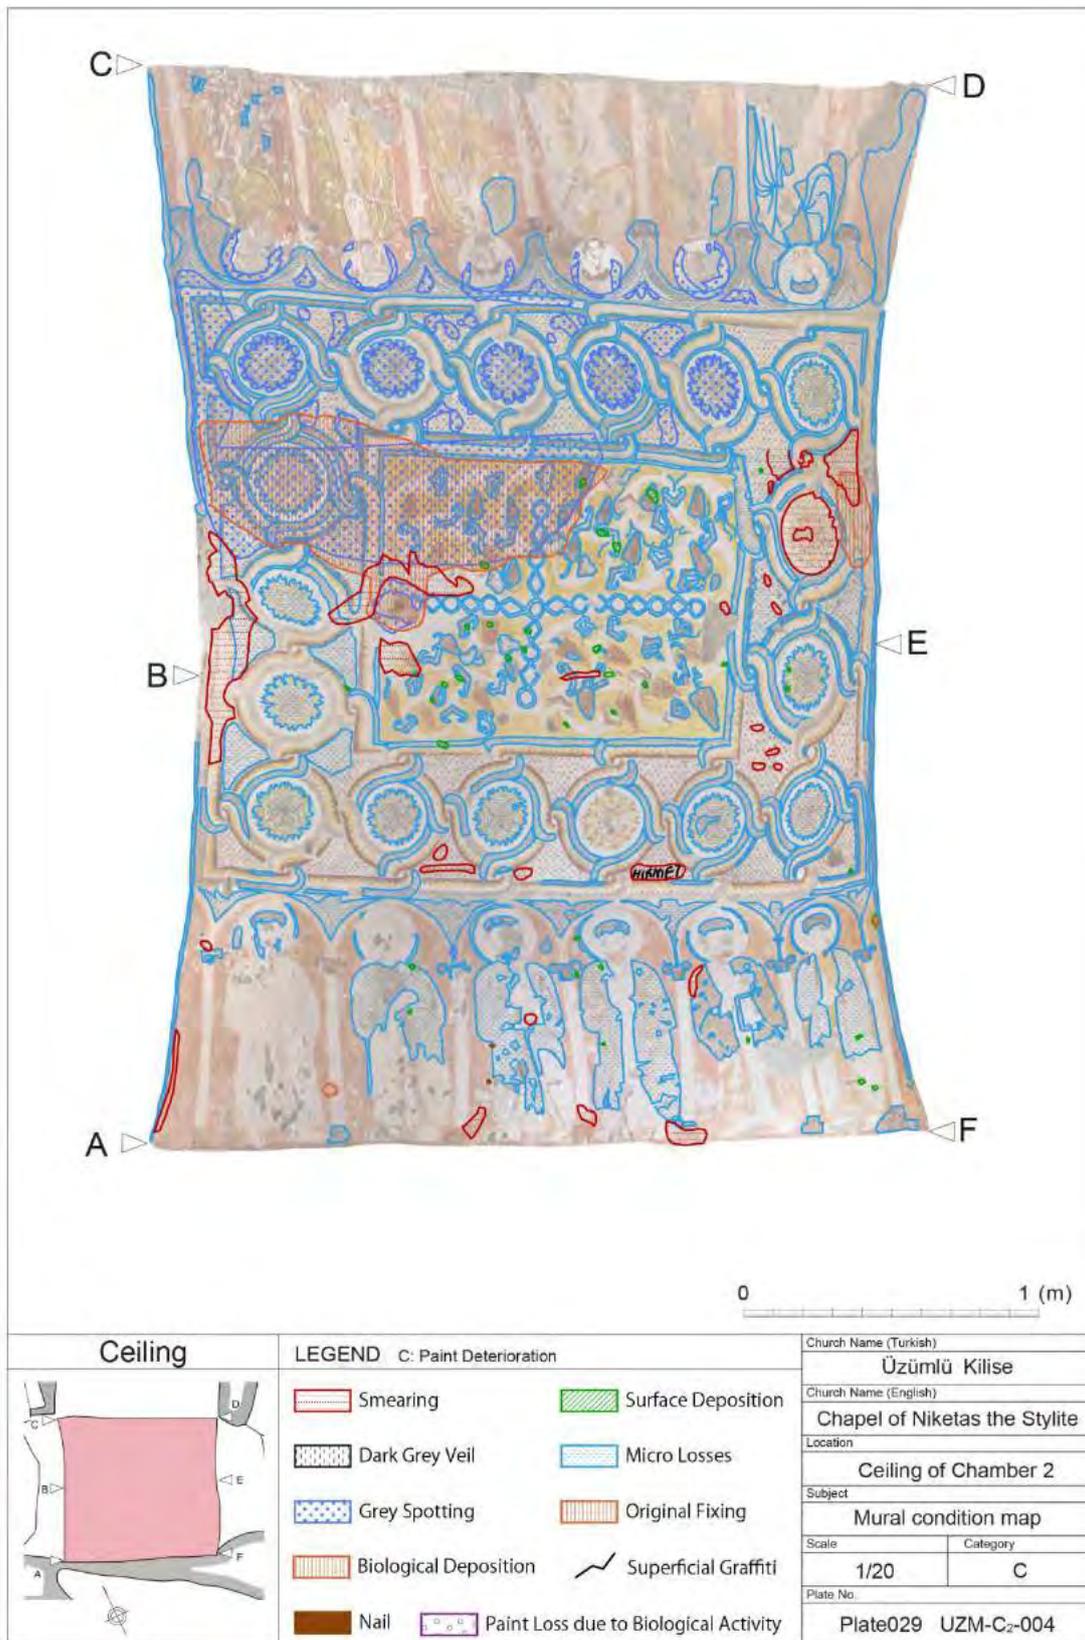
Figure 17: Example of digital image-based documentation of paint layer deterioration on the ceiling in nave

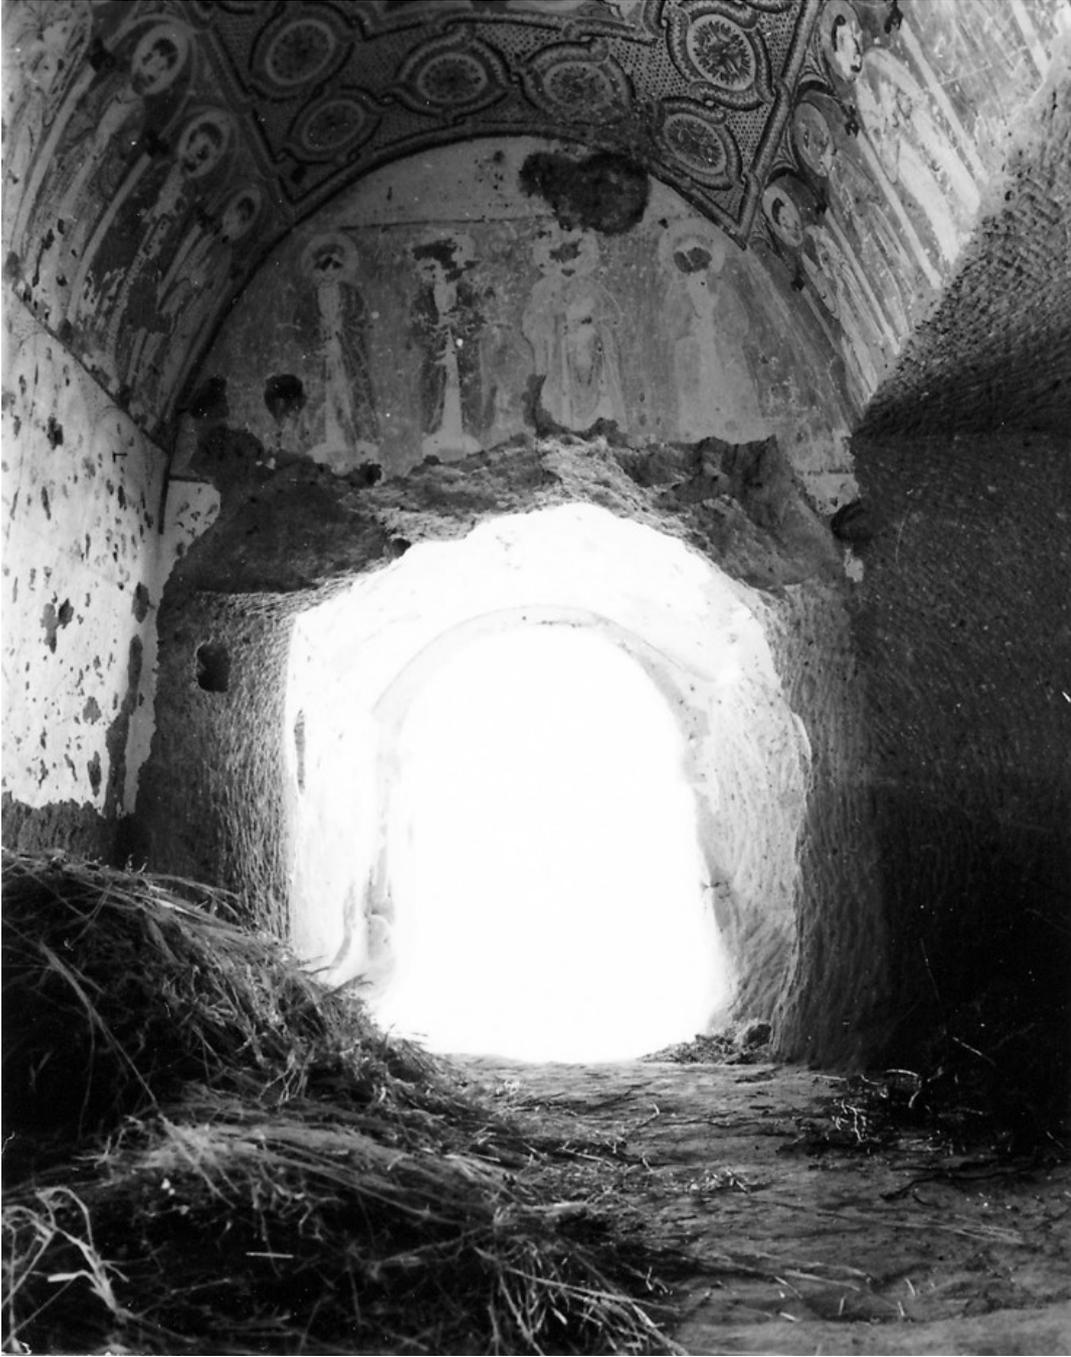
Figure 1b. Transformation from a monastery to a stable for animals was already done by 1970. A pile of hay is seen in the Nave. Interior condition seems to be unchanged.

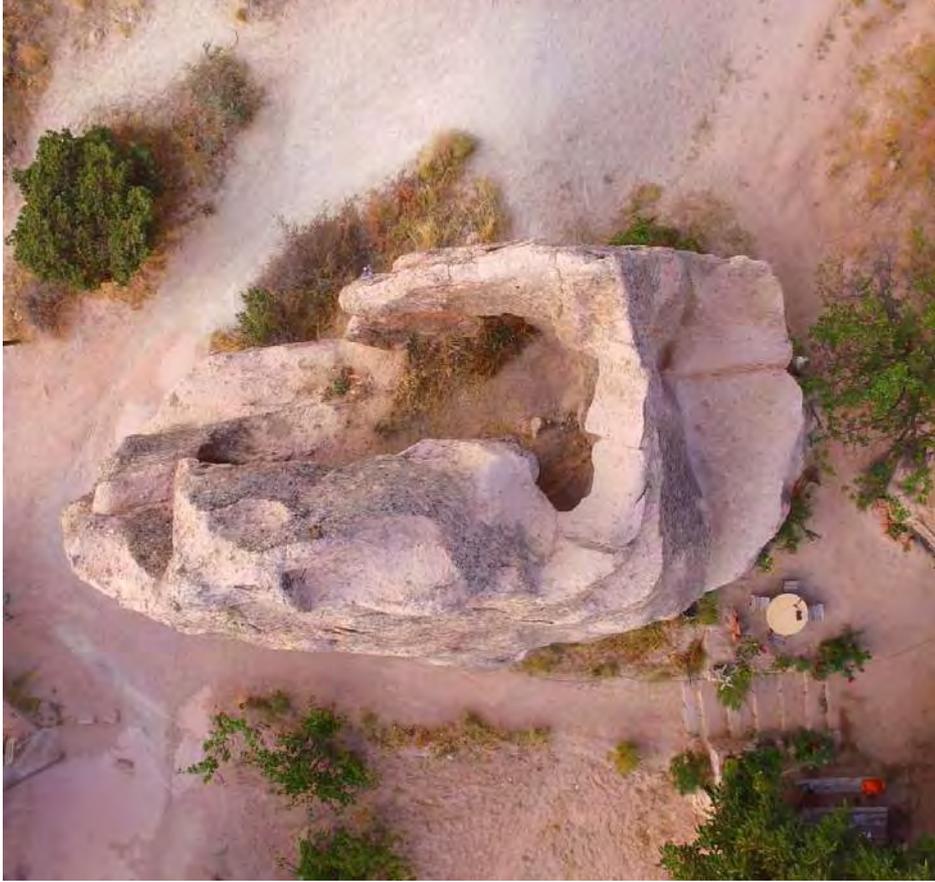
Figure 3c. Condition of the top part of the church in 2015.  
Görsel 3c. 2015 yılında kilisenin üst kısmının durumu.
