Scientific Studies on Conservation for Üzümlü Church and its wall paintings in Cappadocia, Turkey

Vol. 1 : Annual report on the activities in 2014

**University of Tsukuba
2014**

Yoko Taniguchi, University of Tsukuba

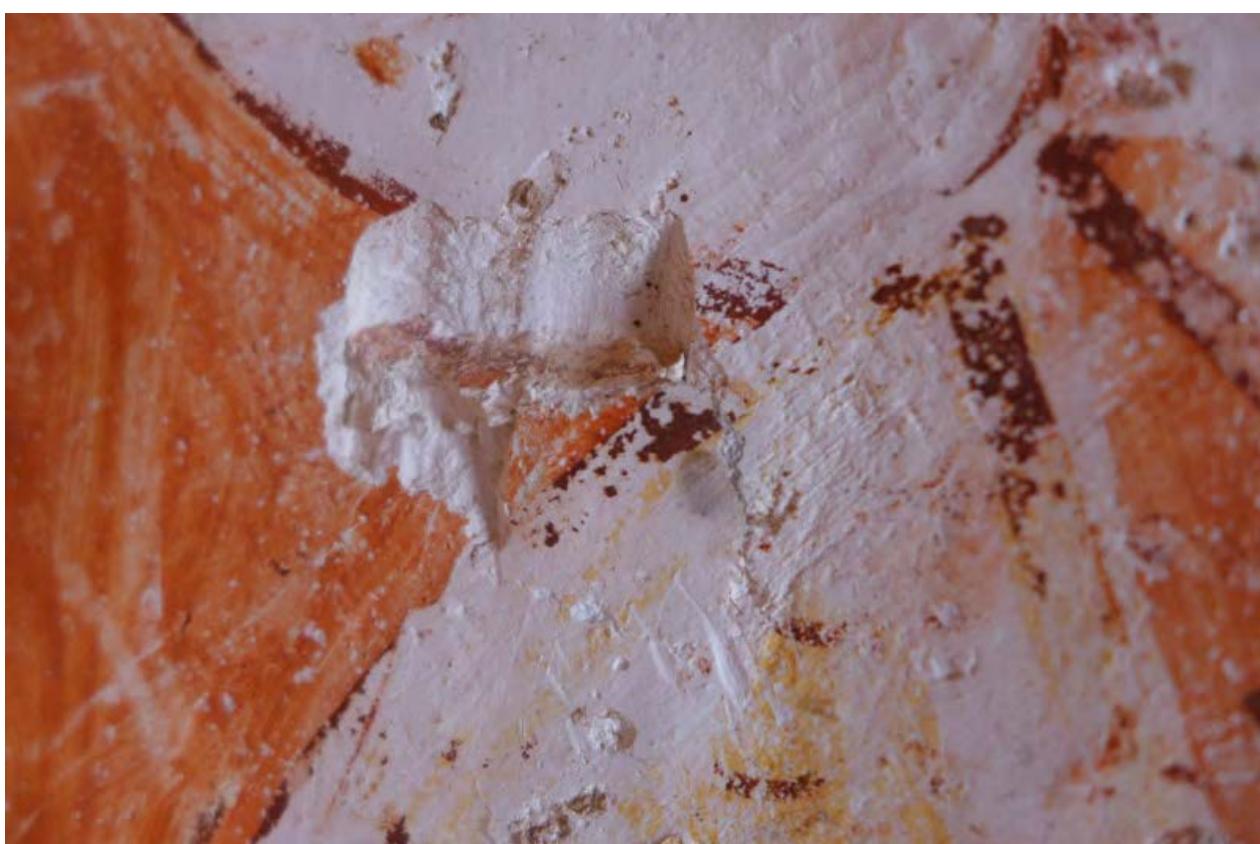
Figure 8. Where damaged through impact, the plaster appears fractured but compressed, suggesting that it is quite a soft material

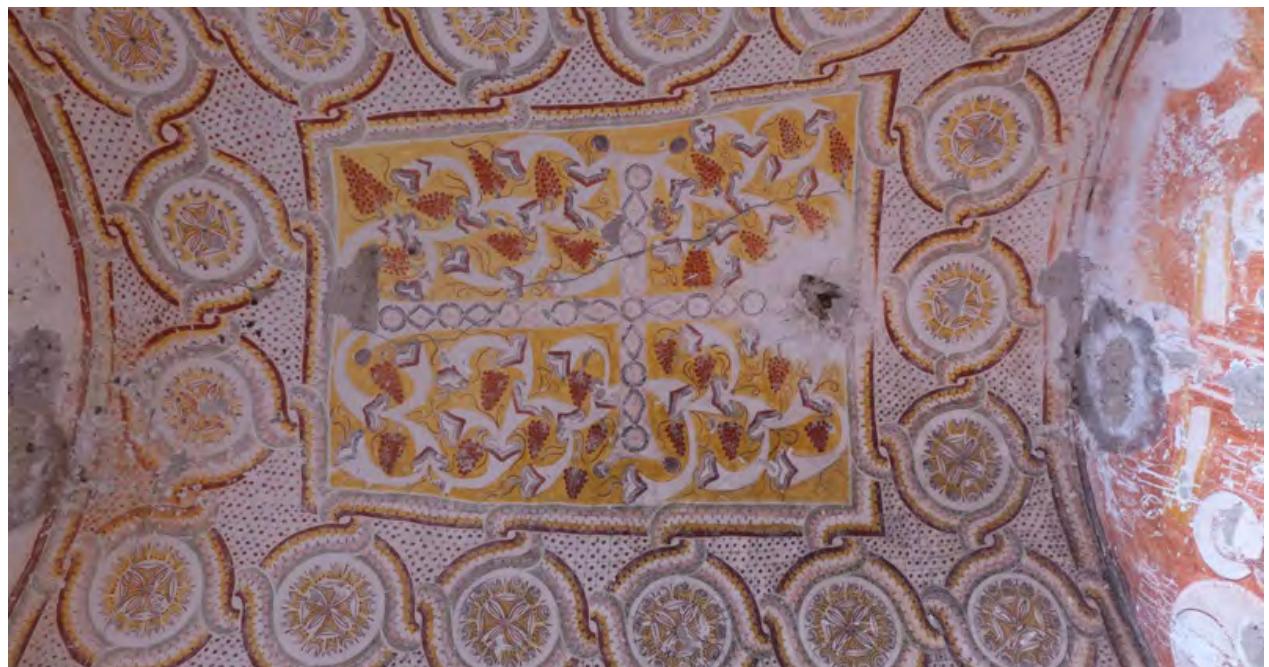
Figure 14. A structural crack can be seen running through the plaster and paint layers on the ceiling of Chamber 2, from east to west

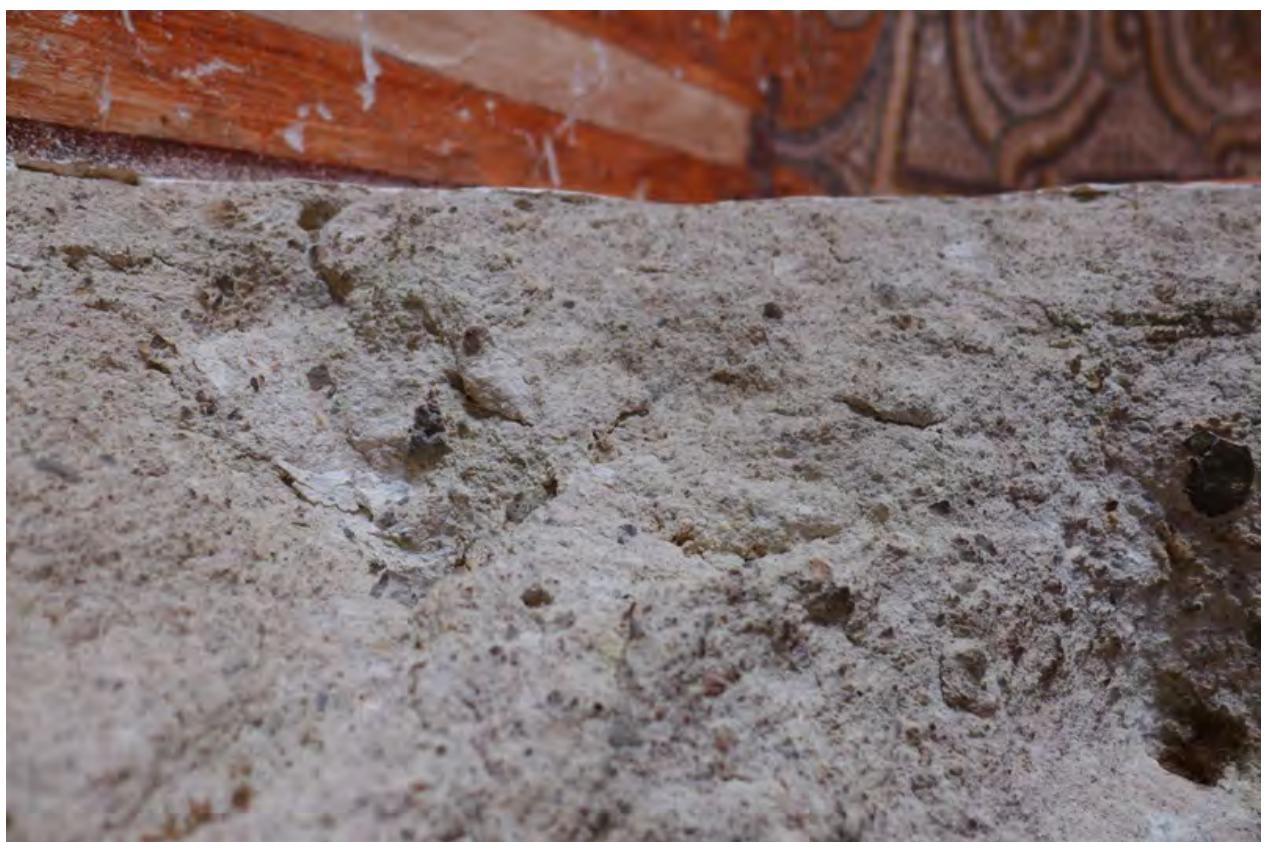
Figure 15. Spalling of the stone was observed in some areas

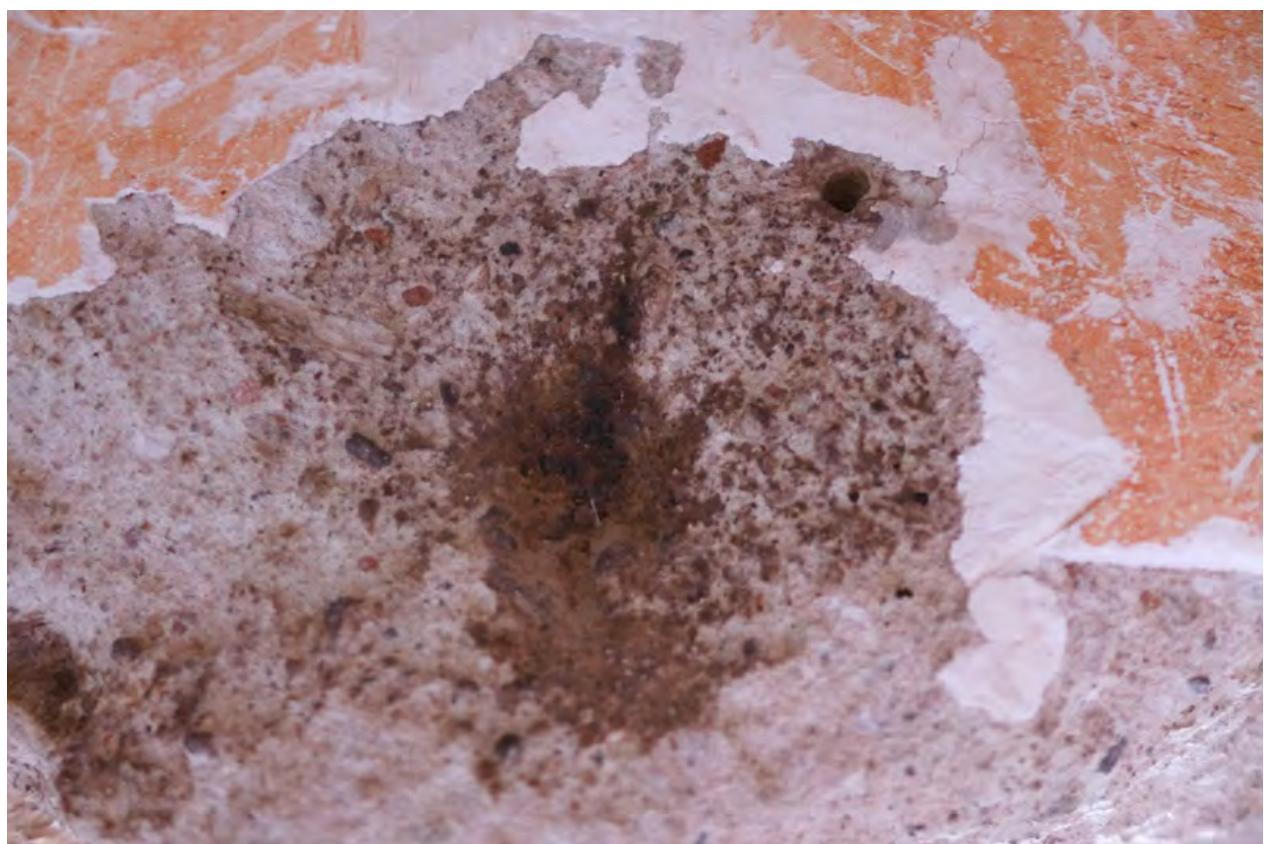
Figure 16. A blackish brown material is deposited in some areas of exposed stone substrate. This may have a biological origin

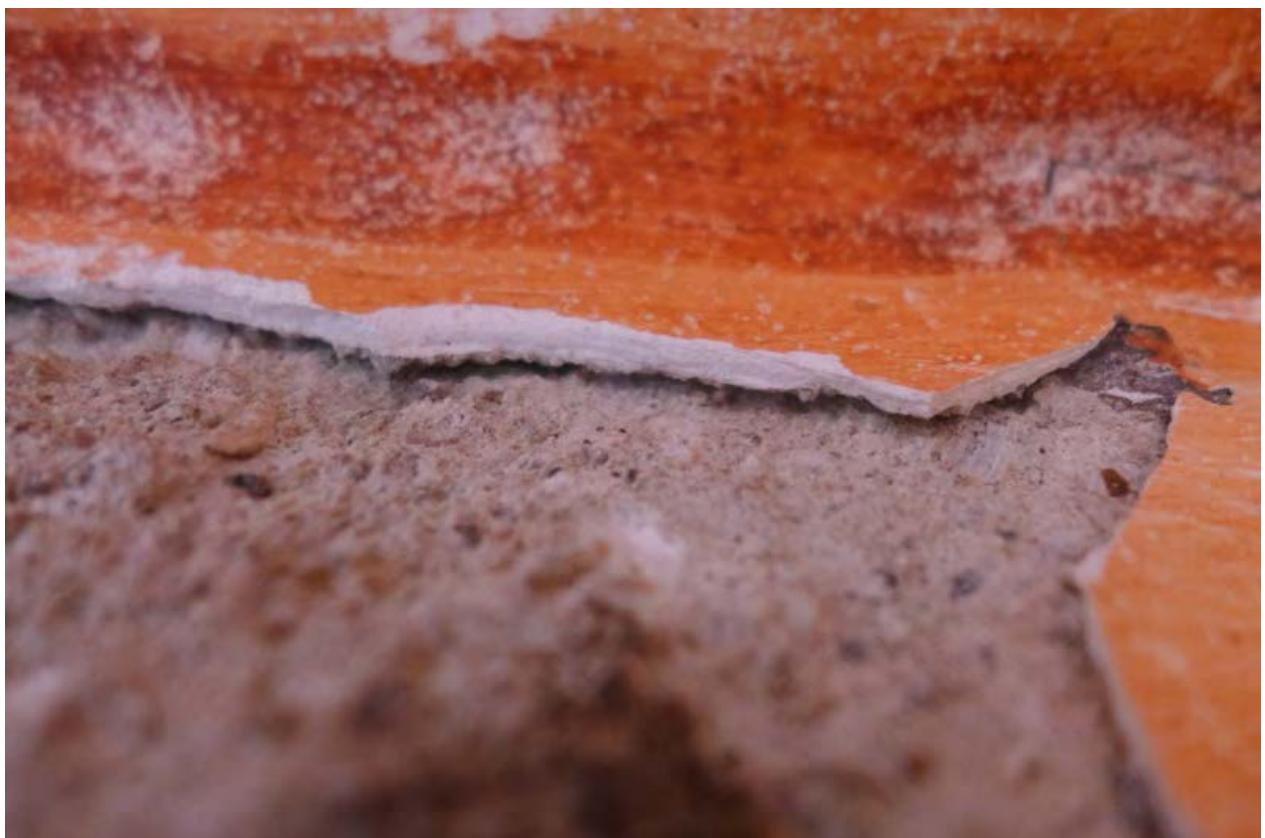
Figure 17. Area of delamination associated with mechanical damage

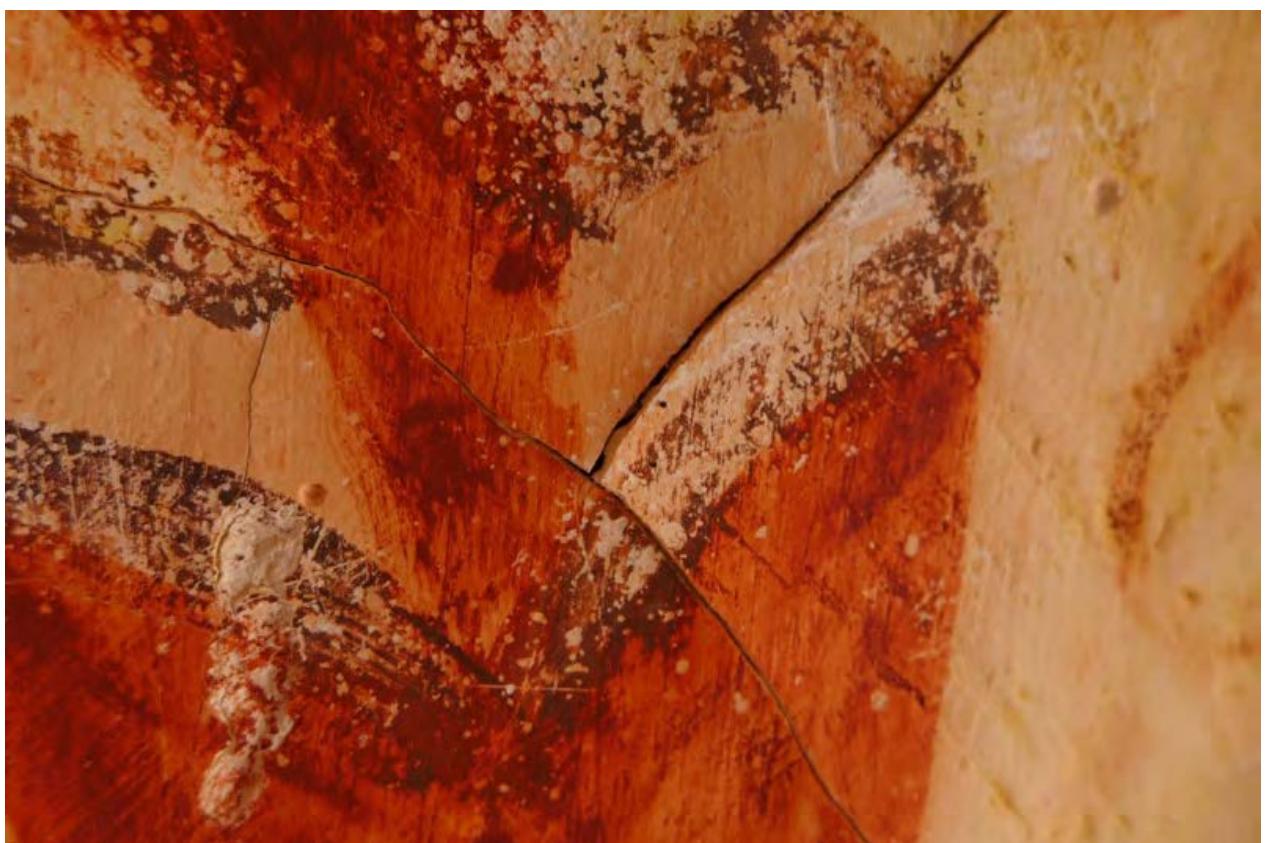
Figure 18. Area of delamination associated with structural cracking

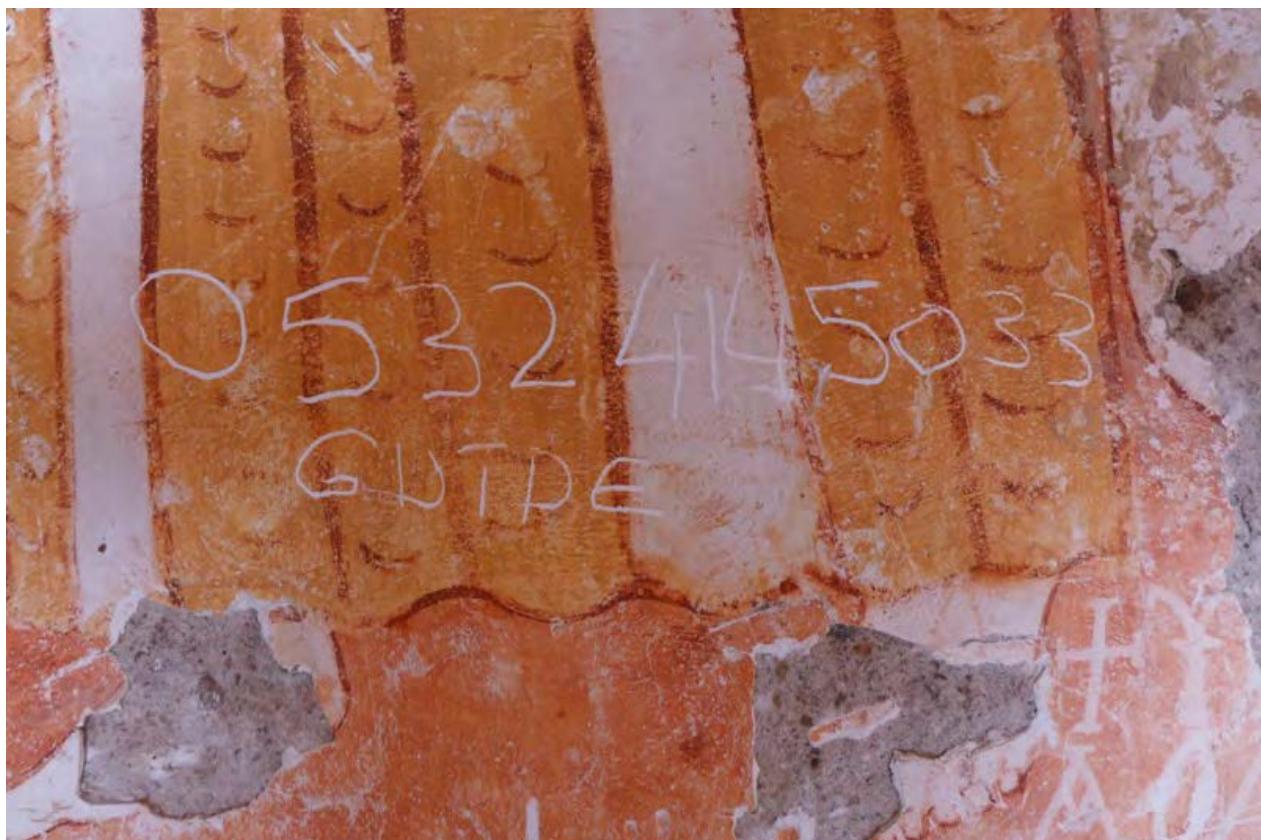
Figure 19. Modern graffiti

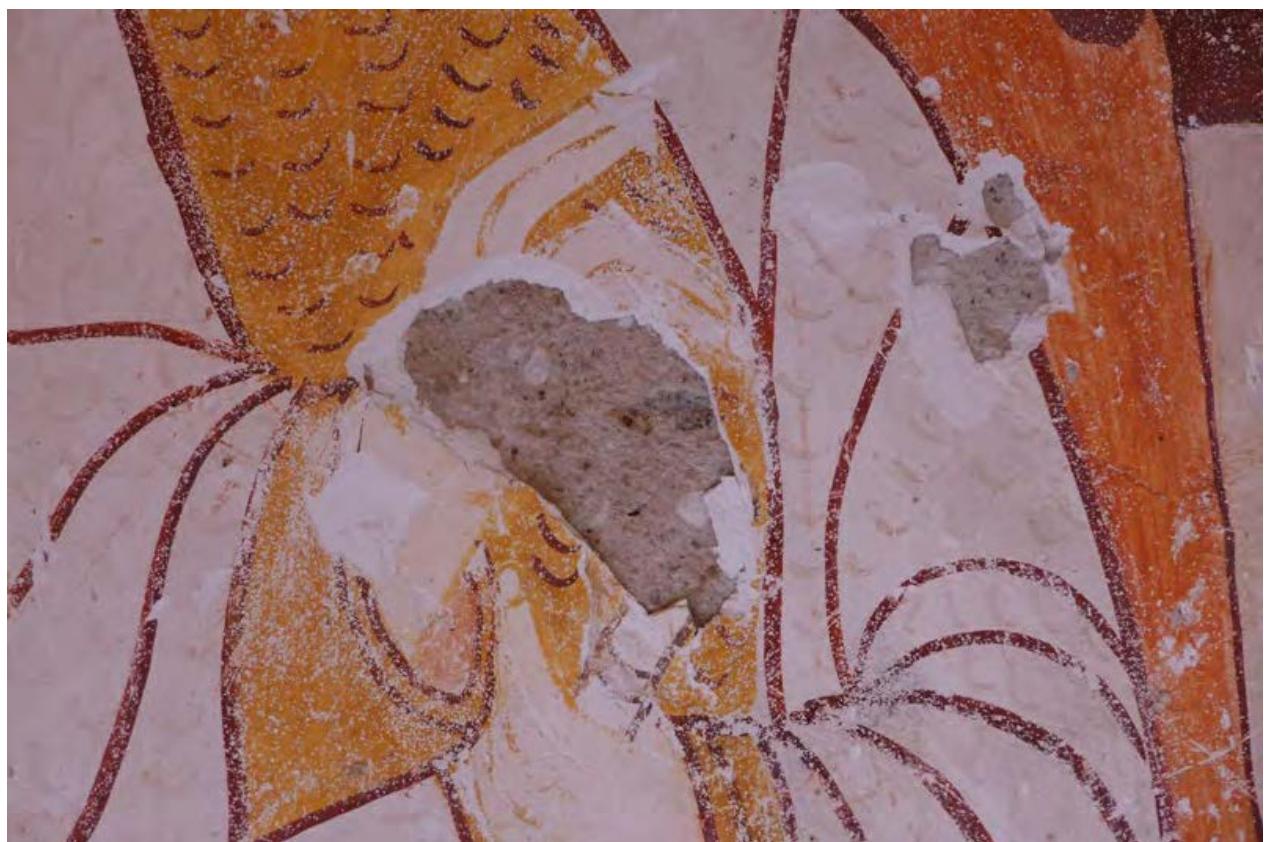
Figure 24. Damage caused by impact

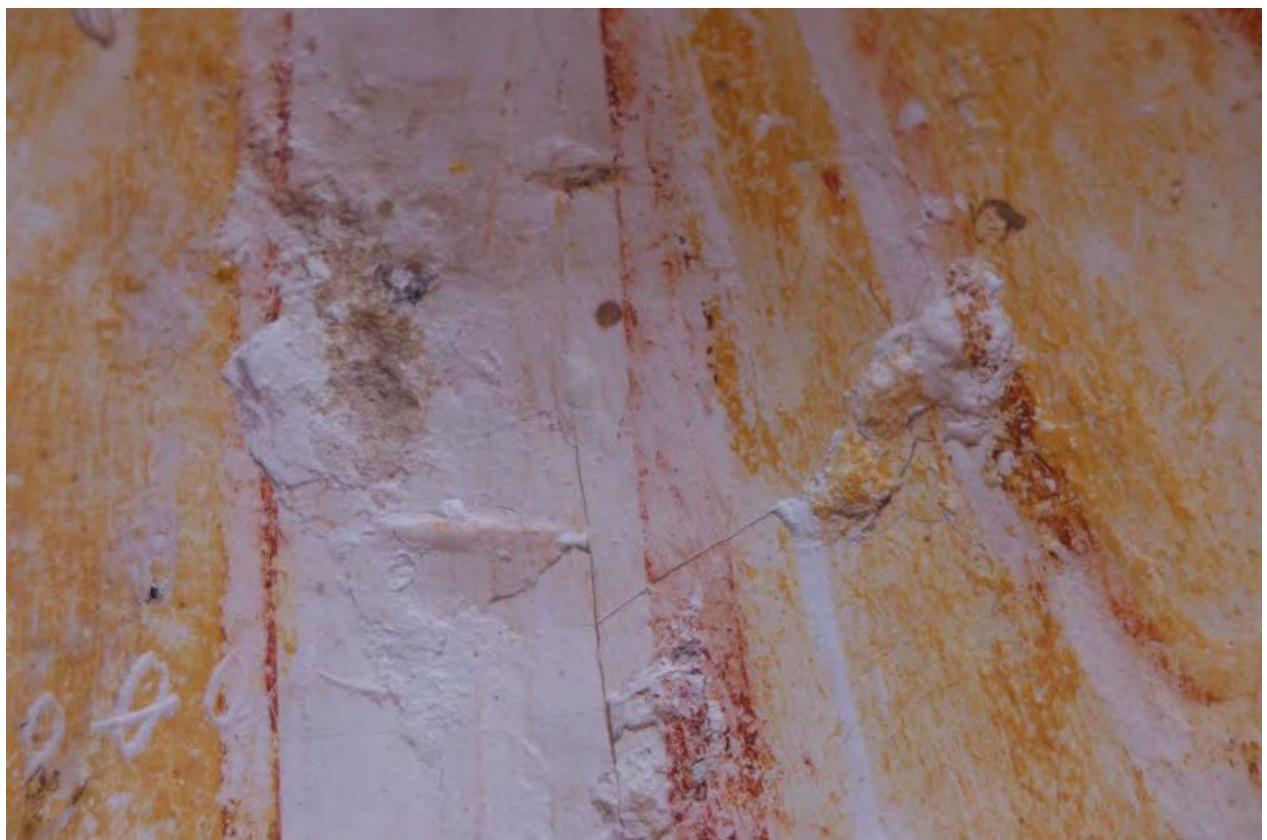
Figure 25. The painting stratigraphy has remained intact despite impact damage

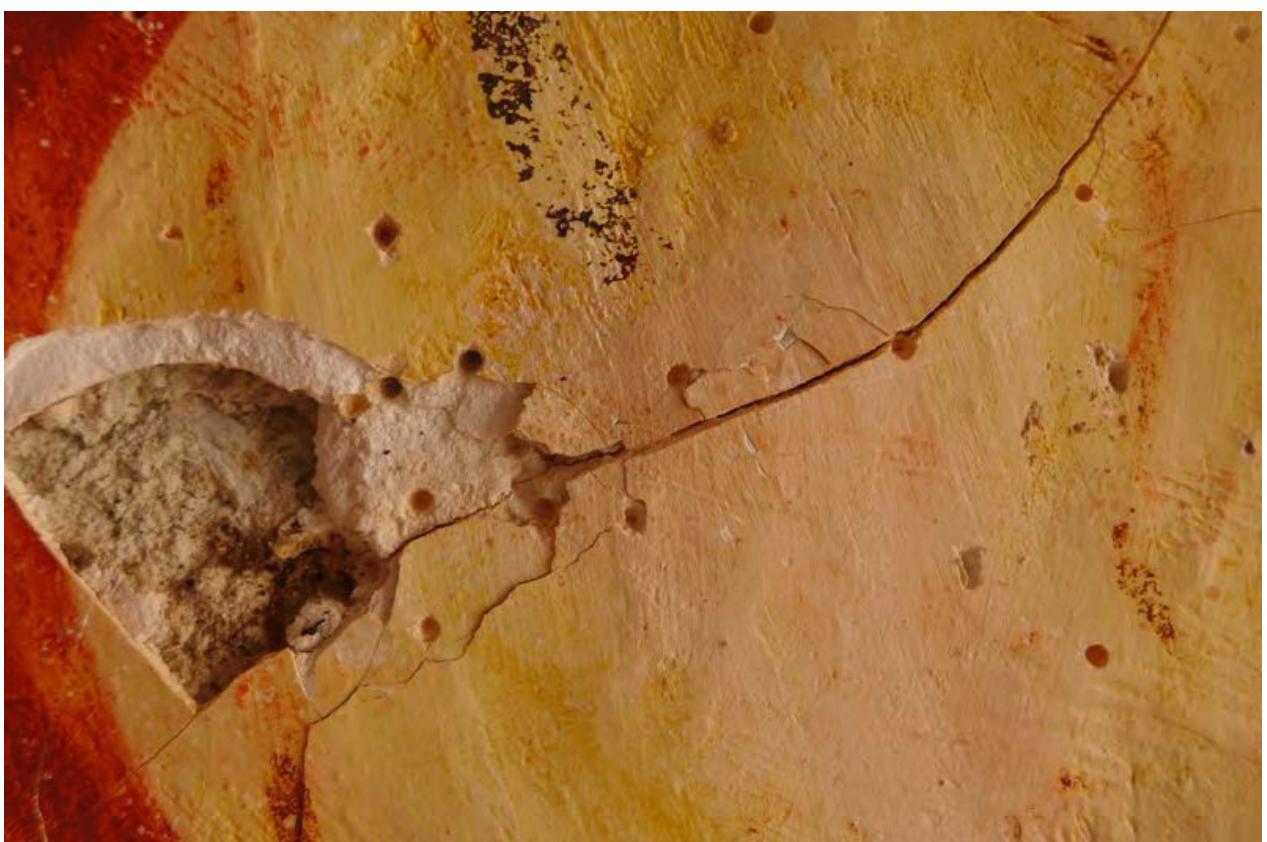
Figure 26. Small and homogenous holes were observed in the plaster layer. Their origin is unknown

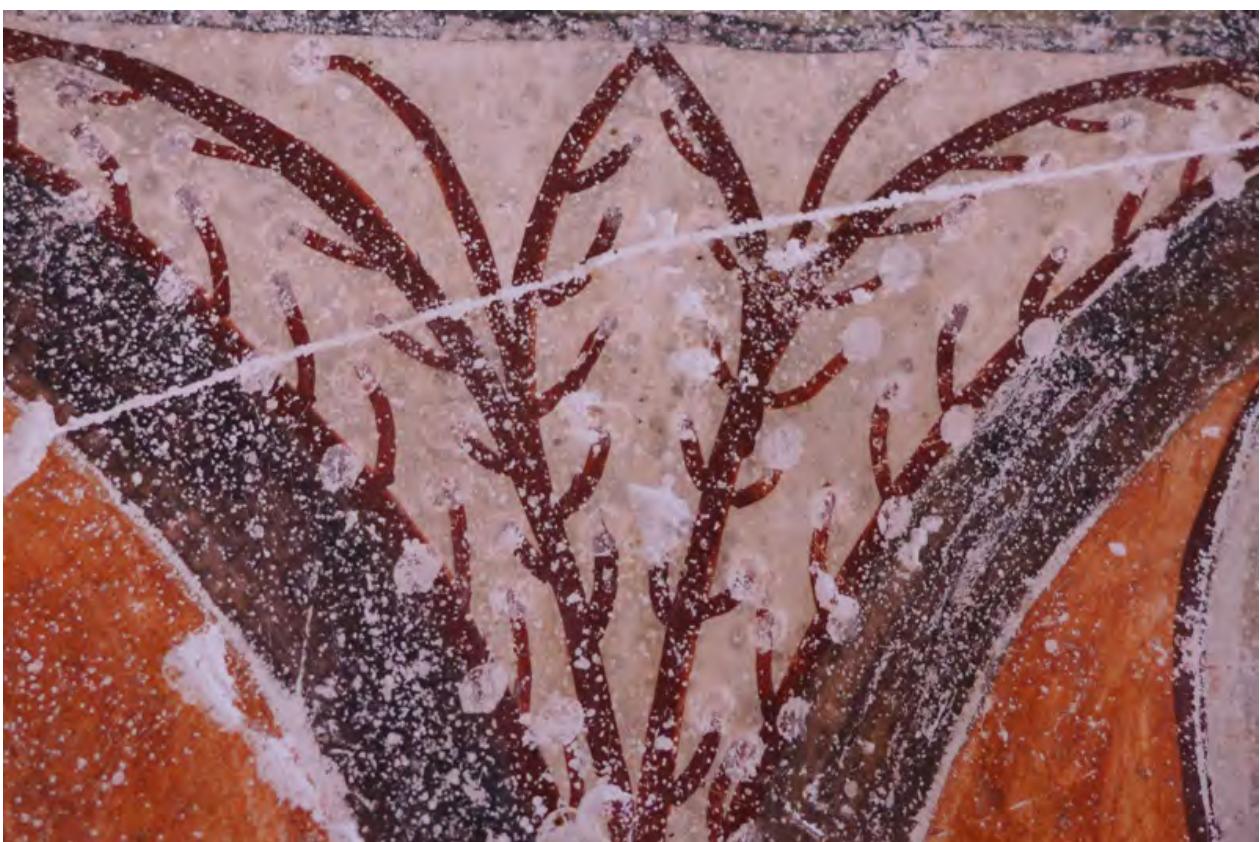
Figure 35. Circular microlosses of the paint layer, and black spotting in adjacent areas
