METHODOLOGY OF HIGH-RESOLUTION PHOTOGRAPHY FOR MURAL CONDITION DATABASE

Symposium Topic D, D-4 Technologies aimed at preventive maintenance and monitoring of sites

KEY WORDS: Photography, documentation, high-resolution image, mural painting, rock-hewn church, Cappadocia

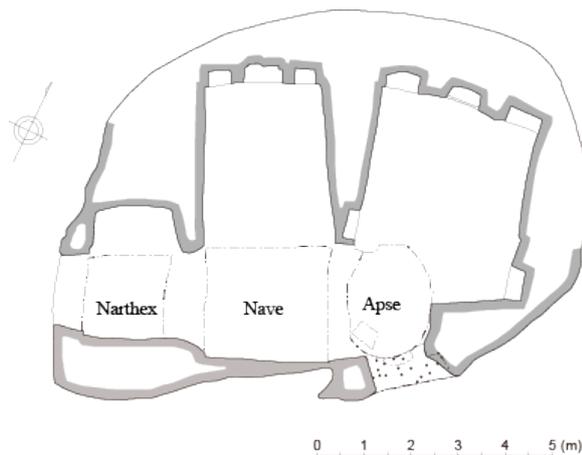
Figure 2. Plan of the Üzümlü church

The Üzümlü church is about 12 m in an east-west direction, and about 8 m in a north-south direction. The church is composed of five chambers (Fig. 2). Although it is unknown how these chambers were used originally, we assume that the three ordered chambers from western entrance to eastwards are "narthex", "nave" and "apse". The two other chambers attaching the north side of *nave* and *apse* may be extra ones, as the ceiling height of these chambers are shorter than the other three

chambers and these two are not covered with mural paintings. The plans of *narthex* and *nave* are imperfect rectangles, and the plan of *apse* is an ellipse. The ceiling of the *narthex* and *nave* are barrel vault and that of *apse* is dome. The two chambers on the north side of *nave* and *apse* are cuboid and were never covered with paintings. Compared with the exposed rock surface of the main chambers, the surfaces of the two chambers are roughly excavated. This obviously may indicate that the main chambers and other chambers were made by different techniques. Therefore, it would seem that the latter two chambers were never painted. Also, these seem to be excavated in a later period.

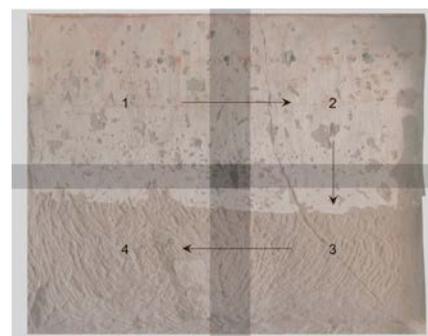
Figure 3. Concept of image merging (the south wall in the *nave*)

Photography was conducted by setting the camera on a tripod horizontally and parallel to the mural painting. Then, the distance between the lens and the mural painting was measured by a digital distance meter. Depending on the dimensions of the mural paintings, the paintings were taken in several shots. When the camera was moved horizontally or vertically, the distance between the lens and the paintings was kept constant, and each shot should contain enough overlap with photographs of adjacent areas, so that the digital merge could be processed successfully. Figure 3 is an example of a merged photograph. In this example, four photos (two rows of two shots) were taken of the wall painting on the south-wall in the *nave*.

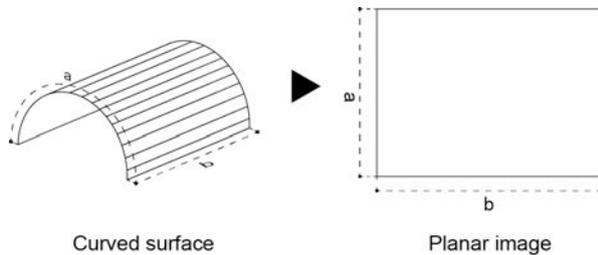
Figure 4. Diagram of conversion from curved surface to planar image

tape. Additionally, the distance between distinctive figures in the mural paintings, such as saints, was measured. When we measured curved surfaces, such as barrel vault or dome, we also measured the inner radial of these in order to make a planar image from the curved surface (Fig. 4).

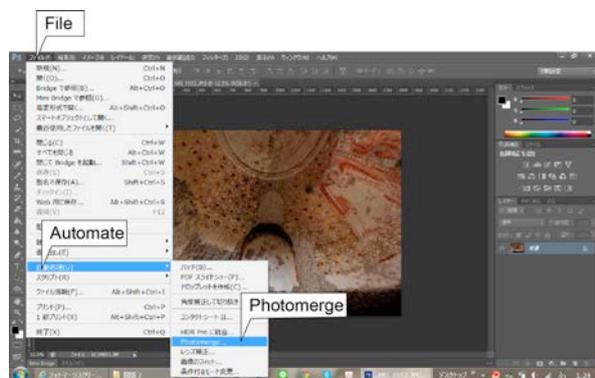
Figure 5. Image merging process 1: "Photomerge" on the menu

- 1) Read files (Fig. 5): read the files to merge. Then select [Automate] in the [File] menu. Then click [Photomerge] and Select [Add Open Files].

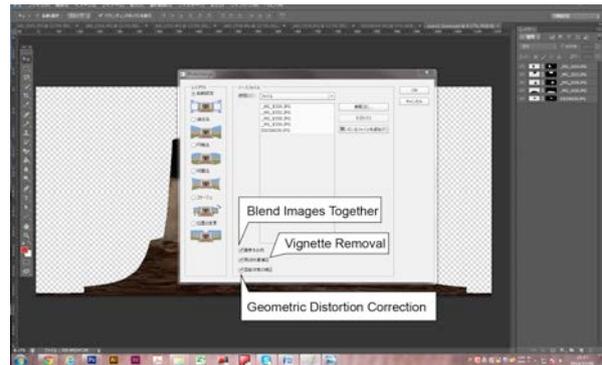
Figure 6. Image merging process 2: Choose the files to combine

- 2) Merge files (Fig. 6): check [Blend Images Together], [Vignette Removal] and [Geometric Distortion Correction]. Then click [OK].
- 3) Check the edge of each of the images (Fig. 7): if the processes above were done correctly, we then check each end of the reading photographs.
- 4) Combine the layers: select [Layer] menu and click [Merge Visible].
- 5) Set the guidelines for revision: select [View] menu and click [New Guide...]. Then move the guides based on the measured places such as Figure 8.

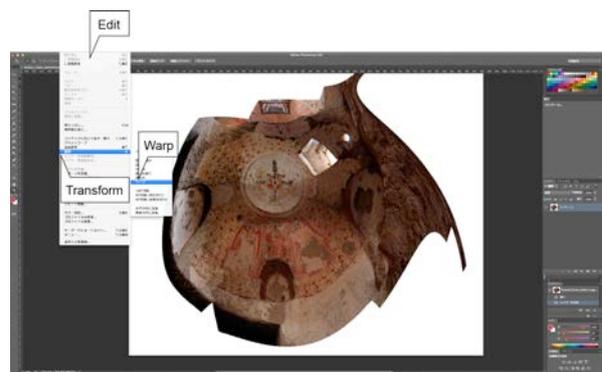
Figure 9. Image merging process 6: Chose "Warp" tool

- 6) Revise the photograph (Fig. 9): select [Edit] menu and click [Warp] from the [Transform] menu, and revise the distorted areas of the merged photographs and adjust them to fit the exact scale.

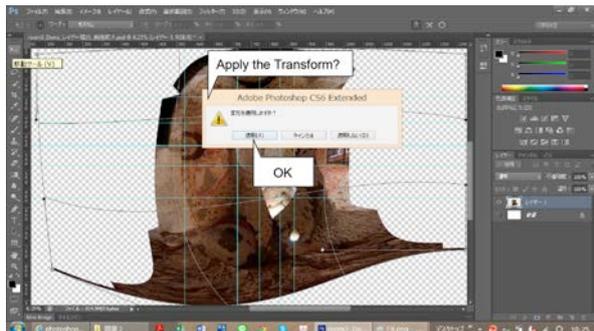
Figure 10. Image merging process 7: Applying the "Warp" tool

- 7) Apply the transform (Fig. 10): after finishing transform, click [Apply] in the window "Apply the transform?"

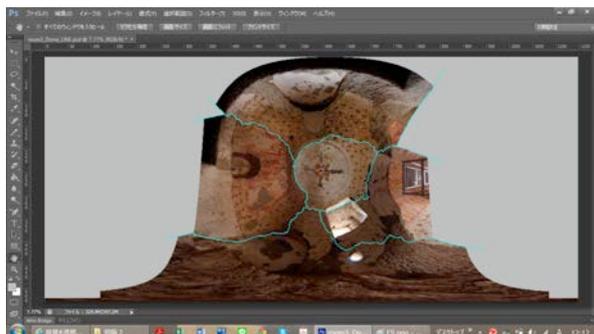
Figure 11. Finished photograph merged five images

Figure 11 is an example of the photograph of the dome, which was merged from five images.

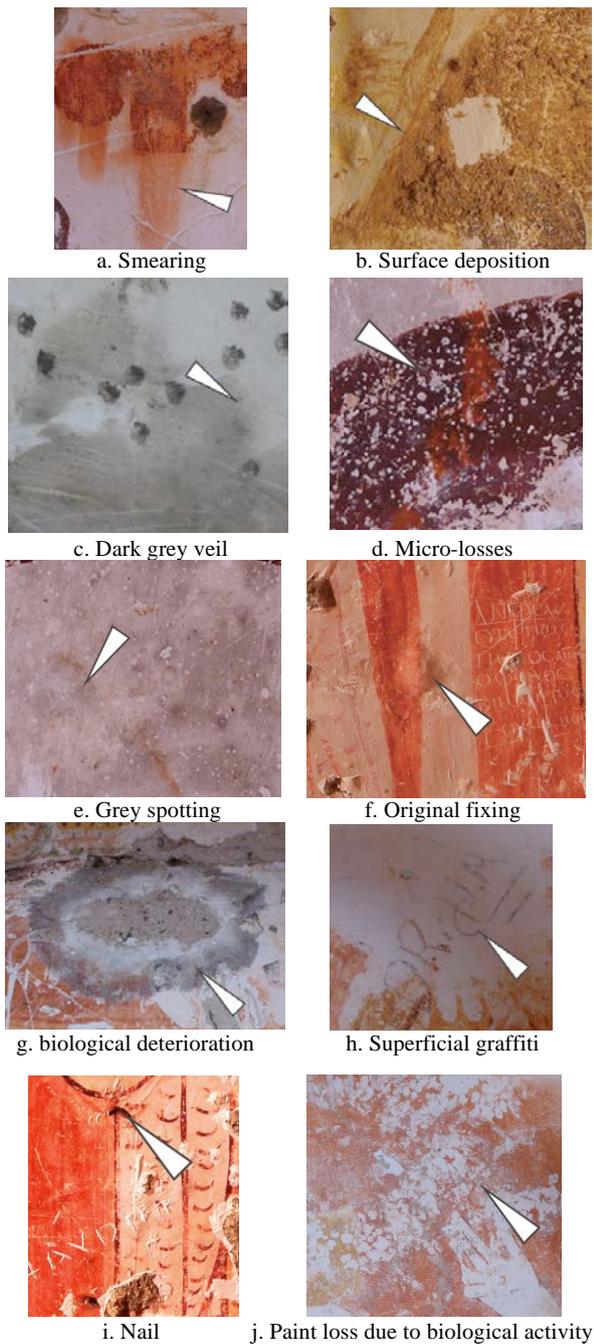
Figure 14. Photos of paint layer deterioration

- c) Paint layer deterioration is identified by ten items: smearing (Fig. 14-a), surface deposition (Fig. 14-b), dark grey veil (Fig. 14-c), micro-losses (Fig. 14-d), grey spotting (Fig. 14-e), original fixing (Fig. 14-f), biological deterioration (Fig. 14-g), superficial graffiti (Fig. 14-h), nail (Fig. 14-i) and paint loss due to biological activity (Fig. 14-j). Smearing is displacement of the paint layer by mechanical action beyond its original location, seen as a spreading of the paint across the surface of the plaster. Surface deposition is deposition of material on the surface of the painting, such as mud from birds' nests or from later construction in the church such as mud plaster. Dark gray veil is veil extending over the surface of the painting, dark gray in color, somewhat patchy, and of unclear origin. Micro losses are extremely small,

rounded losses of the paint layer generally on the order of 0.5-1 mm Ø. Grey spotting is the faint, circular grey spots, 0.5-3 mm Ø, on the surface of the painting. Original fixing is the trace of fixing that may be carried out almost at the same period of mural painting depicted because the colors of this part and around area of that are almost the same. Biological deterioration is discoloration, generally dark gray, of certain areas of painting due to animal inhabitation. Superficial graffiti is the graffiti applied to the surface of the painting using a medium such as paint, ink or graphite. Nail is the part of nail on the paint layer. Paint layer loss due to biological activity is loss of the paint layer due to the former presence of birds' nests primarily which, when separated from the painting surface, removed part of the paint layer.

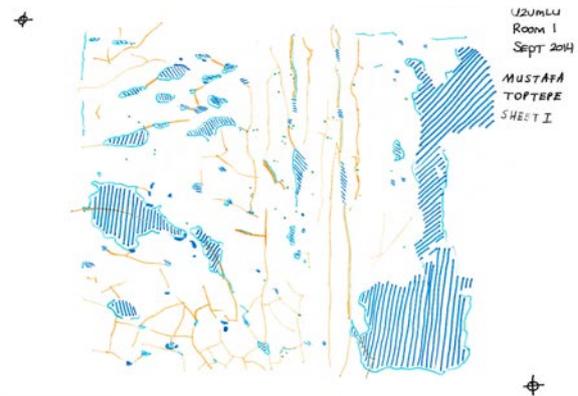
Figure 15. Scanned OHP sheet of plaster deterioration of the ceiling in the narthex

After recording the condition of deterioration of a layer, the OHP sheet was scanned in order to make digital mural condition sheets (Fig. 15). In the case that there were too many items to record an OHP sheet, we used more than two OHP sheets to record one layer. Using Adobe Illustrator, we traced the scanned data with a pen tool. The traced deterioration places were divided into different layers by each item of deterioration. Therefore, one mural condition sheet can show the deteriorated places of selected items in one layer. Then, the scale of mural condition sheets was adjusted to 1/10, 1/15, 1/20, 1/25. As we checked the deterioration of each layer of the mural paintings, we produced 39 mural condition sheets and 13 photographs of mural paintings for the digital heritage inventories. Figure 15 is one of the examples of digital heritage inventories, which is the paint layer deterioration of the ceiling in the nave.
