'Ain Dārā Temple

A Series of Photogrammetry for Protection of
Syrian Cultural Heritage

Damage Assessment and Current Condition of 'Ain Dārā Temple

3D model and Digital Plan of ‘Ain Dārā Temple

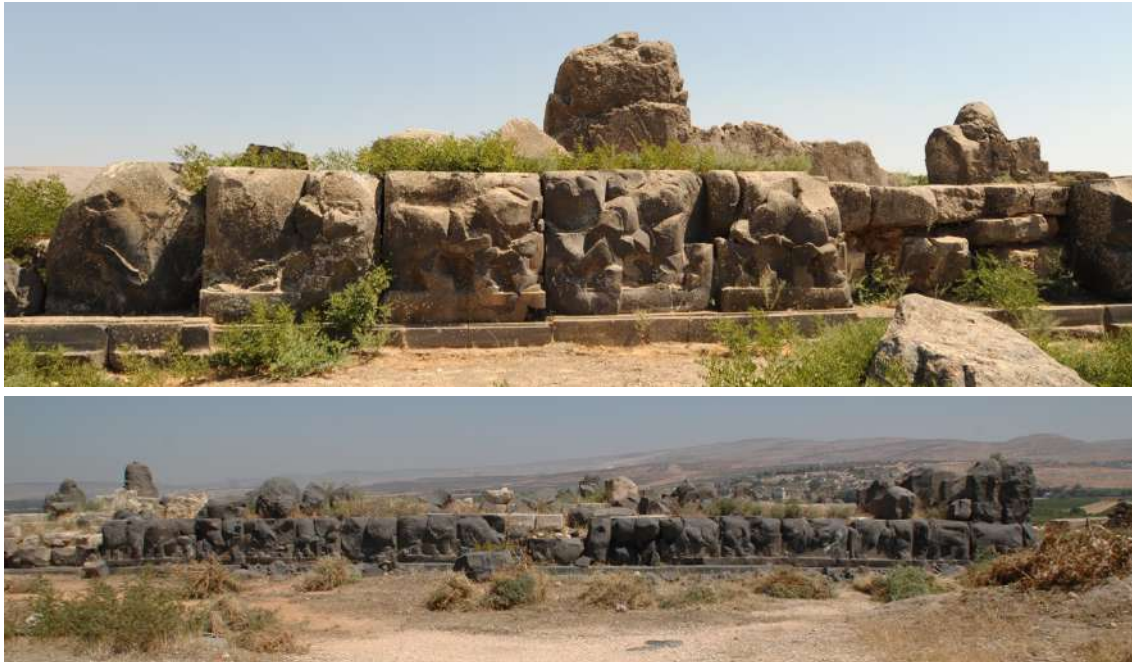
It was built on a low platform and consisted of a portico, an *antecella*, and a *cella*. The building's exterior and interior facades are decorated with a series of Syro-Hittite style basalt reliefs of sphinxes, lions, animal protomes, and creatures with large claws and their remaining feet (Abu Assaf 1990). The temple was surrounded by corridors on three sides. The southeast, southwest and northwest exterior facades are well preserved and decorated with lions and sphinxes with turned heads and faces (Figure 3).

Fig. 3 Upper: Northwest facade.
Lower: Southwest facade. Photos taken by T. Hayashi in 2007

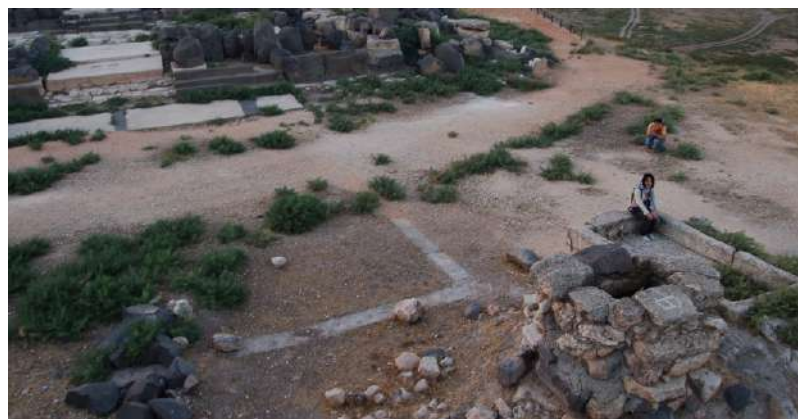
In the courtyard near the entrance, located to the southeast, there was a well and a large stone basin probably used for washing or for ceremonial purposes (Nova'k 2012) (Figure 4).

Fig. 4 Well and stone basin in the temple's courtyard.
Photo taken by K. Shimogama in 2006

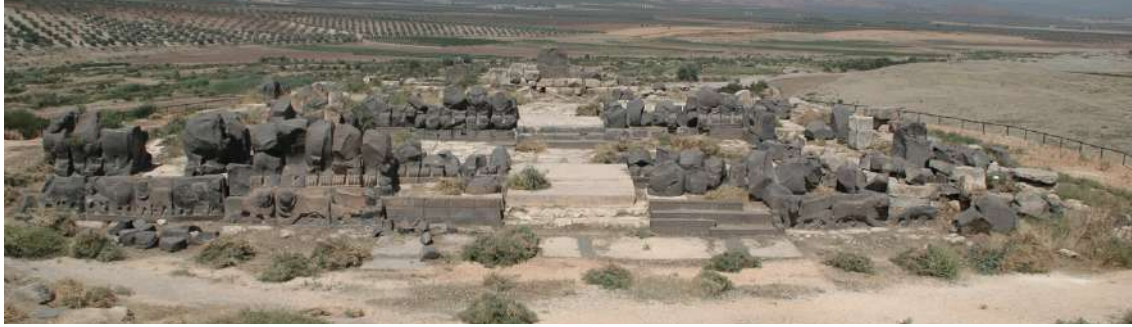
A staircase with a sphinx and two lions on either side led to the portico entrance of the temple (Figure 5).

Fig. 5 The entrance of Ain Dara temple. Photo taken by T. Hayashi in 2007

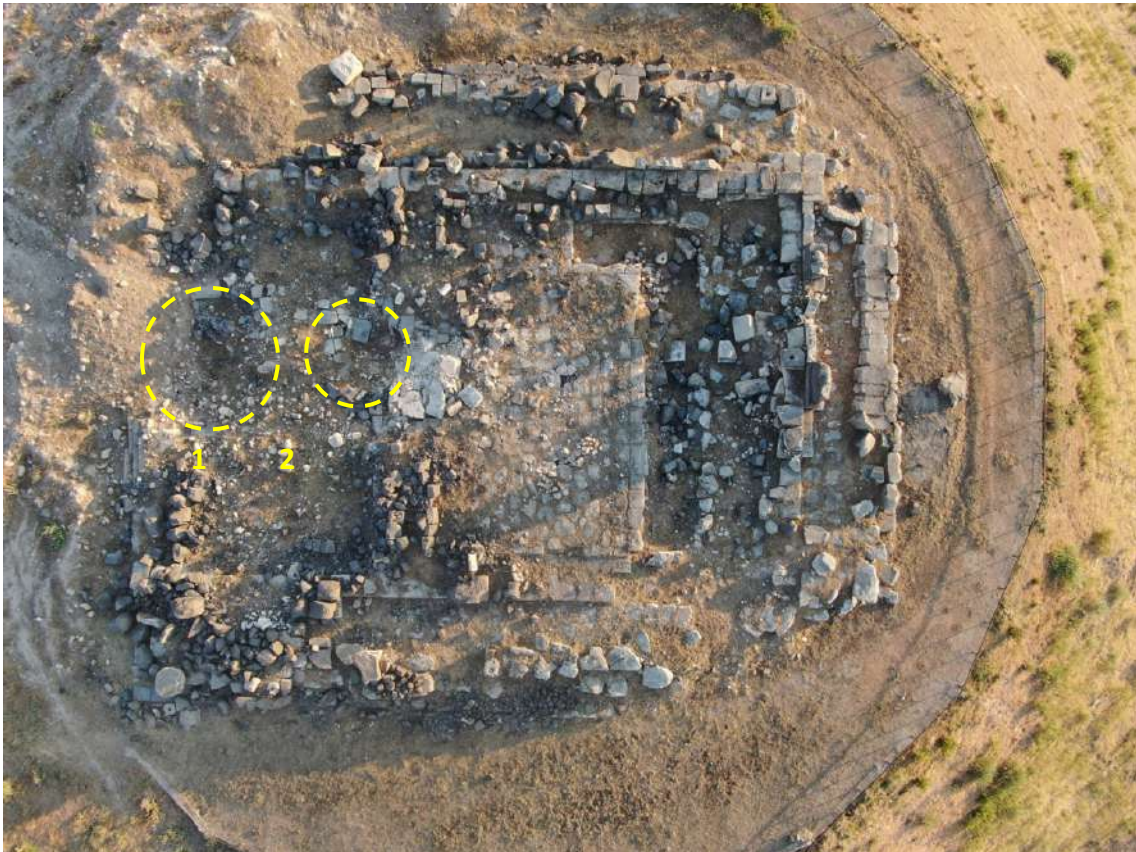
The attack left two large craters in the temple (Figure 6). The location of the first crater was at the entrance where two thresholds are located between the portico and *antecella* (one threshold is carved with pair of two footprints and the other is carved with a single left footprint). The second crater was on the third threshold carved with a single left footprint and located at the entrance of the main hall. The strike appears to have hit the southwestern half of the threshold; however, the other half was severely fragmented. These three thresholds have been completely reduced to rubble and the famous monumental footprints carved into them are gone.

Fig. 6 General view of Ain Dara temple showing two craters

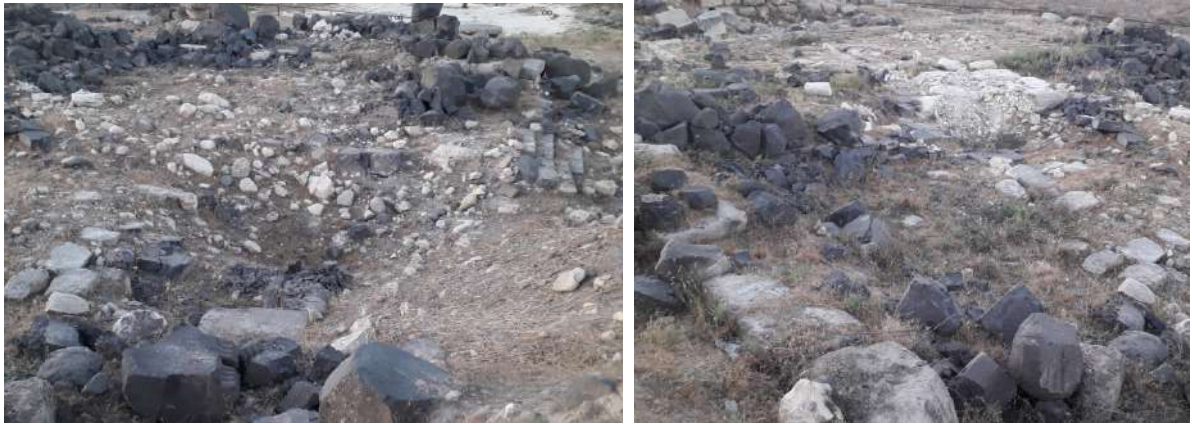
The first crater was larger and deeper than the second (Figure 7). The first is about 6 meters in diameter and the second is about 4 meters in diameter, and the depth of both is more than 1.5 meters. Fragments of the stones were scattered throughout the site. The density of small fragments was high in the southeast corner.

Fig. 7 Craters 1 and 2 caused by the attack

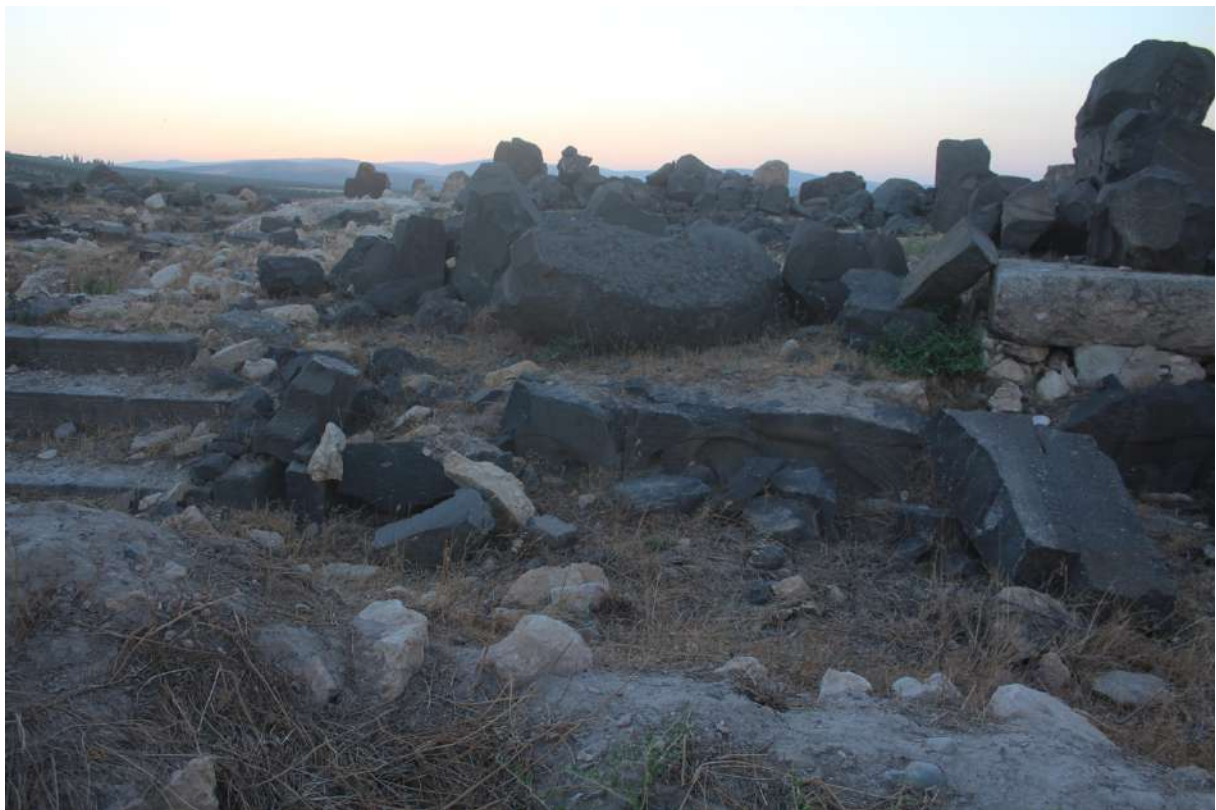
The blast has severely destroyed the temple entrance and most of the sculptures and reliefs have been badly damaged. The portico, staircase and columns bases were destroyed. The basalt stairs on the right were damaged and fragmented (Figure 8). The sphinx and lion blocks on the right of the entrance have been destroyed and only the lower parts near the base remained, where the sphinx and lion's legs can be seen. Further, the basalt blocks above and to the right of these sculptures were fragmented and moved from their original location due to the explosion.

Fig. 8 The two sphinxes on the right side of the entrance

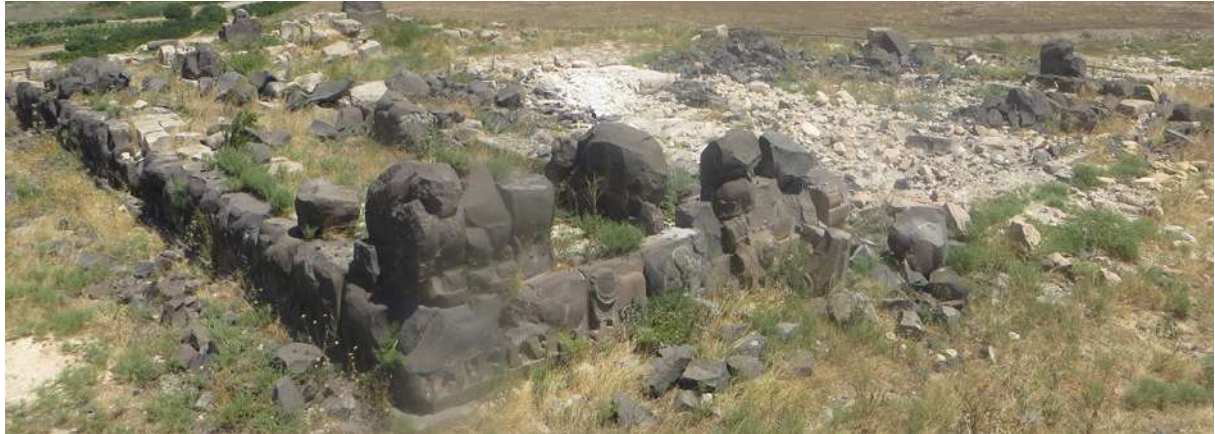
The left side of the entrance consists of several basalt blocks. To the left of the entrance, there is a wide basalt block decorated with intertwined curves. Behind this decorated block is a column base, and behind it, there is a series of at least three blocks carved with creatures with large claws. All these components have been destroyed however, the remaining parts were cracked or fragmented (Figure 9).

Fig. 9 A view from the south corner

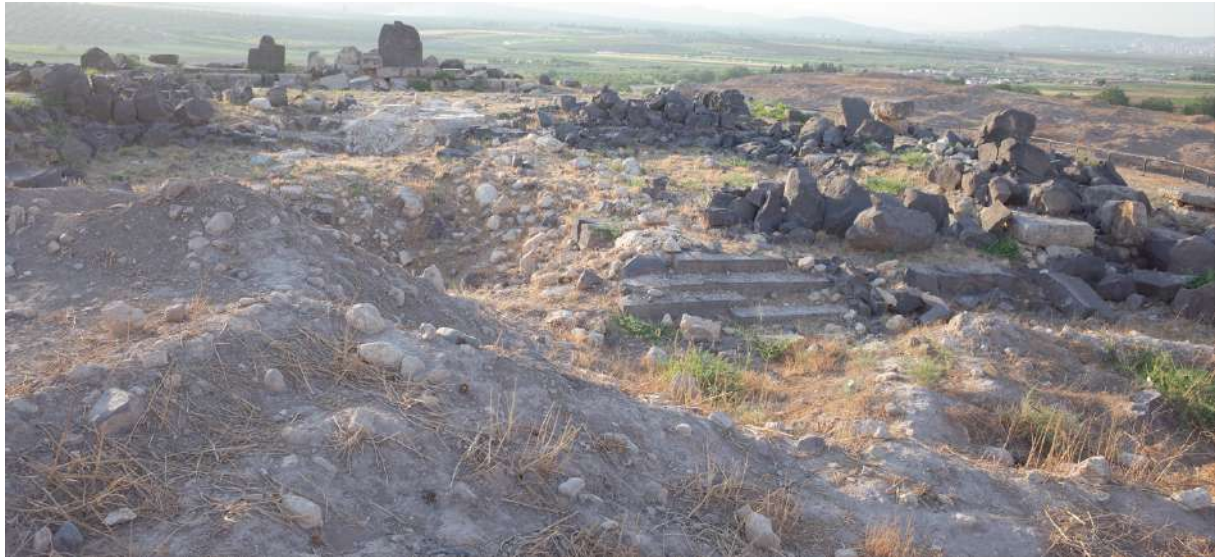
The most damaged part of the temple is the *antecella* (Figure 10). As mentioned, the attack left two craters on the thresholds between the entrance of the temple and the entrance of the main hall. Therefore, all the reliefs, sculptures, decorations, and floor paving have been badly damaged. On the right side of the *antecella*, the decorated blocks with intertwined curves, the imitative window and the carved creatures with large claws above have been destroyed. Decorative blocks on this side of the *antecella* do not exist.

Fig. 10 A view from the south showing the two craters and *antecella*

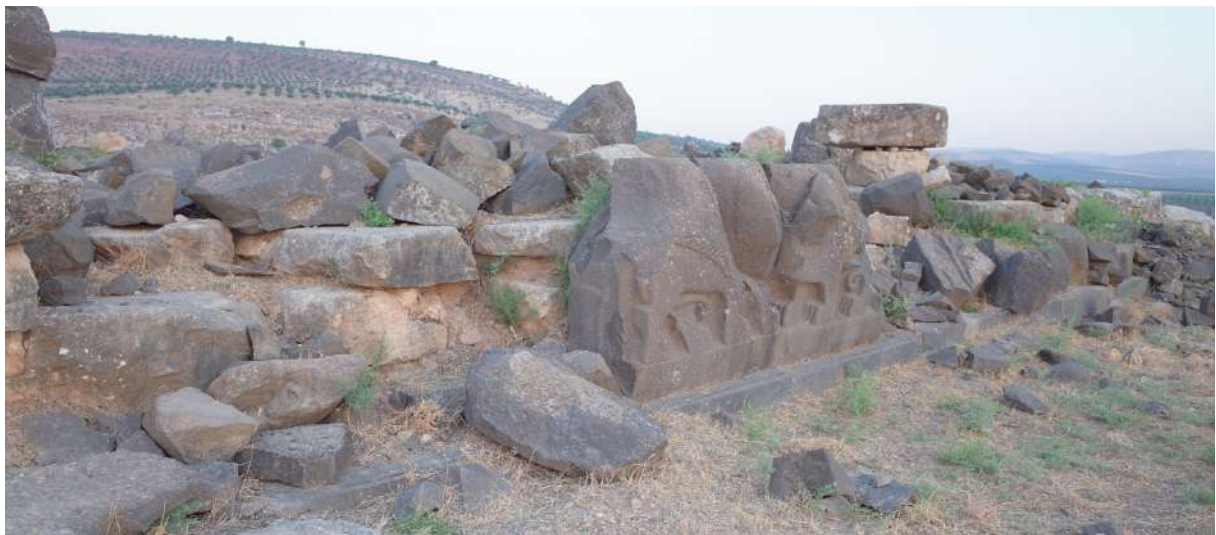
The effects of the blast not only damaged this part of the *antecella*, but also the damage reached the outer facade of the corridor in the northeast. The partly decorated facade with lions was affected and several blocks fell down (Figure 11). There were many basalt stone fragments that probably belonged to the outer facade of the corridor or had been scattered by the blast.

Fig. 11 The corridor's northeast facade

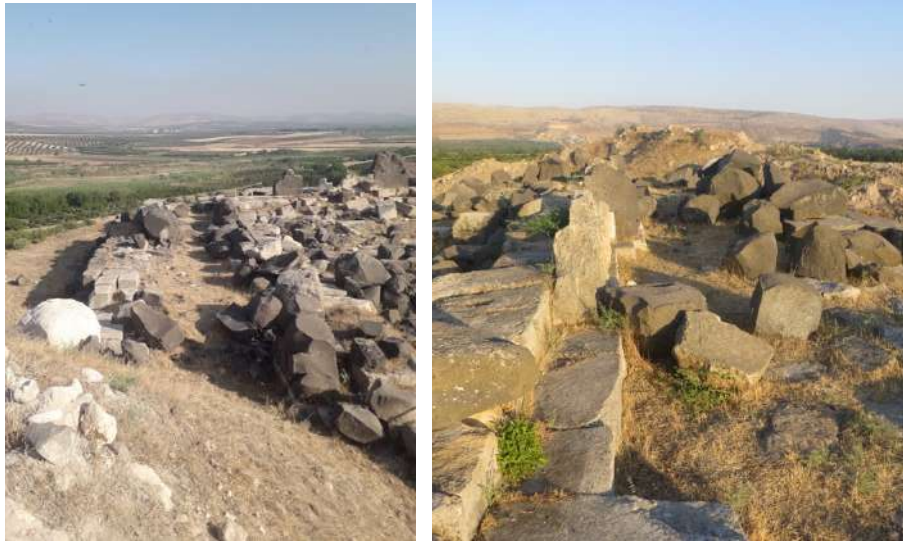
The three basalt steps before the threshold leading to the main hall have been destroyed. Similar to the right side of the *antecella*, the decorated blocks with intertwined curves and the carved creatures with large claws have been destroyed and the stone fragments scattered (Figure 12).

Fig. 12 The corridor on the west side showing the block fragments

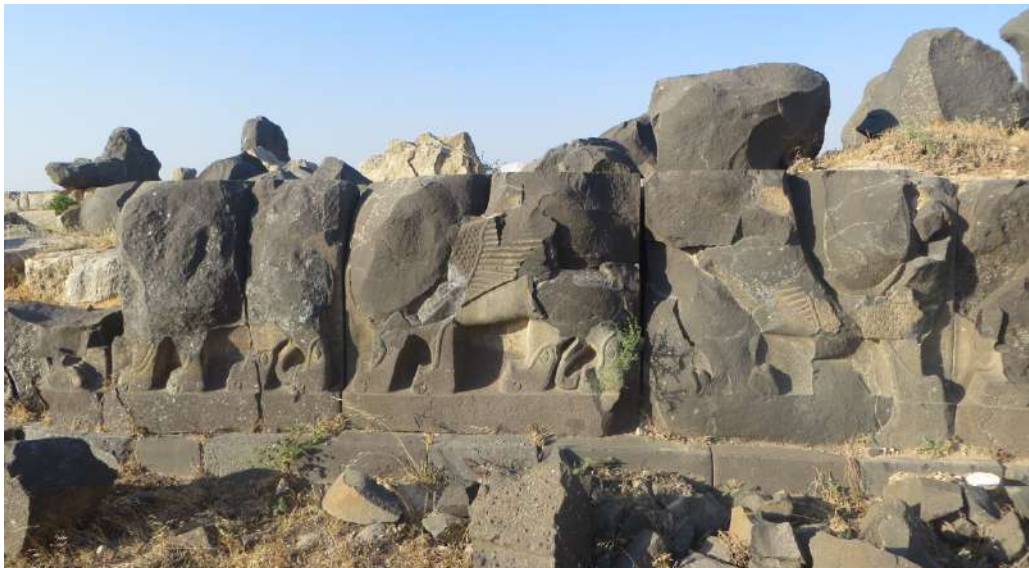
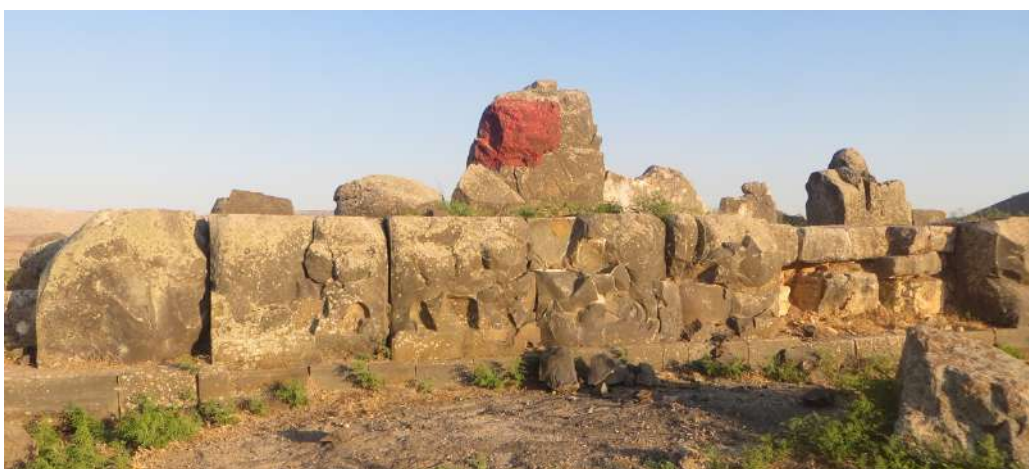
The exterior facade on the southwest and the northwest were relatively intact despite some visible damage including fallen fragments of the decoration, cracks caused by deterioration or the blast (Figure 13). The northern facade was well preserved however, one of the stones carved with reliefs was painted in red. Bullet traces were observed on this facade, likely the painted stone functions as a target as the lower town is used as a military camp by an armed group.

Fig. 13 Upper: The exterior facade on the southwest side
Lower: The exterior facade on the northwest side

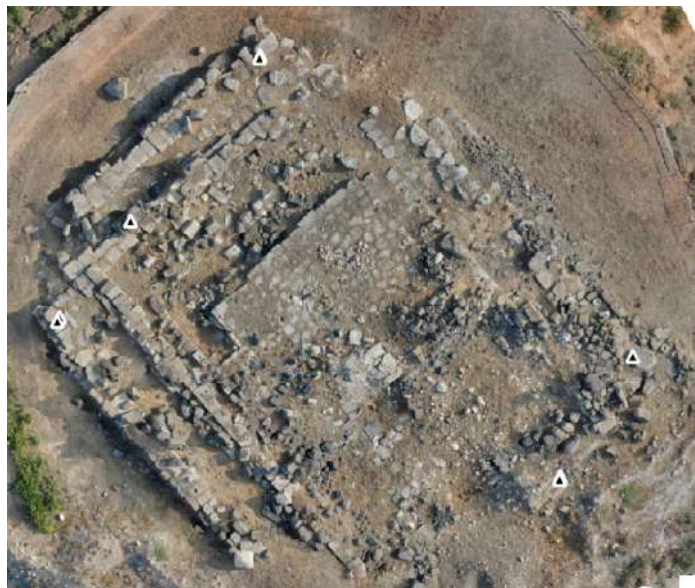
High accuracy GNSS was used to collect the benchmarks at the site. These benchmarks are used to give absolute coordinates (e.g., Latitude/Longitude), scale, and orientation to the generating 3D models and plans. However, despite repeated attempts, the post-processing (processing of coordinate values to increase accuracy) did not work as expected. At least four to five benchmarks were well processed (Fig. 1). Four stable benchmarks were used in the processing.

Fig. 1 Location of the set benchmarks

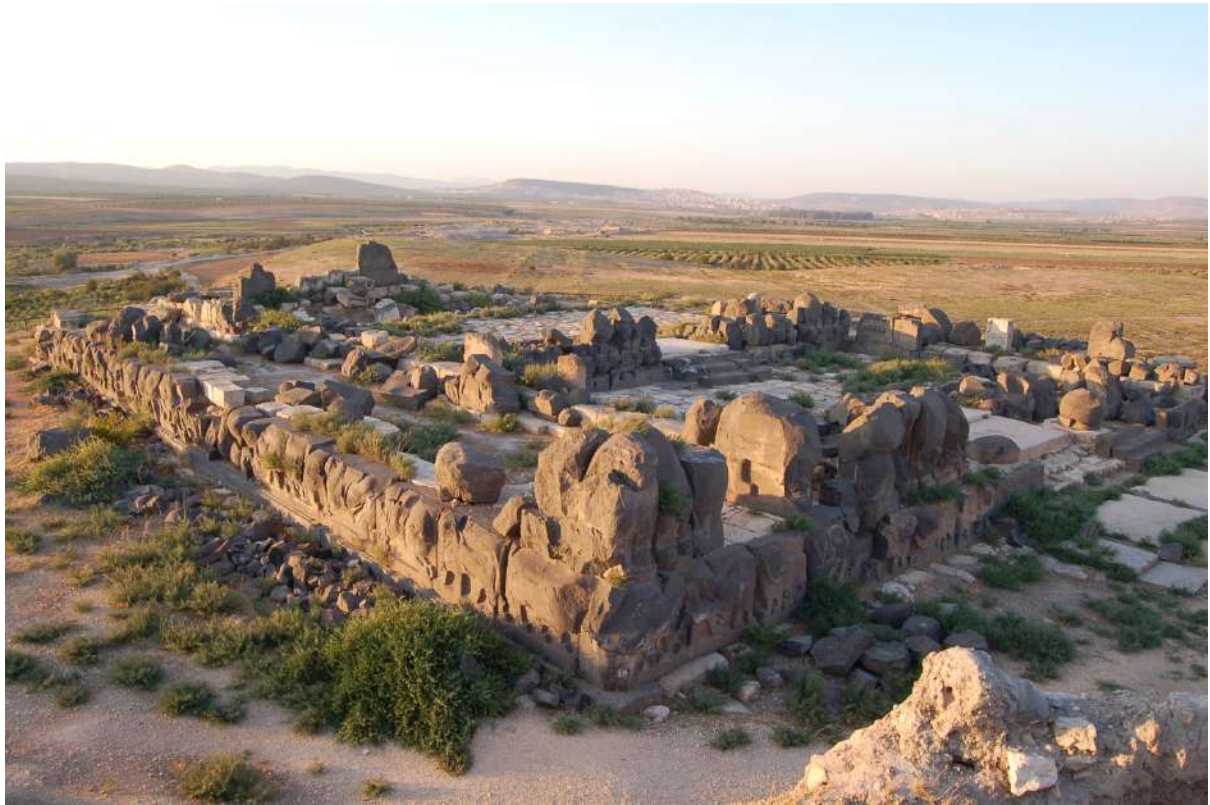
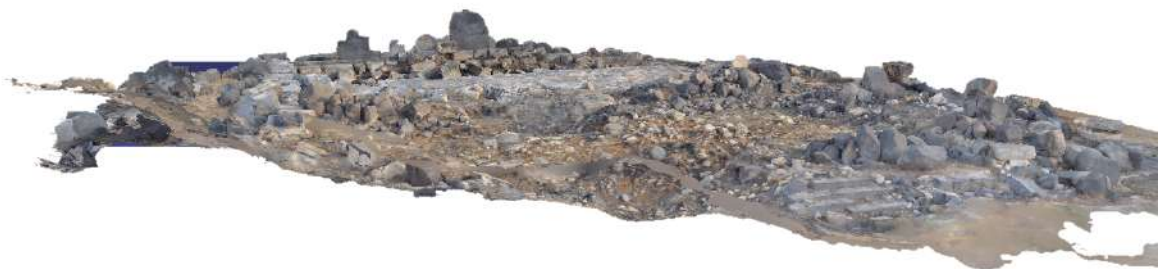
Fig. 4 Comparison with the original state
Upper: Original view (Photo taken by K. Shimogama in 2006)
Lower: 3D model.

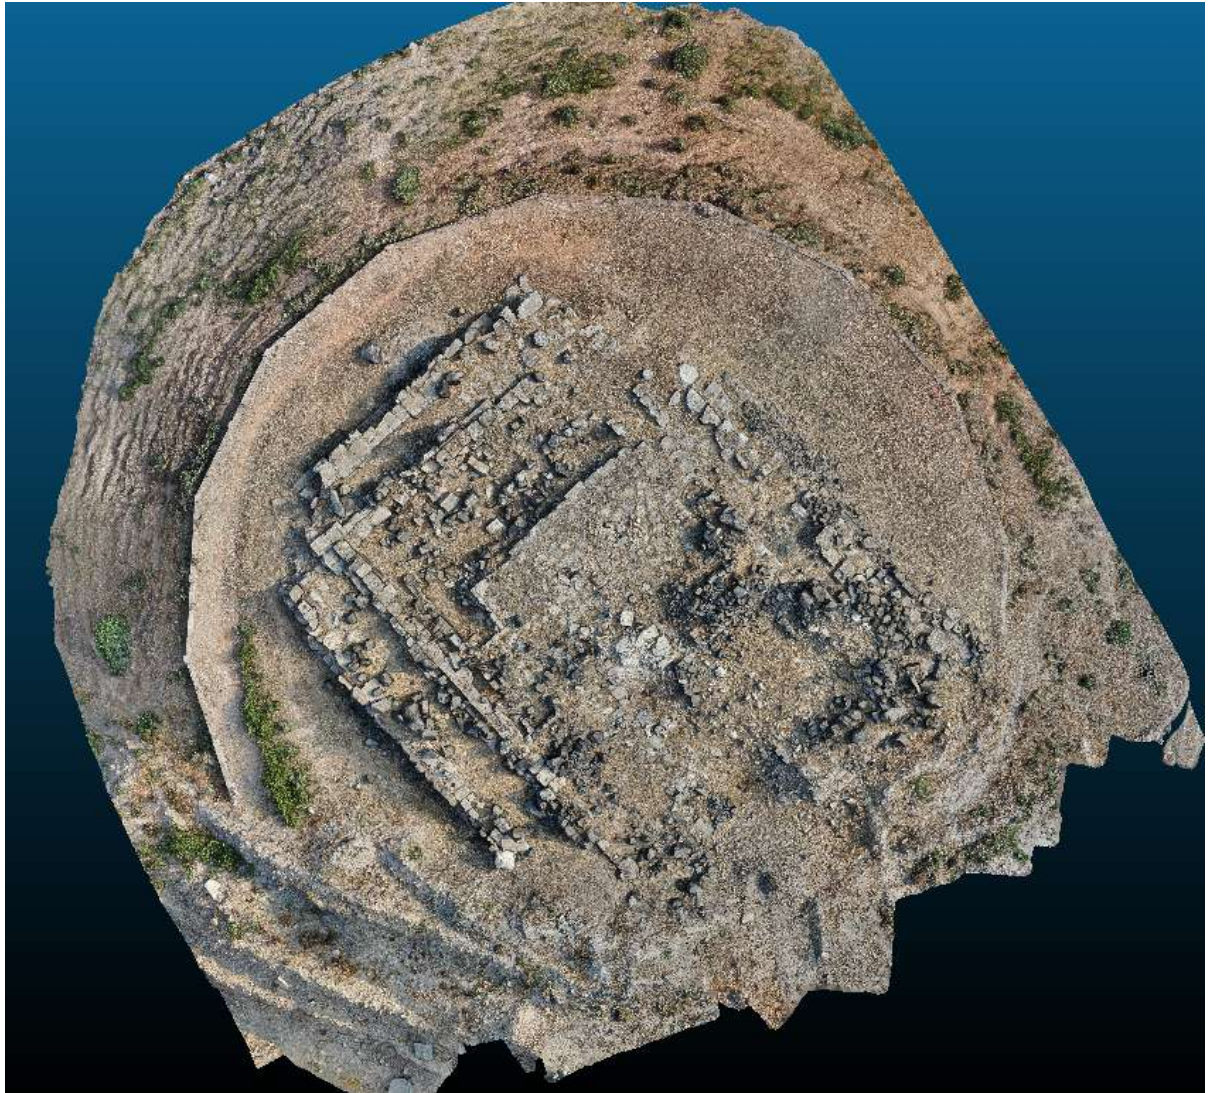
Fig. 10 UAV derived 3D model (Top view)

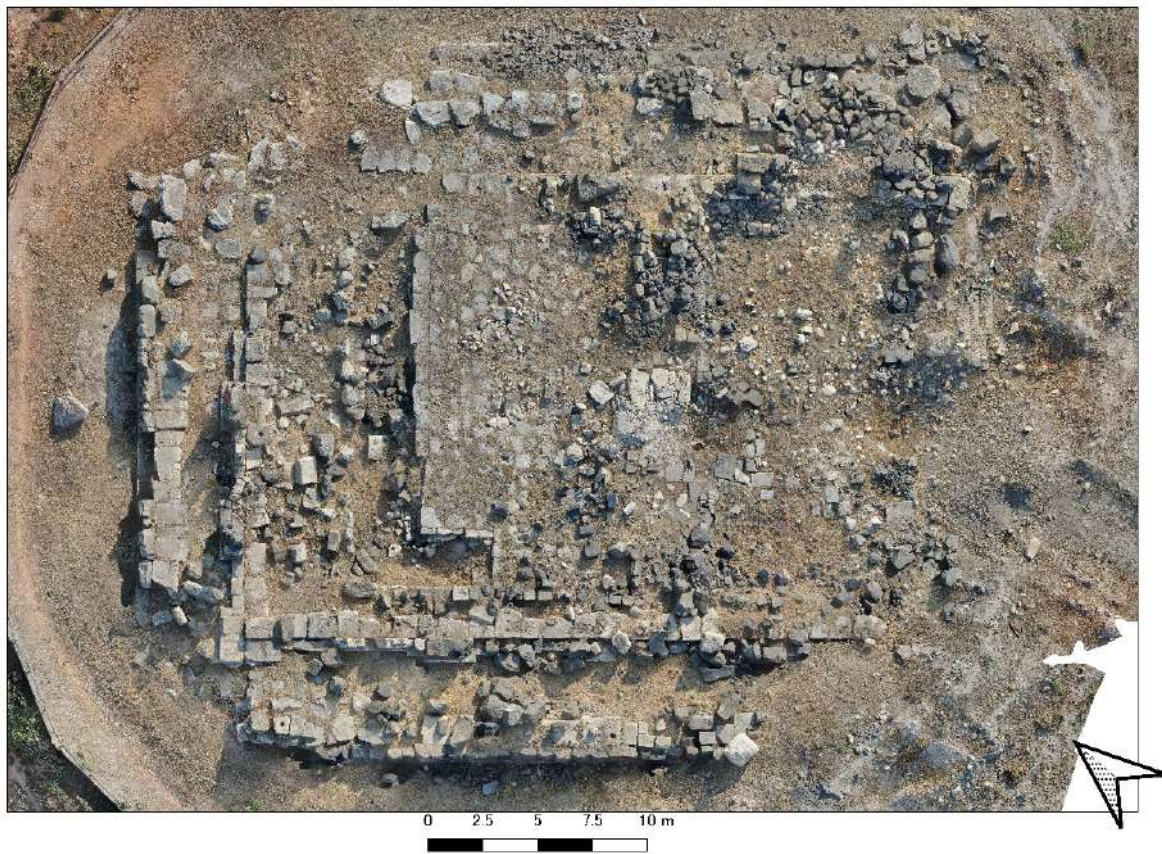
GIS raster data (ortho-photomap) and DEM (Digital Elevation Model) can be derived from the 3D model. These data can be overlaid with satellite images or digital maps, since the absolute coordinates are attached to the model. DEM and GIS raster data were derived from the 3D model generated from the UAV photographs because it had better quality when viewed from above. The detail of the floor stones, remaining walls, and distribution of the fragmented sculptures are visible in the data. GIS raster data and DEM give different impressions and have different advantages. For example, traces of the bombing are clearly visible in the DEM while GIS raster clearly depicts small debris (Fig. 13, Fig. 14).

Fig. 14 GIS raster data of 'Ain Dārā

Ortho-photographs for the top plan (same as Fig. 14) and three side plans (Fig. 15) were derived from the 3D model.

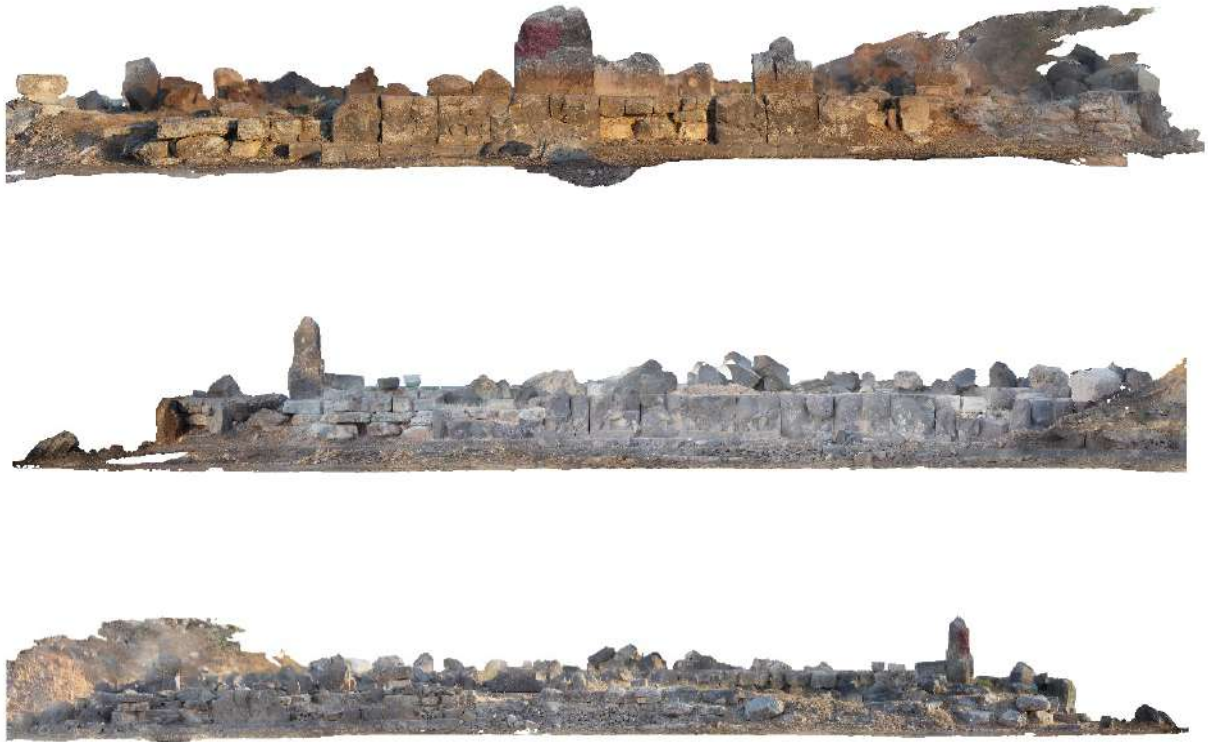
Fig. 15 Ortho-photographs for the side plan

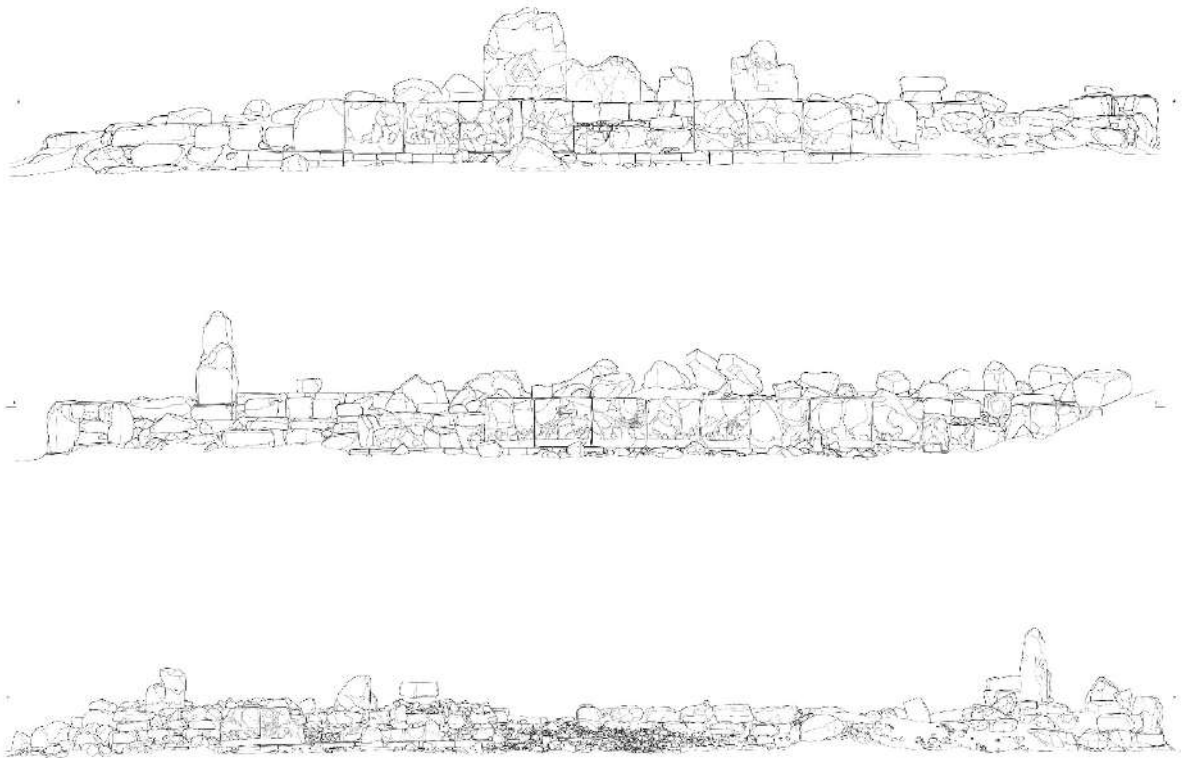
Then the ortho-photographs were digitally traced as drawing plans (Fig. 16, Fig. 17). Many small fragments which are debris from the bombing were recorded. This drawing plan will be utilized as one of the base maps for the reconstruction.

Fig. 17 Side drawing plans (Top: northwest; Middle: southwest; Bottom: northeast)

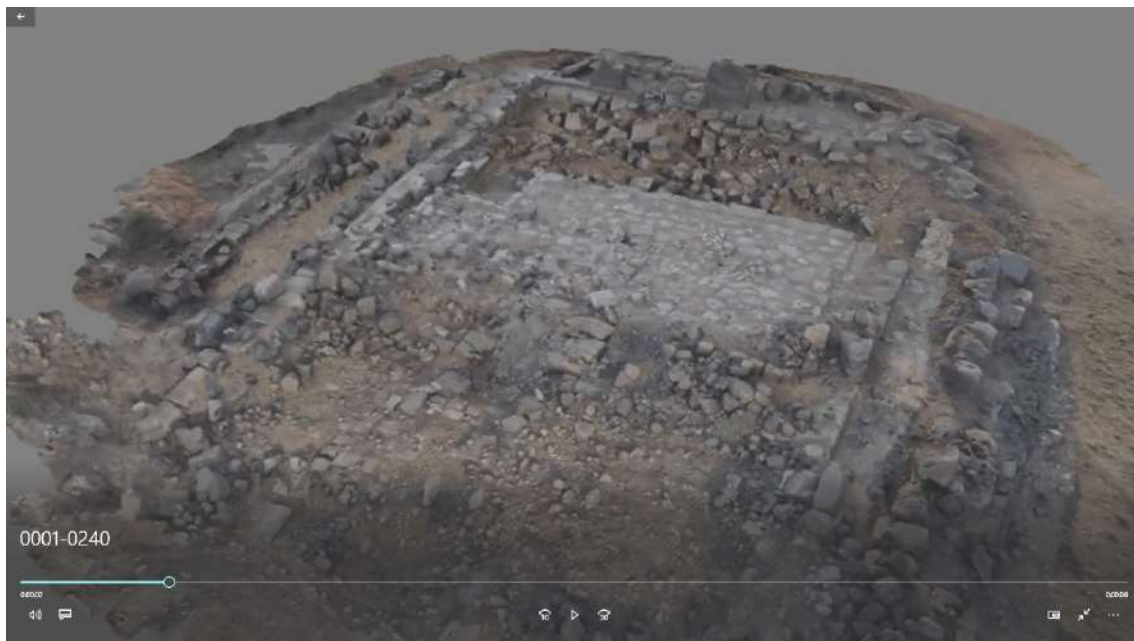
Fig. 18 3D CG movie of ‘Ain Dārā

Movie to introduce the damage to ‘Ain Dārā is generated based on the 3D model and DEM (Fig. 18).
