A Series of Photogrammetry for Protection of Syrian Cultural Heritage

Ancient Villages of Northern Syria Vol. 2

al-BARA

2. Preliminary Survey in al-Bara Ancient City and Making 3D Images of the Church 4

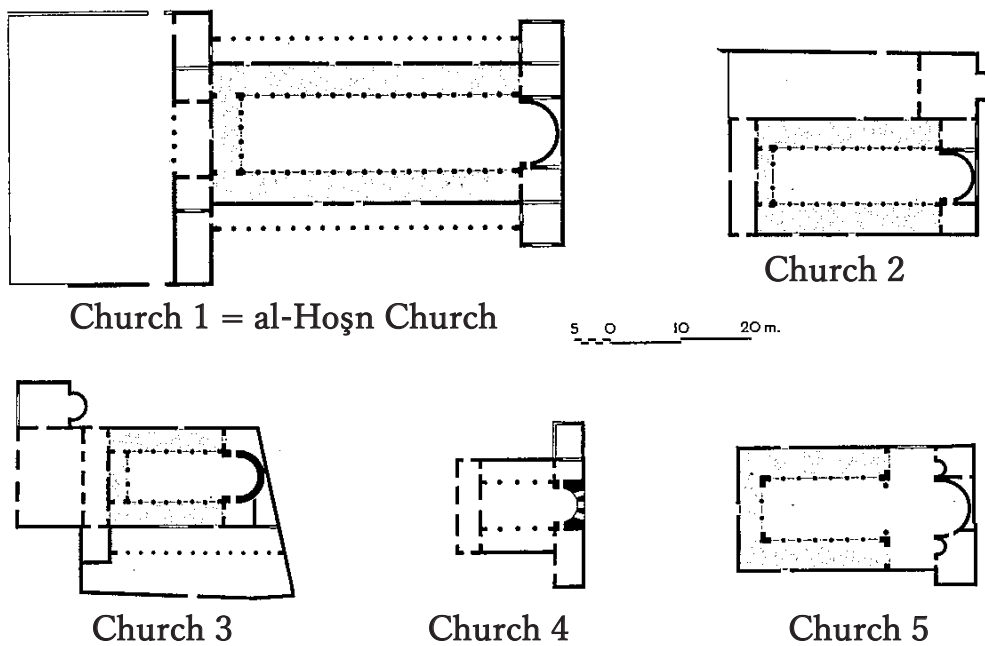
Figure 4. Five churches at al-Bara (Tchalenko 1953, Pl. 139)

At least, five early churches were discovered (Figs. 3 and 4). The largest and well-preserved church is so-called al-Hoşn (horse) Church, which is located on the northern outskirts of the settlement. It is a typical Basilica style church dating to the 5th century. According to colleagues who visited recently, the church was completely destroyed by local people who used the stones for building (Figs. 5 and 6). E (Eglise) 2 is also a large church located to the south of al-Hoşn Church, and dates to the 5th century. Based on colleagues' information and Google Earth, it has also disappeared recently. The middle sized Churches 3 and 5 in the middle of the al-Bara village were heavily damaged and their foundations barely remain. The two churches are believed to belong to the 6th century (Tchalenko 1953). The smallest sized Church 4 (Petite église), which is located just north of Church 4, is the most well preserved church in al-Bara. It is said that the church dates to the 6th century. Therefore, it was decided to document the Church 4 using 3D images.

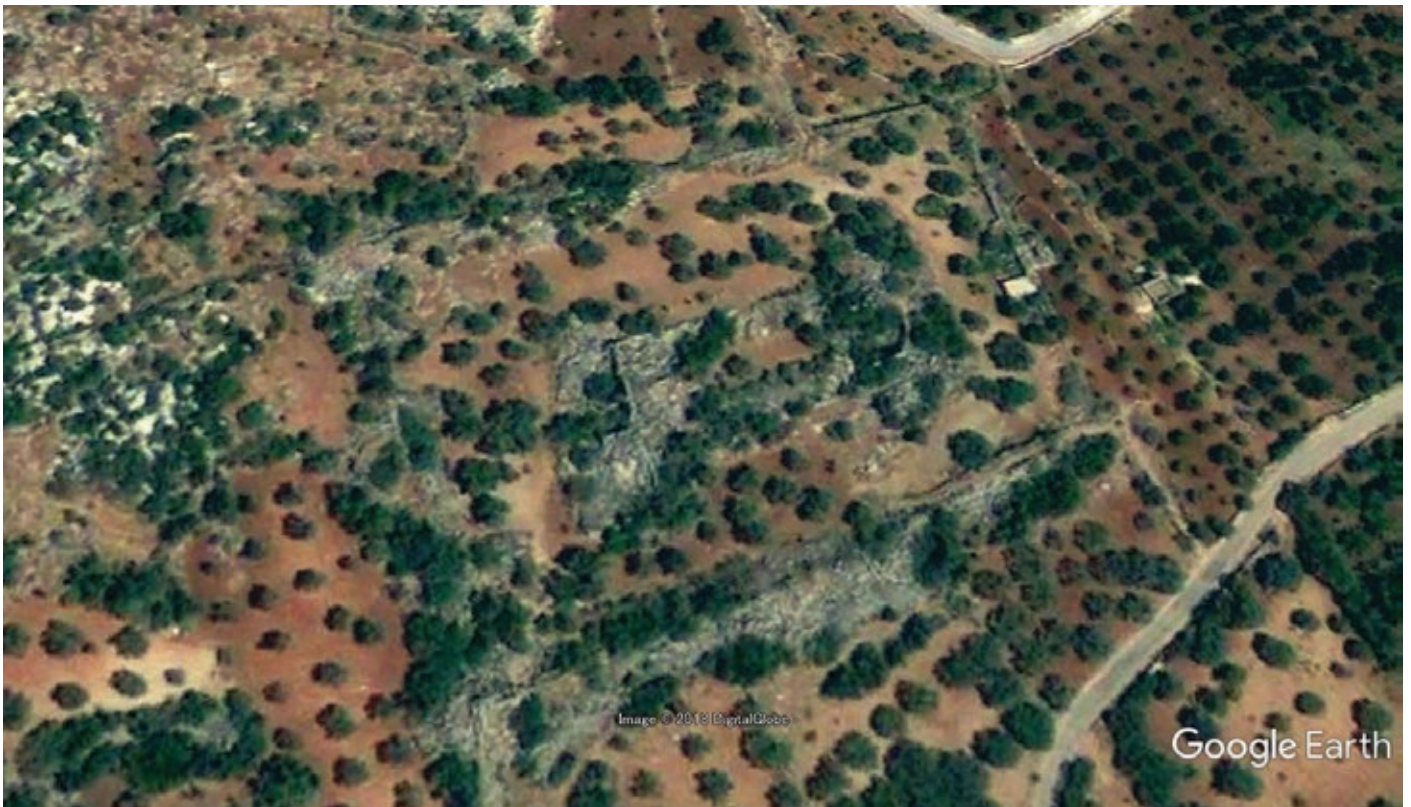
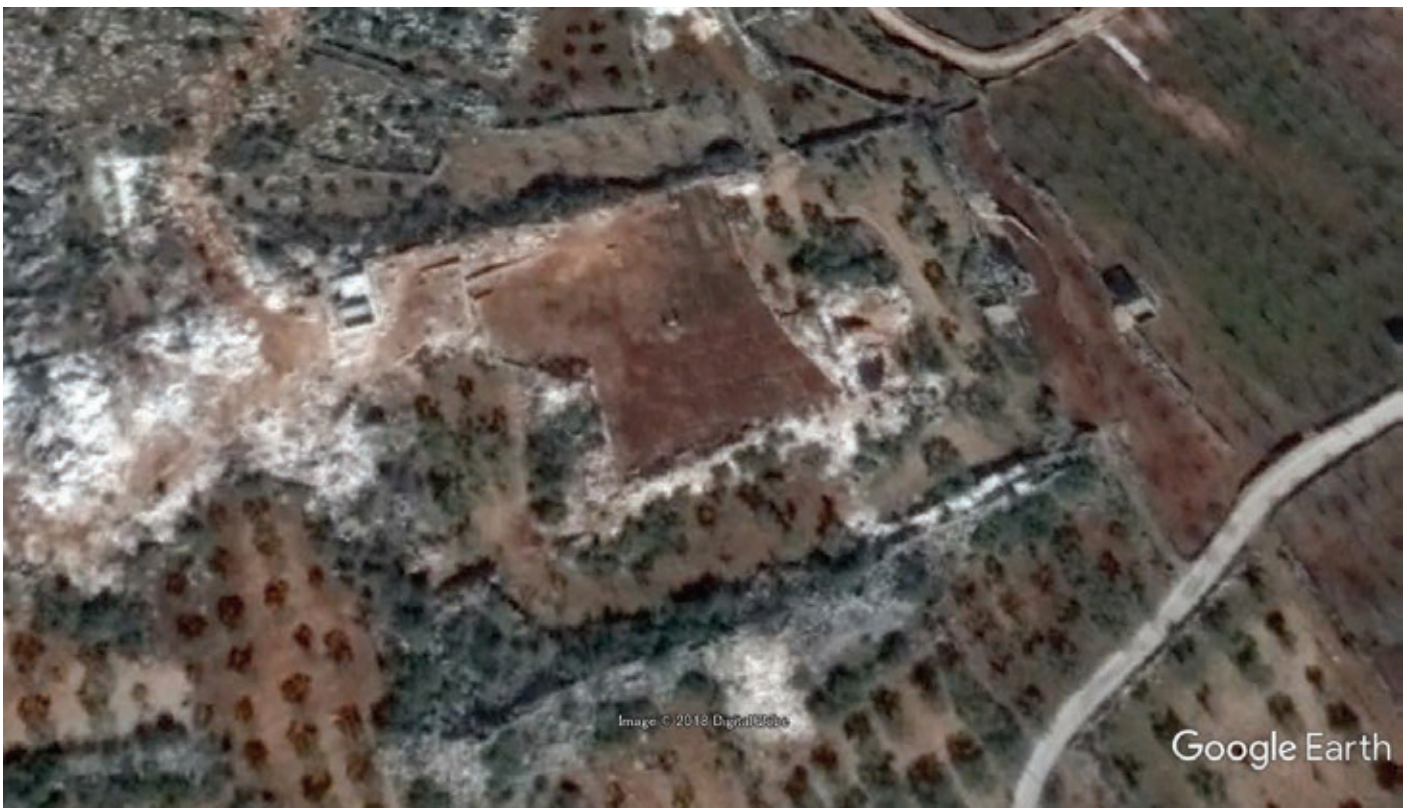
Figure 5. al-Bara, Church 1 June, 2010 (Google Earth)

Figure 6. al-Bara, Church 1 Feb. 2017 (Google Earth)

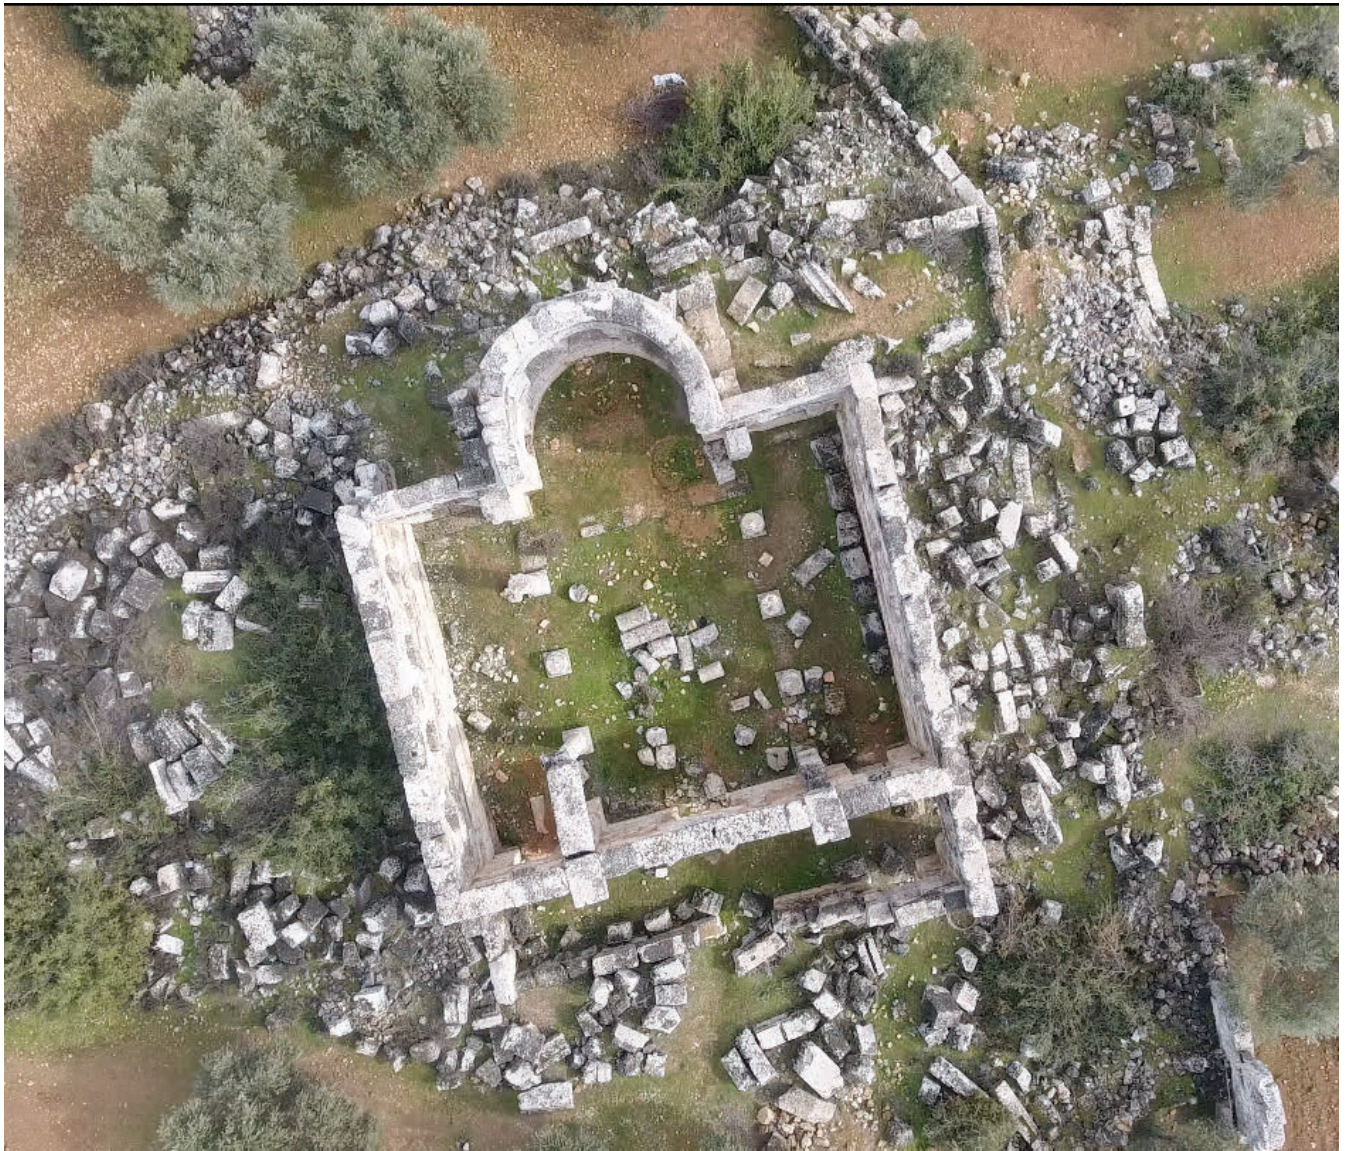
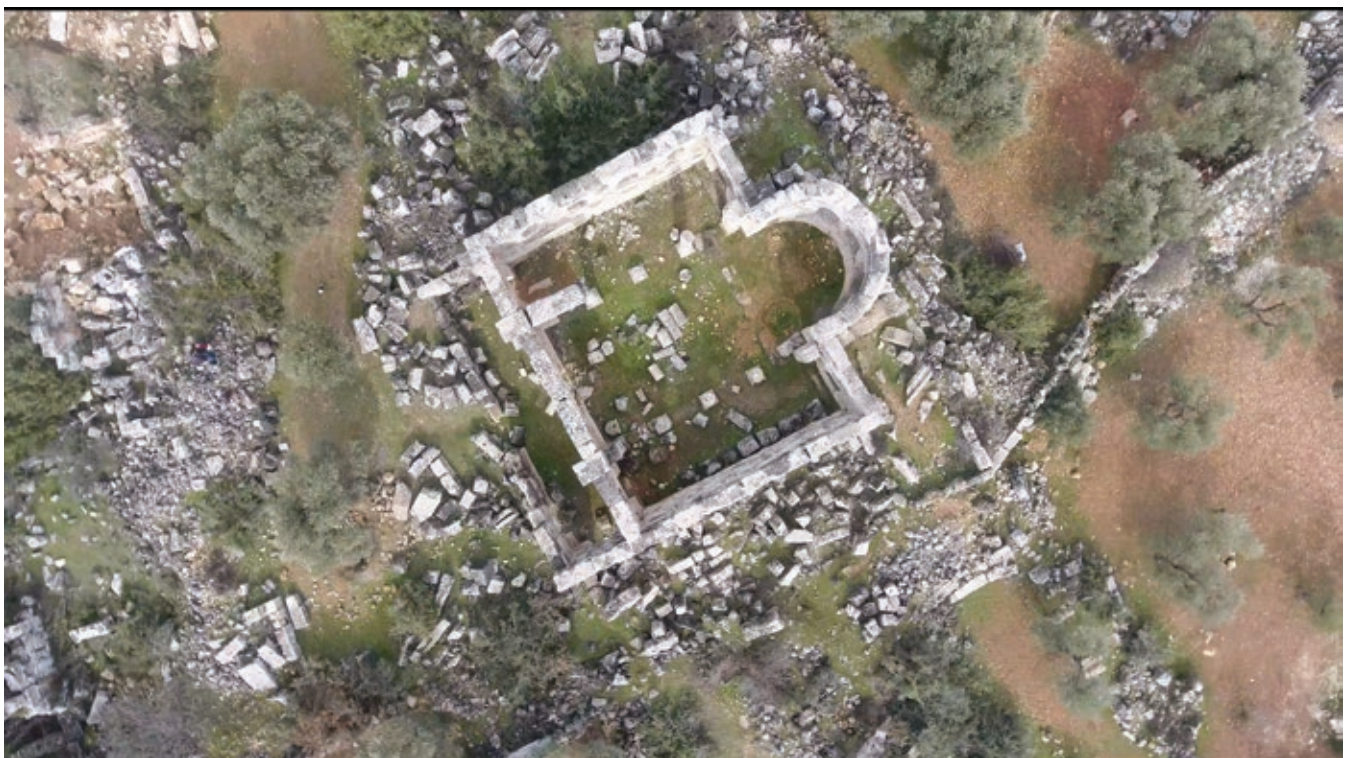
Figures 7, 8. Church 4 (Photographs by UAV.)

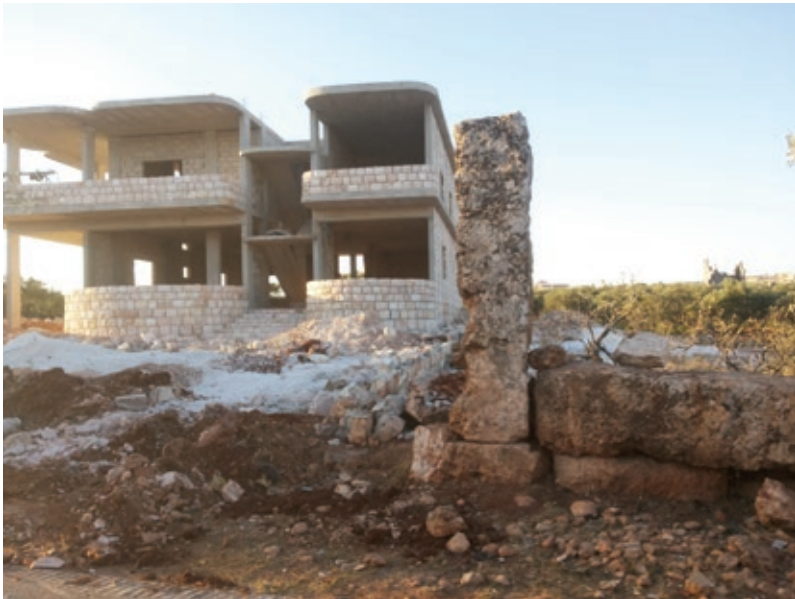
Figure 2. Modern building built using heritage site stones

Since 2011, most of the archaeology sites, standing ruins, and museums in the region have suffered from an excessive level of vandalism and destruction, mainly due to military action and looting. Furthermore, some of the sites seem to have been intentionally and systematically destroyed to the extent that they may eventually disappear. Recently, the most common pressing phenomena is dismantling of the archaeological ruins, recycling the stones into carved or hewn blocks and their sale to local people for use in new houses (Fig. 1-3).

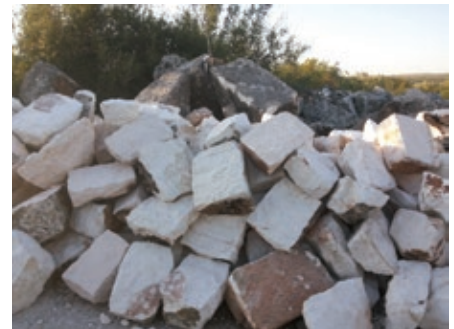
Figure 3. Carved blocks

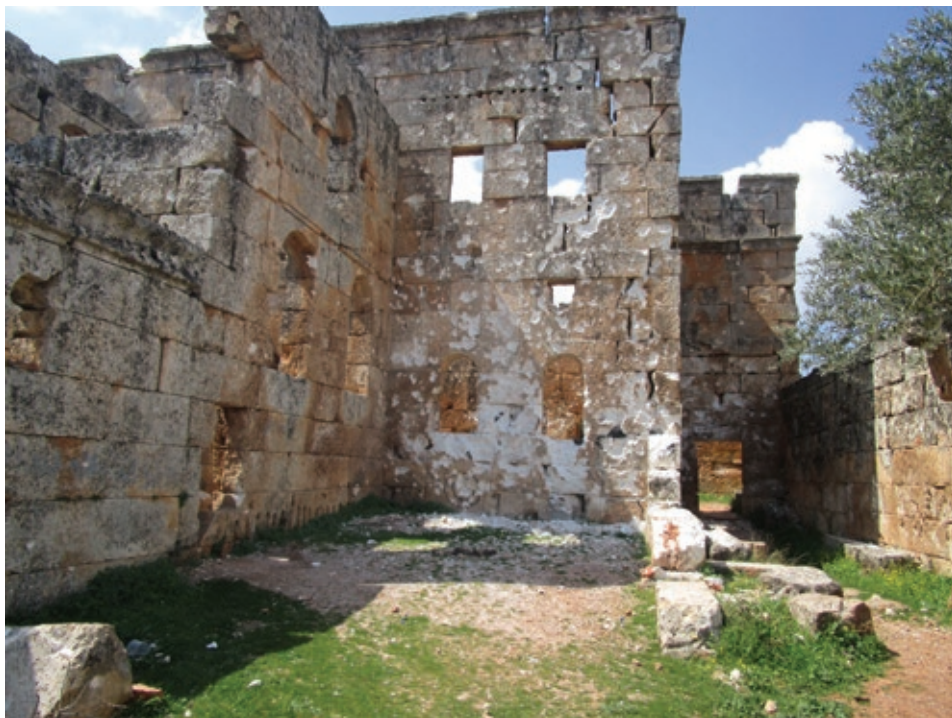
Figure 4. Deir Sobat, traces of munitions fire

The team began a survey in the ancient city of al-Bara starting from the northern part of the city. Lack of a map or plan for the ancient city was one of the main obstacles at the beginning of the work. Therefore, the drawing and maps published by G. Tchalenko (1953)² who researched the Roman and Byzantine remains in this region were utilized. The starting point was the northern side of the ancient city from Qalat abu Safian, Church 1 (al-Hoşn Church), Church 2, Pyramidal-roofed tomb, Church 4, 5 and Dier Sobat. Most of these sites were subjected to varying degrees of damage and vandalism. Specifically, loss of wall sections, traces of shelling on the walls, use of the walls for target practice and recycling building stones were observed as the major cause of damage (Fig. 4, 5).

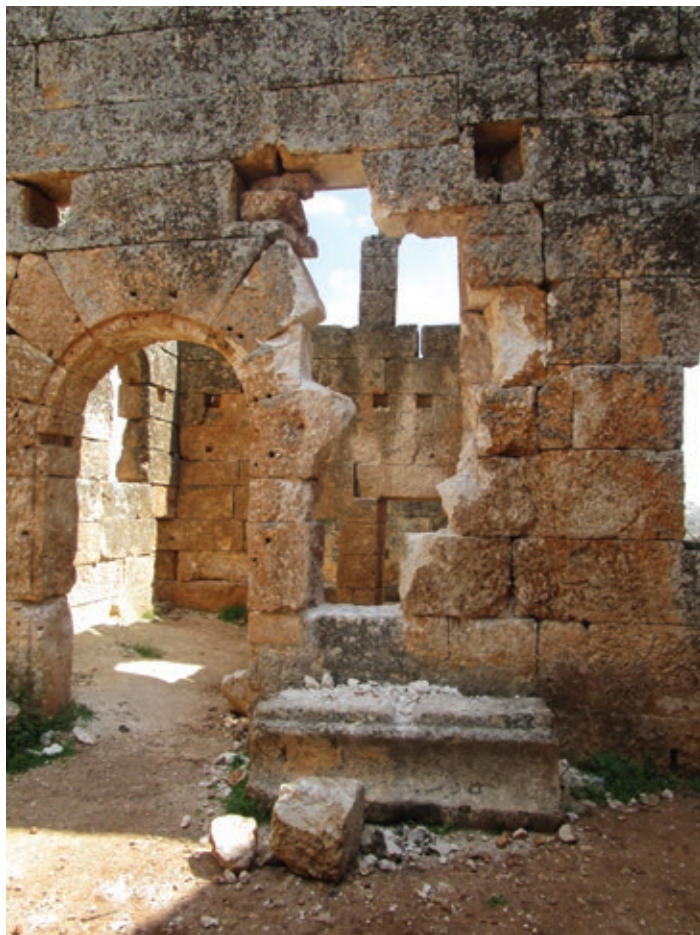
Figure 5. Deir Sobat, collapsed part of interior wall

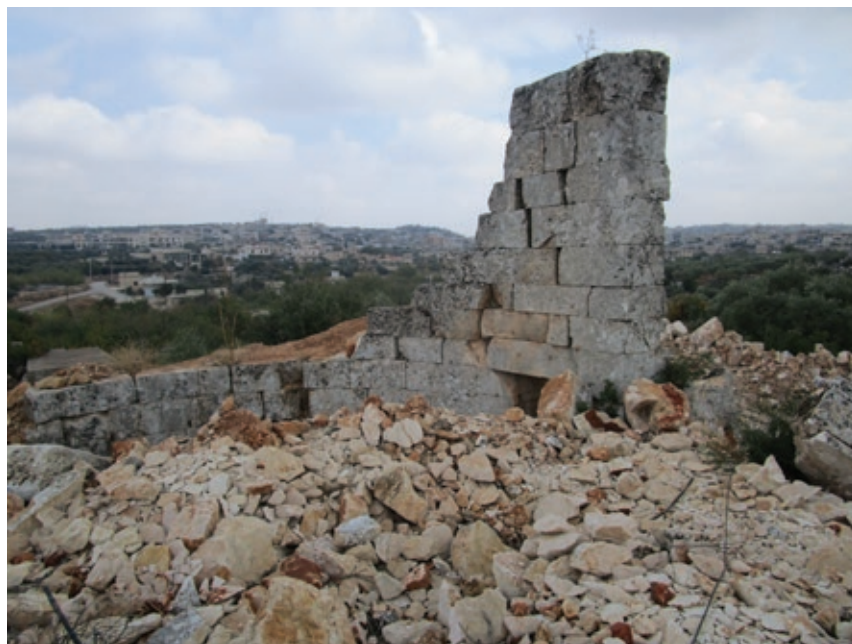
Figure 6. Eastern part of al-Hoşn church (apse)

figs. The size of the small trees indicates that they have been newly planted. The entire building has been destroyed or bulldozed. The arched-shape remnants left standing in the eastern section, is likely an apse (Fig. 6, 7). The survey and photos suggest that the stones from the building were recycled and re-located. The recycled stones were used to construct a stone base (terrace) where later a new modern building was built (Fig. 8). The remnants of the standing walls, and the remains of broken and unshaped stones were pushed aside to define the field boundary (Fig. 9).

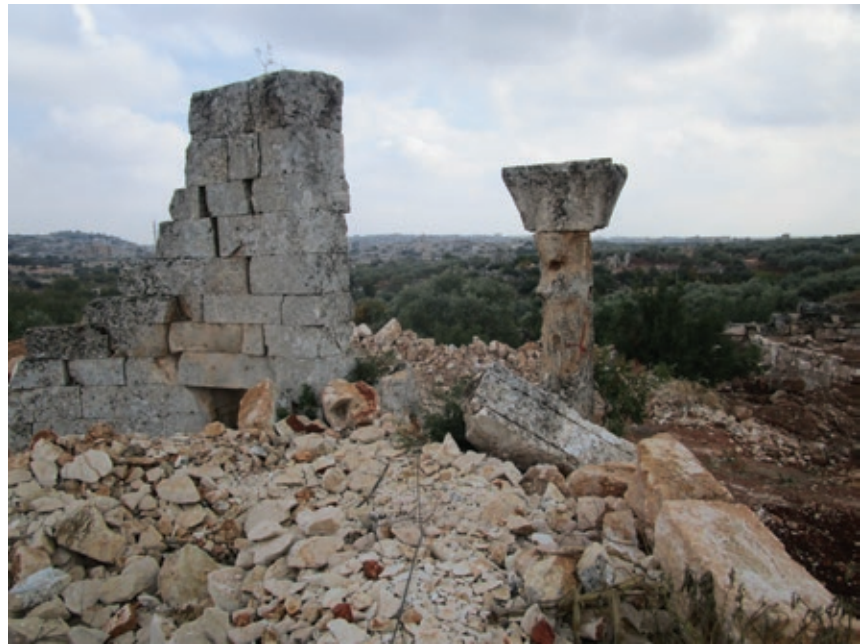
Figure 7. Remains of the eastern walls of al-Hoşn church

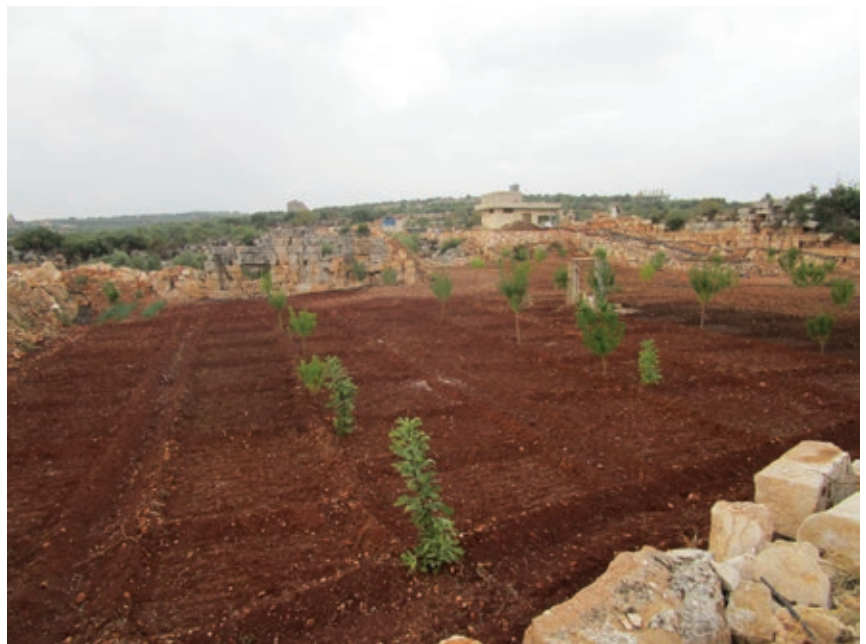
Figure 8. Turning the al-Hoşn church into a field and the construction of a modern house

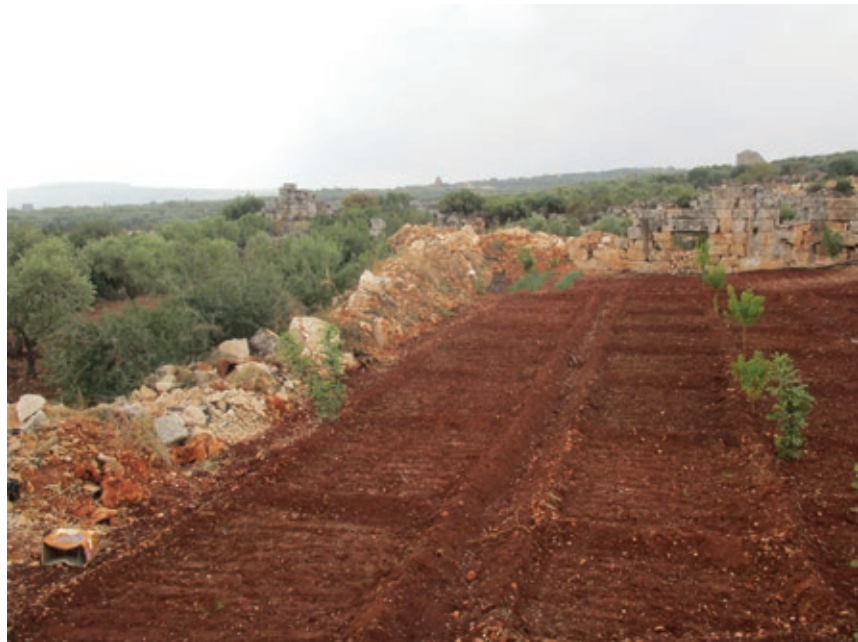
Figure 9. The remnant of al-Hoşn Church used in field boundary

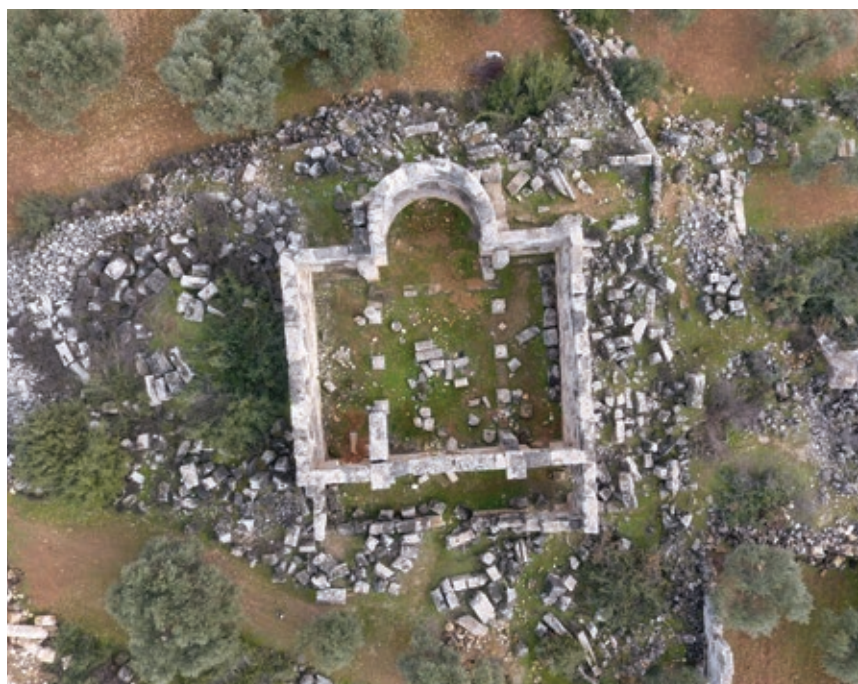
Figure 10. Church 4

Within this massive chaos and systemic destruction, a small beautiful church building stands intact. Thus, this building has been selected for 3D modeling. The reason for its selection is to enable the documentation of its details because of the systematic destruction of the surroundings very close to the building and there is concern that the building will be damaged (Fig. 10-12).

The Church 4 building has a T-shape. Its axis is aligned east–west (apse-entrance), and the structure is not very tall. Even though the building size is small, it has several access doors in the east and west.

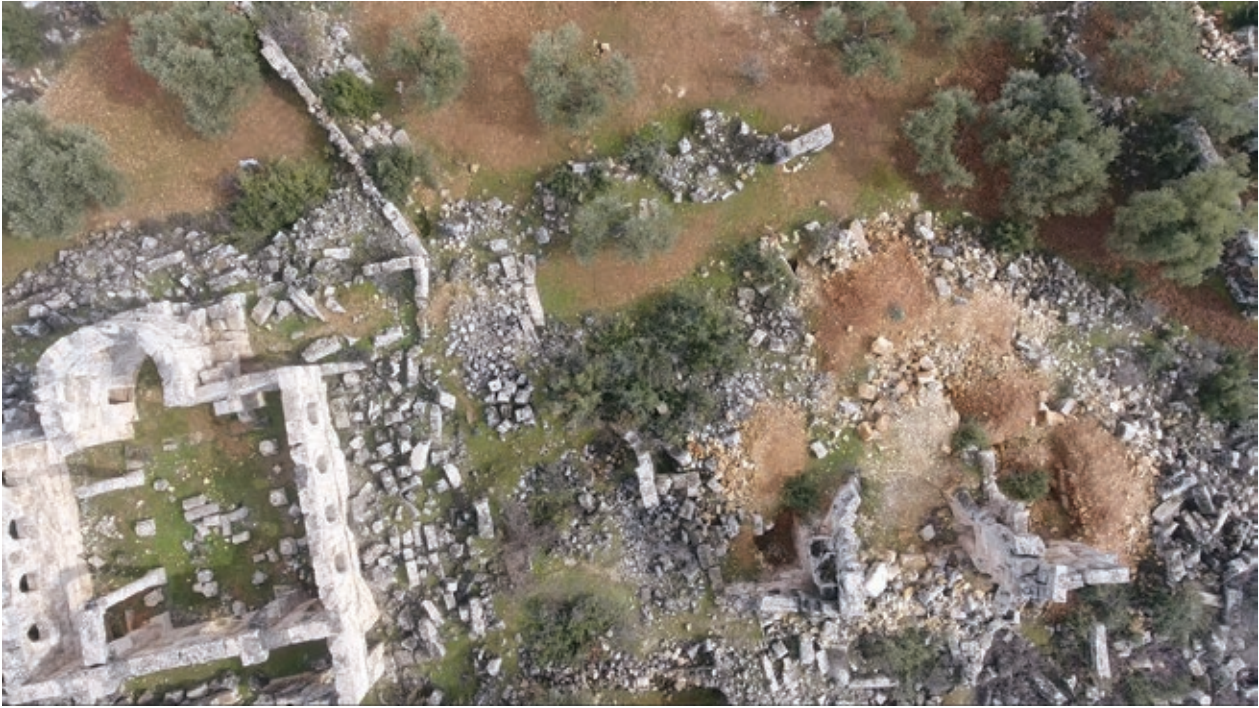
Figure 11. Church 4, illegal excavations and destruction near by

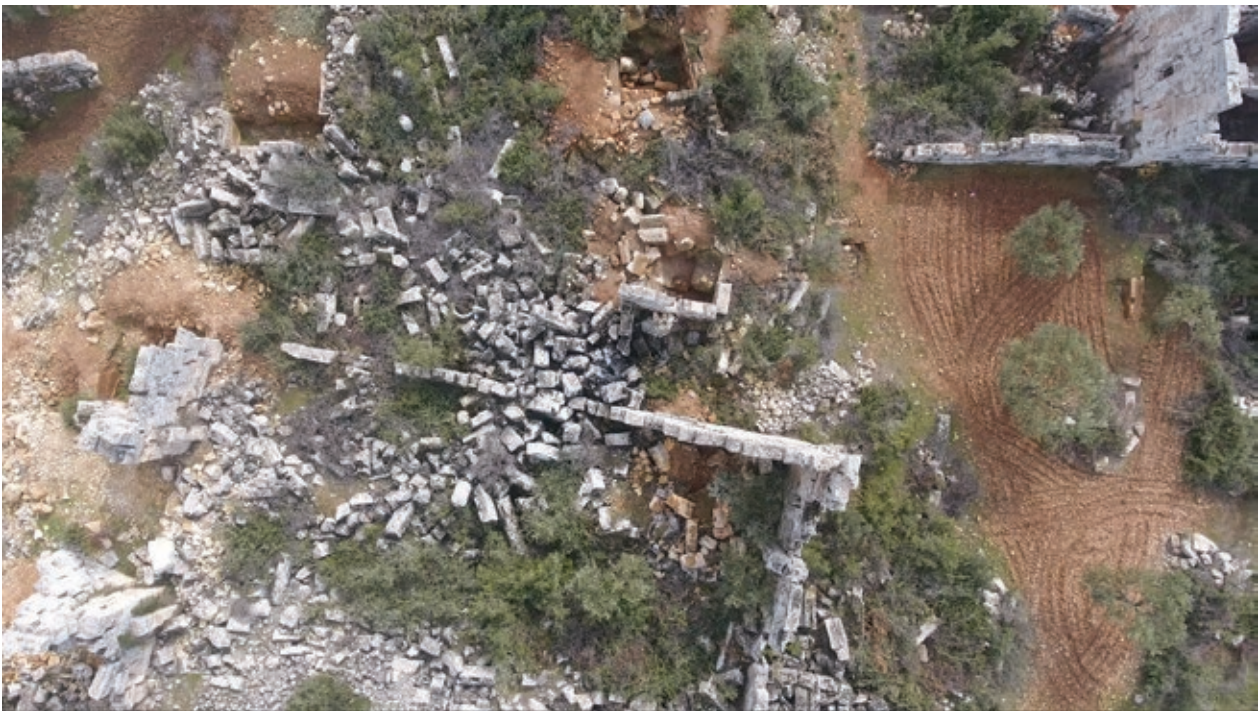
Figure 12. Illegal excavation and destruction in the Church 5

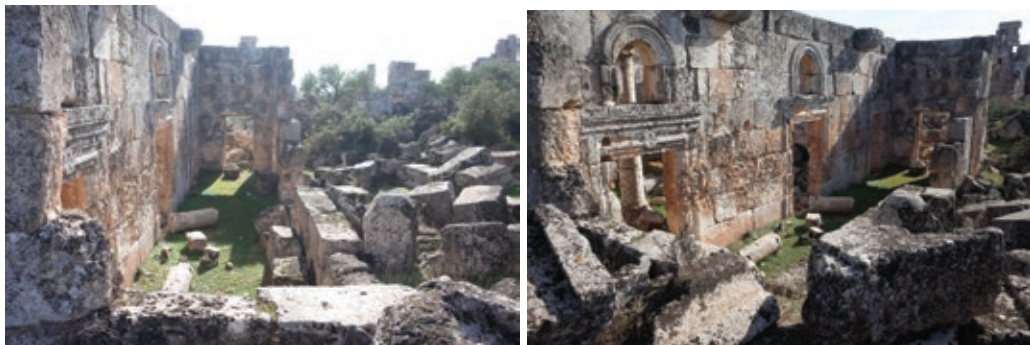
Western facade and aisle

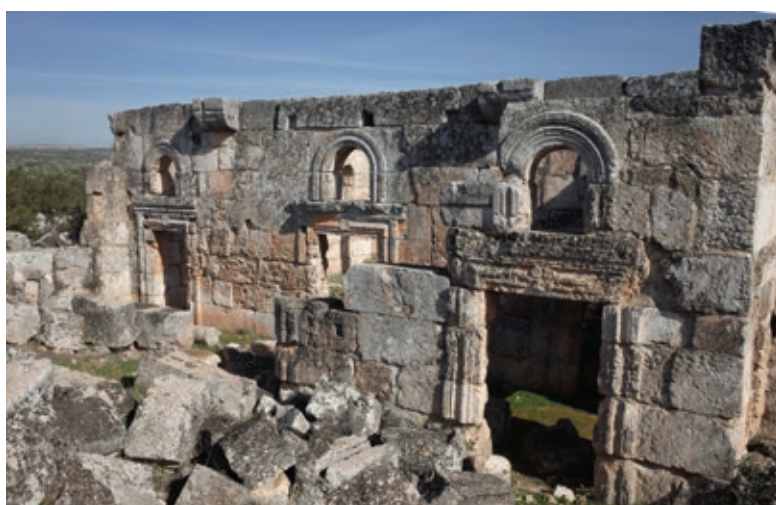
General view from the west

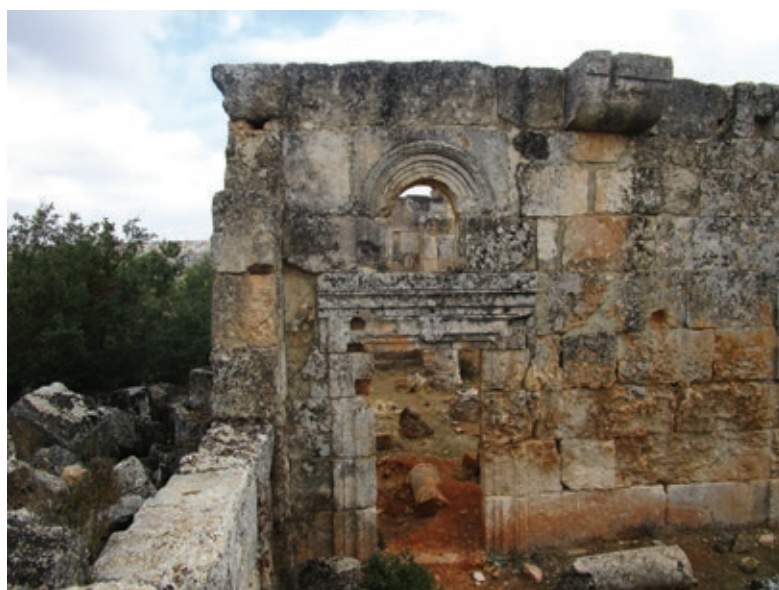
Western facade

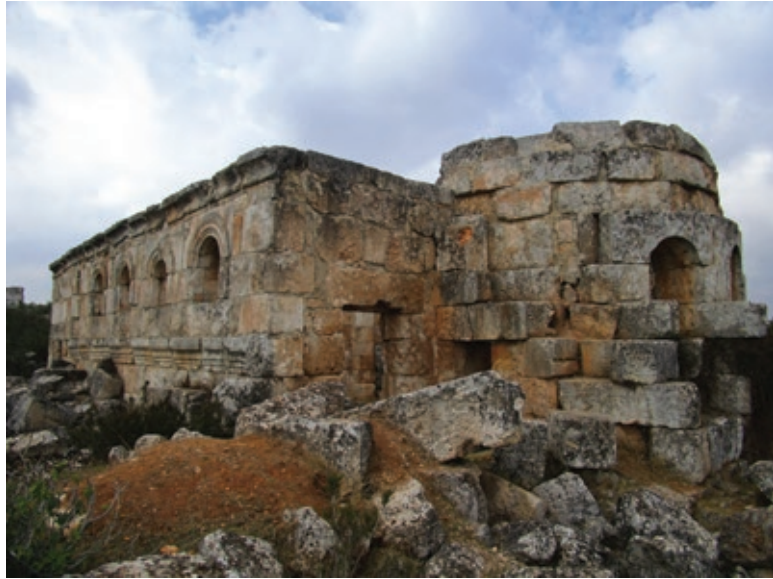
General view from the southeast showing the apse and the southern facade

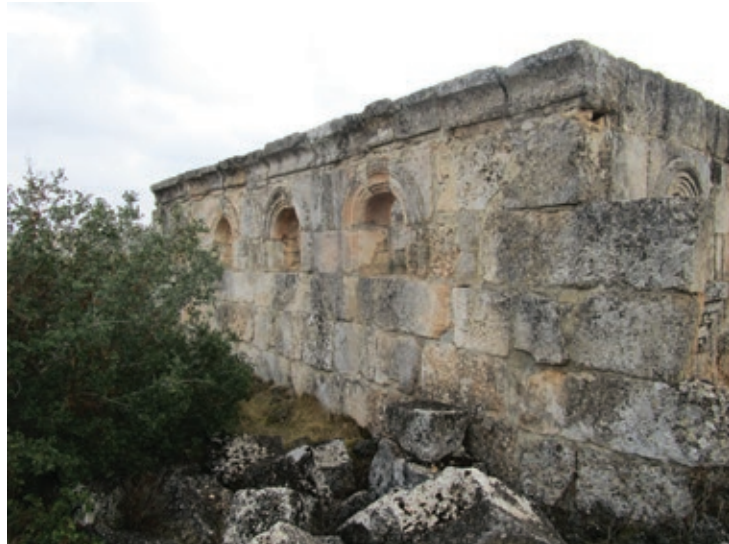
General view from the northwest showing northern facade

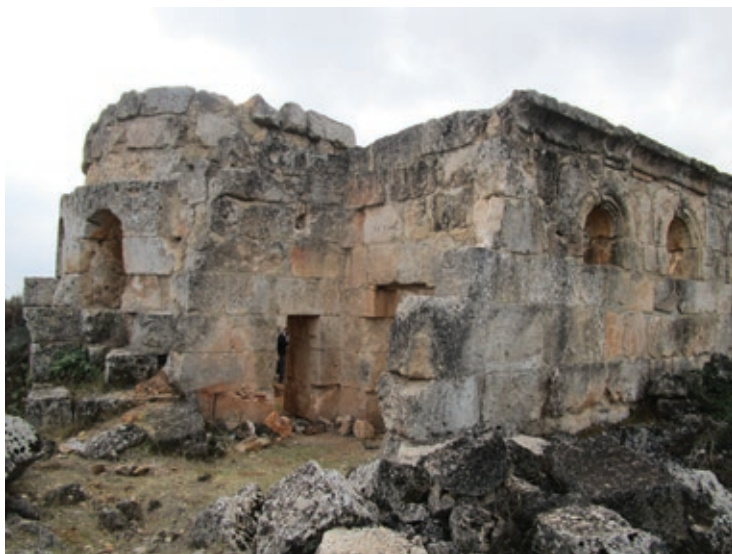
General view from the northeast

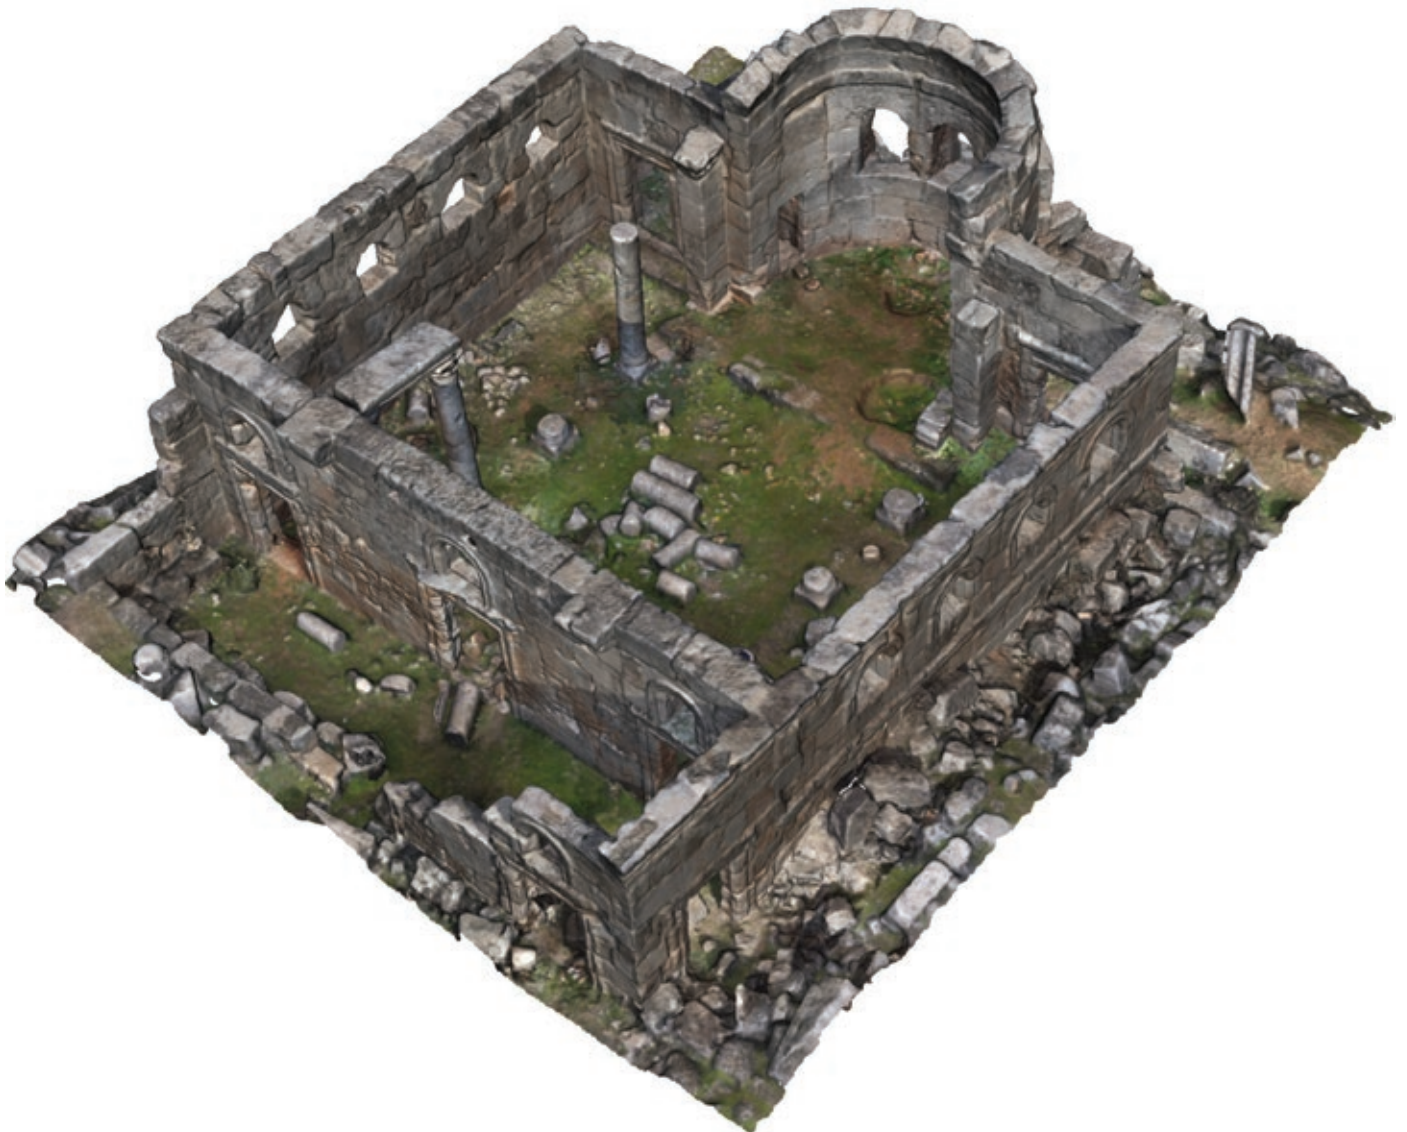
Figure 1. Overview of al-Bara Church 4

The 3D model of Church 4 in al-Bara, illustrated in this brochure was processed using Photoscan Pro (Agisoft), based on photographs collected by local colleagues in Syria. More than 3,600 photographs were used for the processing, including photographs collected by a UAV (drone). The overlap of the photographs was sufficient in most cases, which enabled the creation of a comparatively consistent 3D model. All of the photographs were processed in a single calculation, which generated a single model of the whole church (i.e. processing with one “chunk” in Photoscan). However, the model may include skewness or errors, since control points to aid accurate rectification were not available in this case. Several points to set scale and orientation were collected and the associated information is attached to the model. Thus, the 3D model provides a capable measurement using 3D point cloud processing software (e.g. Cloud Compare, Meshlab, etc.).

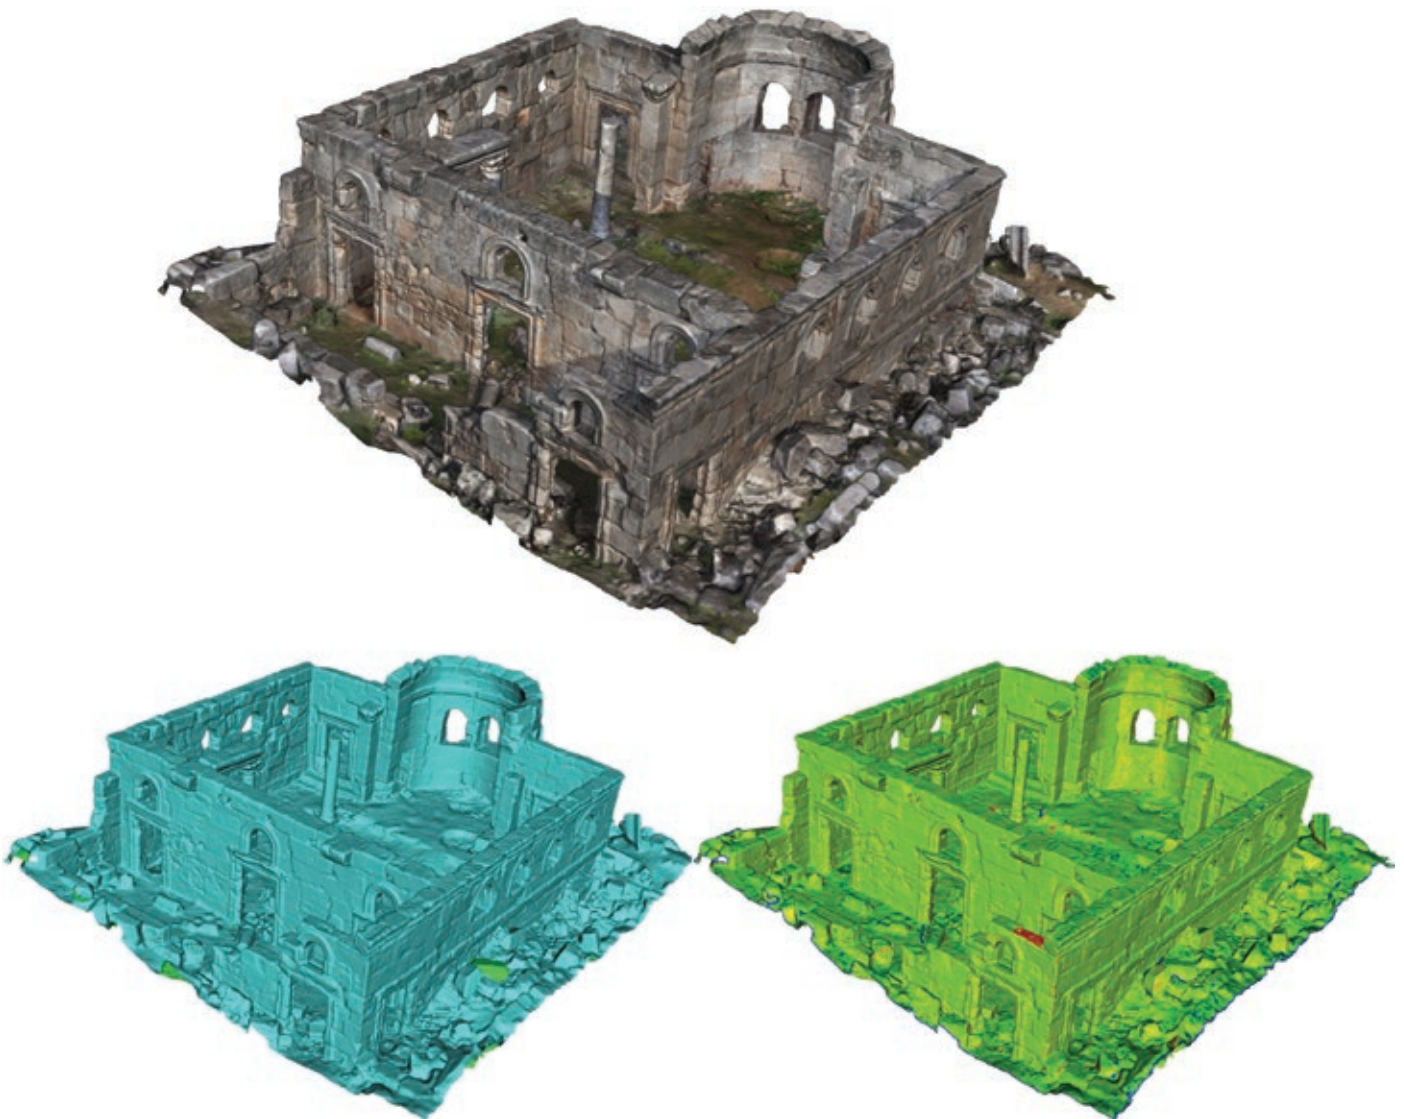
Figure 2. Bird’s-eye view from the south-west

Several bird’s-eye view figures are illustrated in this section. Besides several noises due to miss-matching of pixels, most of the sections turned out to be successful. Although the focus is on the building the collapsed building stones were intentionally left around the church in the model. This is because the spread of the related material may help the safeguarding or reconstruction of the church to some extent.

Not much “special” masonry was observed. However, the protruding stones observed in Figure 19 “C” seem to be stones from the attached walls (also see Figure 2).

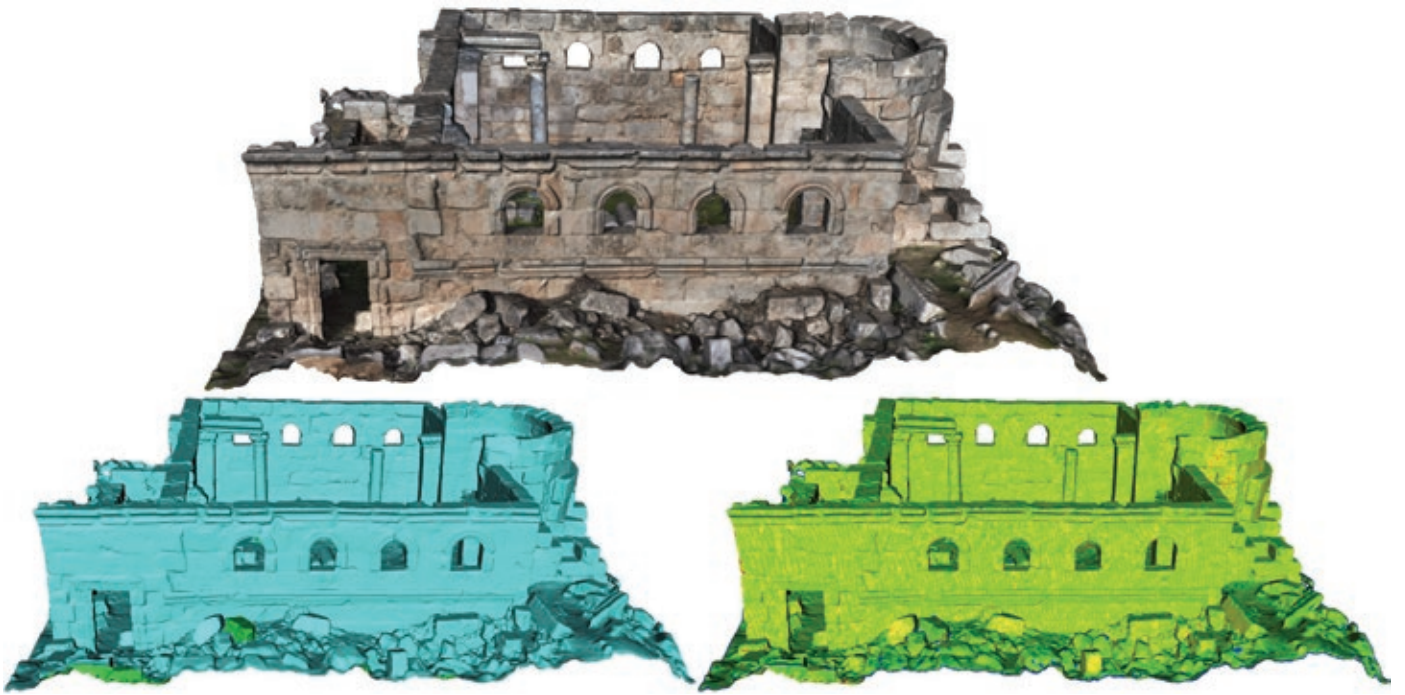
Figure 3. Bird's-eye view from the south

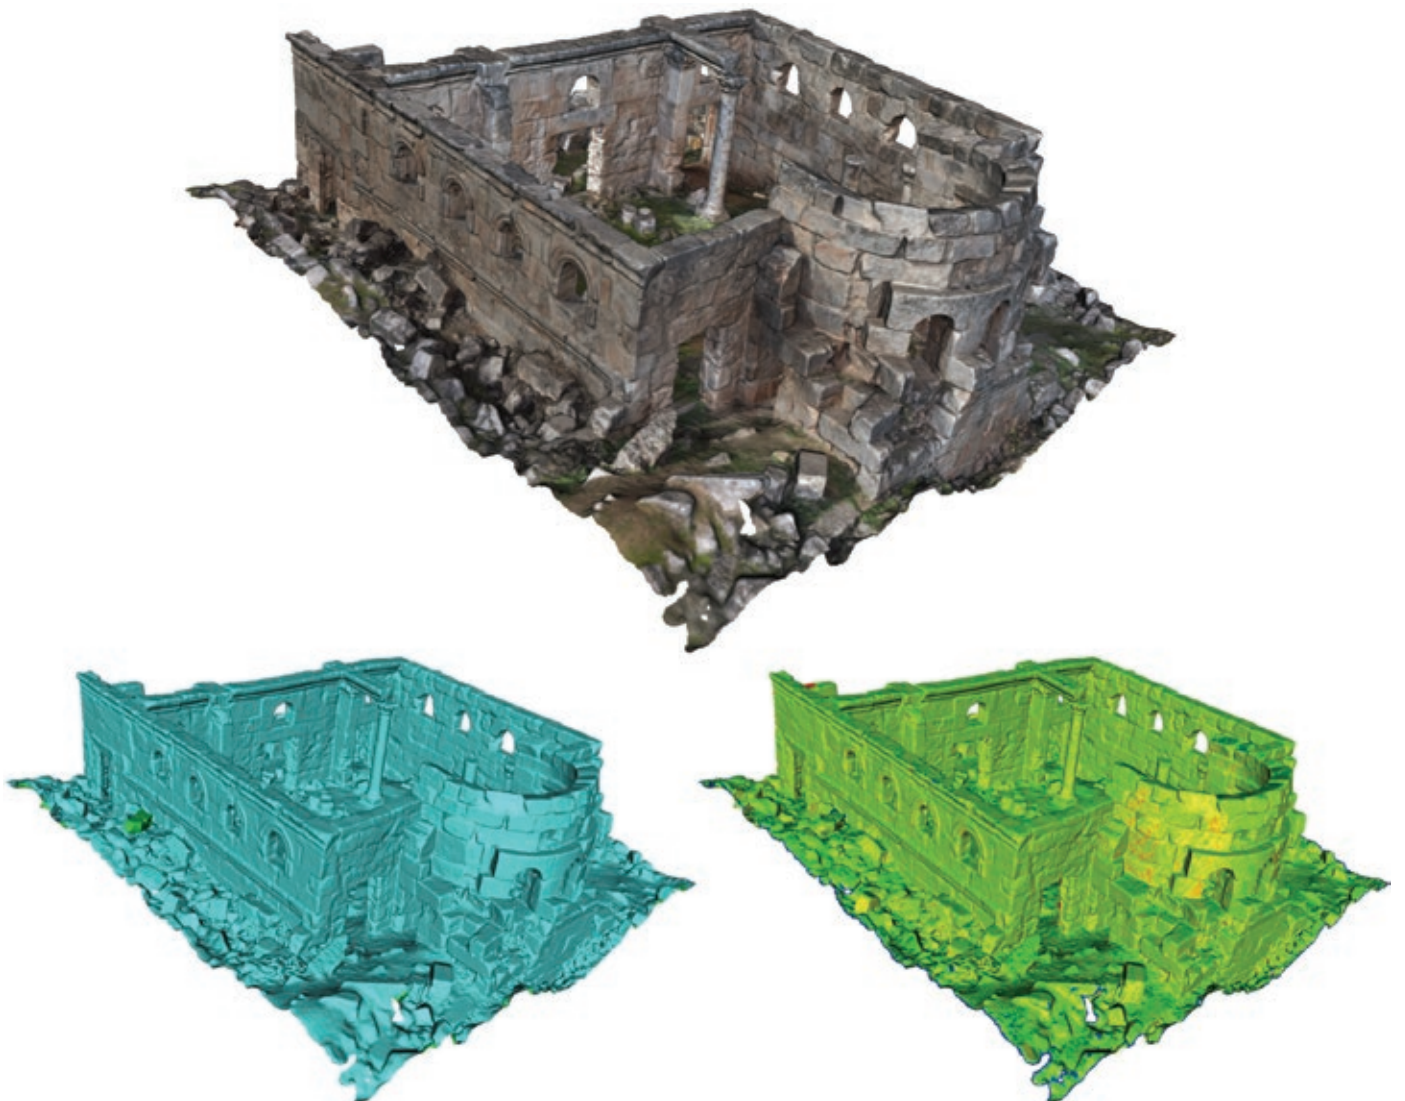
Figure 4. Bird's-eye view from the south-east
