A Series of Photogrammetry for Protection of Syrian Cultural Heritage

Ancient Villages of Northern Syria Vol. 2

al-BARA

2. Preliminary Survey in al-Bara Ancient City and Making 3D Images of the Church 4

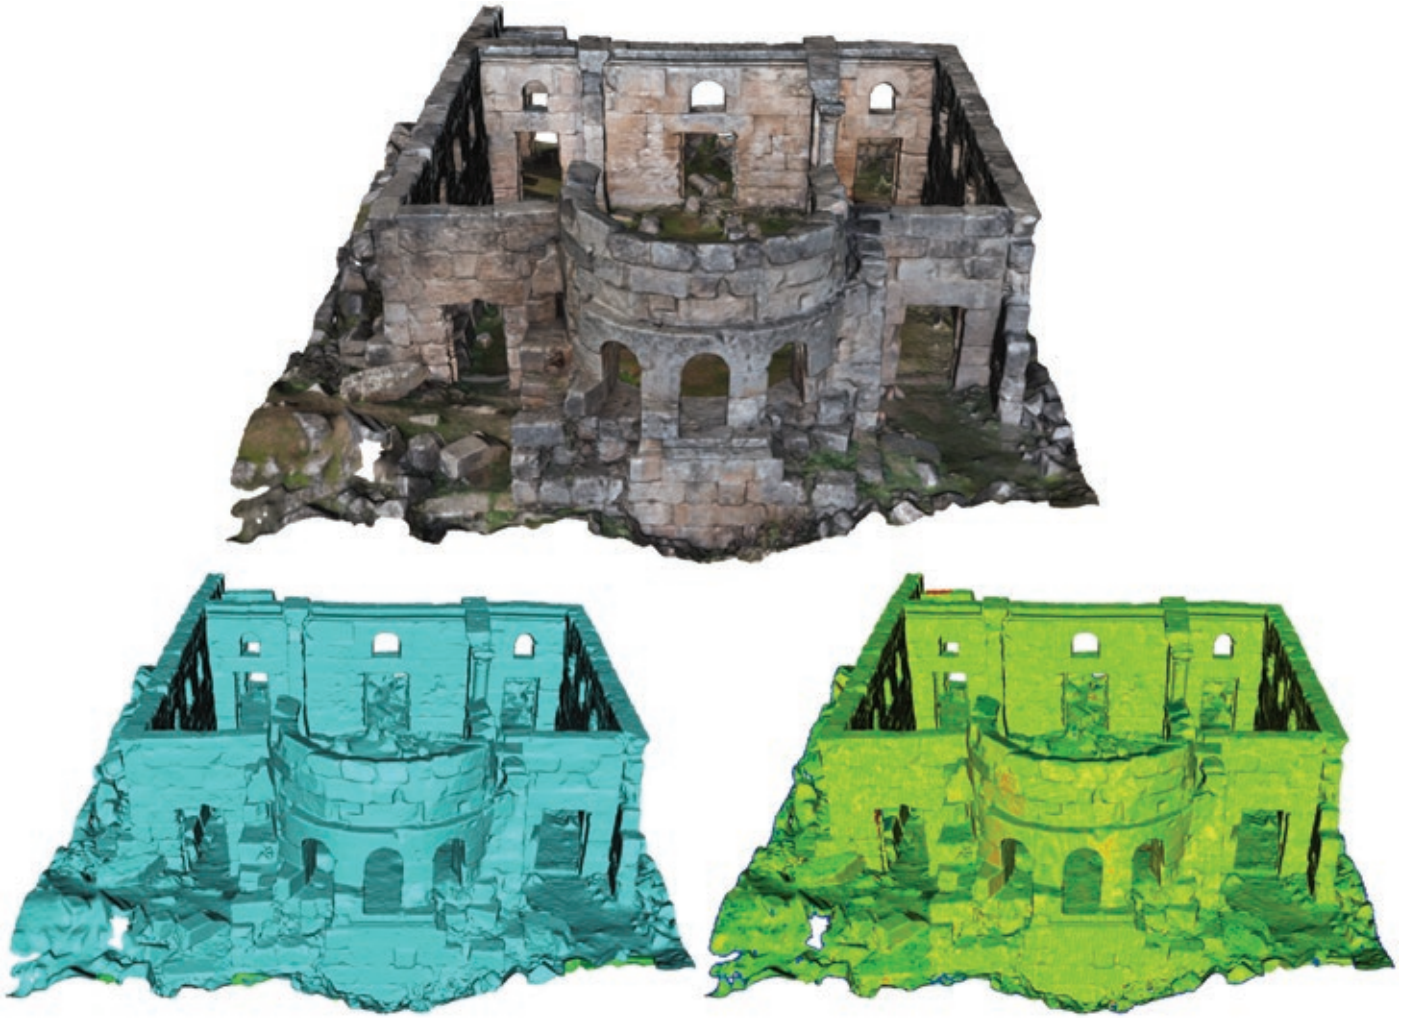
Figure 5. Bird's-eye view from the east

Several bird’s-eye view figures are illustrated in this section. Besides several noises due to miss-matching of pixels, most of the sections turned out to be successful. Although the focus is on the building the collapsed building stones were intentionally left around the church in the model. This is because the spread of the related material may help the safeguarding or reconstruction of the church to some extent.

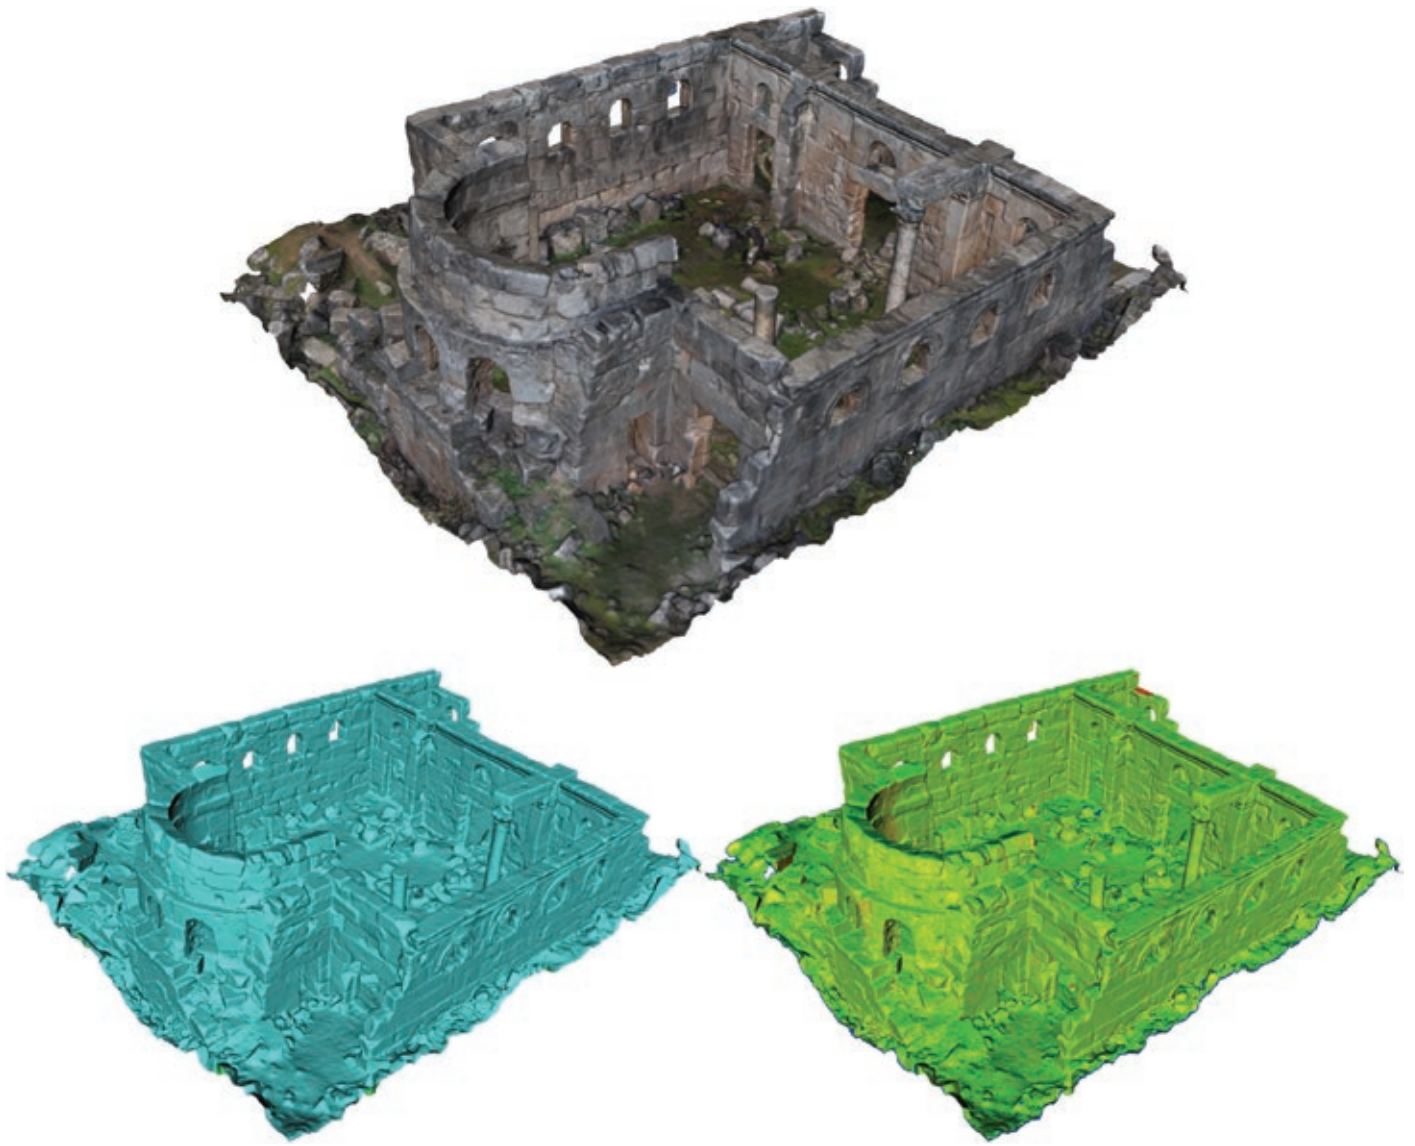
Figure 6. Bird's-eye view from the north-east

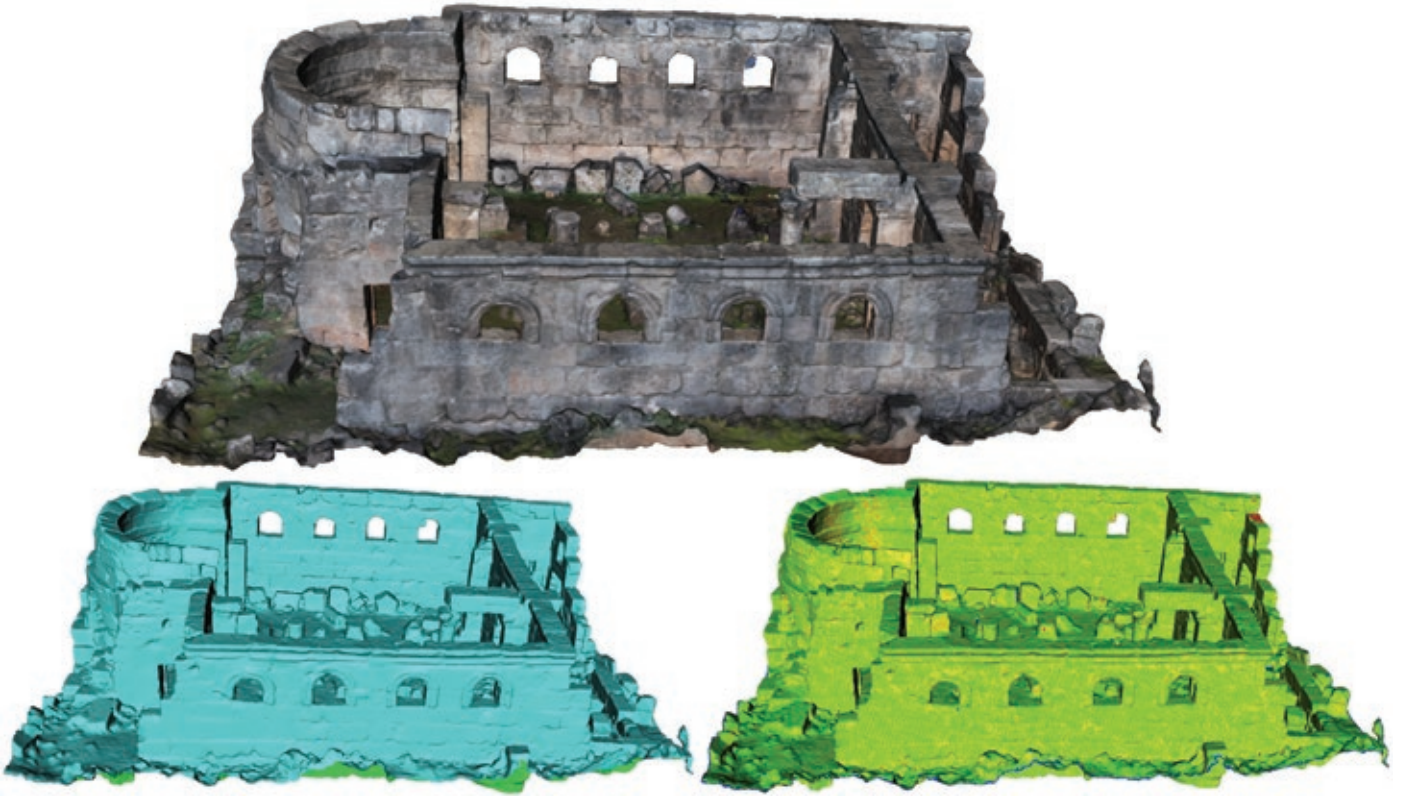
Figure 7. Bird's-eye view from the north

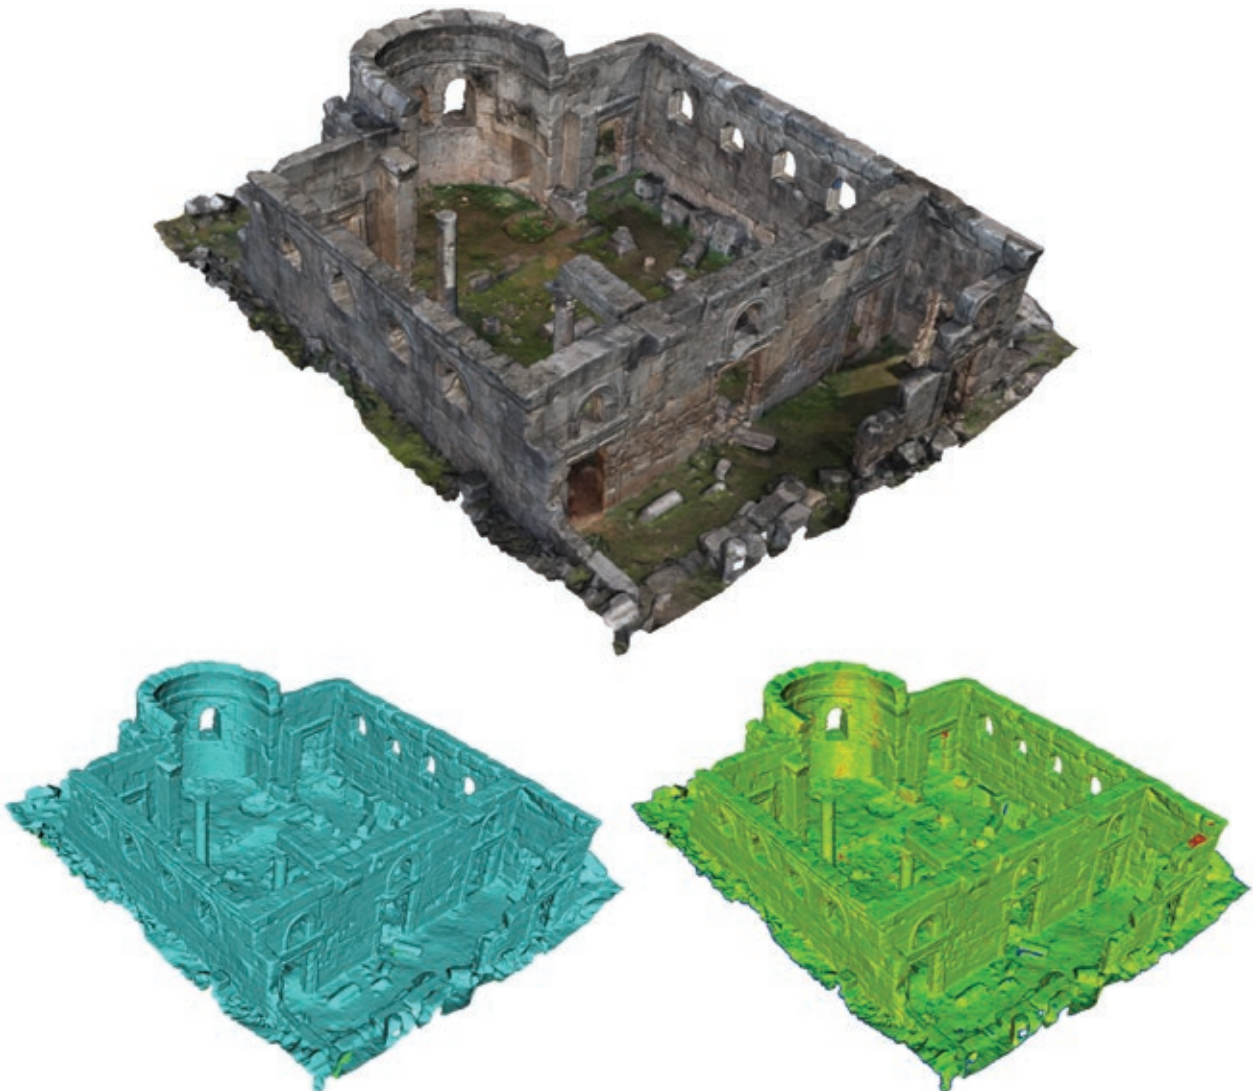
Figure 8. Bird's-eye view from the north-west

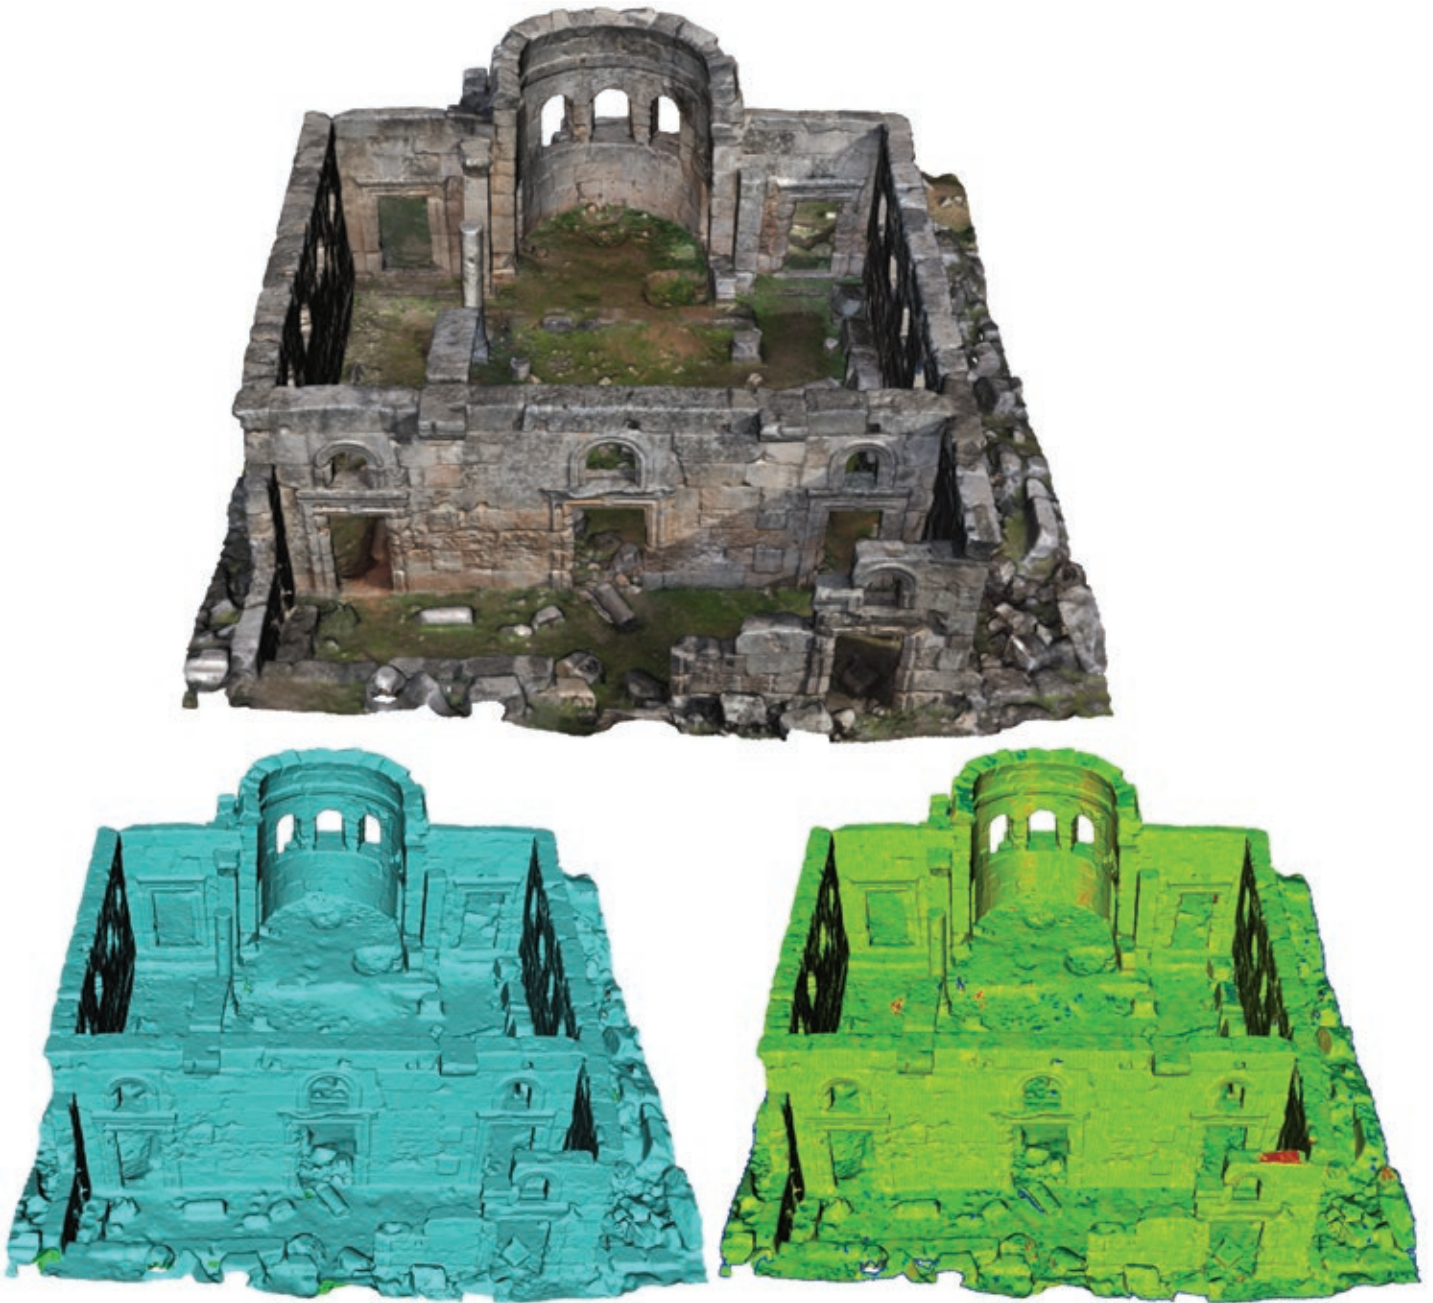
Figure 9. Bird's-eye view from the west

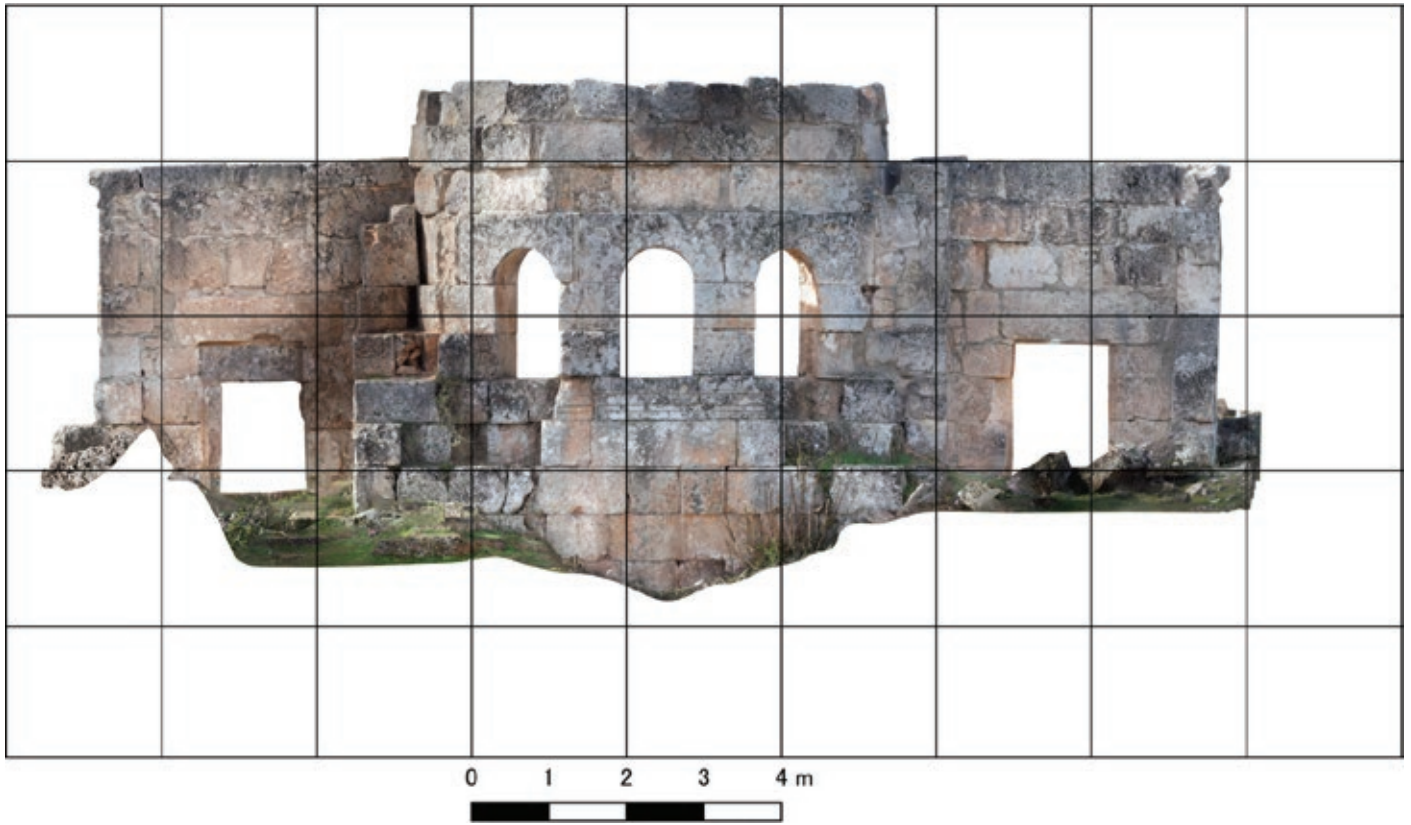
Figure 10. Section of eastern wall (outside of the apse)

Several section plans (i.e. ortho-photographs with scale) of the church are introduced here. The missing parts in the plans are the places covered by ground or surrounding the dislocated stones.

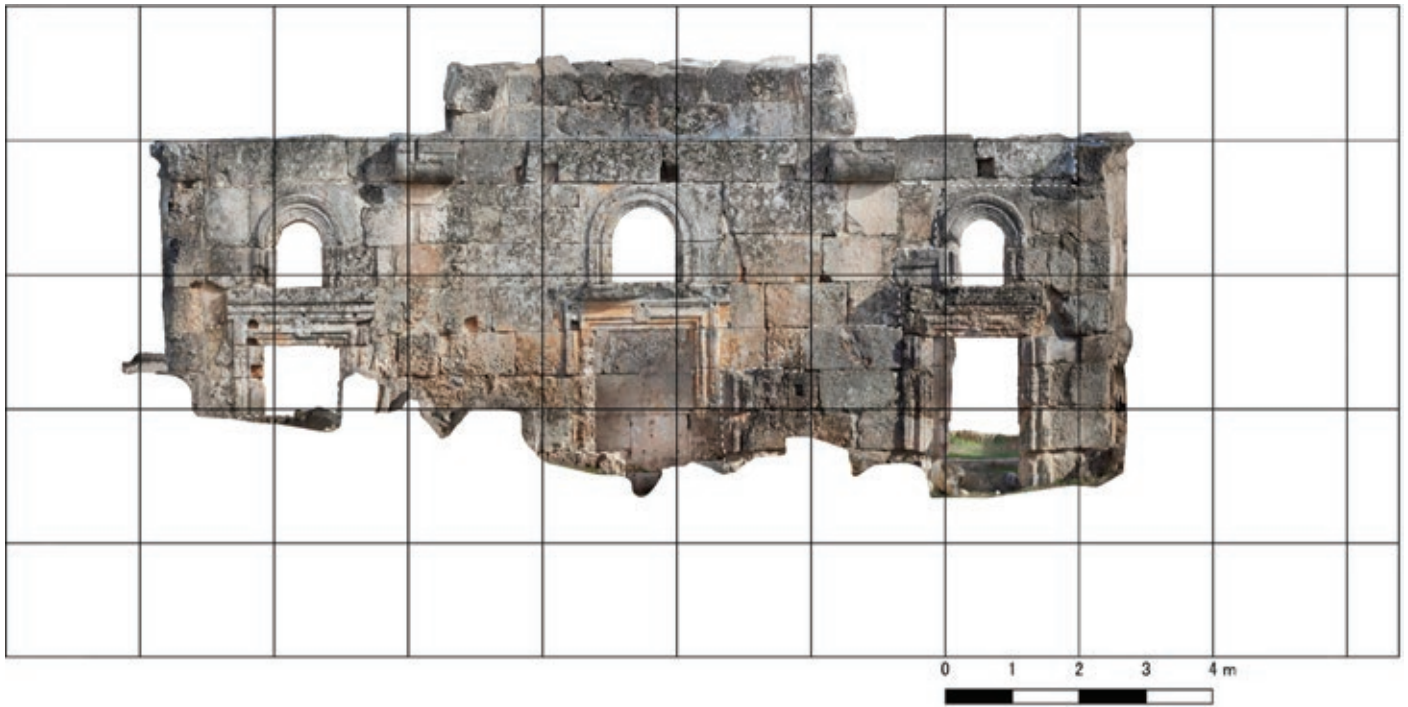
Figure 12. Plan of the western wall (the inner wall is hidden by the remaining outer side wall: white dotted line)

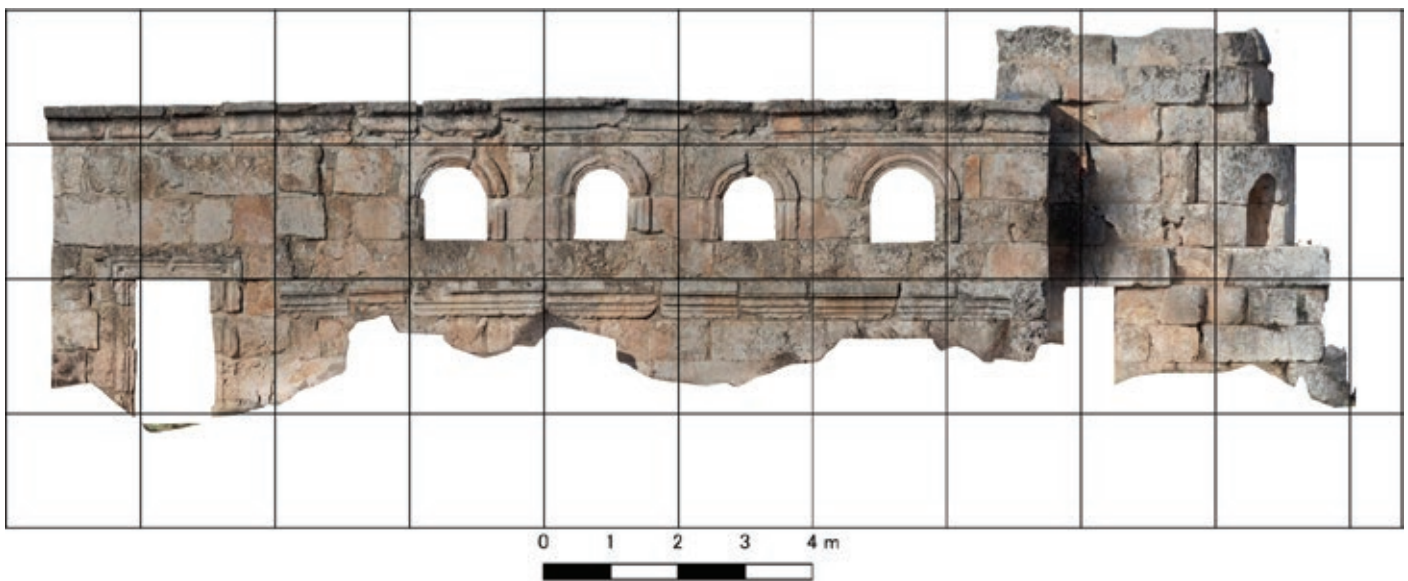
Figure 13. Section of southern wall

There is a line of decorated stones under the window in the southern wall that does not exist for the northern wall. Perhaps this difference should be considered from the viewpoint of its relation with the surrounding buildings (e.g. facing the main street), if the stones are in their original location.

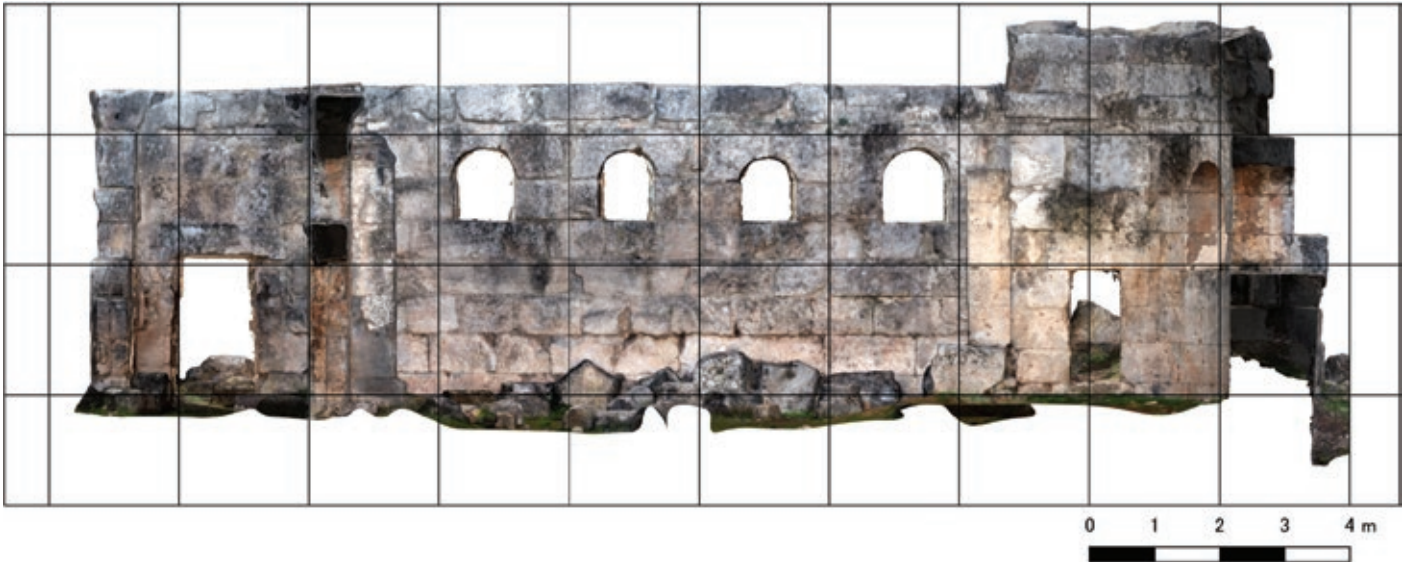
Figure 14. Section of inside wall (southern wall)

Plans of inside walls are illustrated here. The inside walls are revealed by cutting the 3D model in half showing some of the transections.

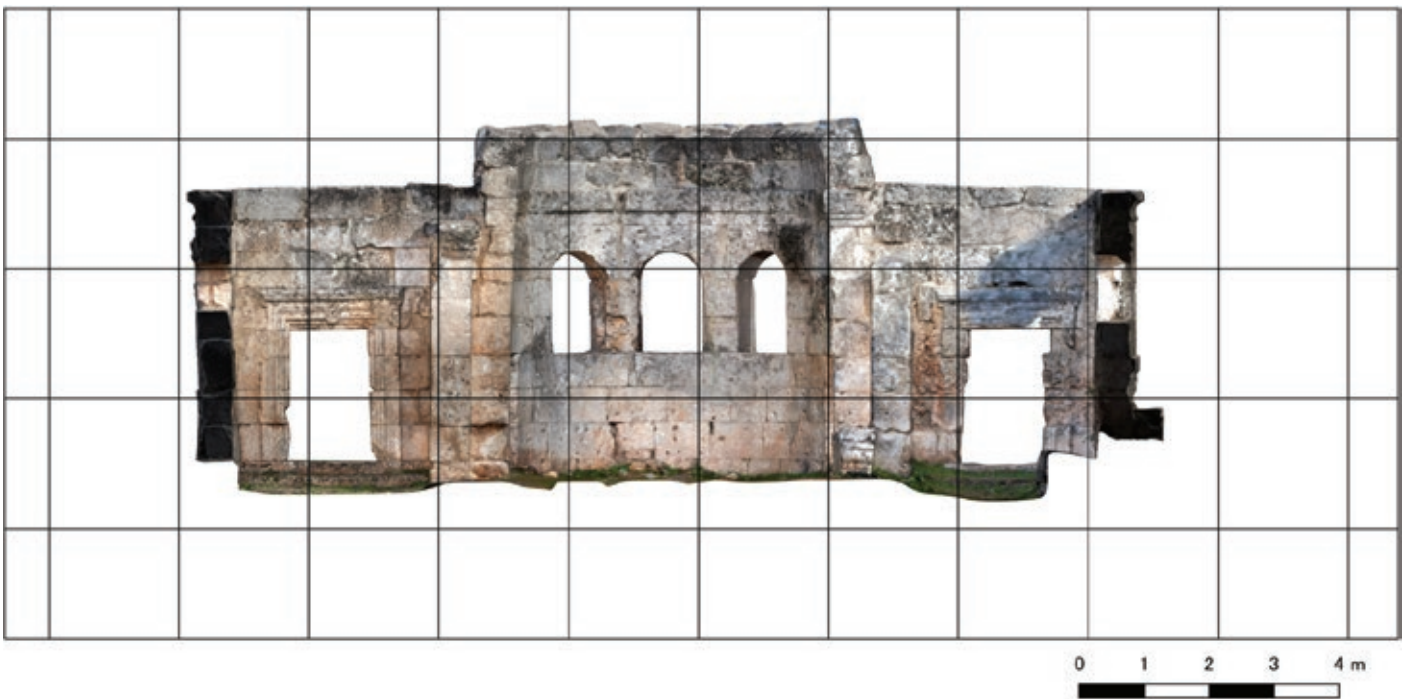
Figure 15. Front section of the apse (east)

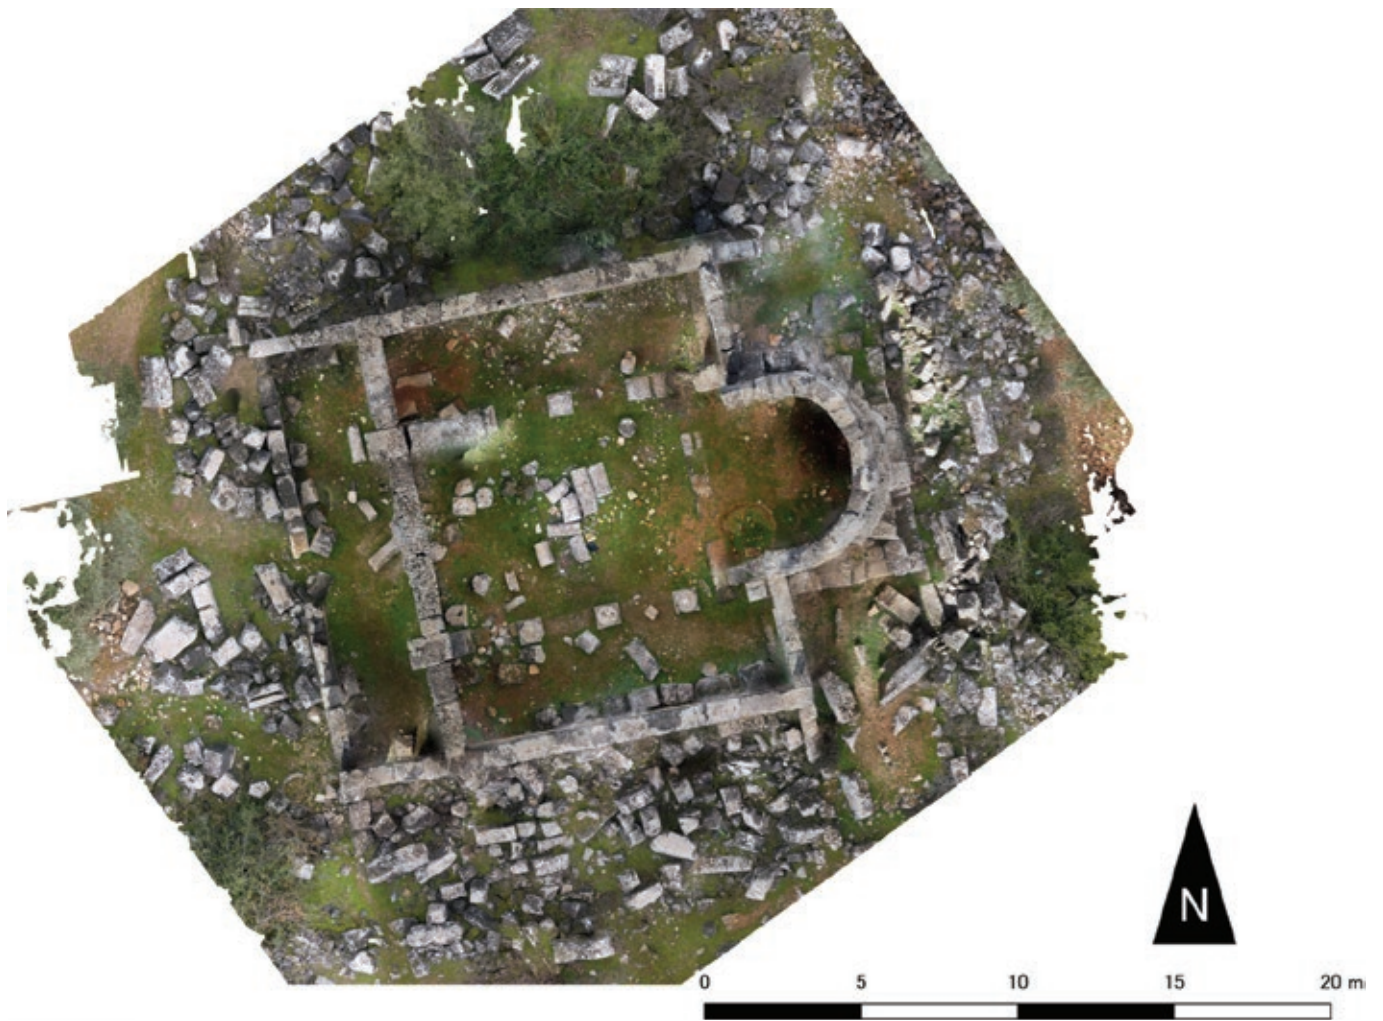
Figure 16. Ortho-photograph from above (Top view)

The top view ortho-photograph, point cloud data, and a plan generated from the ortho-photograph are illustrated here. The ortho-photograph shows that many dislocated stones are scattered around the church. The orientation of the church is given from the GPS values tagged to the photographs collected from the UAV (Since the GPS device utilized is not high-precision, its orientation can vary slightly from the actual one).

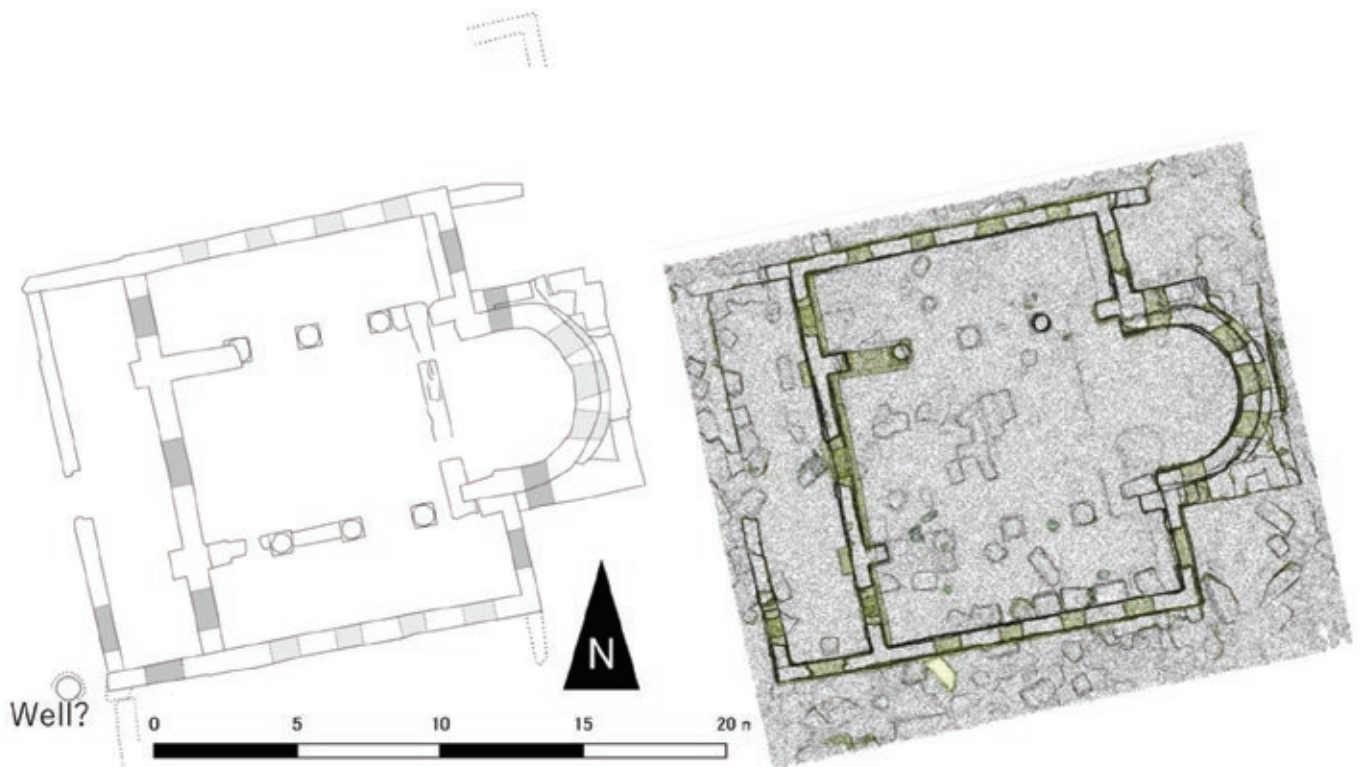
Figure 17. left. Top plan (Derived from the ortho-photograph.) , right. point cloud data

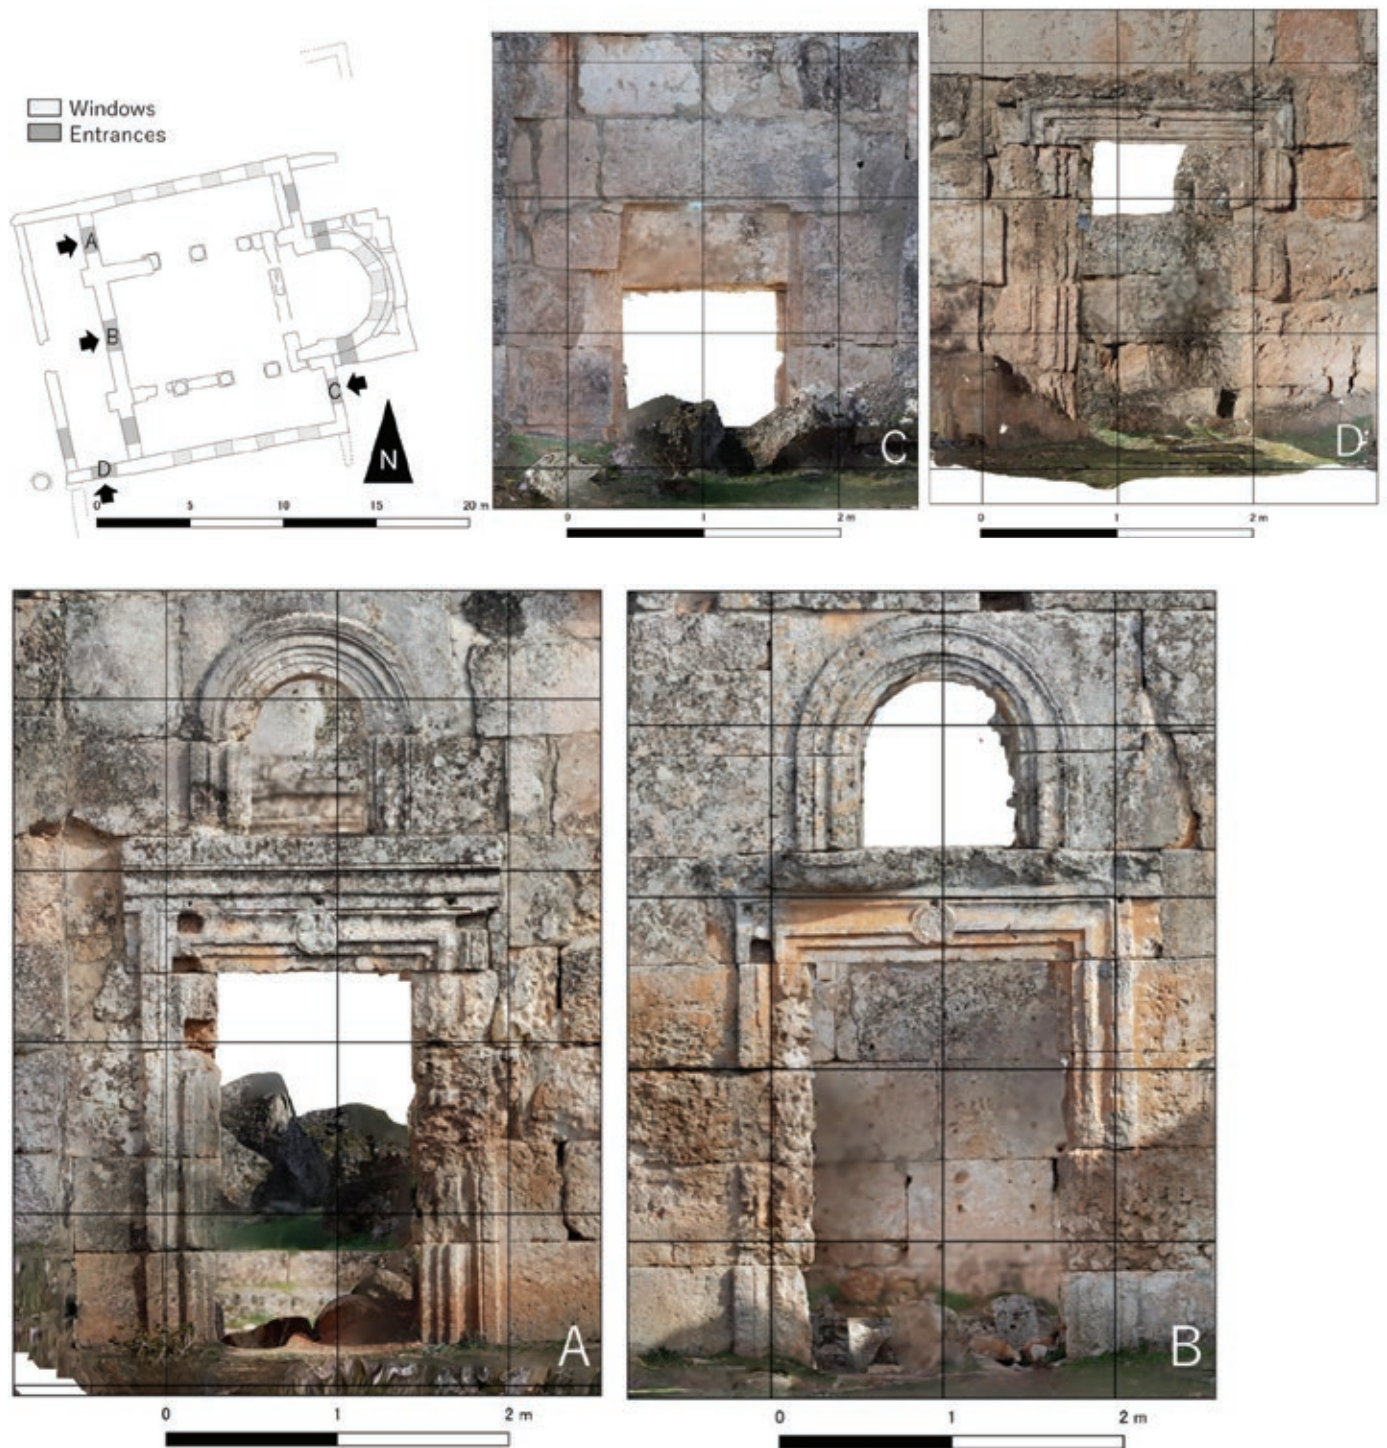
Decoration of the entrances is seen only on the western side with the outer side of entrance C showing “no decoration”. Perhaps decoration is more specific to the main entrance (west) than the outer views.

Figure 18. Comparison of the entrances

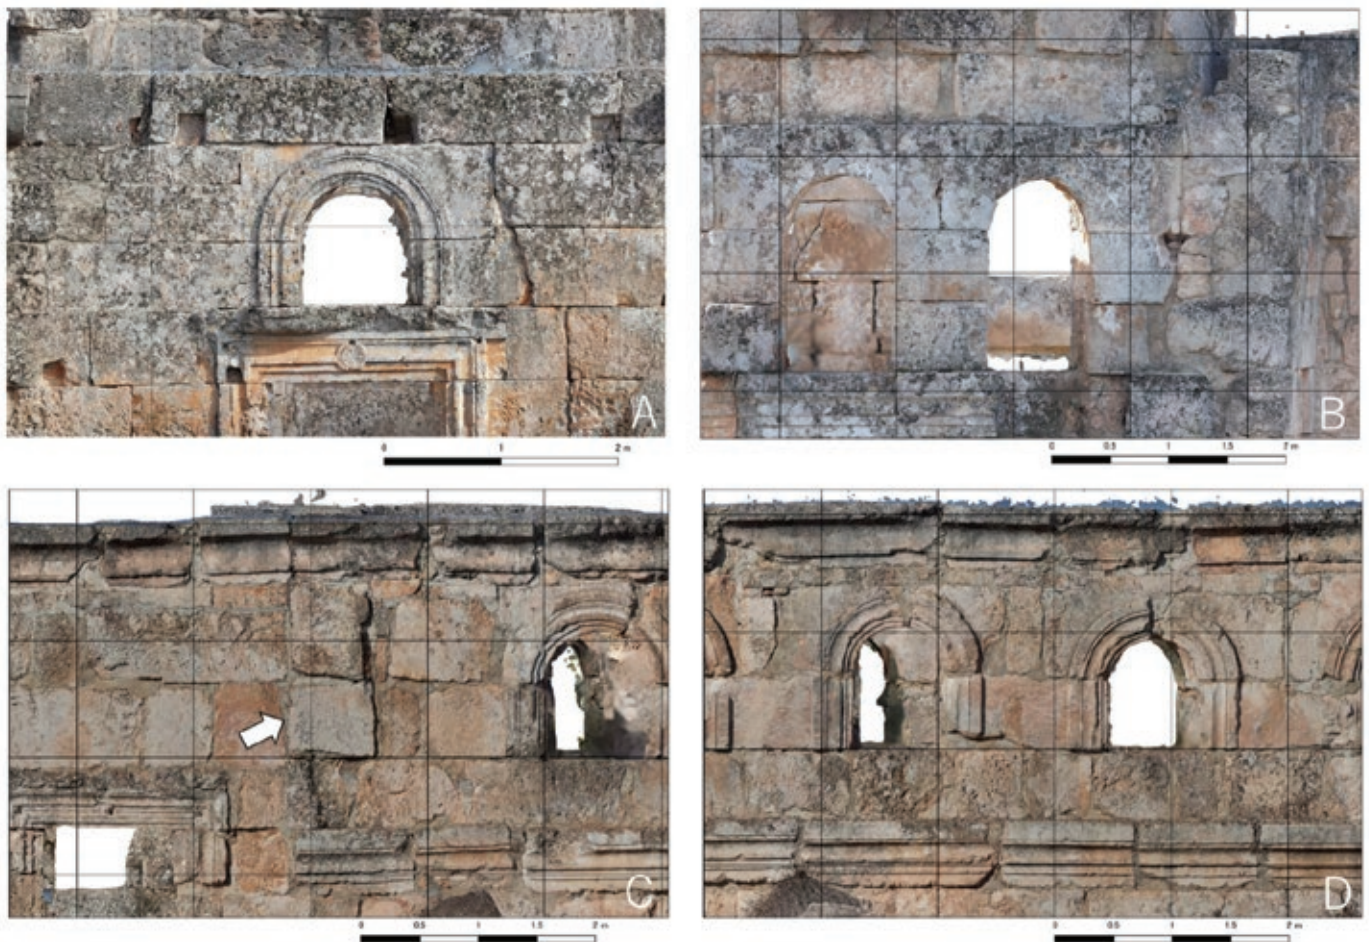
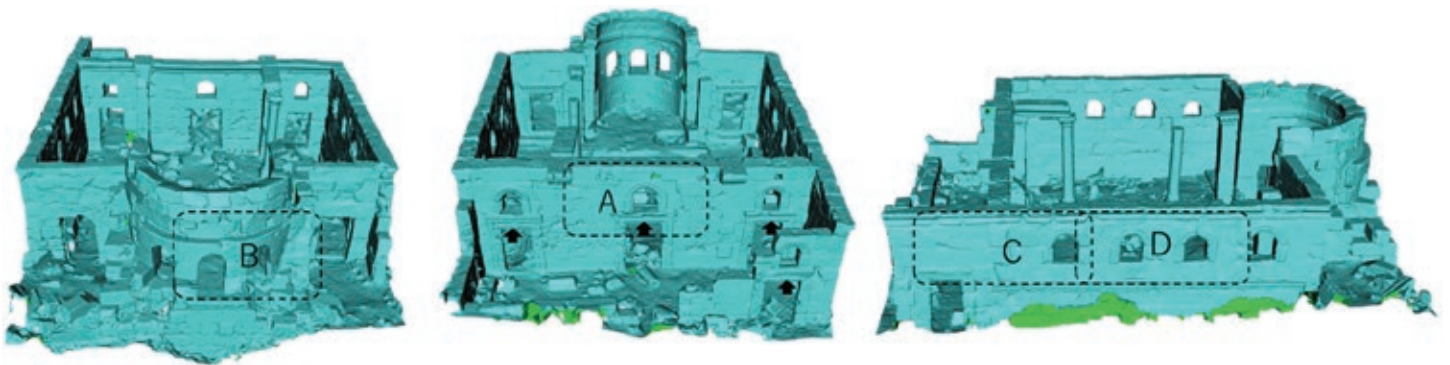
Not much “special” masonry was observed. However, the protruding stones observed in Figure 19 “C” seem to be stones from the attached walls (also see Figure 2).

Figure 19. Masonries observed in the church

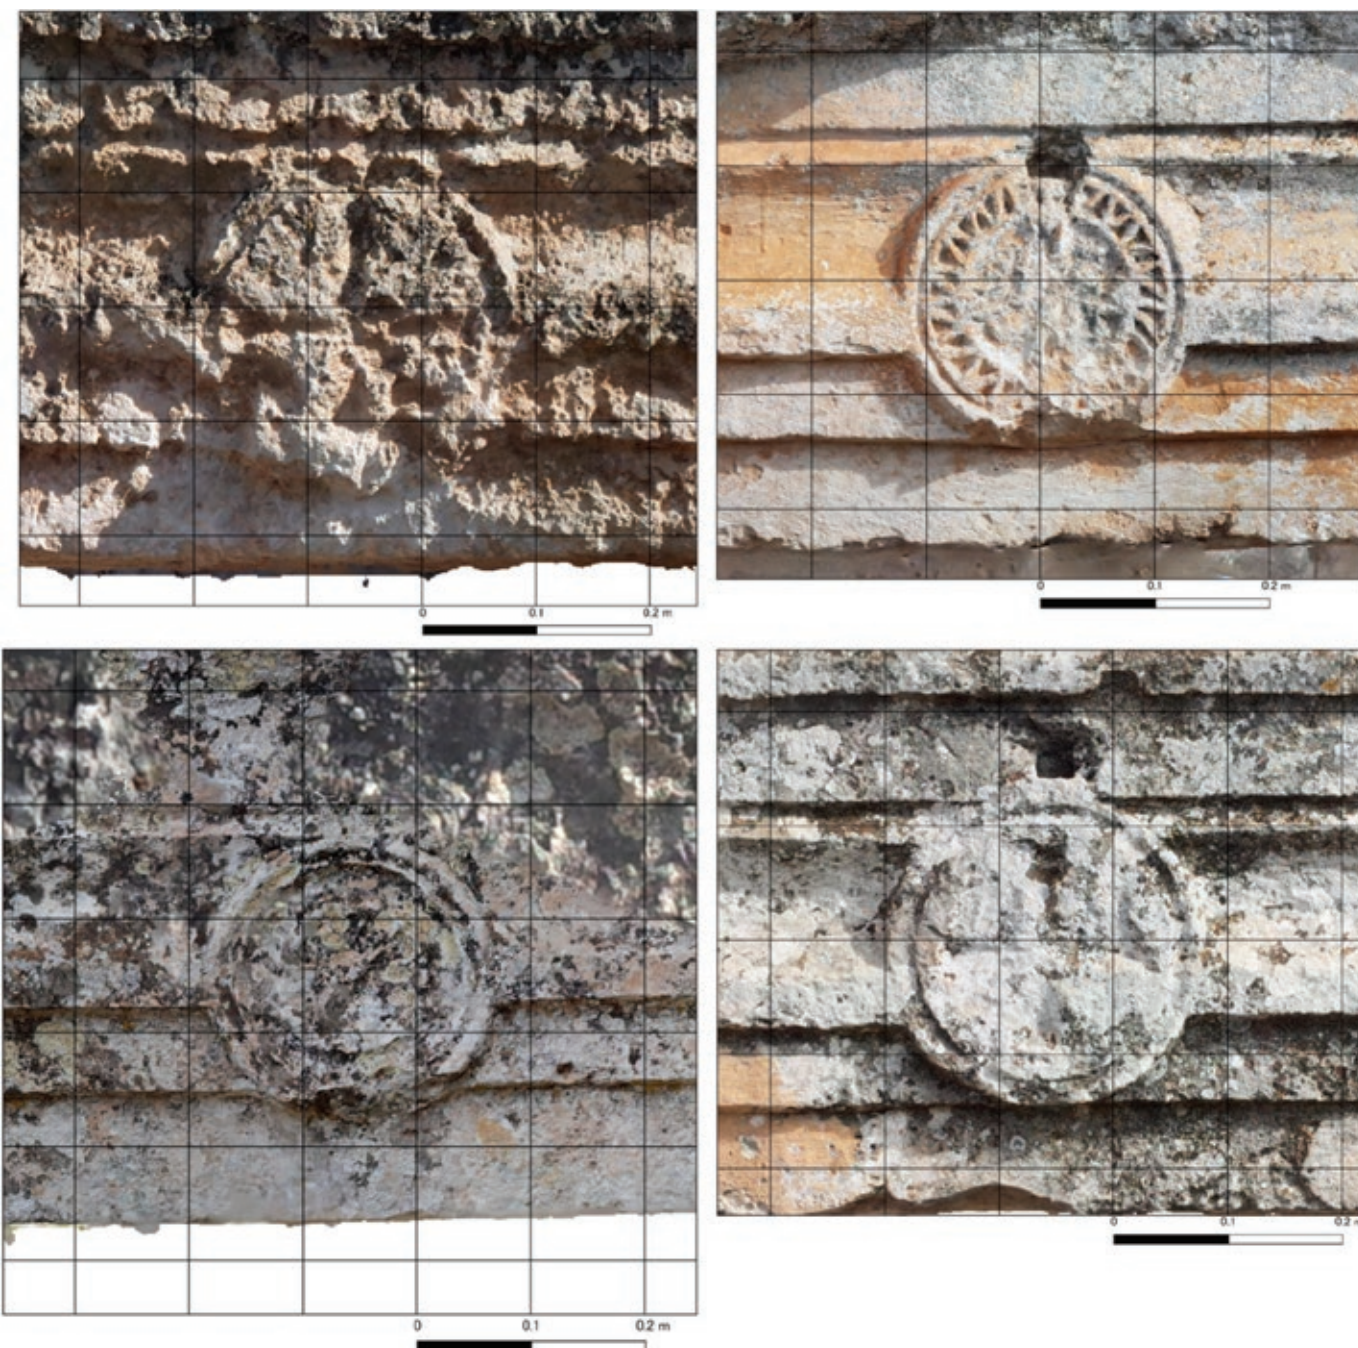
Six symbols on the lintel stones of the entrances are observed in this church, comprising four on the outer side, two in the inner space. The four symbols of the outer side are illustrated here.

Figure 20. The symbols observed on the church

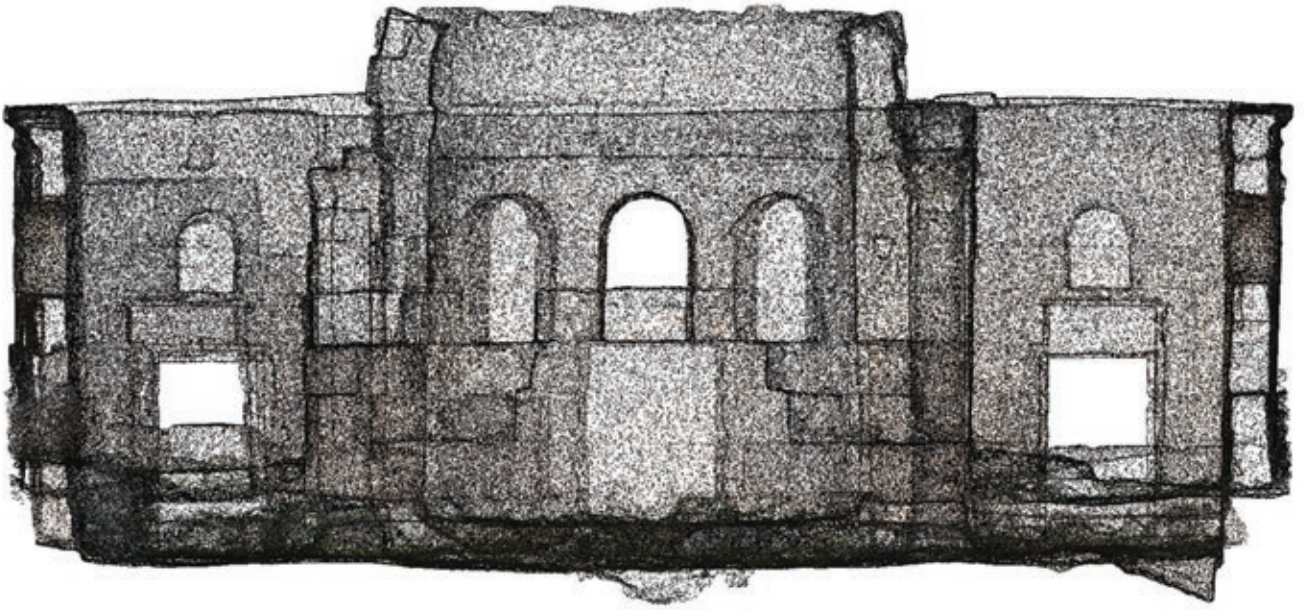
Figure 21. Half transparent view from the east

The point-cloud models are used to show half transparent views from different angles. This may help further understanding of the positional relationship between the structures.

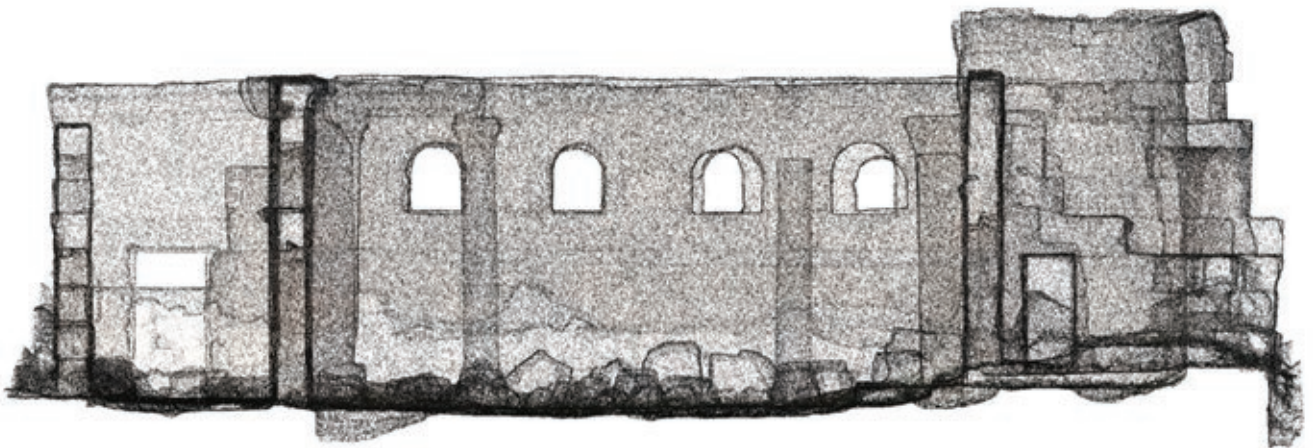
Figure 22. Half transparent view from the south
