A Series of Photogrammetry for Protection of Syrian Cultural Heritage

Ancient Villages of Northern Syria Vol. 2

al-BARA

2. Preliminary Survey in al-Bara Ancient City and Making 3D Images of the Church 4

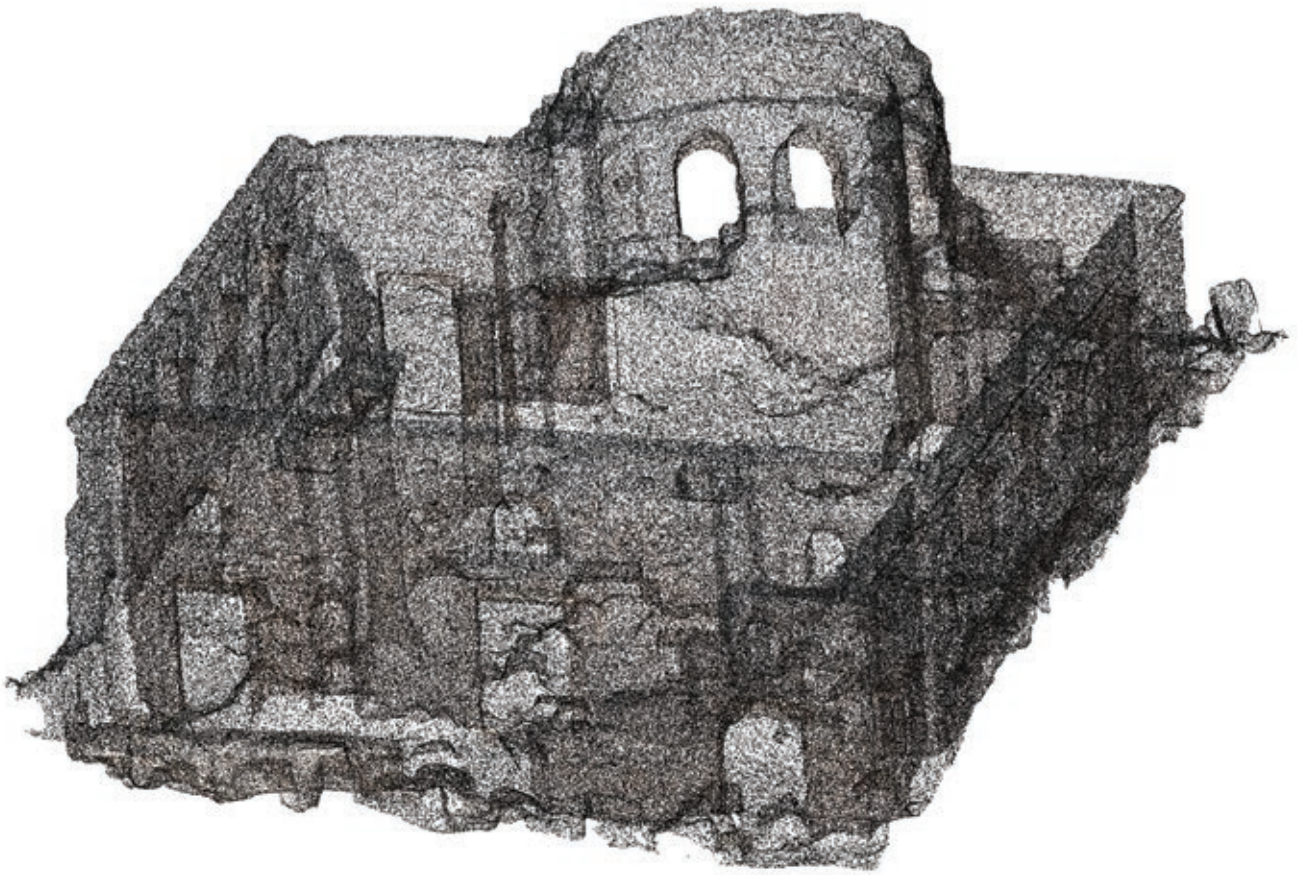
Figure 23. Half transparent view from the south-west

The point-cloud models are used to show half transparent views from different angles. This may help further understanding of the positional relationship between the structures.

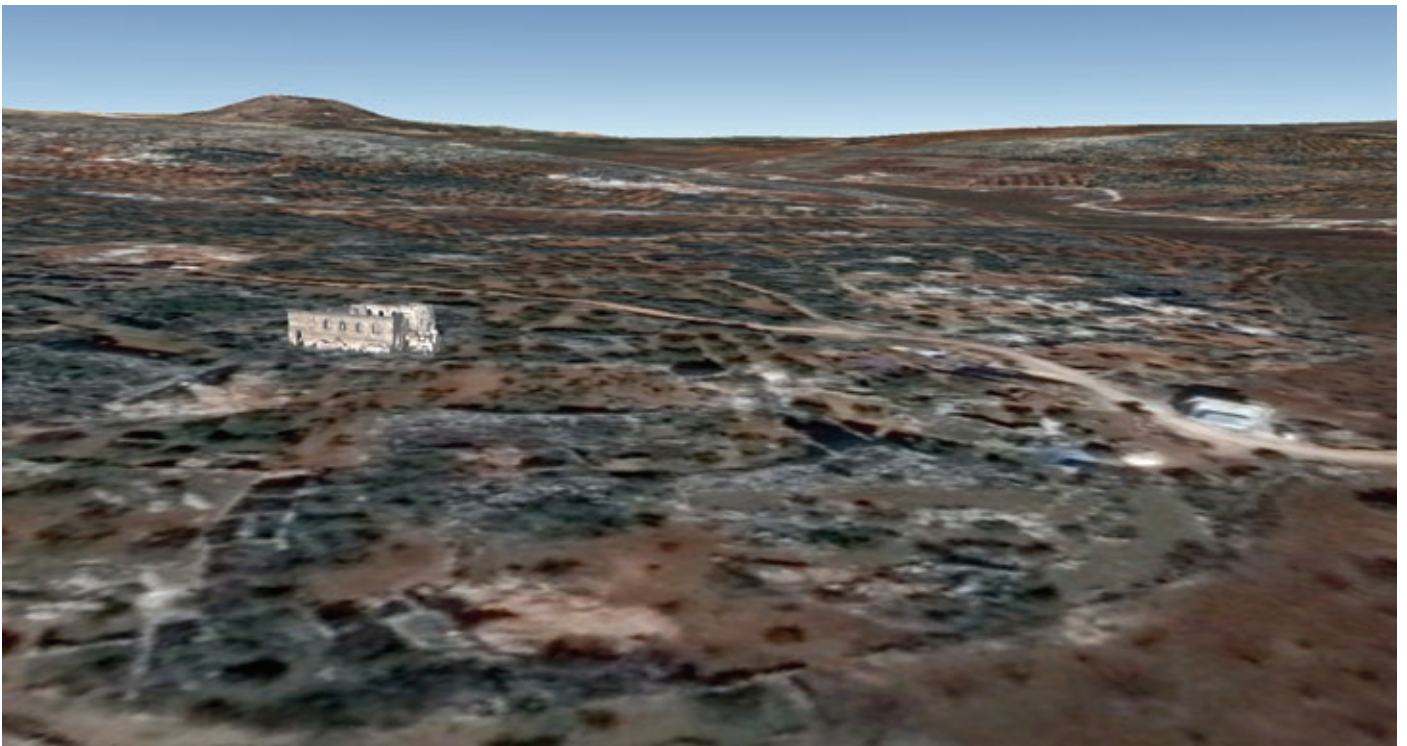
Figure 24. Model combined with Google Earth (facing north-west)

The 3D model is combined with Google Earth images and the surrounding landscape can be determined from this result. As such, the geographical context can be understood.

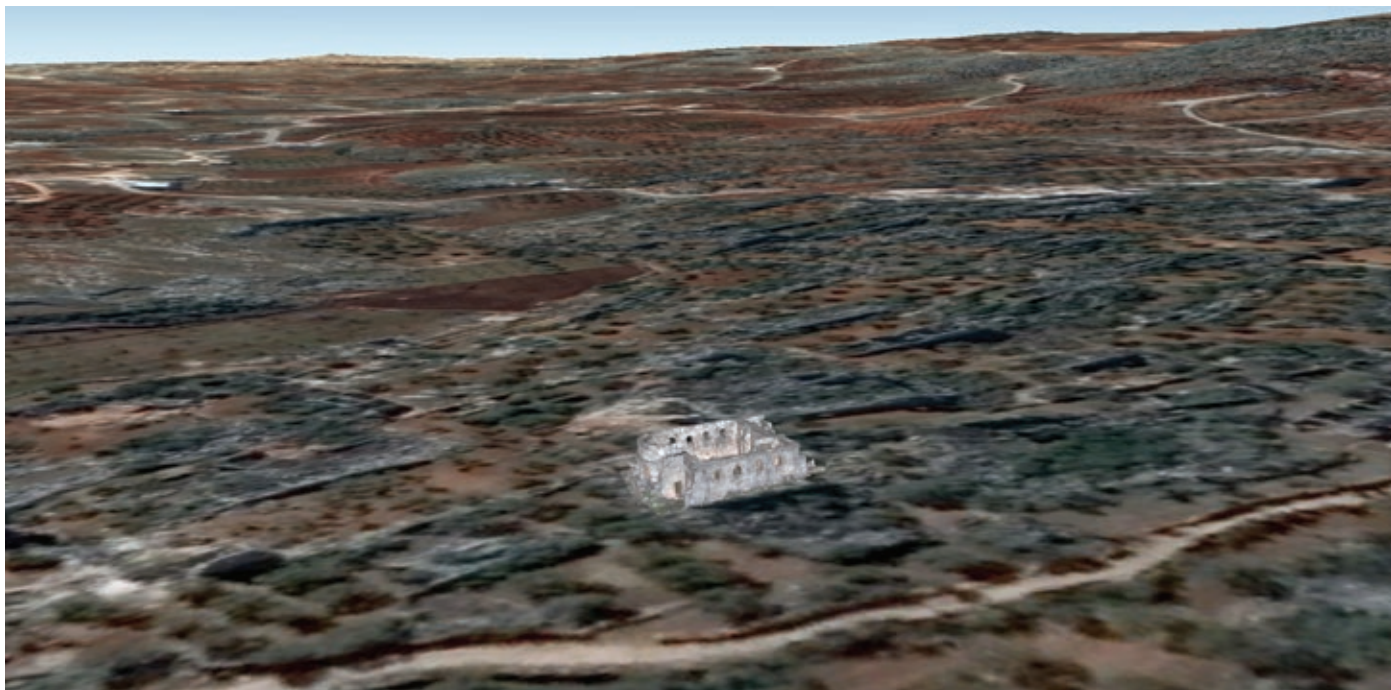
Figure 25. Model combined with Google Earth (facing south)
