# Scientific Studies on Conservation for Üzümlü Church and its wall paintings in Cappadocia, Turkey

**Vol. 2 (Report on the activities in 2015-2016)**

University of Tsukuba  
2017

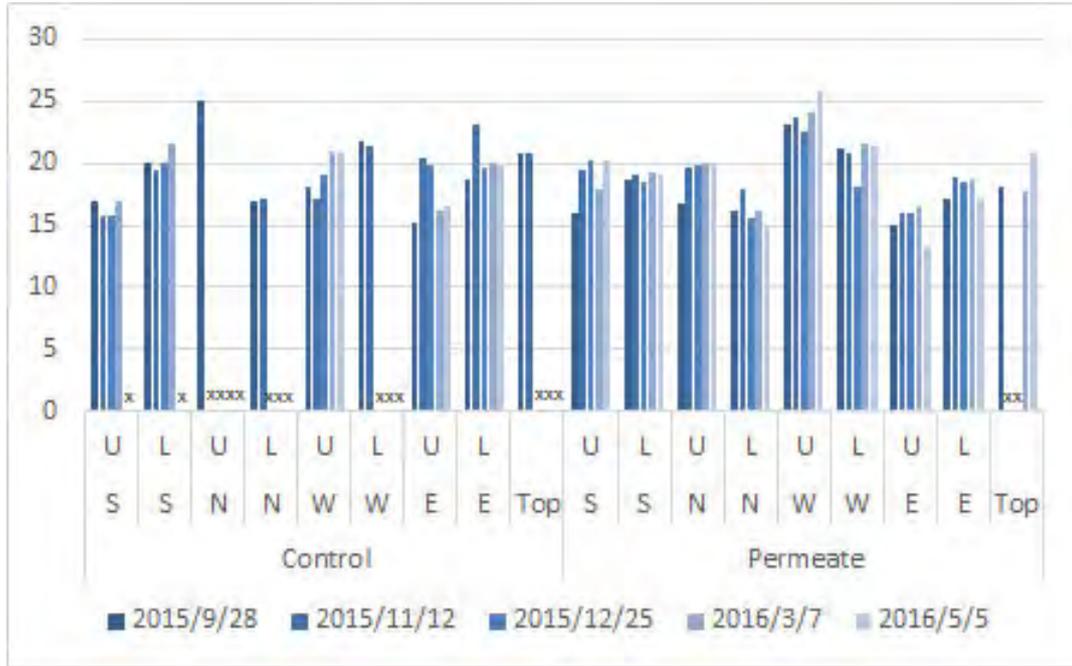
To quantify the degree of weathering of the tuff masses, stainless steel nails were anchored to the rock surface in September 2015. Surfaces facing in each of the four directions (north, east, west, and south) were identified and two nails were set in each direction such that one nail was located in the upper region and one in the lower region of the surface. One nail was then located on the top, leaving a total of nine nails on each test rock. The length of the nail appearing outside of the rock was measured with a digital caliper on both right and left sides. The nail length was measured by local collaborators every few months. In the 'control' mass, weathered tuff powder accumulated below the rock, and four out of the nine nails fell within the first four months from anchoring. In contrast, in the 'treated' mass, weathered deposits were generally small and only one nail fell off (Figure 1.1). The treated surface darkened distinctly as time passed (Figures 1.2a and 1.2b). The north side of the Üzümlü Church was also tested with the same material (Figures 1.7 and 1.8). However, this area showed less darkening compared to that on the rock masses.

Figure. 1.1 Comparison of anchors (control and Permeate HS-360)  
Şekil. 1.1 Çivilerin karşılaştırılması (kontrol ve permeate HS-360)

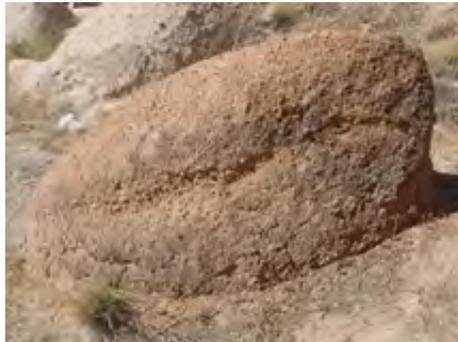
Figure. 1.2a Condition of area treated with Permeate HS-360 (Sep 2015)

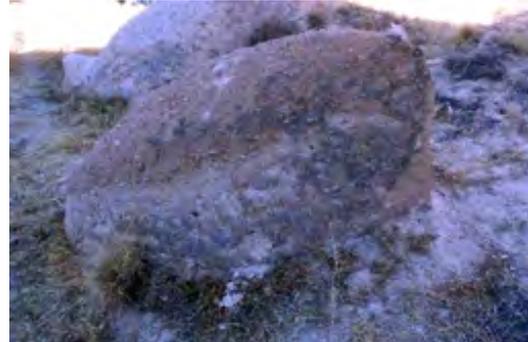
Figure. 1.2b Condition of area treated with Permeate HS-360 (Sep 2016)

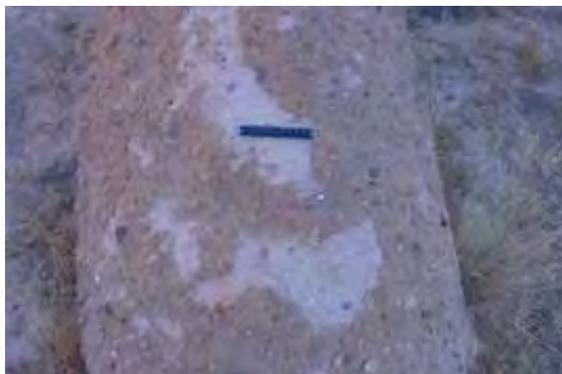
Figure. 1.3 Condition of area treated with Permeate HS-360. Some areas of the consolidated surface were detached (Sep 2016)

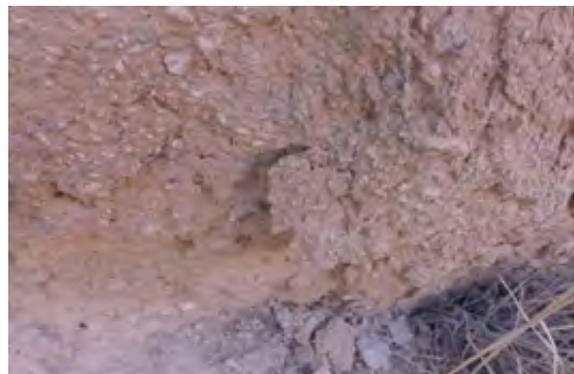
Figure. 1.4 Condition of area treated with Permeate HS-360. The lower portion showed weathering under the consolidated layer (Sep 2016)

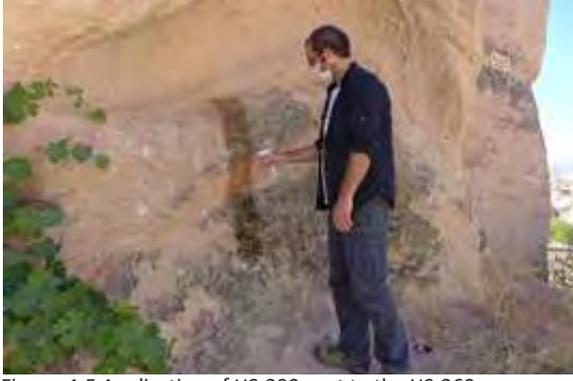
Figure. 1.5 Application of HS-390 next to the HS-360 area (after 1 year) (north side of the church)

In order to improve protection and to minimize darkening, a modified type of Permeate HS-390 was applied to another rock mass and on the north side of the church, next to the HS-360 area. 10 stainless steel anchors were placed on the new mass (Figure. 1.8). Periodical monitoring shall be carried

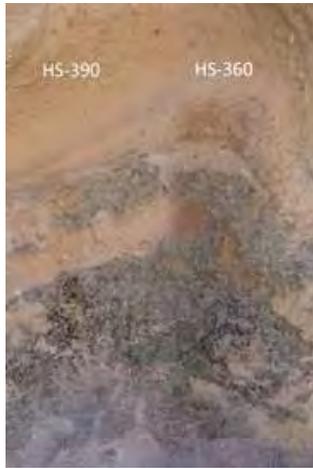
Figure. 1.7 Surfaces 24 hours from application (HS-390) and 1 year from application (HS-360)

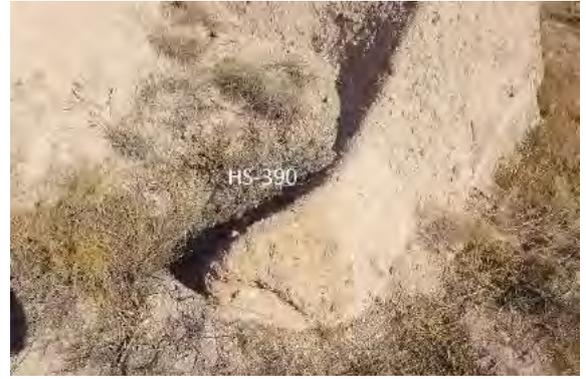
Figure. 1.8 Surface 24 hours from application

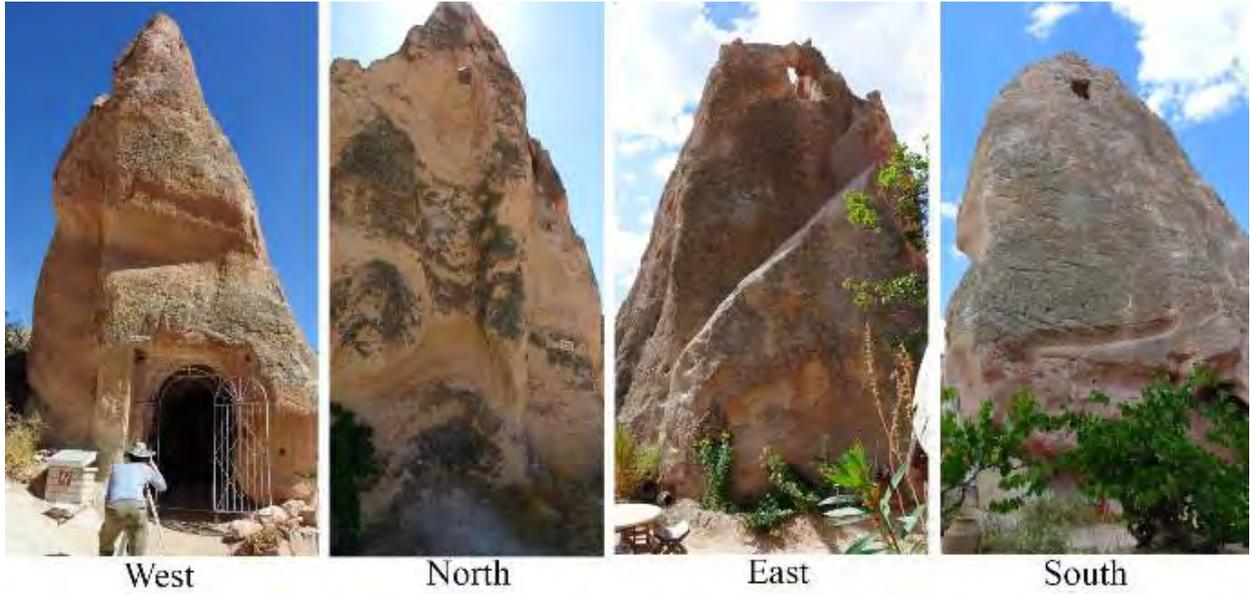
In the western façade, we have observed a very intense biological patina, which appears distributed mainly in the upper and middle areas (Fig. 1). The lower area next to the entrance looks rather not colonized. In this exposure, where the biological patina looked different we have collected two samples (W1 and W2). The northern surface is characterized by a sub-vertical inclination and seems mainly eroded. Here, the biological patina appears very compact and looks to be mainly composed of lichens and mosses. In this area, we took four samples in the lower zone (N1, N2, N3, and N4). The eastern exposure is sub-vertical and it is suffering from a strong colonization consisting of lichens. In the upper and lower area, we have collected two fragments (E1, E2). In the southern exposure, the surface appears widespread colonized, and we have taken two samples from the lower zone (S1, S2).

Figure. 2.1 Distribution of biological colonization in different exposures  
Şekil 2.1 Kilisenin farklı cephelerindeki biyolojik kolonizasyon dağılımı

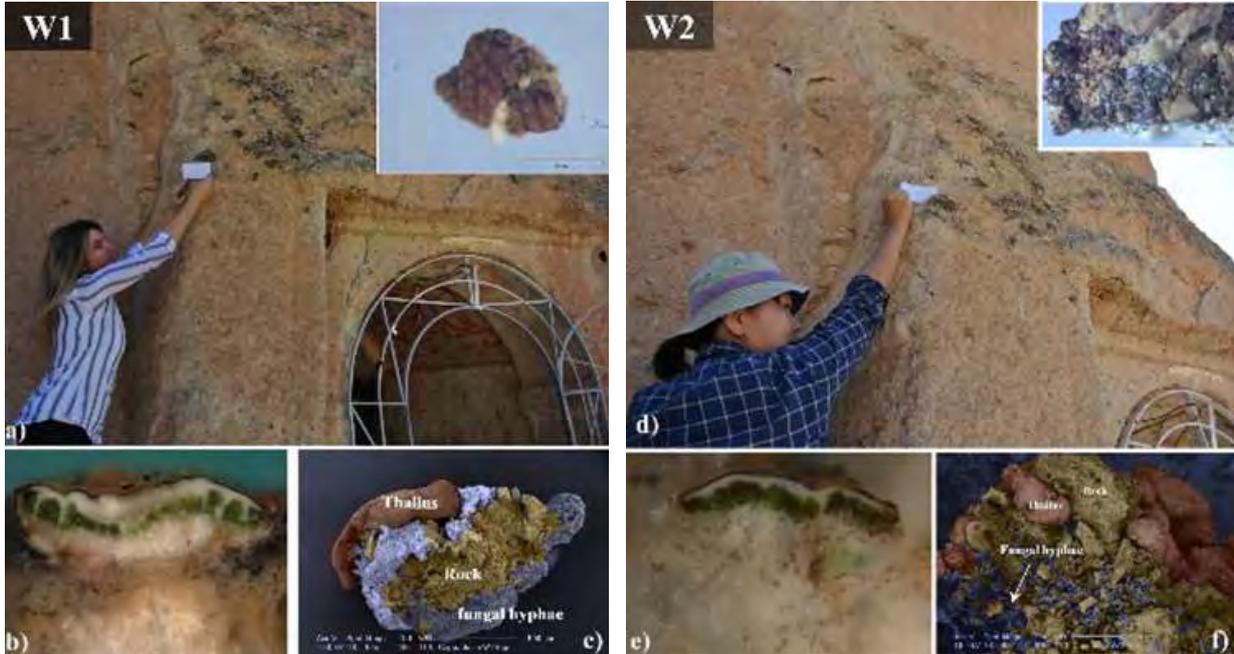
In both samples W1 and W2 has been observed the presence of the crustose lichen *Acarospora* sp., characterized by a red-brown thallus with small areoles firmly attached to the substrate (Fig 2 a, d).

Figure. 2.2 Biological colonization in west exposures a), d) Sampling points and pictures under the stereomicroscope; b), c) Microphotograph of the sample in polished cross sections; c), d) SEM image in false colour of the fragments.

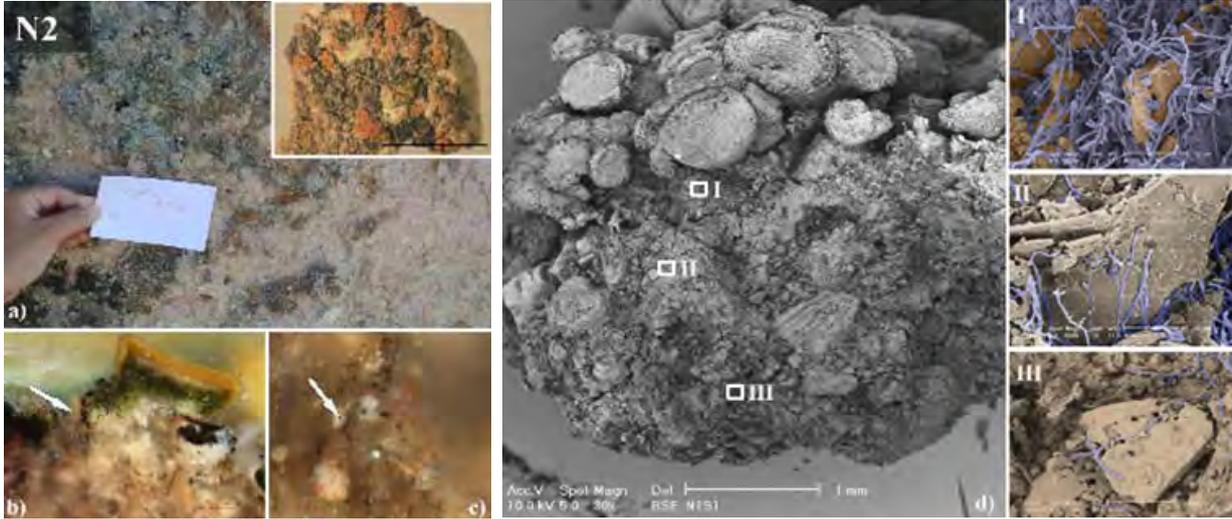
In the fragment N2 have been observed the crustose lichens *Caloplaca* and *Lecanora* cfr. *crenularia*, characterized by orange and brown apothecia without a thalline margin (Fig. 4 a). Meristematic fungi were also observed by OM in the polished cross-section (Fig. 4b, c).

The SEM details of the entire fractured sample show several spherical bore-holes arising from fungal hyphae and the reproductive fungi structures that actively penetrate inside the grains leaving tunnels and bore-holes on the surface (Fig. 4 d).

Figure. 2.4 Biological colonization in north exposures a) Sampling point (N2) and picture under the stereomicroscope; b) ,c) Microphotograph of the sample in polished cross section; d) SEM image of the entire fragment with detail in false colour.

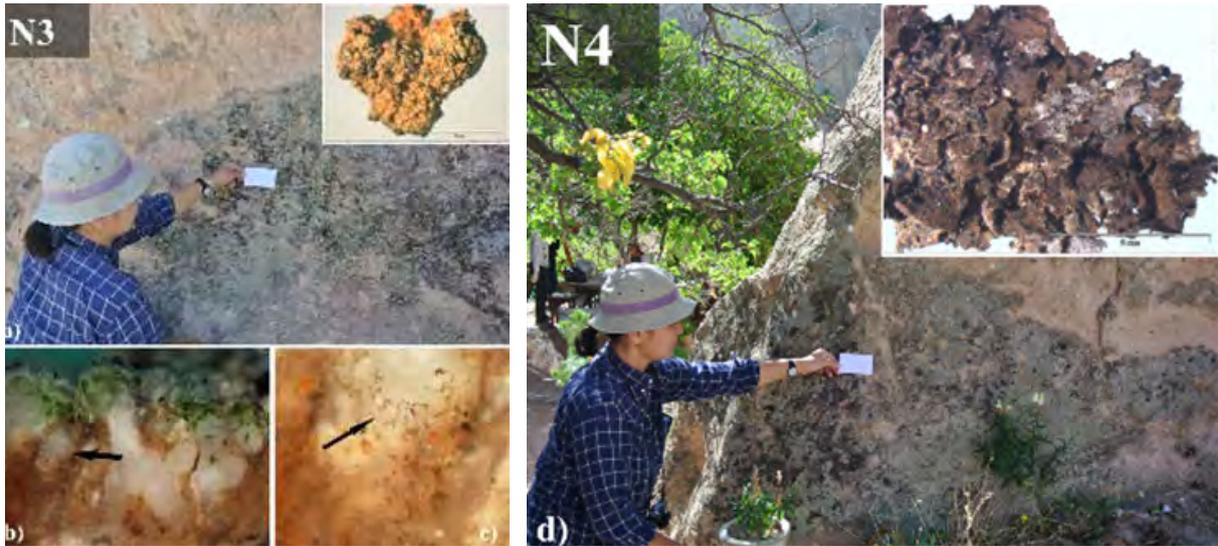
In the fragment N3 has been observed a crustose lichen Xanthoparmelia group Neofuscelia, the thallus is areolate and verrucose; the surface appear ash gray, globular, and epruinose. In addition, the OM observation (Fig. b, c) showed a dense presence of black meristematic fungi.

Figure. 2.5 Biological colonization in north exposures a), d) Sampling points (N3, N4) and pictures under the stereomicroscope; b), c) Microphotograph of the sample in polished cross section, the arrows underline the meristematic fungi presence.

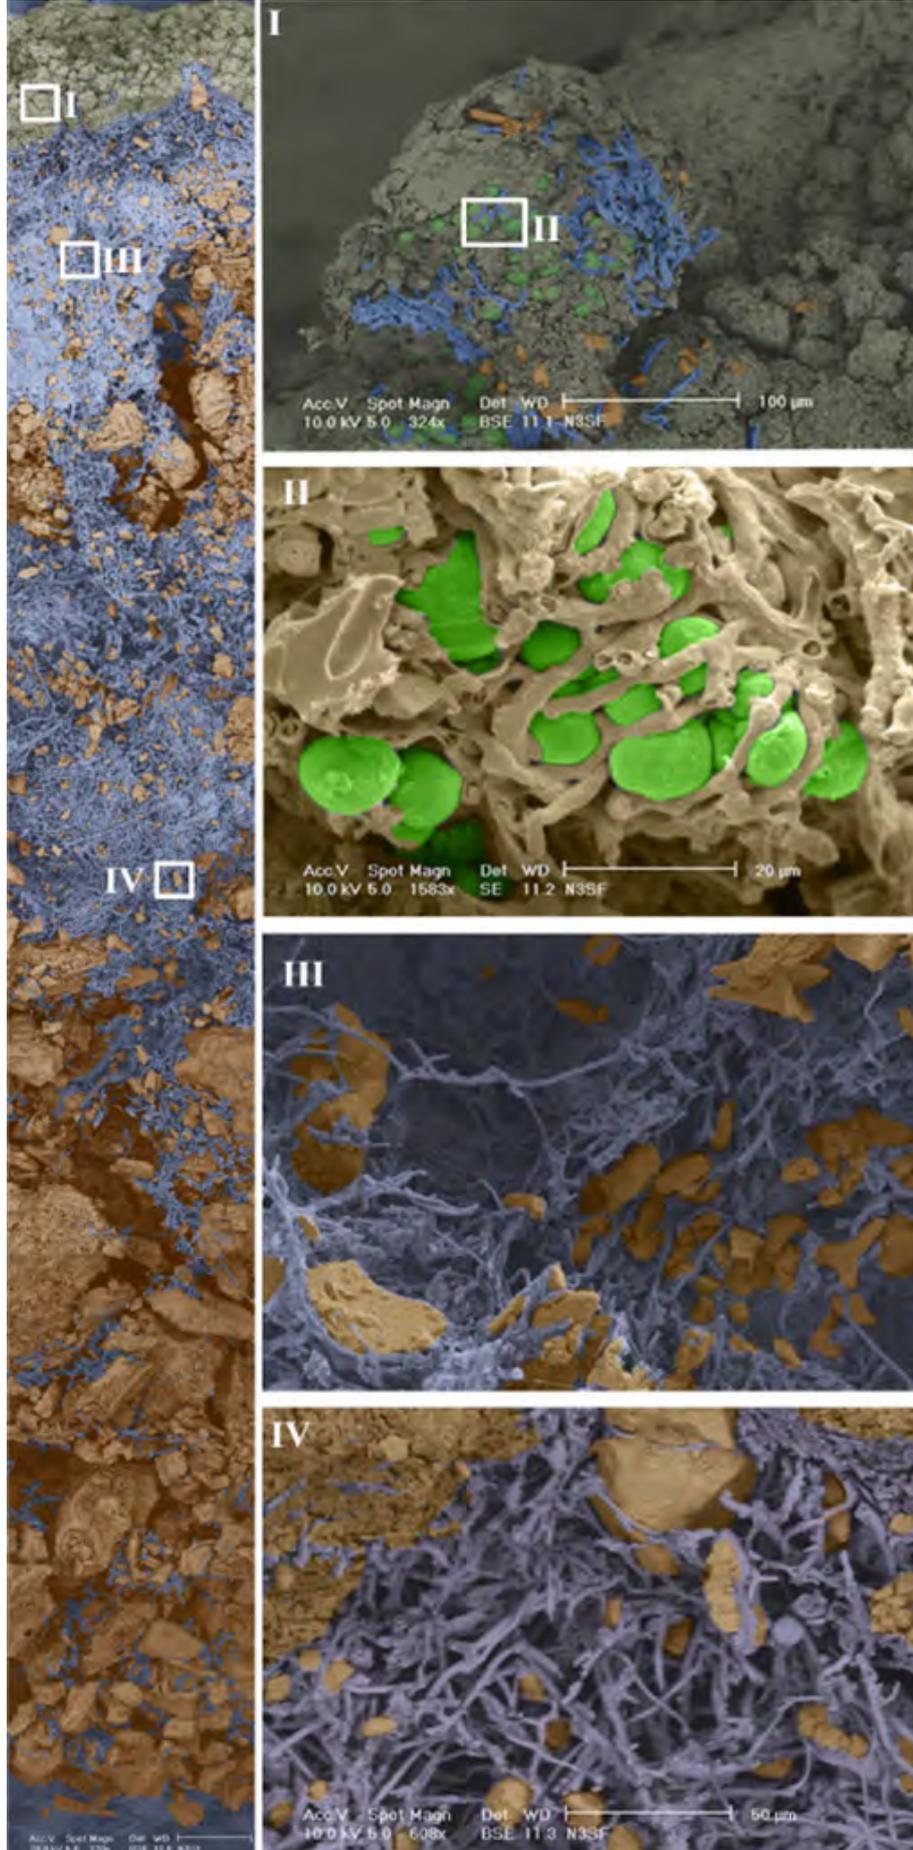
The SEM observation of the entire fractured sample shows the striking density and penetration of the networks of fungal hyphae inside the rock. In detail, the Fig. 6 I and II show the photobiontic layer in the thallus structure, while Fig. 6 III and IV underline as the mineral grains are completely embedded in the hyphae networks.

Figure. 2.6 SEM image in false colour at different magnification of the N3 fragment.  
Şekil 2.6 N3 örneğinin farklı gelişmekte olan SEM analizinin renki görüntüsü

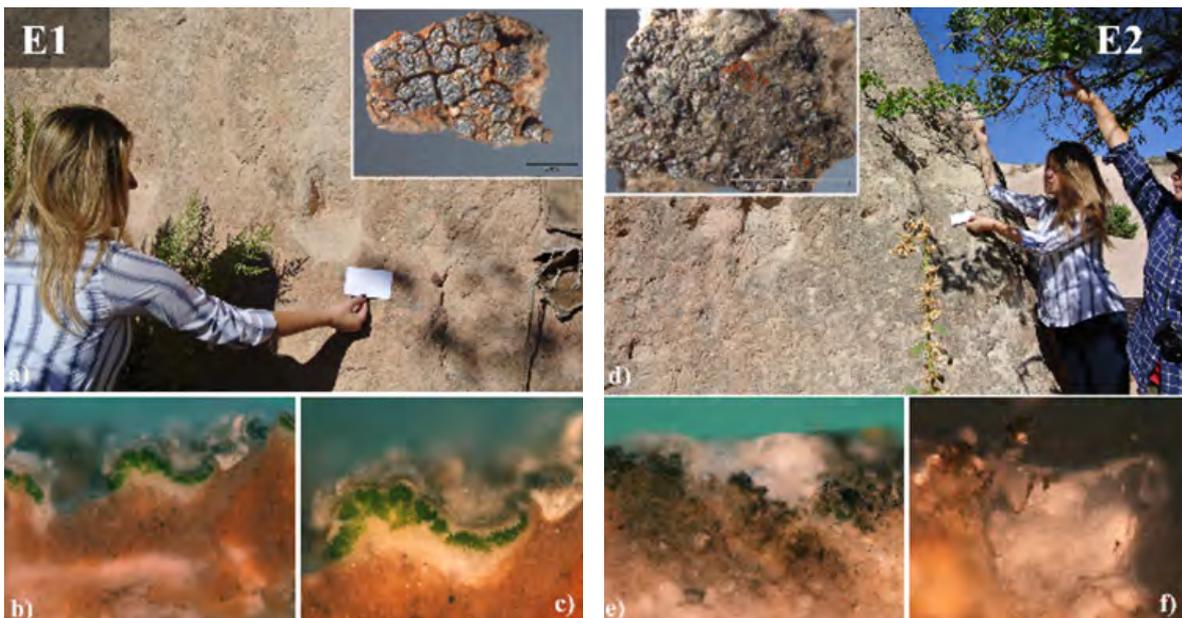
In the fragment E1 has been observed the crustose lichen *Aspicilia*; the thallus is grayish-white and appear cracked-areolate, with the surface of each areole irregular (Fig 7 a). Under the thallus area is evident a bright orange coloration (Figs. b, c).

In the fragment E2 has been observed the crustose lichen *Caloplaca*, characterized by orange and white apothecia without a thalline margin (Figs. 7 d). Meristematic fungi were also observed inside the rock by OM in the polished cross-section (Fig. 7 f).

Figure. 2.7 Biological colonization in east exposures a), d) Sampling points (E1, E2) and pictures under the stereomicroscope; b), c), e), f) Microphotograph of the sample in polished cross sections.

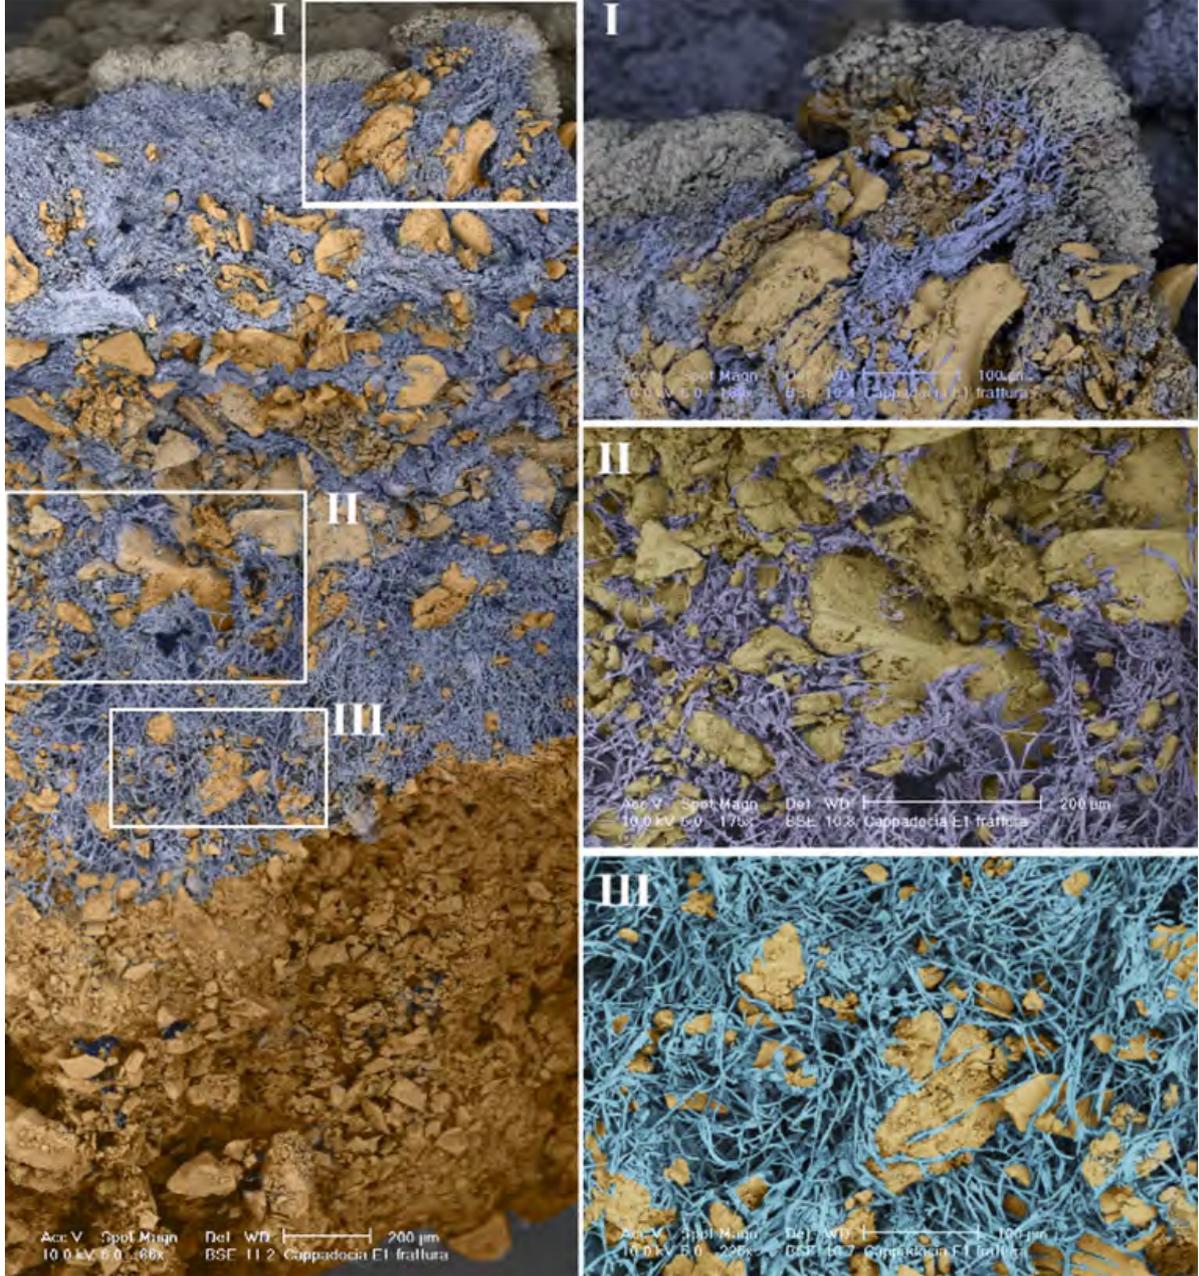
Figure. 2.8 SEM image in false colour at different magnification of the E1 fragment.

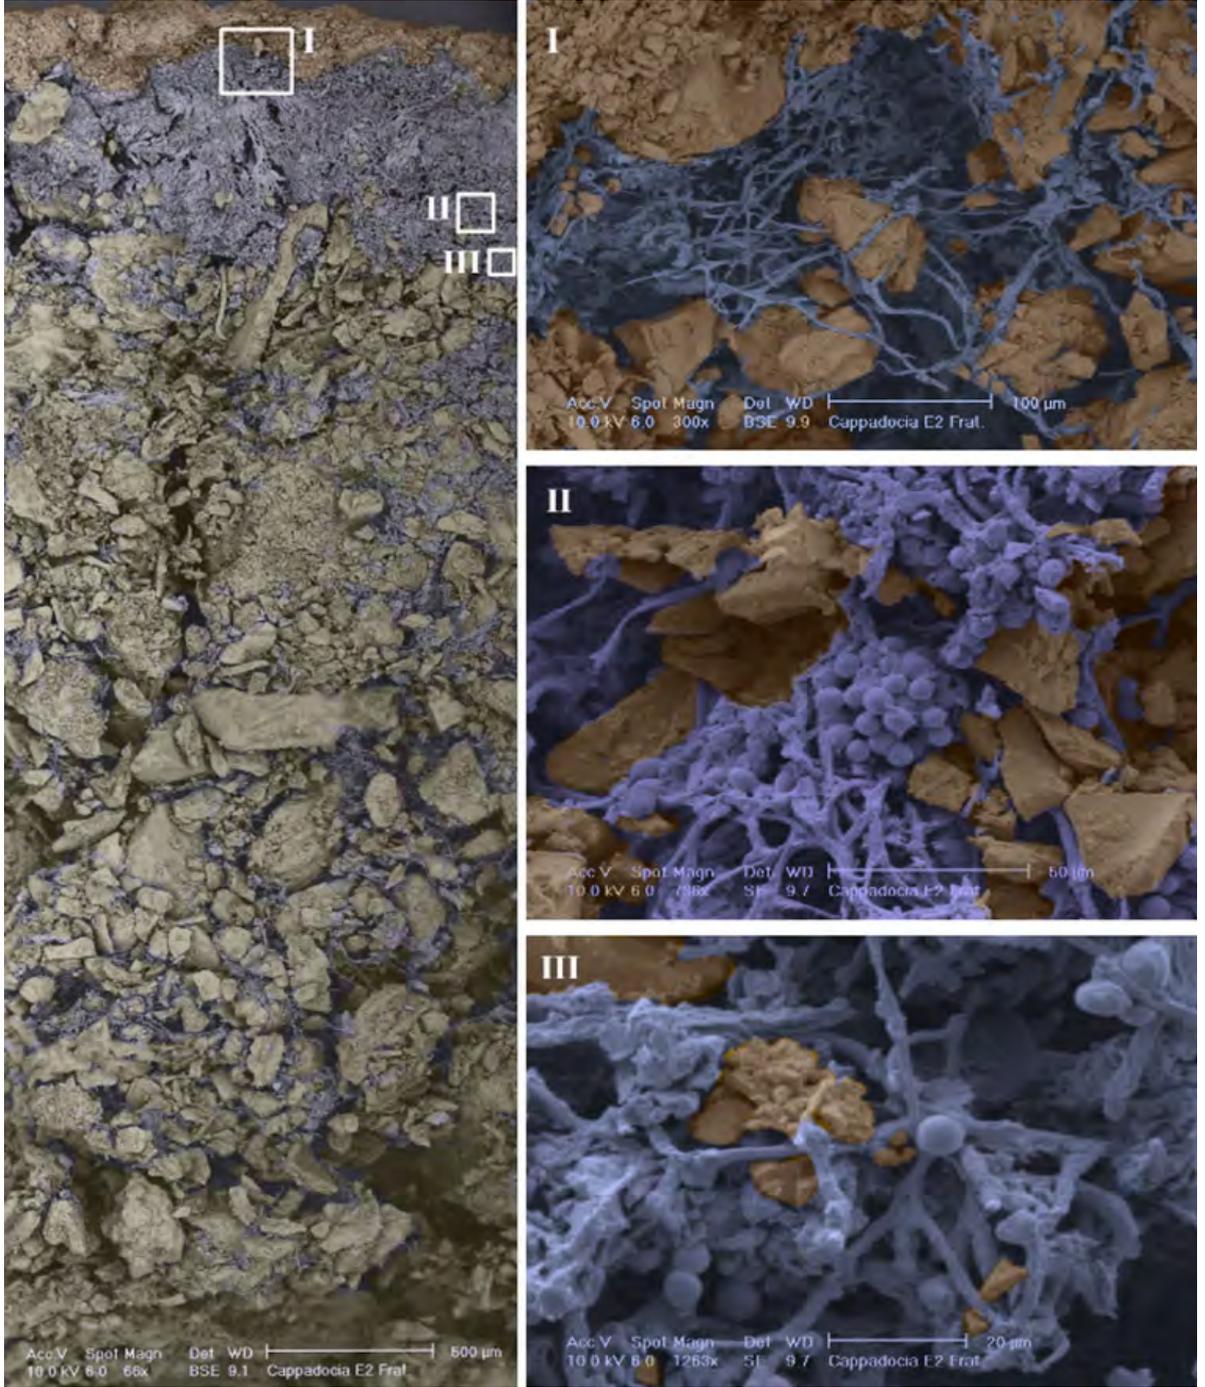
SEM observations of the fragment showed a strong network of fungal hyphae under the surface where few rock grains have been observed (Fig. 9). The abundance of hyphae decreases with the depth, and only a few hyphae can be seen in the bottom part. Interesting, in an area of sample figures 9

II and III shown a detail of circular structures of size of about 5 µm, but their nature is still to be investigated.

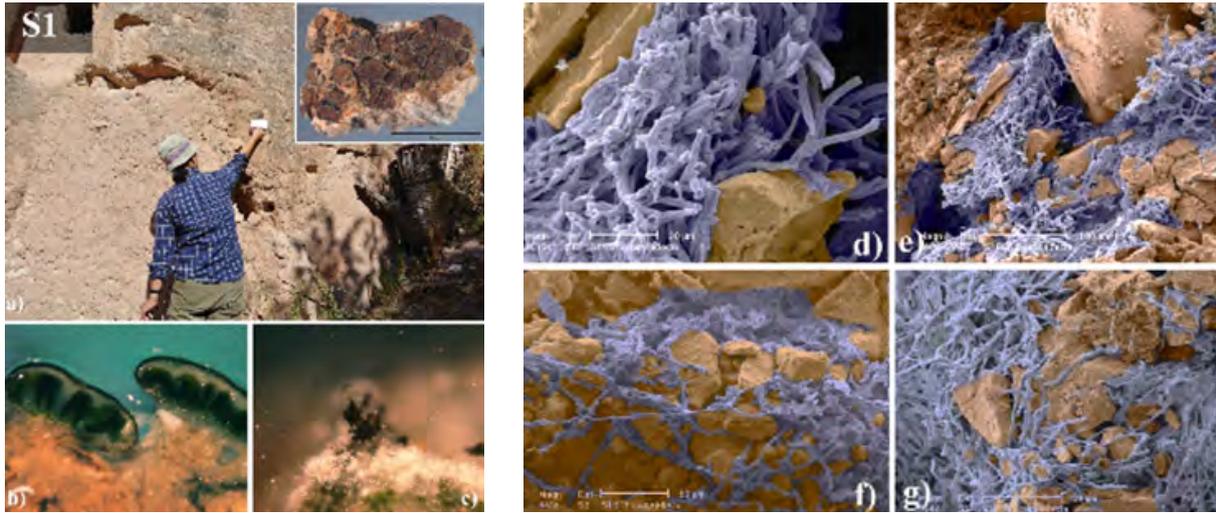
In the fragment S1 has been observed a crustose lichen *Acarospora*; the thallus appears with angular areoles and the upper surface is reddish brown (Fig 10 a). In addition, the OM observation (Fig. 10 c) showed the presence of black meristematic fungi over the surface.

The SEM details of the fractured sample show mineral grains completely embedded in the hyphae networks and fragmentation of portion of the rock (Figs. 10 d, e, f, g).

Figure. 2.10 Biological colonization in south exposures a) Sampling point (S1) and picture under the stereomicroscope; b), c) Microphotograph of the sample in polished cross section; d), e), f), g) SEM image in false colour of details observed in the sample

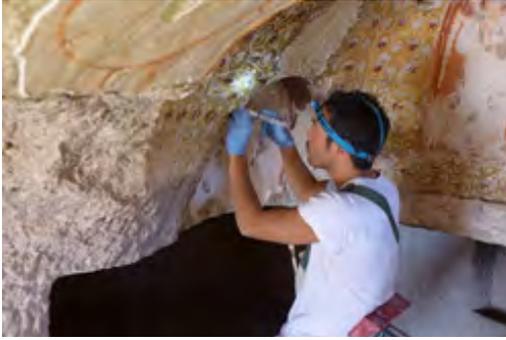
Figure 3.12 Grouting work at the altar  
Şekil 3.12 Mihrap'ta yapılan enjeksiyon çalışması

Wall paintings were stabilized once more following the 2015 interventions. Although most areas were relatively stable at the time of our second intervention, some particular areas along the rock cracks were detached and delaminated. Those voids were filled with grouting mortar using needles to increase cohesion. Some areas were pre-wetted with an ethanol and water mixture before injection. Edging mortar was used to stabilise wall paintings that showed delamination and lacuna (Figures 3.8 – 3.17).

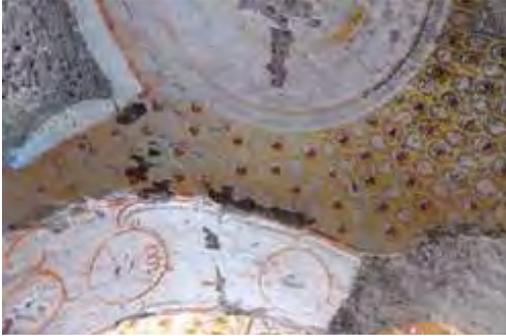
Figure 3.14 After intervention (altar)  
Şekil 3.14 müdahale sonrası (mihrap)

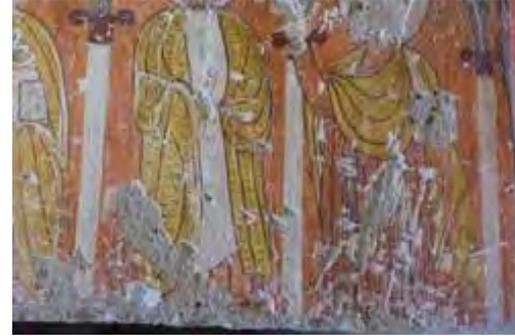
Figure 3.15 After intervention (nave)  
Şekil 3.15 müdahale sonrası (kilise ortası)

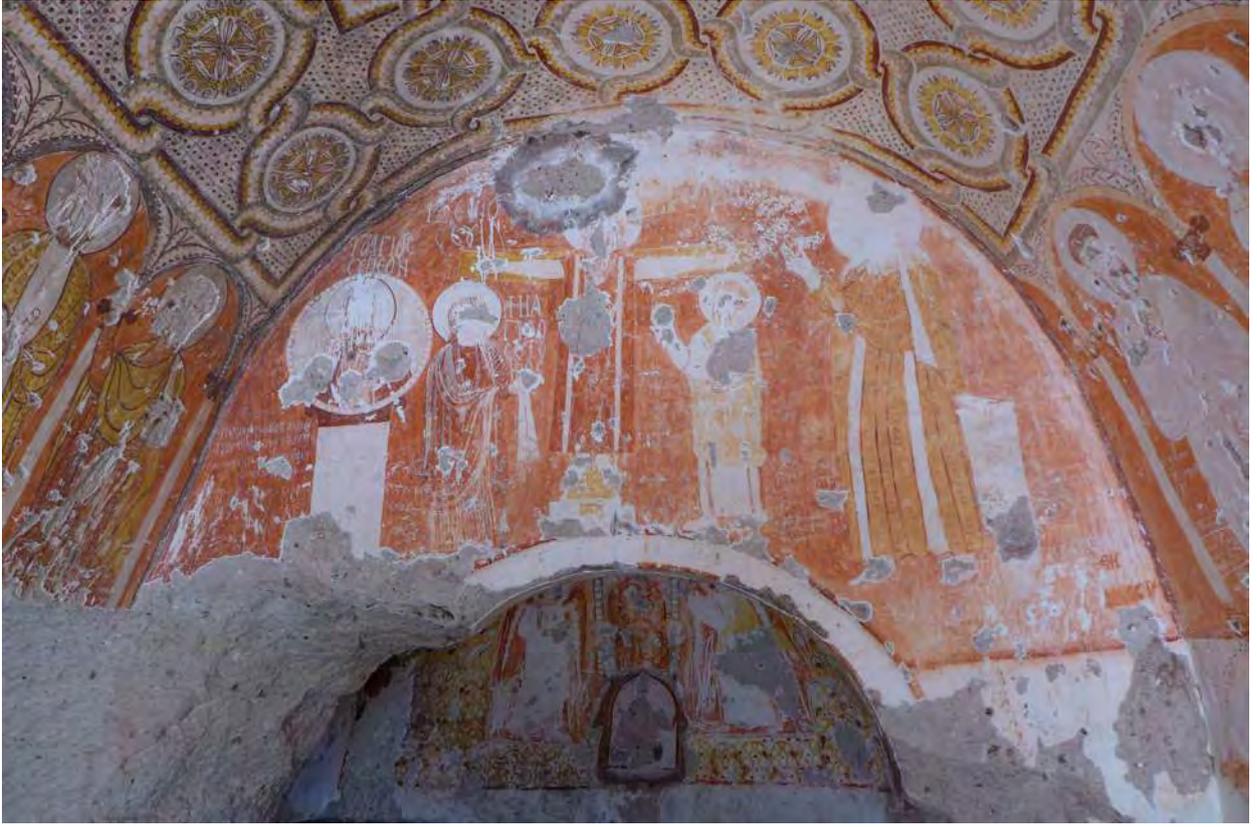
Figure 3.19 As of September 2015; after toning recent touristic graffiti.  
Şekil 3.19 Eylül 2015'ten itibaren, son turistik grafitilerin tonlama işlemi sonrası

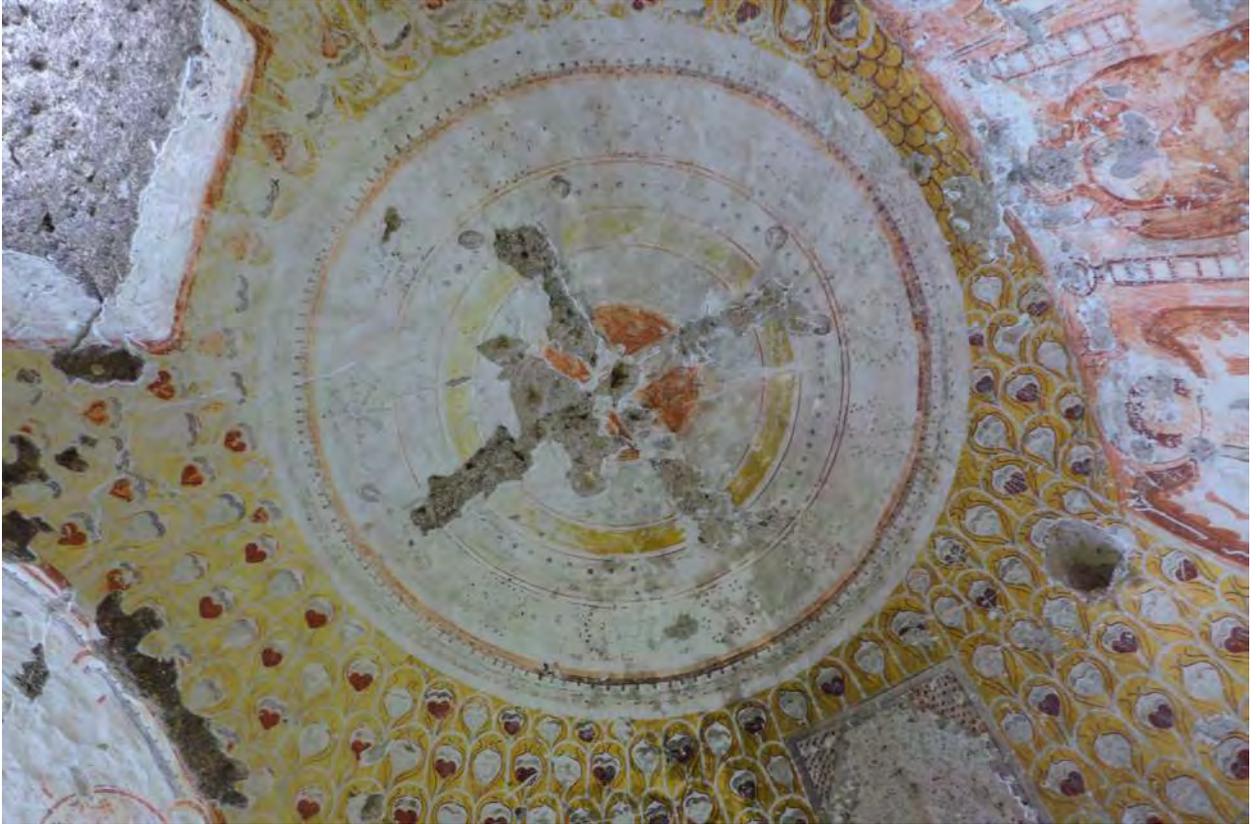
Figure 3.20 After intervention in September 2016  
Şekil 3.20 Eylül 2016 müdahale sonrası

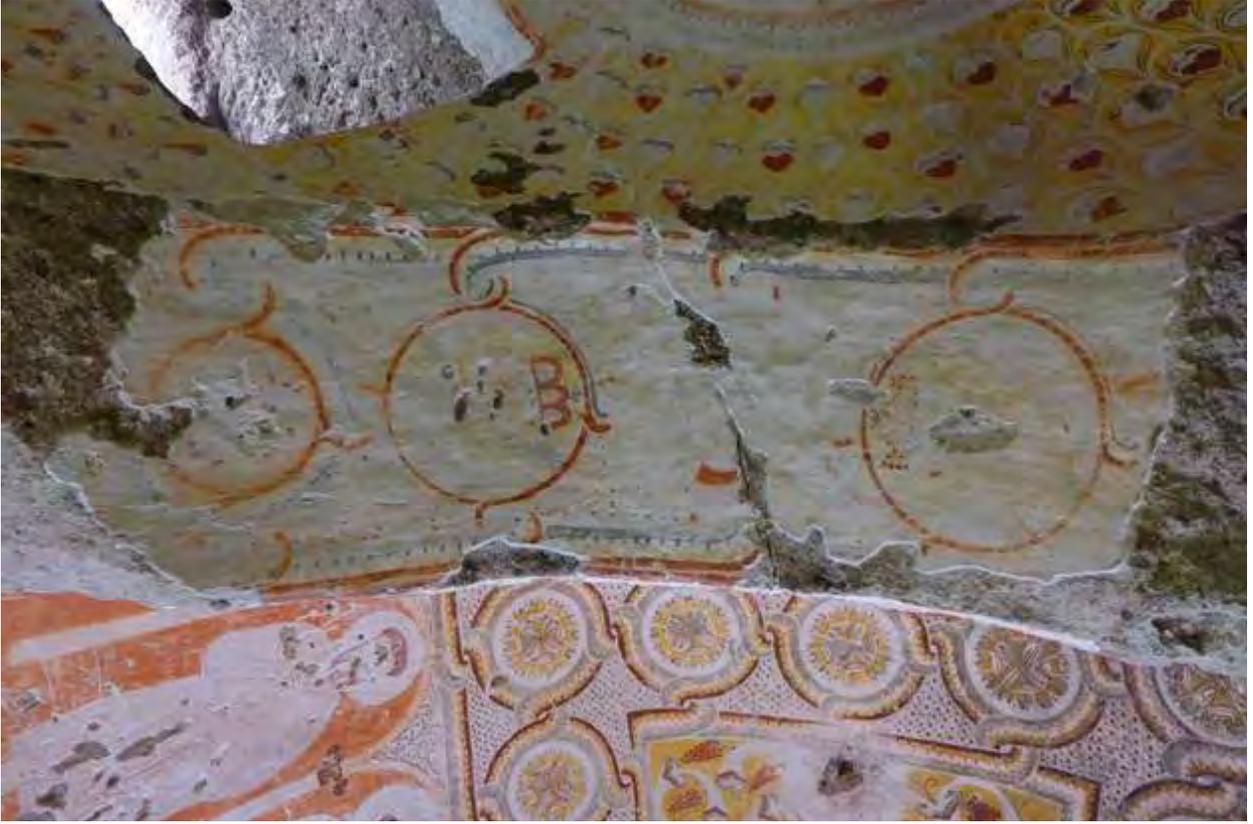
Figure 3.21 After intervention in September 2016 (altar)  
Şekil 3.21 Eylül 2016 müdahale sonrası (mihrap)

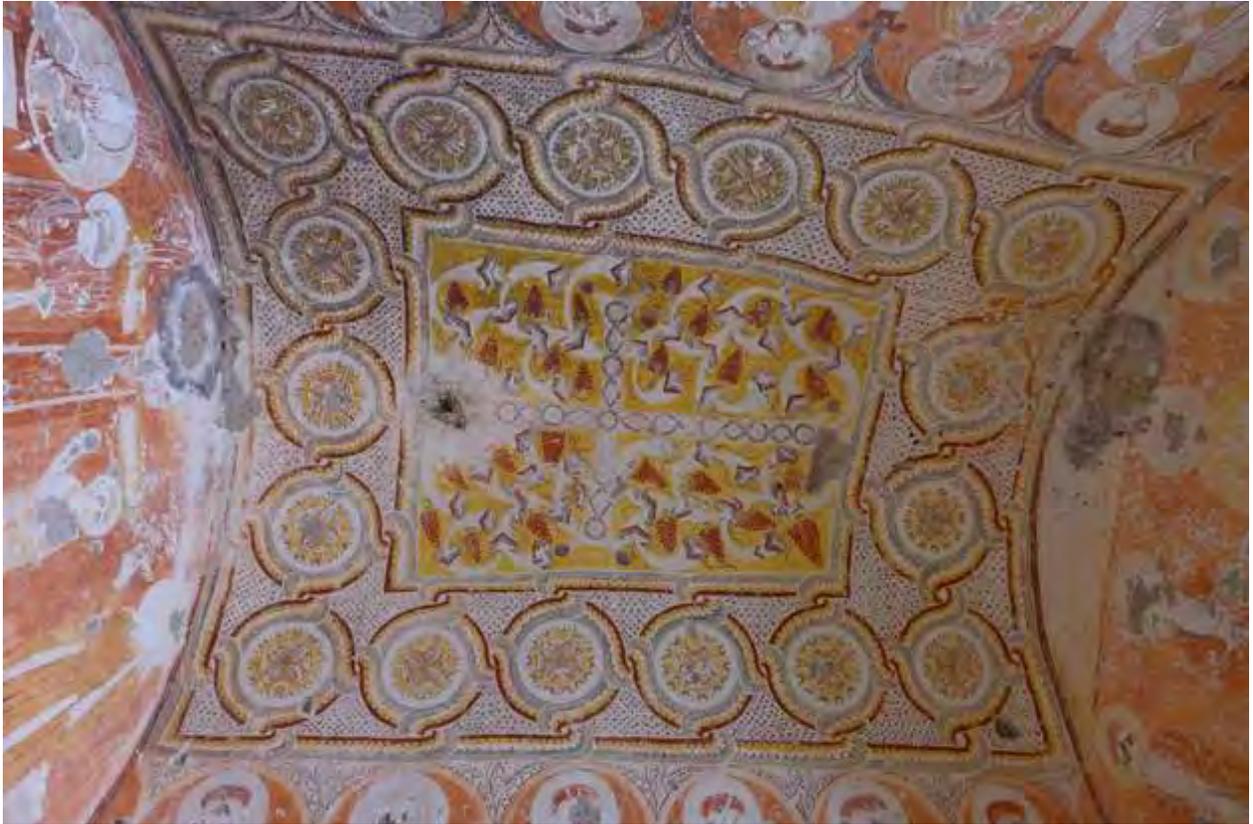
Figure 3.22 After intervention in September 2016 (altar/nave)  
Şekil 3.22 Eylül 2016 müdahale sonrası (mihrap/kilise ortası)

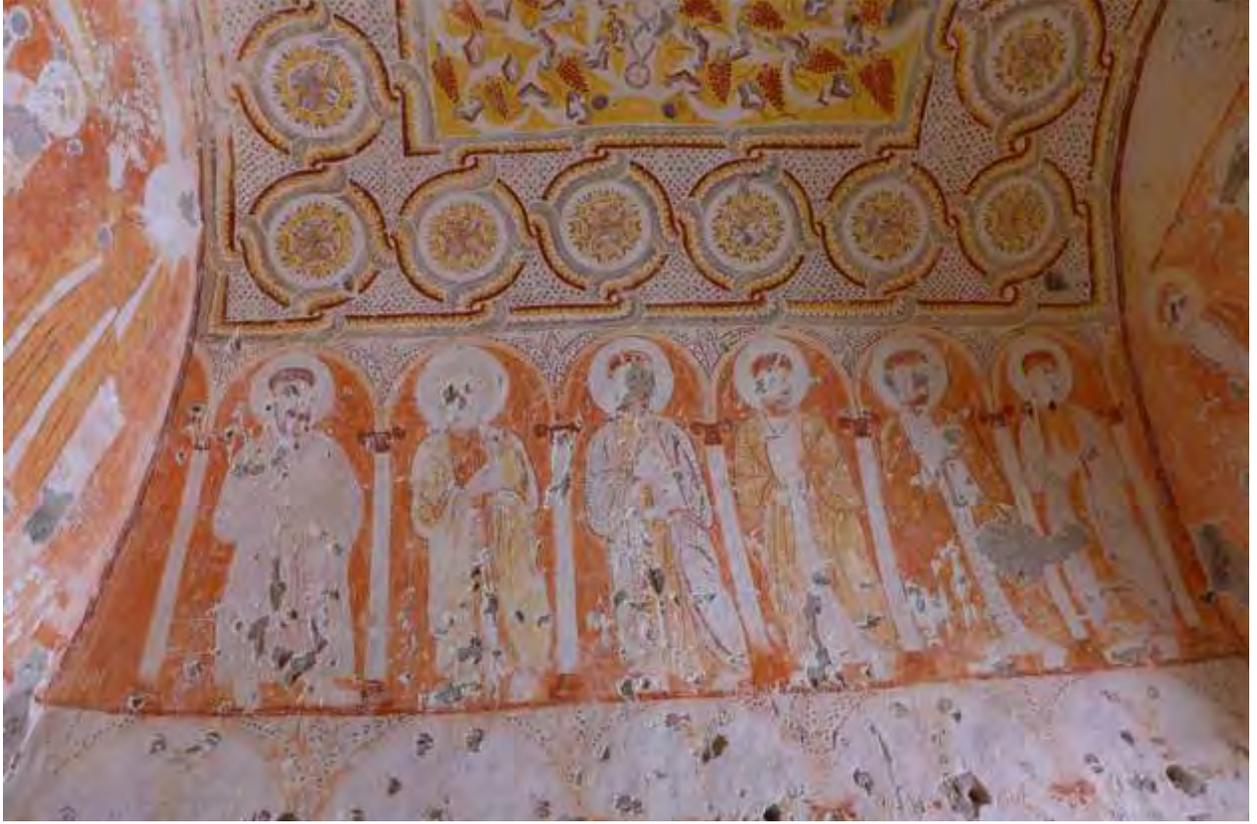
Figure 3.23 After intervention in September 2016 (nave)  
Şekil 3.23 Eylül 2016 müdahale sonrası (Kilise ortası)

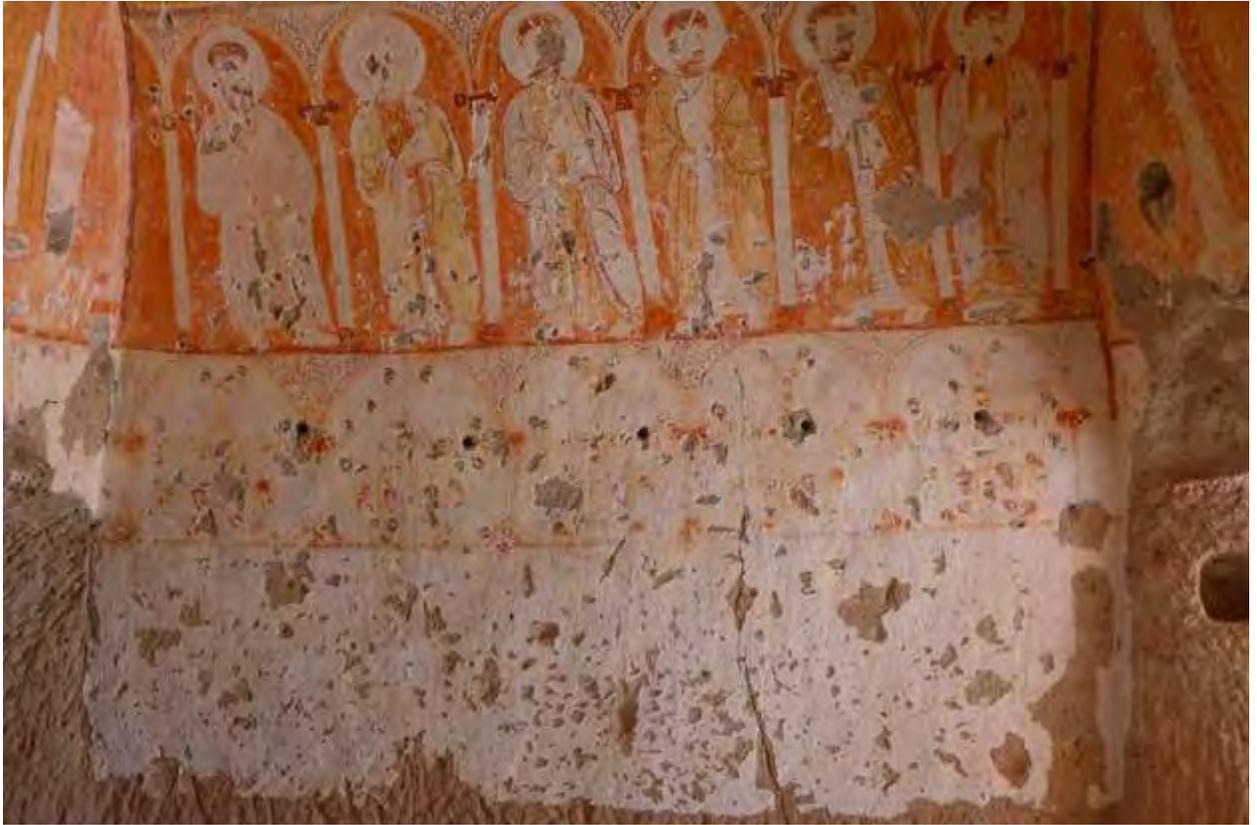
Figure 3.24 After intervention in September 2016 (nave, south wall)  
Şekil 3.24 Eylül 2016 müdahale sonrası (kilise ortası, güney duvar)

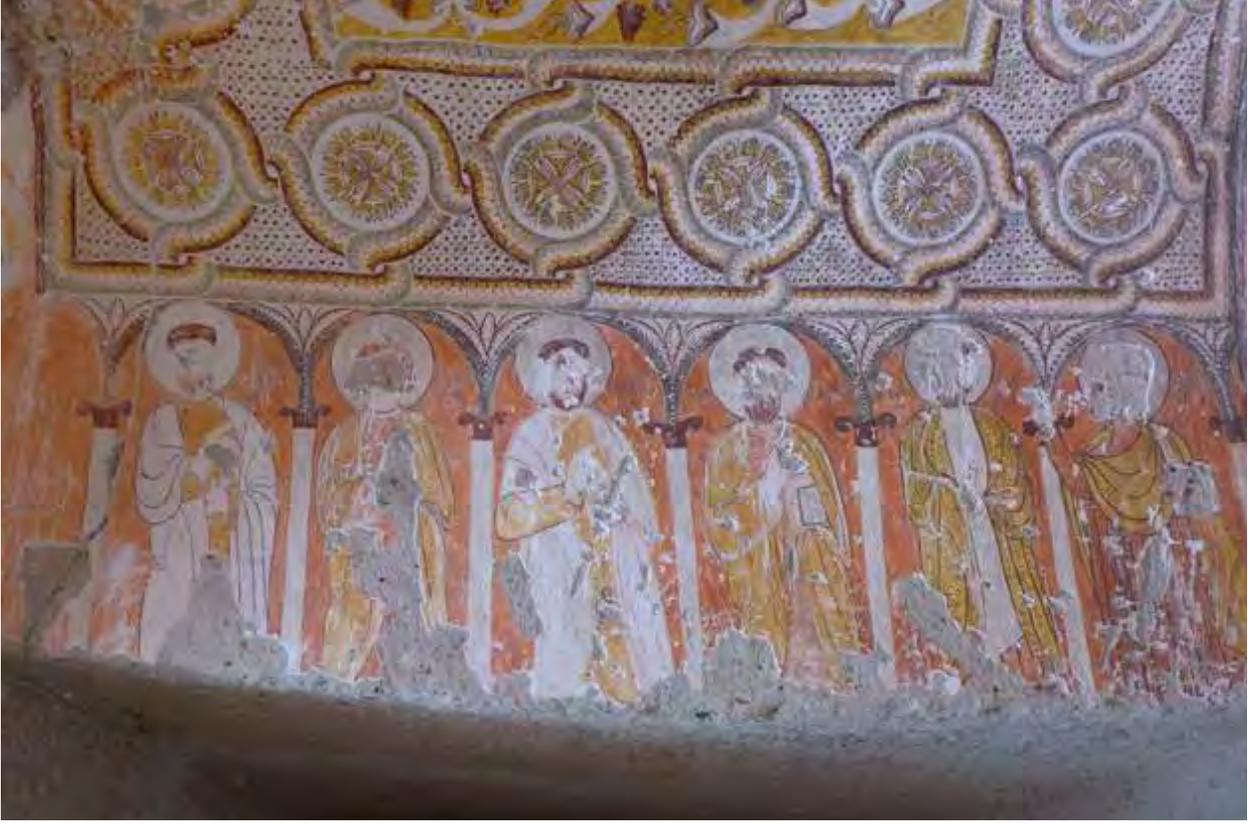
Figure 3.25 After intervention in September 2016 (nave, south wall)  
Şekil 3.25 Eylül 2016 müdahale sonrası (Kilise ortası, güney duvar)

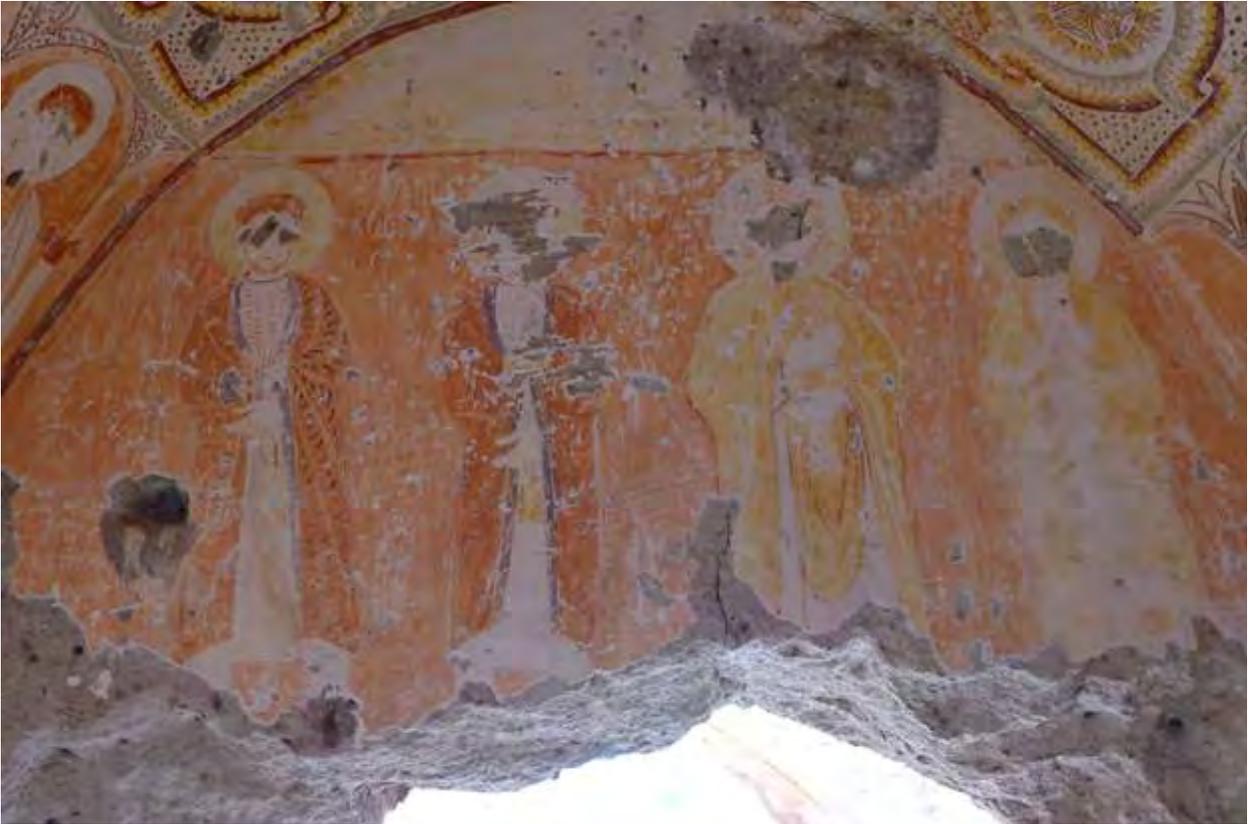
Figure 3.26 After intervention in September 2016 (nave, north wall)  
Şekil 3.26 Eylül 2016 müdahale sonrası (Kilise ortası, kuzey duvar)
