# Scientific Studies on Conservation for Üzümlü Church and its wall paintings in Cappadocia, Turkey

**Vol. 2 (Report on the activities in 2015-2016)**

University of Tsukuba  
2017

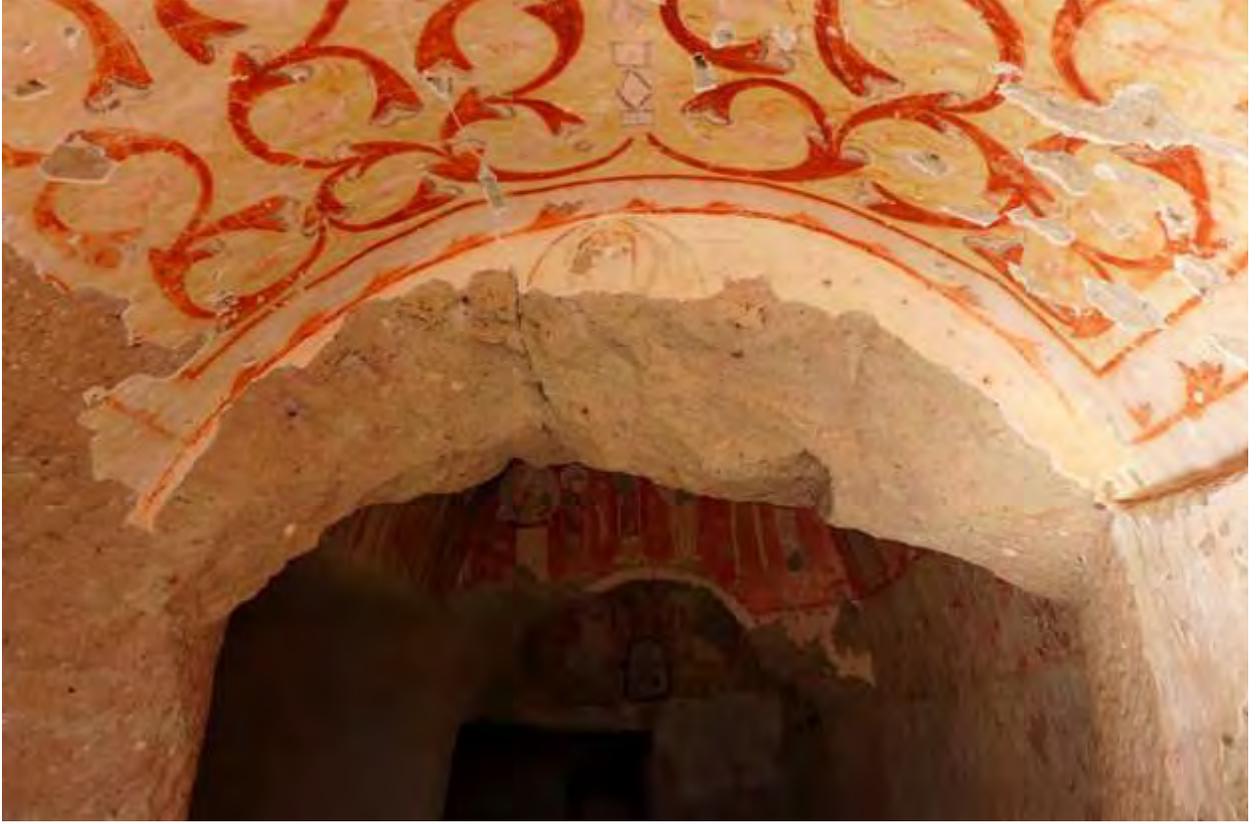
Figure 3.27 After intervention in September 2016 (nave, south wall)  
Şekil 3.27 Eylül 2016 müdahale sonrası (Kilise ortası, güney duvar)

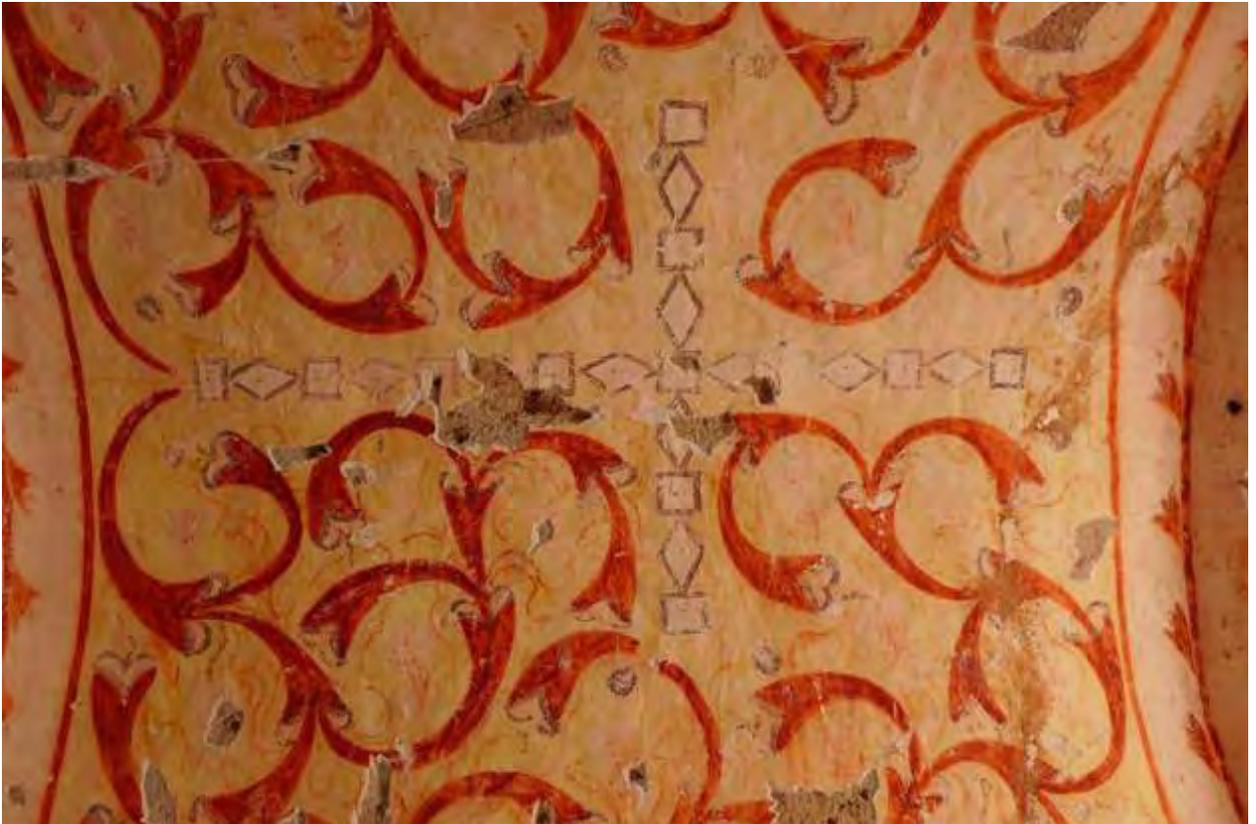
Figure 3.28 After intervention in September 2016 (narthex, north wall)  
Şekil 3.28 Eylül 2016 müdahale sonrası (narteks, kuzey duvar)

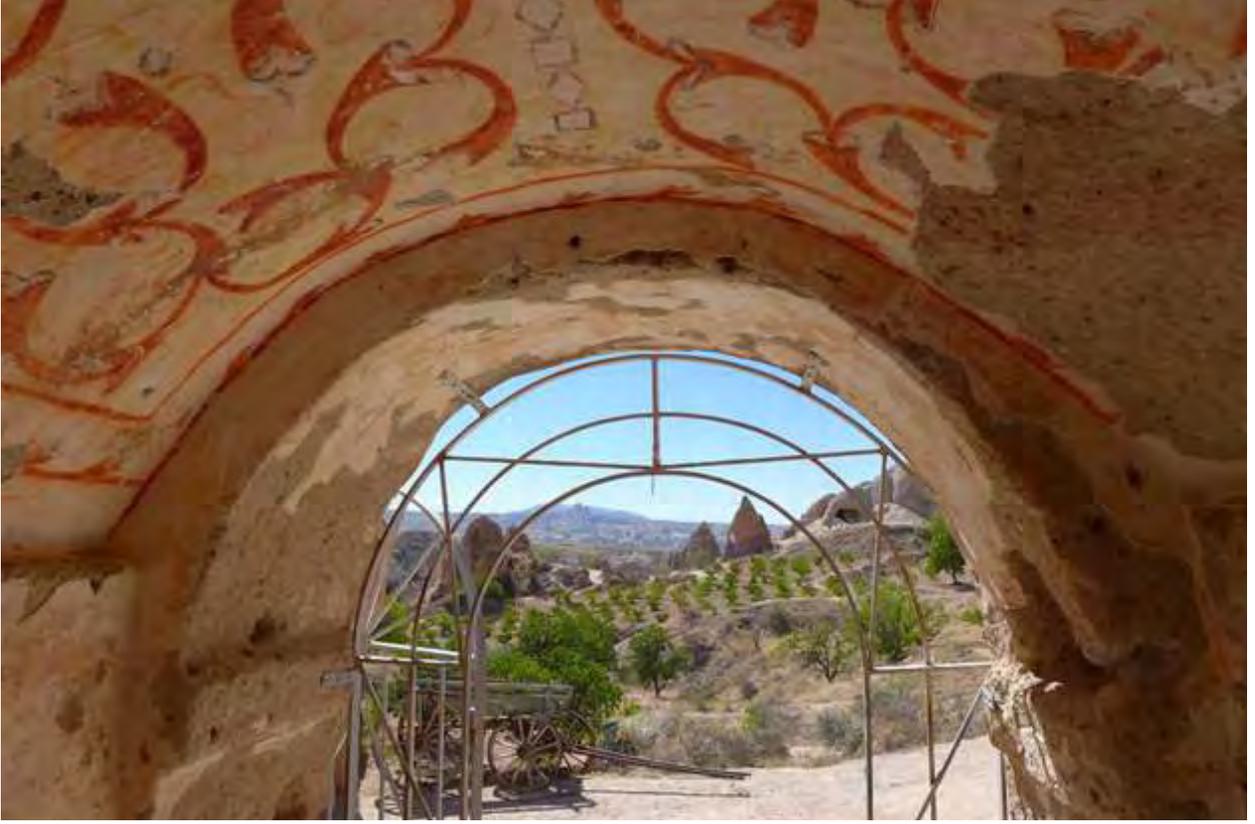
Figure 3.29 After intervention in September 2016 (narthex)  
Şekil 3.29 Eylül 2016 müdahale sonrası (narteks)

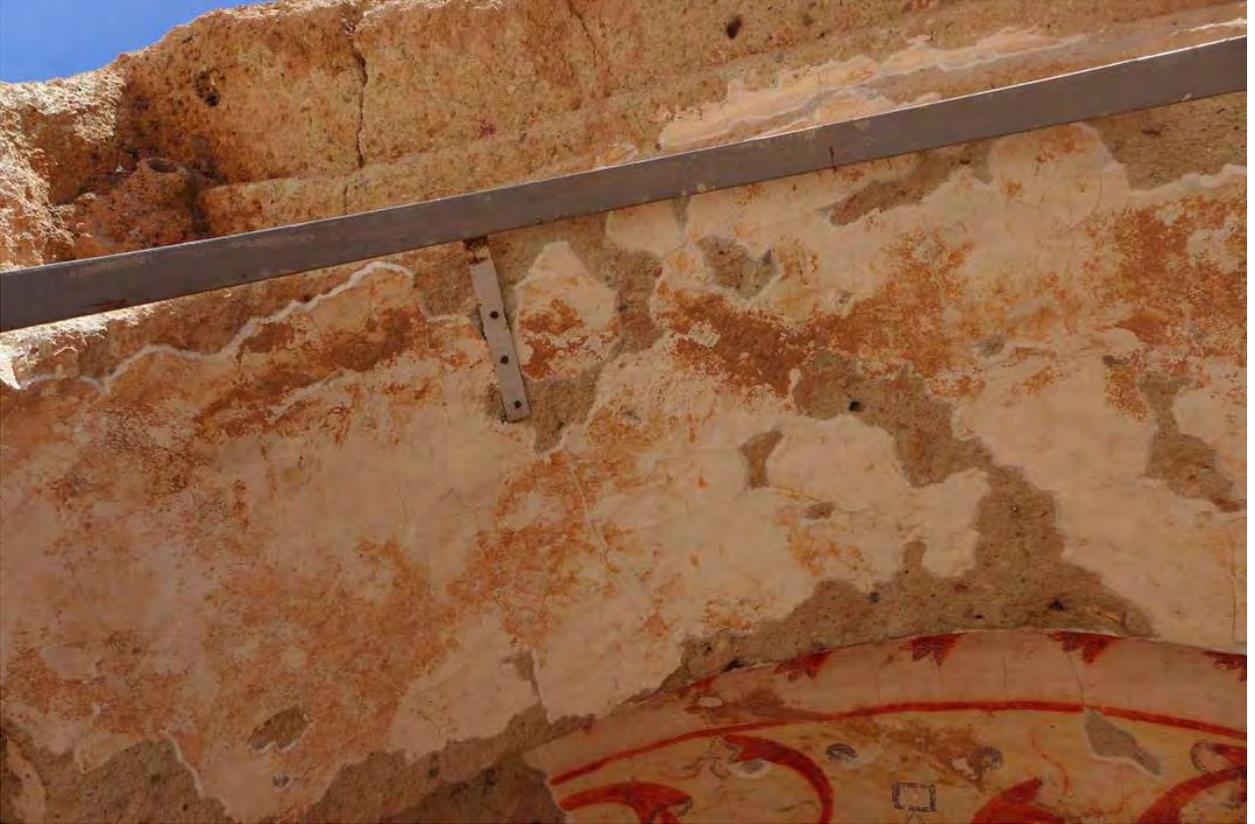
Figure 3.30 After intervention in September 2016 (west)  
Şekil 3.30 Eylül 2016 müdahale sonrası (batı)

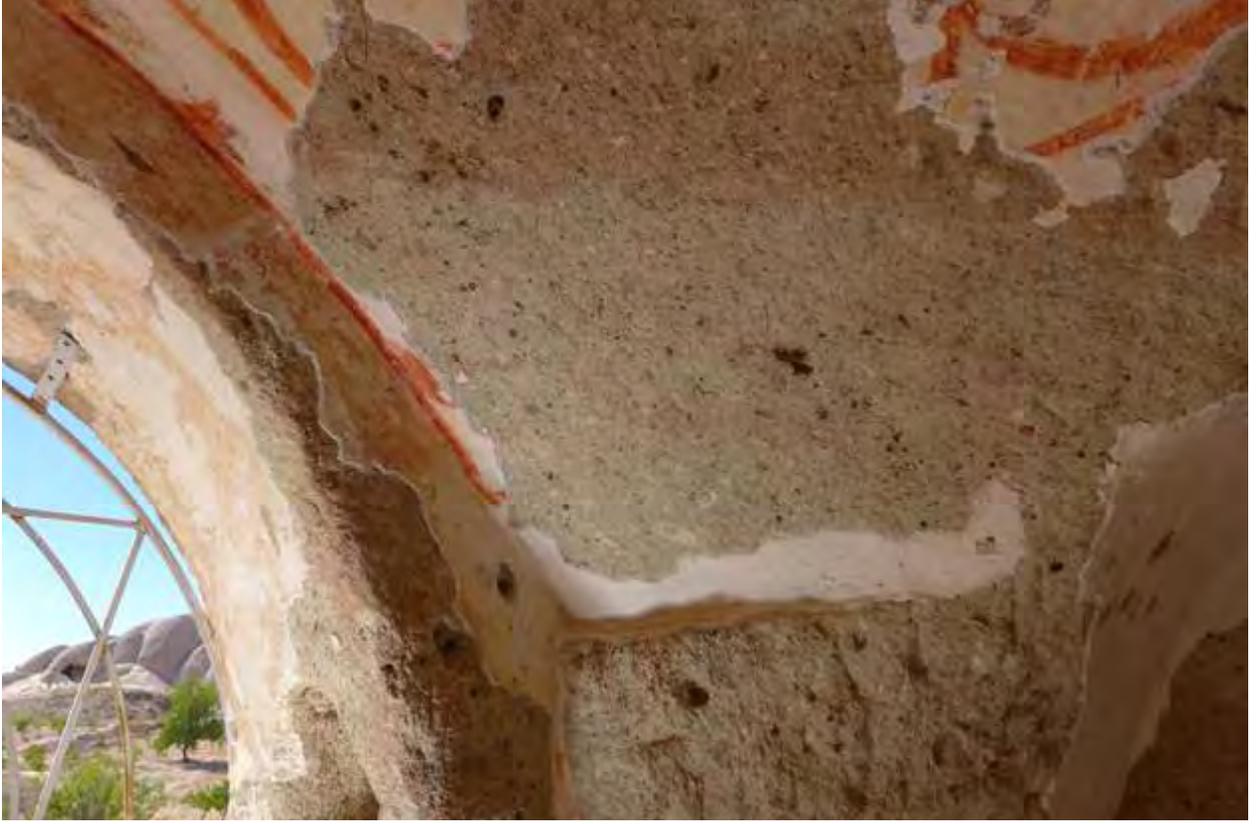
Figure 3.31 After intervention in September 2016 (entrance)  
Şekil 3.31 Eylül 2016 müdahale sonrası (giriş)

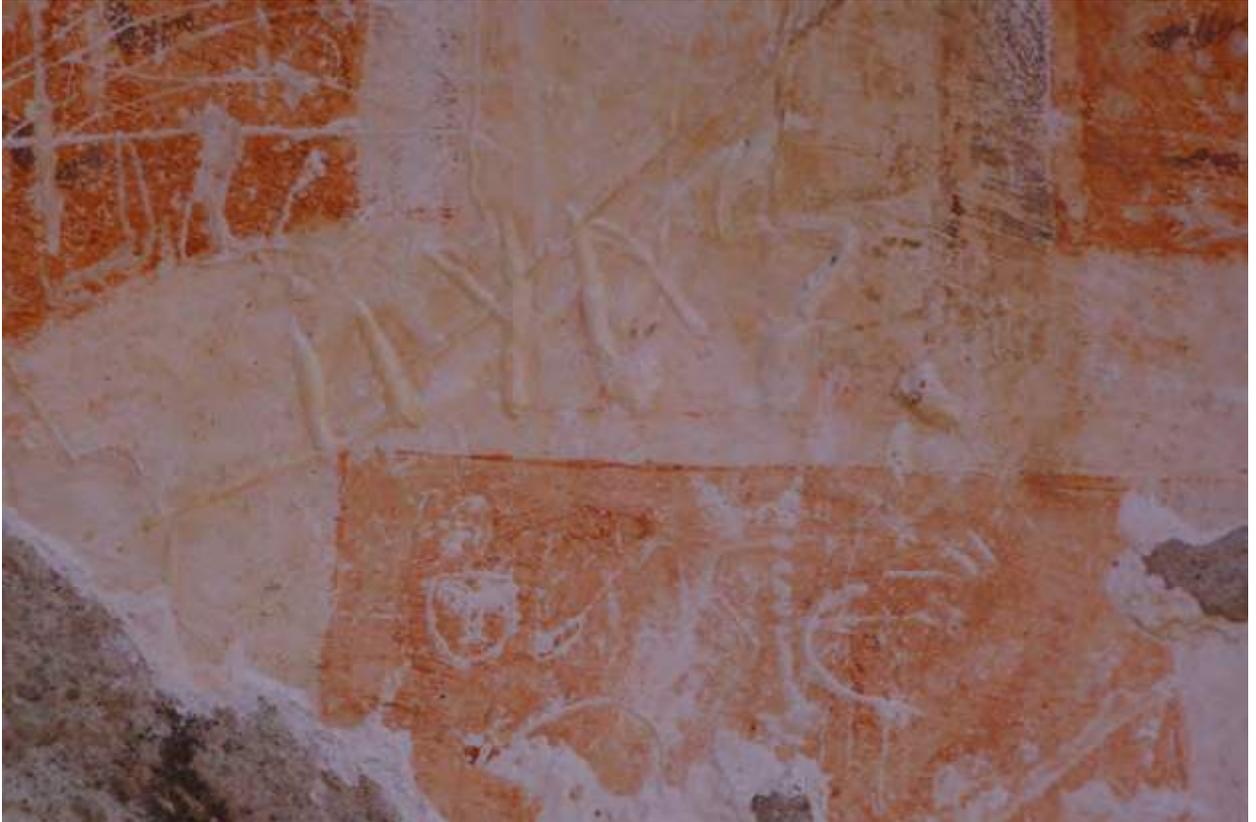
Figure 3.32 After intervention in September 2016 (narthex, north)  
Şekil 3.32 Eylül 2016 müdahale sonrası (nartex, kuzey)

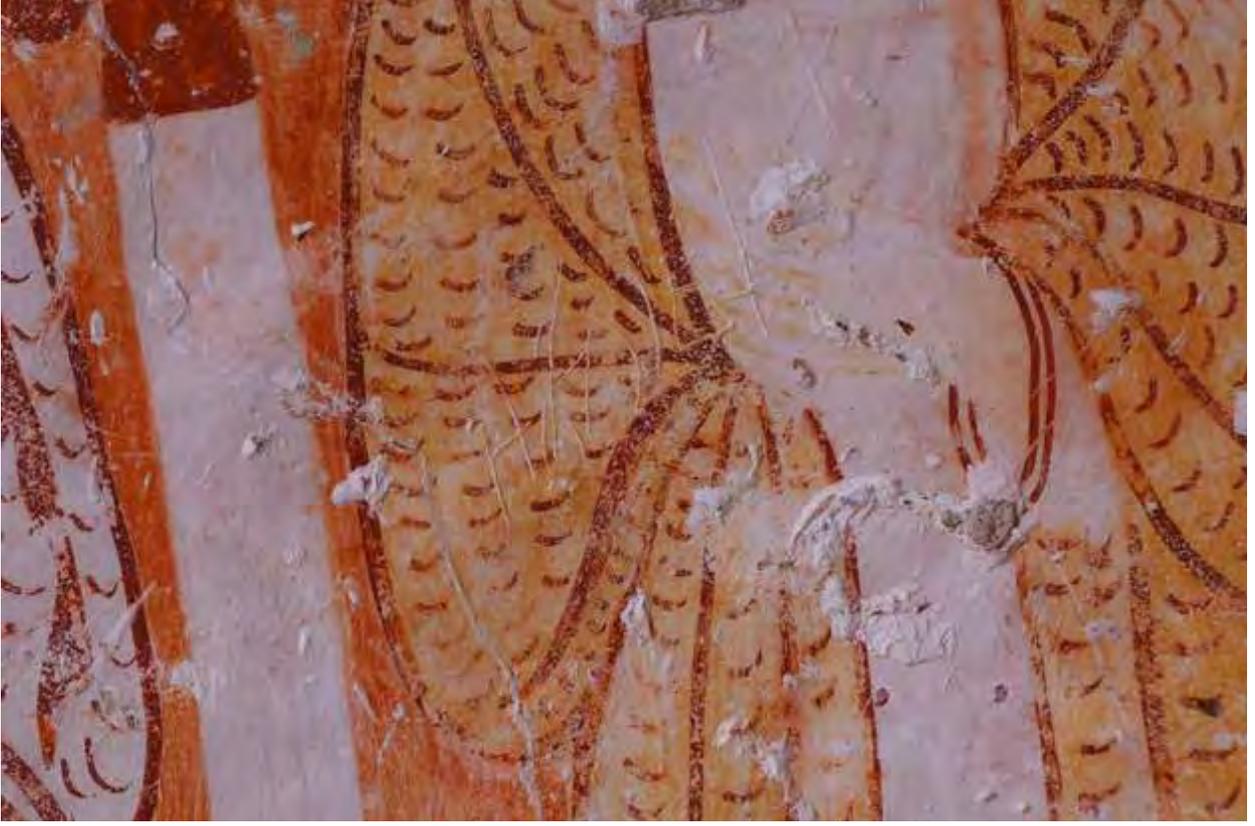
Figure 3.33 After toning in September 2016 (nave)  
Şekil 3.33 Eylül 2016 tonlama sonrası (Kilise ortası)

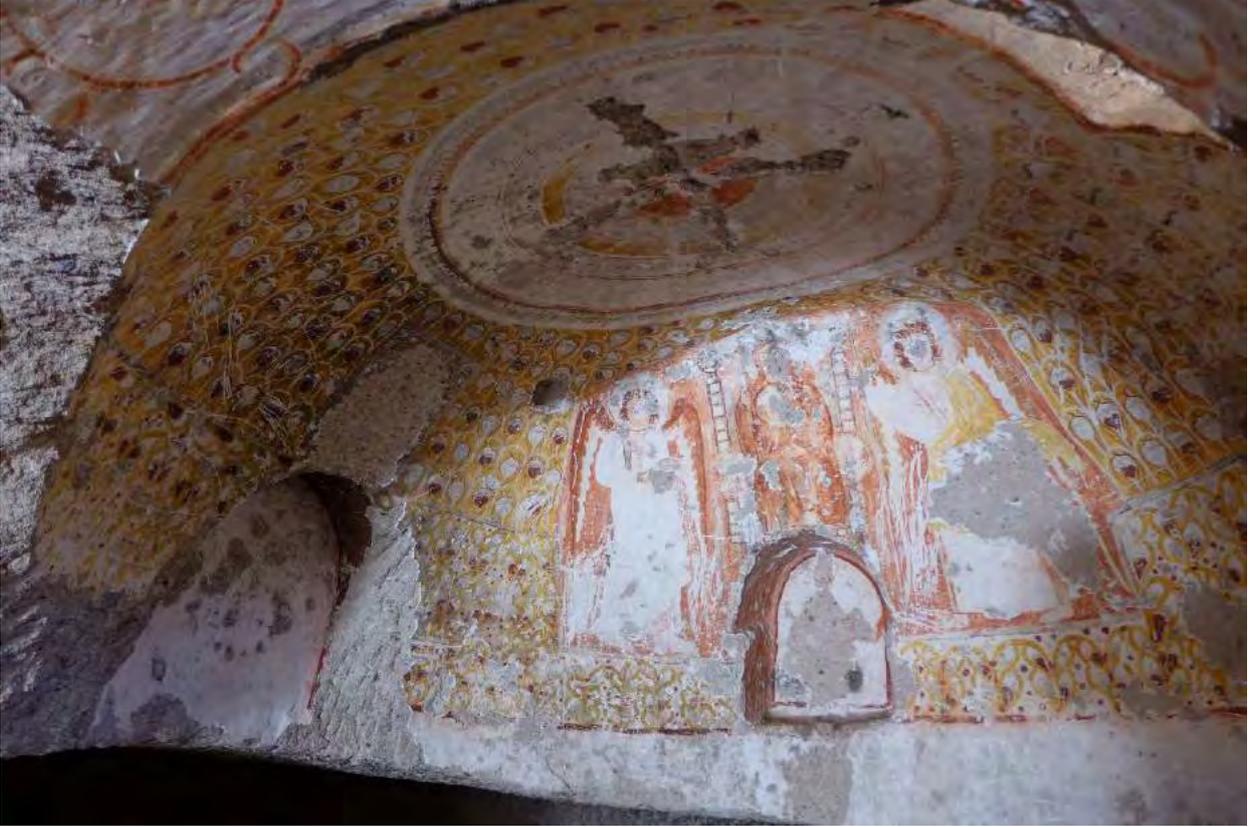
Figure 3.34 After toning in September 2016 (nave)  
Şekil 3.34 Eylül 2016 tonlama sonrası (Kilise Ortası)

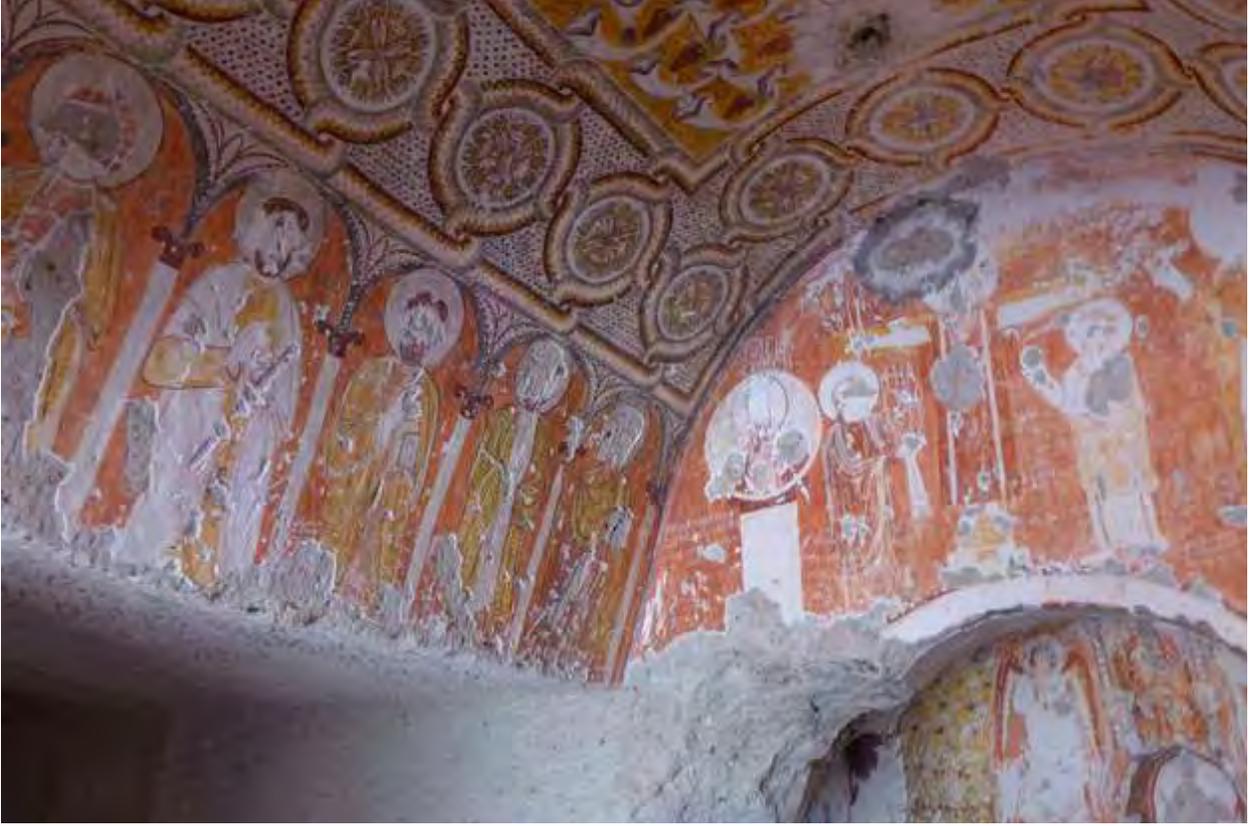
Figure 3.35 After intervention in September 2016 (altar)  
Şekil 3.35 Eylül 2016 müdahale sonrası (mihrap)

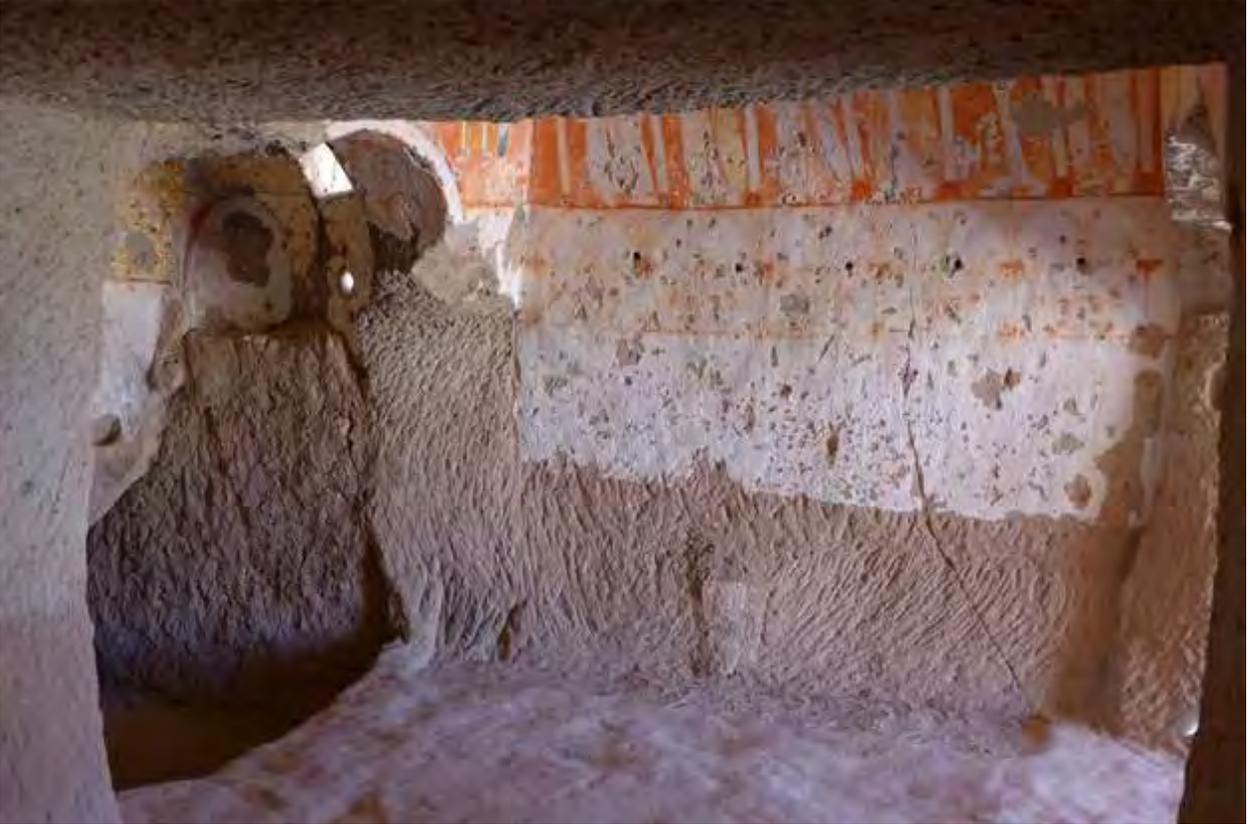
Figure 3.36 After intervention in September 2016 (nave)  
Şekil 3.36 Eylül 2016 müdahale sonrası (Kilise ortası)

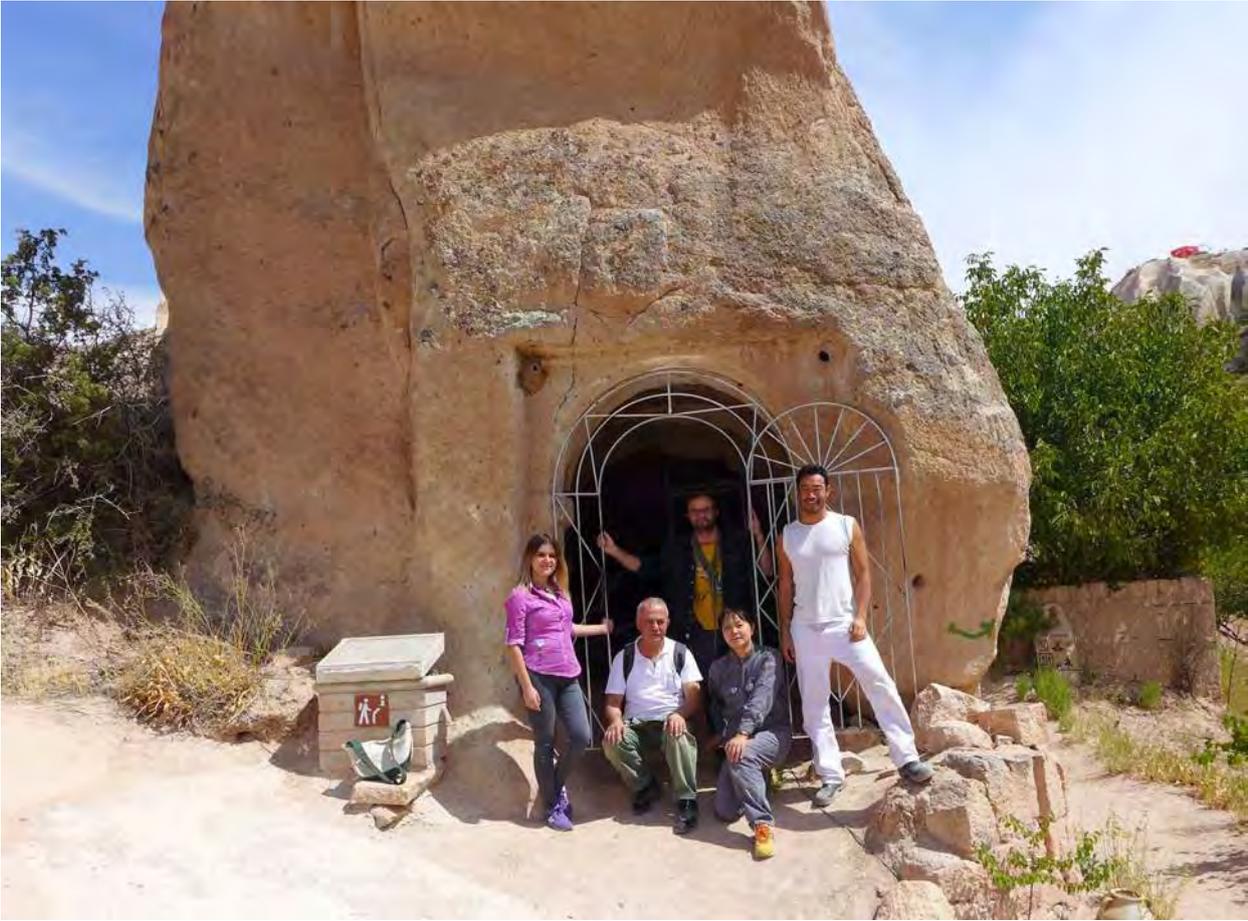
Figure 3.37 After intervention in September 2016 (nave, altar)  
Şekil 3.37 Eylül 2016 müdahale sonrası (Kilise ortası, mihrap)

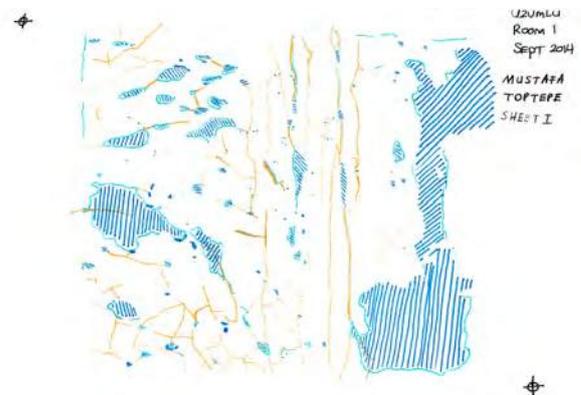
Figure 15. Scanned OHP sheet of plaster deterioration of the ceiling in the narthex

After recording the condition of deterioration of a layer, the OHP sheet was scanned in order to make digital mural condition sheets (Fig. 15). In the case that there were too many items to record an OHP sheet, we used more than two OHP sheets to record one layer. Using Adobe Illustrator, we traced the scanned data with a pen tool. The traced deterioration places were divided into different layers by each item of deterioration. Therefore, one mural condition sheet can show the deteriorated places of selected items in one layer. Then, the scale of mural condition sheets was adjusted to 1/10, 1/15, 1/20, 1/25. As we checked the deterioration of each layer of the mural paintings, we produced 39 mural condition sheets and 13 photographs of mural paintings for the digital heritage inventories. Figure 15 is one of the examples of digital heritage inventories, which is the paint layer deterioration of the ceiling in the nave.

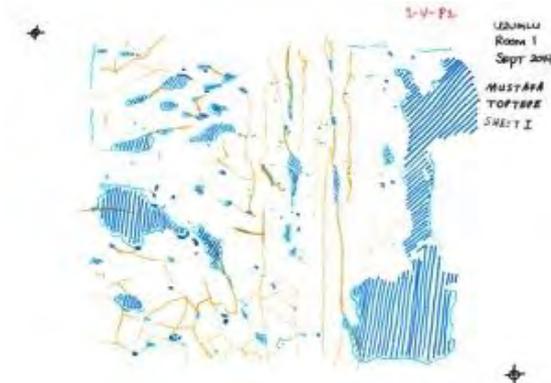
Figure 16: Scanned OHP sheet of plaster deterioration on the ceiling in narthex.

After the state of layer deterioration was documented, an OHP sheet was scanned to create a digital mural condition sheet (Fig. 16). In cases where the number of items was too large for these to be recorded on an OHP sheet, we used more than two OHP sheets to document one layer. Using Adobe Illustrator, we traced the scanned data with a pen tool. The traced deterioration sites were divided into different layers according to each item of deterioration. Therefore, each mural condition sheet can show the deterioration sites of selected items when a pdf file is created and viewed via pdf viewer software. The approximate scale of the mural condition sheets was then adjusted to 1/10, 1/15, 1/20 and 1/25. As we checked the deterioration of each layer of the mural paintings, we produced 39 mural condition sheets and 13 image mosaics of the mural paintings for the digital heritage inventories. An example is Fig. 17, which shows the paint layer deterioration of the ceiling in nave. All the digital inventories of the printed versions (Taniguchi 2015) that we created are available for viewing in Appendix 3 at the following webpage address: [http://rcwasia.hass.tsukuba.ac.jp/kaken/contents/content%20images/0\\_20150723\\_uzumlu\\_2014\\_final\\_s.pdf](http://rcwasia.hass.tsukuba.ac.jp/kaken/contents/content%20images/0_20150723_uzumlu_2014_final_s.pdf).

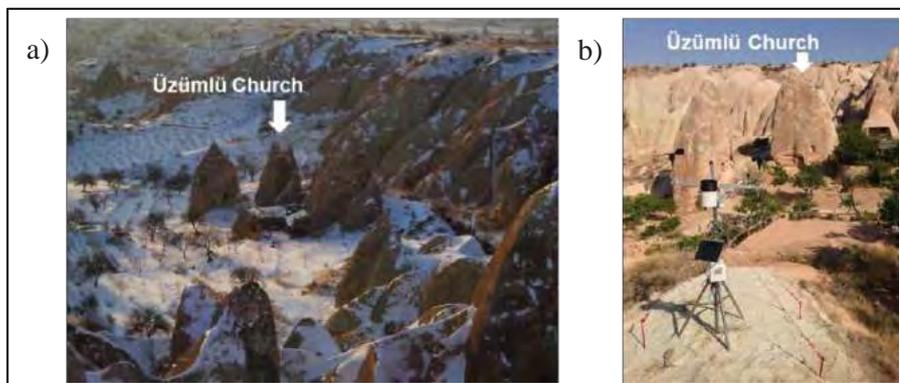
Fig. 1: Üzümlü Church (a) Appearance in winter (b) Environmental monitoring stations.

The Üzümlü Church (Fig. 1) in the Red Valley, a stand-alone rock-hewn church, was selected for this case study. The church shows deterioration phenomena such as severe cracking, surface disintegration and exfoliation caused by the environment, rock composition and tectonic activity as well as biological and human activities including continuous vandalism. The church structures have not been treated in the past, providing a unique opportunity for this type of study.

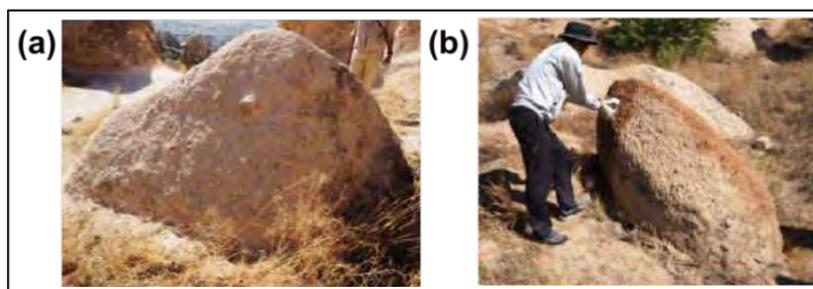
Fig. 7: Outdoor exposure test rocks: (a) Control (b) Treated mass.

Two small-scale tuff masses near Üzümlü Church were chosen for the test. Fig. 7 shows the one (b) that was splayed with the Permeate® HS-360 and the other (a) that was left untreated as a control. To quantify the degree of weathering of the tuff masses, stainless steel nails were anchored to the rock surface (Fig. 8a). Two nails were set in each direction (upper and lower parts) and on the top; i.e. each test rock contained nine nails. The nail length appearing outside the rock was measured with a digital calliper (Fig. 8b) on both right and left sides. After anchoring, the measurement error of four different measurements was checked because the rock surface was considerably uneven. The relative error for the average value was mostly within 10%. The nail length was measured by local collaborators every few months. In the ‘control’ mass, weathered tuff powder accumulated below the rock, and four out of the nine nails fell off the mass in the four months after anchoring. In contrast, in the ‘treated’ mass, the weathered deposits were generally small and only one

nail fell off. As flakes of a particular suitable thickness appeared to exfoliate in some places in the ‘treated’ mass in winter, deterioration might occur if moisture could accumulate in local areas of the mass. A follow-up examination will consider the possibility of frost damage.

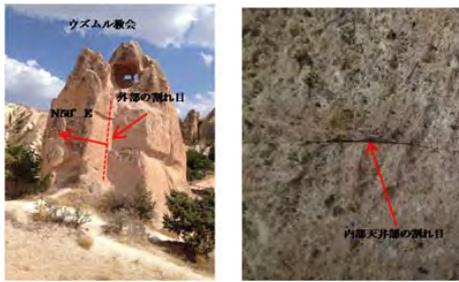
写真2 ウズムル教会割れ目状況

また、教会岩窟の外壁には割れ目に起因する崩落跡が多数残っている。崩落の発生原因については、割れ目に沿った降雨、降雪による水の浸透・浸食、あるいは凍結融解の繰返しによる要因が考えられる。特に北西面に走っている割れ目(写真2-左側)が谷筋とほぼ平行、N50° E の角度で教会に貫通していることが内部からも確認できる(写真2-右側)。さらに、内部天井部の割れ目に水分の移動によるものと考え

られる石灰質の堆積物が確認された。このことから、外部からの水の浸入が教会内部の環境に影響を与えている可能性が示唆された。

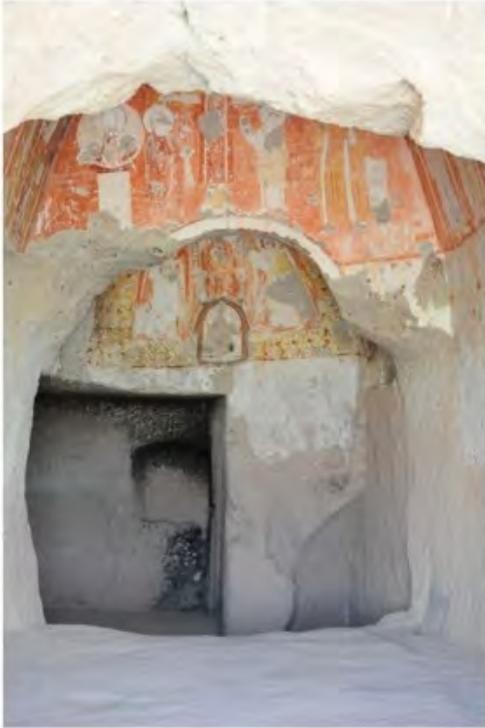
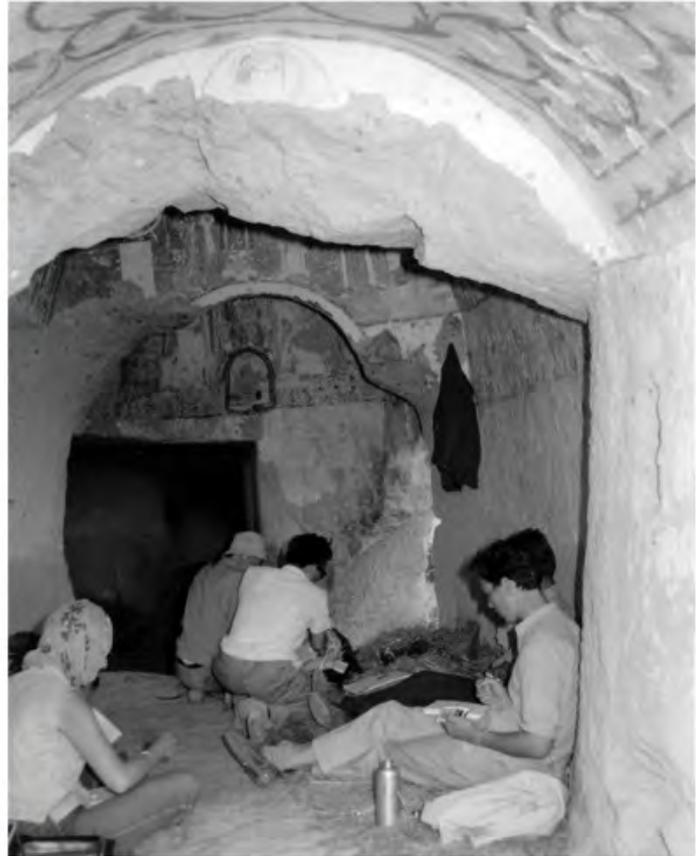
Figure 1a. Inside of Üzümlü church in 2015 (left) and 1968/70 (right)  
Görsel 1a. Üzümlü Kilisesinin içi, 2015 yılı(sol) 1968/70(sağ)

Tokyo Devlet Güzel Sanatlar ve Müzik Üniversitesi'nden (Günümüzdeki adıyla Tokyo Devlet Sanat Üniversitesi) bir ekip Kapadokya bölgesinde 1968-1970 yılları arasında bir takım araştırmalar yapmıştır. Bu ekip, Masaru Meno ve Yasushi Nagatsuka gibi genç sanatçılar, mimari ve sanat tarihçilerinden oluşmaktaydı. Ekip geleneksel yöntemlerle birlikte bir olta kullanmak gibi bazı sıra dışı yöntem ve araçlar da kullanarak yüzlerce mağarada ölçüm yapıp bu mağaraları fotoğraflamıştır. 1968-1970 arasında ve 2015'te (1a ve b görselleri) çekilmiş fotoğraflar kıyaslandığında, yakın zamanda yapılmış duvar yazısı örnekleri dışında duvar resimlerinde ya hiç değişiklik olmamış ya da gerçekleşen değişimler asgari düzeydedir. Bu da duvar resimlerinin dayanıklı ve sağlam olduğunu göstermektedir.

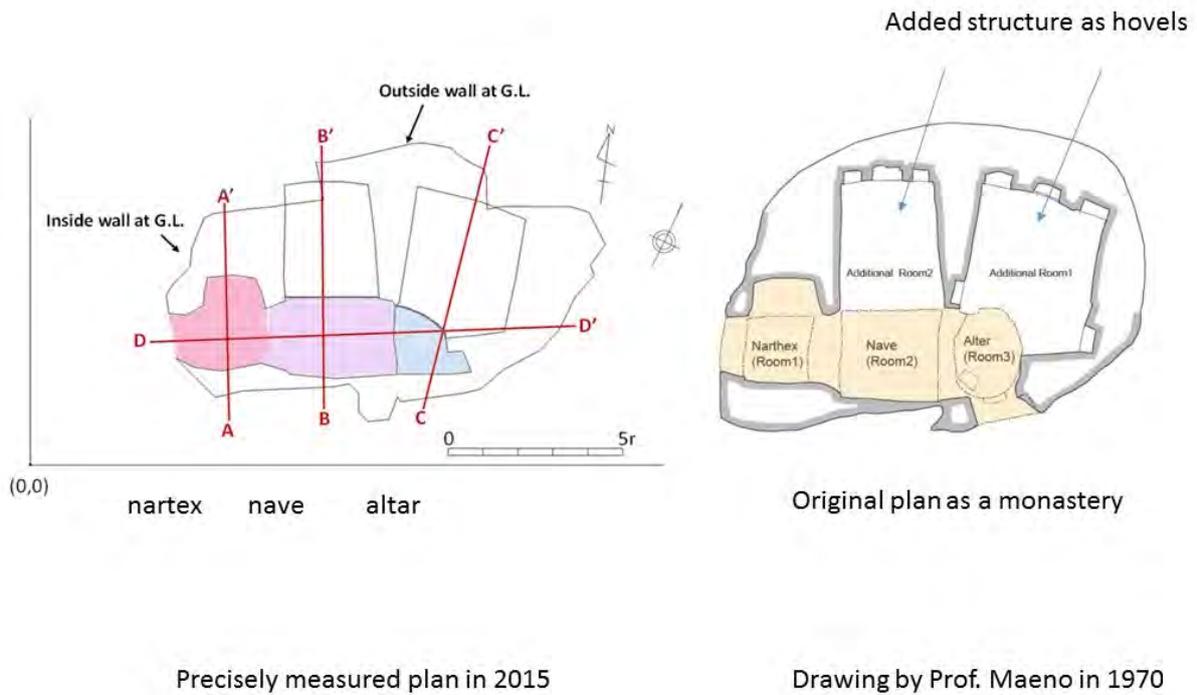
Figure 3a. Comparison of measurements between 2015 (left) and 1968/70 (right)  
Görsel 3a. 2015 (soldaki) ve 1968/70 (sağdaki) yıllarında yapılmış ölçümlerin karşılaştırması.

Figure 3 shows two surveys, one from 1968/70 (right) and one from 2015 (left). Together these indicate that the north-eastern side of the exterior surface has been eroded to a great degree.

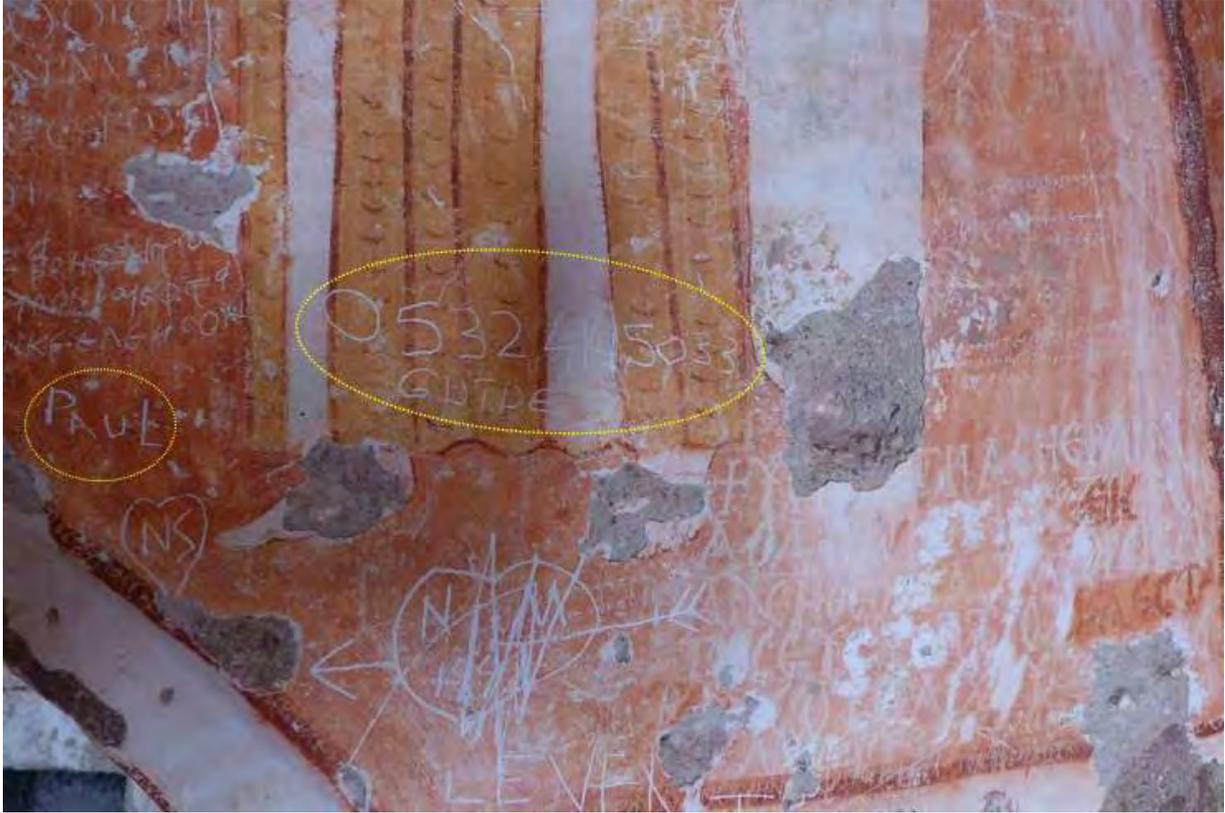
One of the main causes of ongoing serious damage to the wall paintings at Üzümlü church is extensive graffiti by tourists, most likely local tourists. Figure 13 clearly shows large incisions in the wall presenting the Turkish mobile number “0532445033”, and the words “guide” and “Paul”, which appeared between 2010 and 2013. These are not related to acts of cultural genocide, which have increased recently in West Asian regions such as in the Mosul museum and Palmyra attacks.

Some other graffiti containing personal names includes dates such as 2014 and 2015, which indicates that these actions took place recently. Therefore, measures to prevent further damage should be taken as soon as possible; these may include posting signs at the site, setting up a proper platform along the church floor, or educating local tourist guides.

Figure 13. Modern incised graffiti by local visitors.

Kişisel isimler içeren diğer duvar yazıları 2014 ve 2015 yıllarında yapılmış, yani yakın zamanda meydana gelmiştir. Bu nedenle, gelecek zararları engelleyecek önlemler en kısa zamanda alınmalıdır. Bu önlemler uyarı tabelaları asmak, kilise zeminine uygun bir platform yerleştirmek ve yerel turist rehberlerini eğitmek şeklinde olabilir.

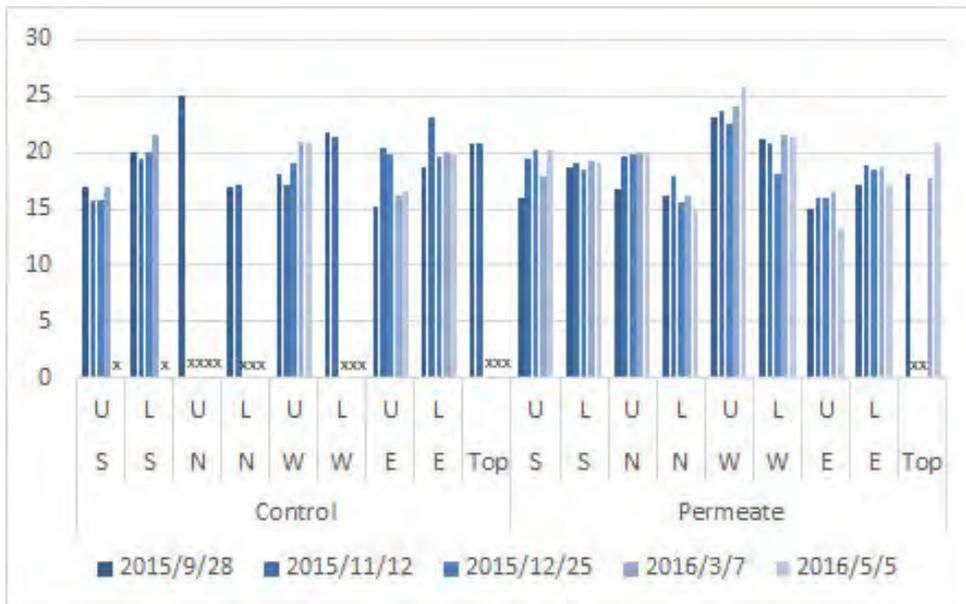
Two small rock masses with similar rock and weathering characteristics were chosen for testing (Figure 14). One rock was sprayed with an alkoxysilane based consolidate and water repellent agent (Permeate HS-360, 150g/m<sup>2</sup>), and the other was left as untreated as a control specimen. In order to compare the degree of weathering, 9 SUS anchors (nails) were set in each rock mass (North, East, South, West: lower and higher positions, and the top). The exposed length of each anchor was measured periodically using a digital caliper. Since the surface of the rocks is extremely friable, the measurement was not accurate enough (Figure 15). However, the number of remaining anchors demonstrated that surface treatment had a clear effect of (Table 2): after less than 8 months of exposure, 6 anchors of 9 were lost due to heavy weathering.

Figure 15. Periodical measurement of exposed length of SUS anchors  
Görsel 15. SUS sabitleyicilerinin açıkta kalan kısmının uzunluklarının düzenli ölçümü

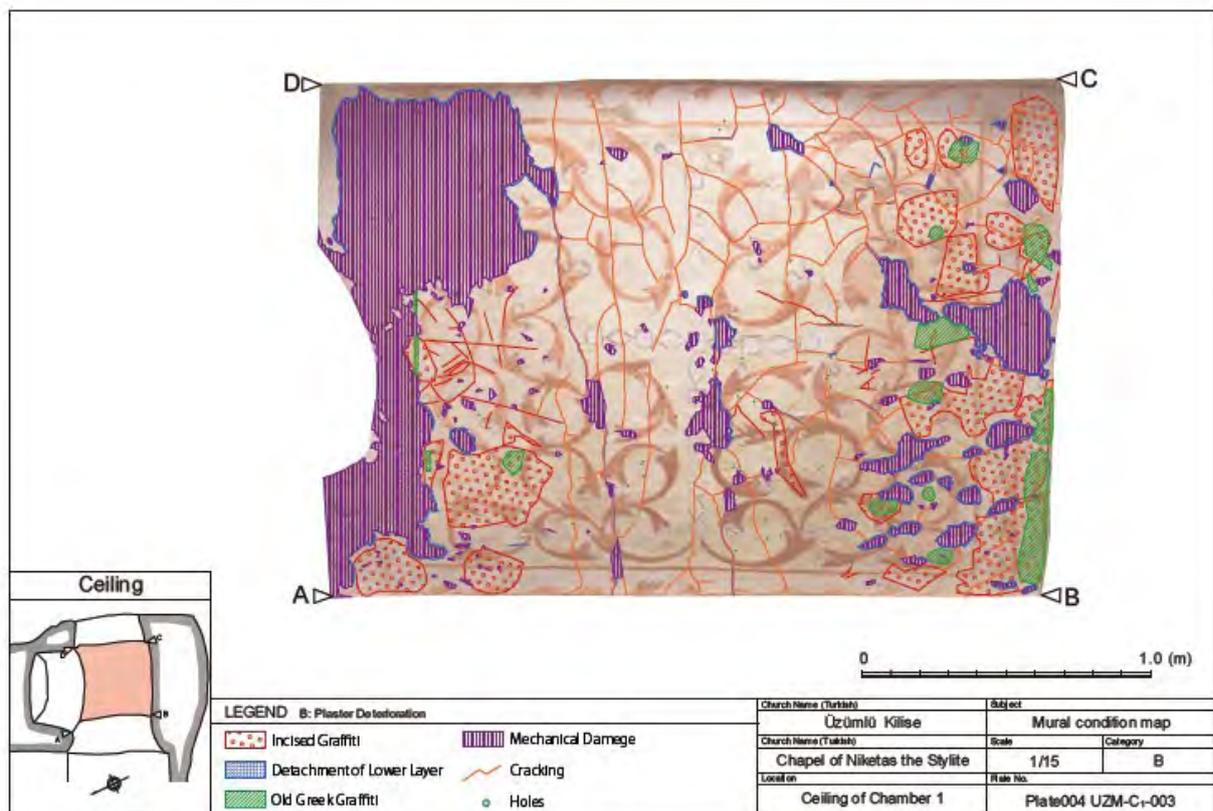
Figure 7. A complete example of condition assessment

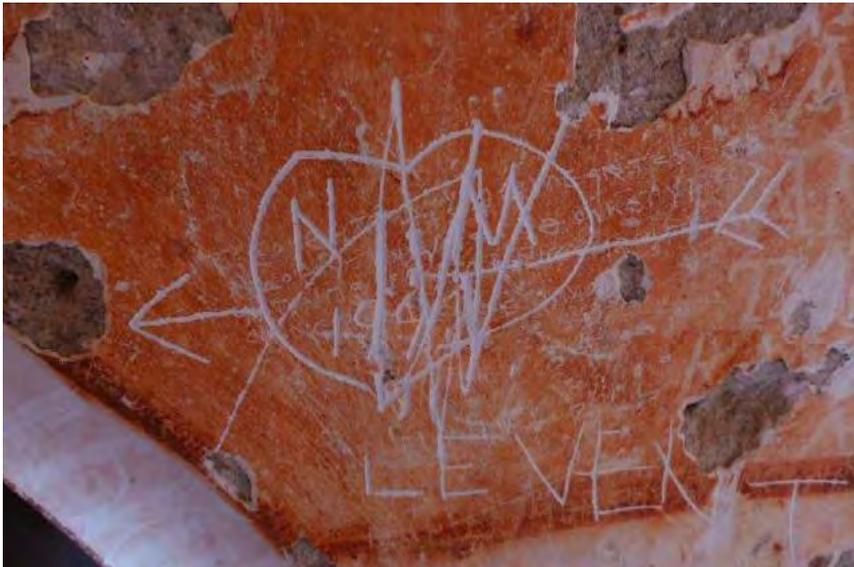
Mechanical damage has often revealed the bright white gypsum ground and plaster beneath the paint layers. White areas are quite distinguishable and optically overshadow darker tones in paintings. Such vandalism may be classified and defined by period and purpose. First, there is iconographic vandalism during what could be characterized as an iconoclastic period. Second, there was graffiti applied as part of worshipping practices depicting saints, horses, and prayers in Greek letters both pre- and post-dating the iconoclastic period. Third, there is graffiti by tourists or locals with names and dates (Figures 8, 9). The second case in particular should be the subject of more careful study before any conservation intervention is initiated. This is necessary to achieve a balance between preserving the cultural importance of the work as a historical witness and upholding its original visual aesthetic toning.

Figure 8. Graffiti, possibly by tourists

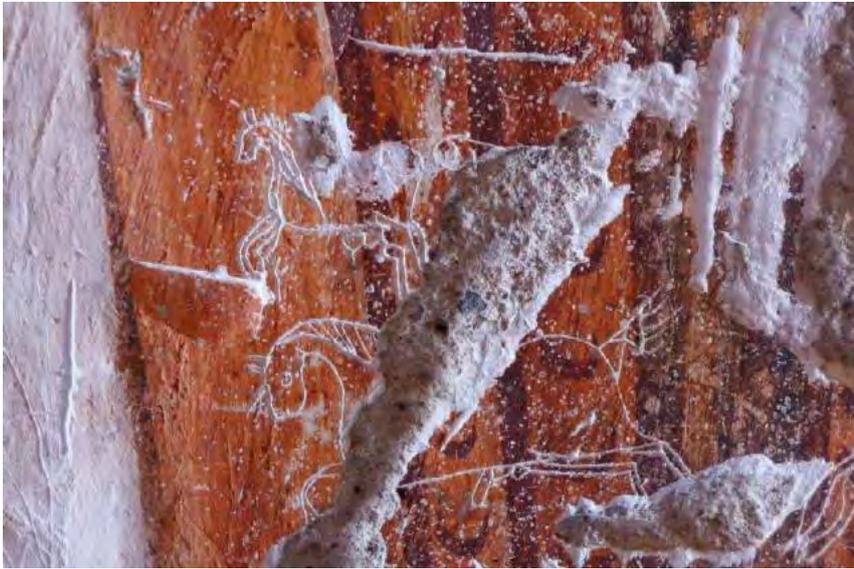
Figure 9. Graffiti, possibly from the Christian period

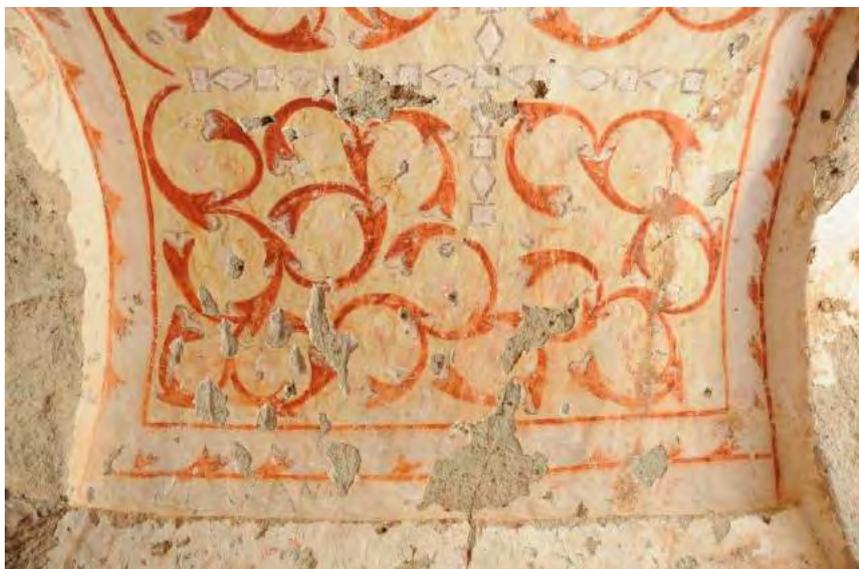
Figure 10. A scene of vines without grapes

the Narthex in particular has inexplicably lost important grape motifs in the centre of its vine decorations (Figure 10). A similar motif of grapes and vines is visible in the vault of the Nave endured better. Particular metal-based pigment alterations, likely caused by exposure to the outdoor environment, were observed, including the alteration of lead-based pigments to PbO.

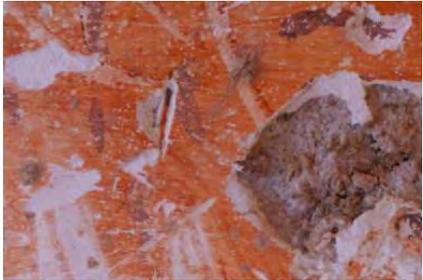
BIYOLOJIC BOZULMA	BIOLOGIC ACTIVITY  Evidence of animal inhabitation (insects, spiders). Often, they appear to have inhabited pre-existing fractures in the rock, possibly exacerbating deterioration

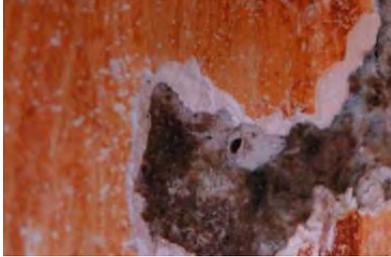
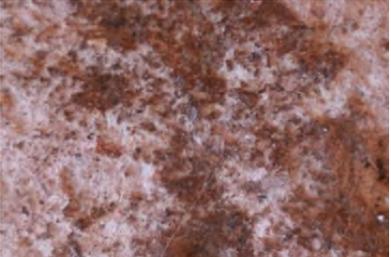
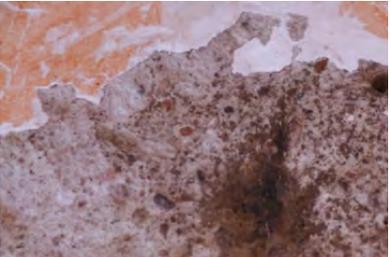
SIYAHLAŞMA	DEPOSITION OF DARK MATERIAL  Deposits of dark brown or blackish material on the surface of the rock. Its origin is unclear, but it may be caused by biologic activity (ex. insects, bats). It appears to have been deposited on the stone after a loss of plaster, but this is uncertain – similar deposits do not appear on the surface of the plaster or paint layers. Could it have formed under the plaster and contributed to detachment? If of insect or animal origin, what caused the depopulation?

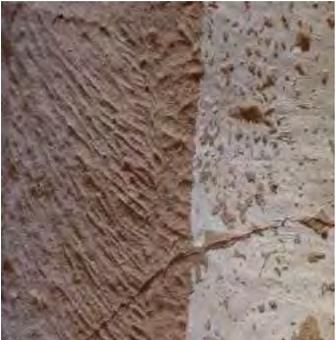
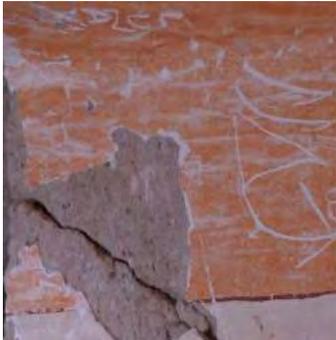
YAPISAL ÇATLAH  <hr/> STRUCTURAL CRACKS  Large cracks which run through the body of the rock, caused by faulting

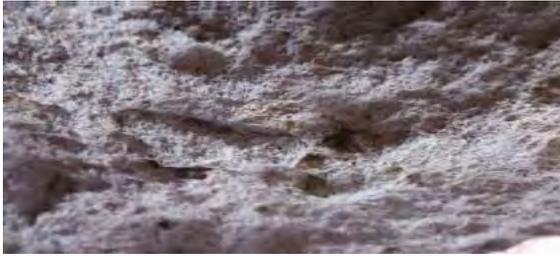
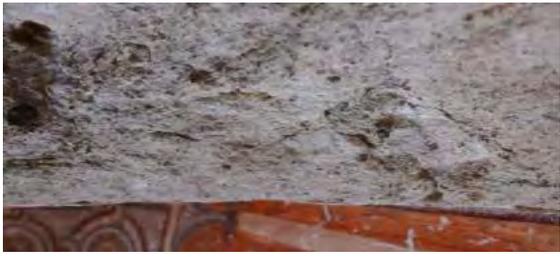
<p>YÜZEYDE KÜÇÜK ÇATLAK</p>	<p>SPALLING</p> <p>Detachment of the rock on a small scale, in parallel to the surface of the rock, probably more due to internal failure of the rock itself than macro-failure of the structure, though the two factors may be inter-related</p>
