# Scientific Studies on Conservation for Üzümlü Church and its wall paintings in Cappadocia, Turkey

**Vol. 2 (Report on the activities in 2015-2016)**

University of Tsukuba  
2017

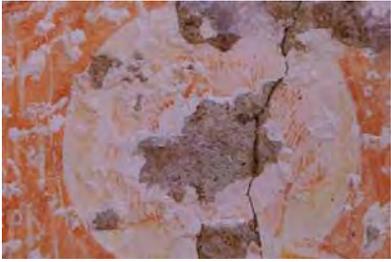
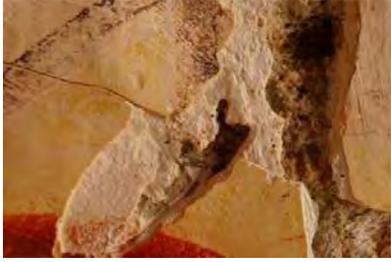
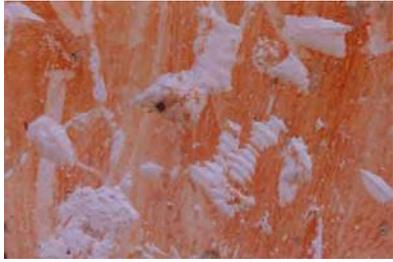
<p>YAPISAL ÇATLAH</p>	<p>STRUCTURAL CRACKS</p> <p>Large cracks which run through the body of the rock, caused by faulting</p>

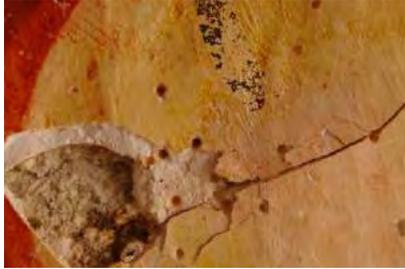
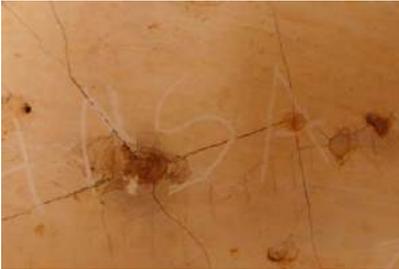
<p>BÜTÜN ÇATLAKLAR</p>	<p>CRACKING</p> <p>Cracking of the plaster layer most often resulting from cracking of the rock structure and mechanical damage, though there may be other causes</p>

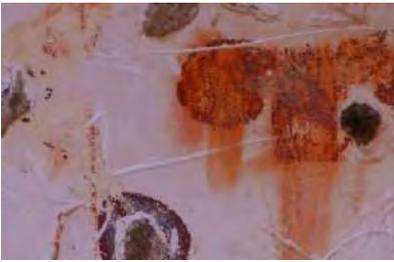
<p>LEKELENMELER</p>	<p>SMEARING</p> <p>Displacement of the paint layer by mechanical action beyond its original location, seen as a spreading of the paint across the surface of the plaster. Generally appears to have been caused by contact with the paint layer, perhaps in combination with the presence of water</p>

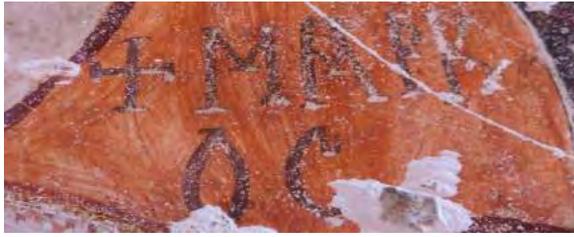
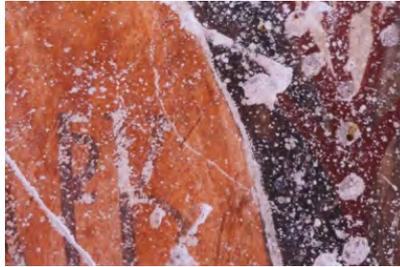
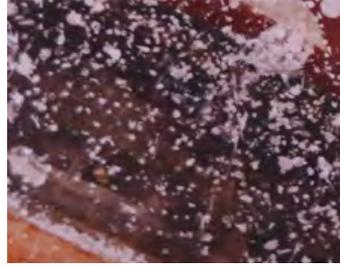
MIKRO KAYIPLAR

MICRO LOSSES

Extremely small, rounded losses of the paint layer generally on the order of 0.5-1 mm Ø. Not always confined to specific paint layers, but does appear to be somewhat location-specific

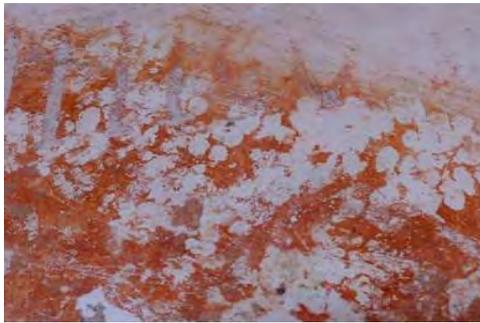
BİYOLOJİK  
NEDENLERLE  
BOYA TABAKASINDA  
KAYIP

PAINT LAYER LOSS DUE TO BIOLOGIC  
ACTIVITY

Loss of the paint layer due to the former presence of birds' nests (primarily) which, when separated from the painting surface, removed part of the paint layer

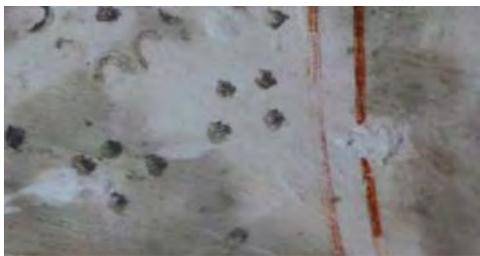
KOYU GRI  
LEKELENMELER

DARK GREY VEIL

Veil extending over the surface of the painting, dark grey in color, somewhat patchy, and of unclear origin. Does not appear to be soot.

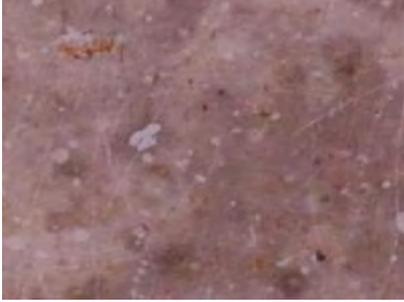
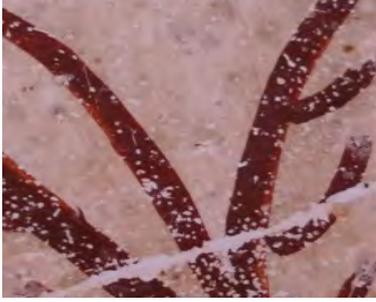
<p>GİRİ LEKELENMELER</p>	<p>GREY SPOTTING</p> <p>Faint, circular grey spots, 0.5-3 mm Ø, on the surface of the painting. Origin unclear, but often generally occurs in the same vicinity as the grey veil</p>

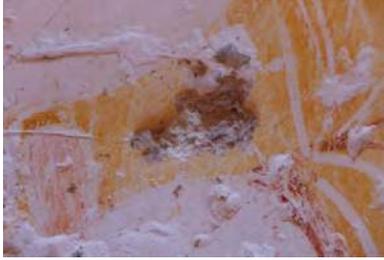
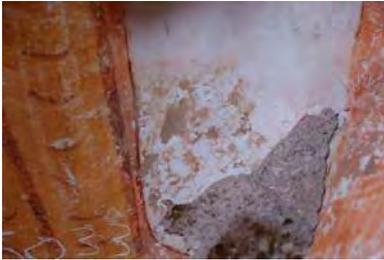
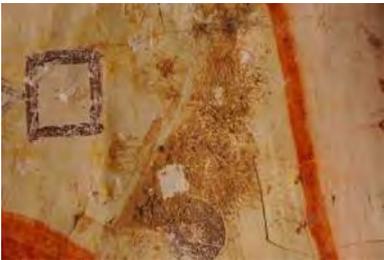
<p>YÜZEY BİRİKİNTİLERİ</p>	<p>SURFACE DEPOSITION</p> <p>Deposition of material on the surface of the painting, such as mud from birds' nests or from later construction in the church (ex. mud plaster)</p>

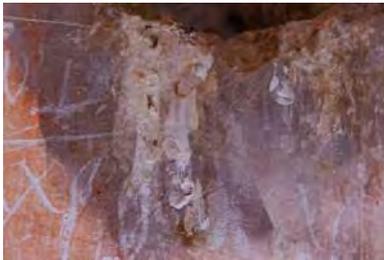
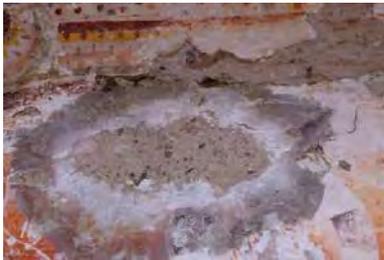
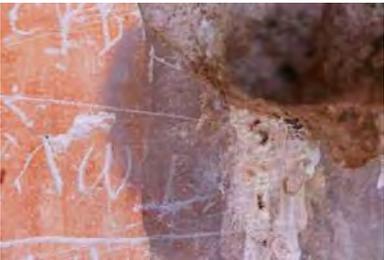
<p>BİYOLOJİK BOZULMA</p>	<p>BIOLOGIC DETERIORATION</p> <p>Discoloration (generally dark grey) of certain areas of painting due to animal inhabitation. Has also resulted in the peeling and detachment of the plaster layer in certain areas</p>

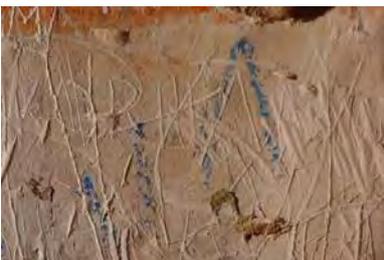
<p>YÜZEYSEL GRAFİTİ</p> <p>SUPERFICIAL GRAFFITI</p> <p>Graffiti applied to the surface of the painting using a medium such as paint, ink, or graphite. At times the original paint layer used as a medium by taking advantage of its friability/water sensitivity</p>

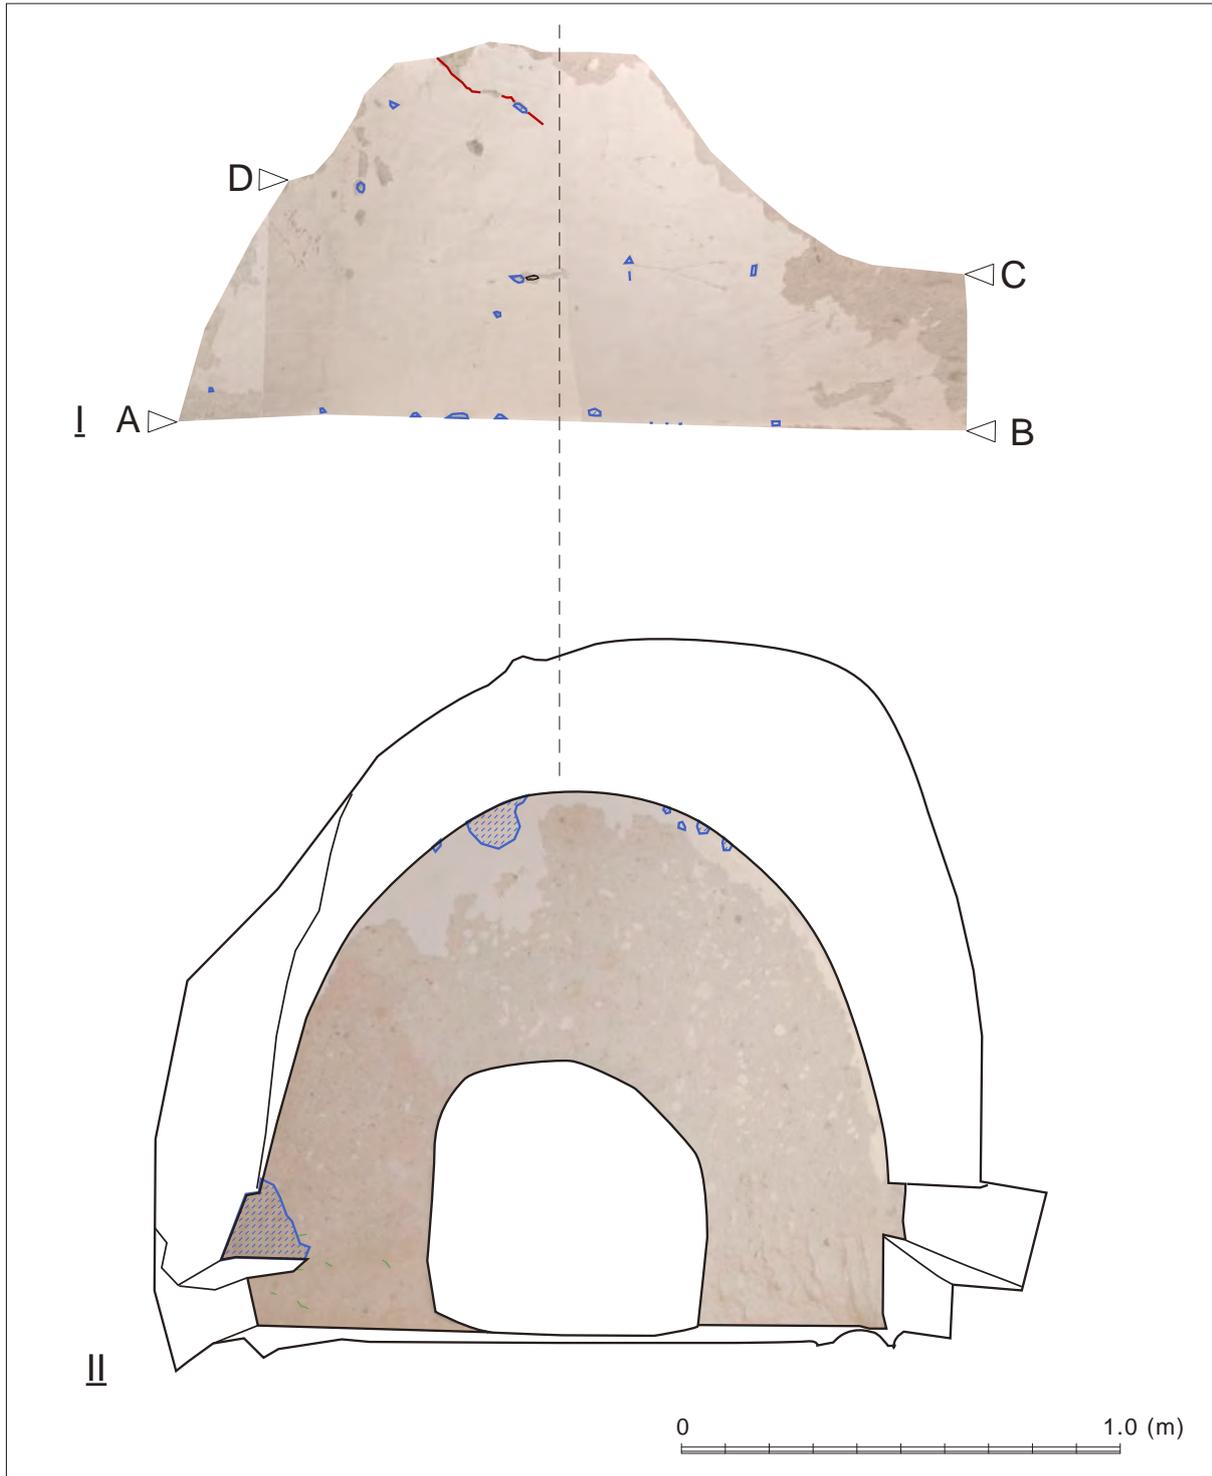
<p><b>Ceiling</b></p>		<p><b>LEGEND</b> A: Rock Deterioration</p> <p> Deposition of Dark Material</p> <p> Spalling</p> <p> Structural Cracks</p> <p> Biologic Activity</p>		<p>Church Name (Turkish)</p> <p><b>Üzümlü Kilise</b></p>
		<p>Church Name (English)</p> <p><b>Chapel of Niketas the Stylite</b></p>		<p>Location</p> <p><b>North Arch of Chamber 1</b></p>
		<p>Subject</p> <p><b>Mural condition map</b></p>		
		<p>Scale</p> <p><b>1/15</b></p>	<p>Category</p> <p><b>A</b></p>	
		<p>Plate No.</p> <p><b>Plate 011 UZM-C<sub>1</sub>-010</b></p>

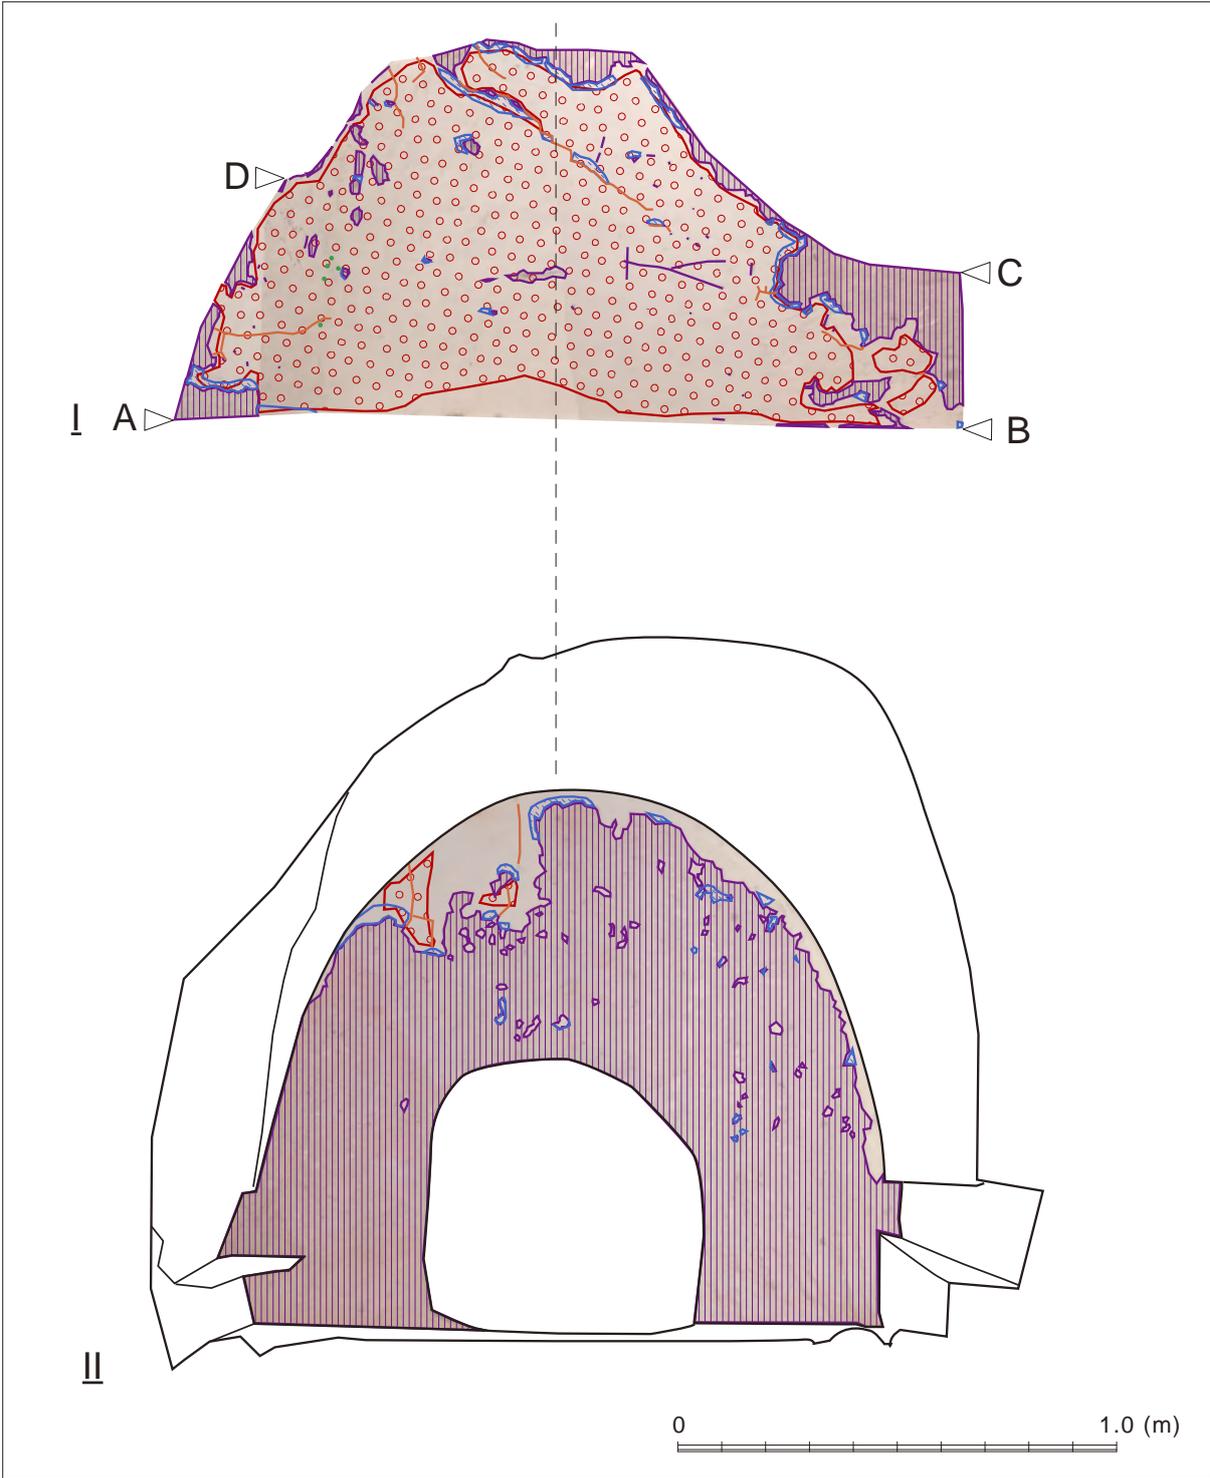
<p><b>Ceiling</b></p>	<p><b>LEGEND</b> B: Plaster Deterioration</p> <ul style="list-style-type: none"> <li> Incised Graffiti</li> <li> Detachment of Lower Layer</li> <li> Mechanical Damage</li> <li> Cracking</li> <li> Holes</li> </ul>	Church Name (Turkish)
		Üzümlü Kilise
		Church Name (English)
		Chapel of Niketas the Stylite
		Location
		North Arch of Chamber 1
		Subject
		Mural condition map
		Scale
		1/15
		Category
		B
		Plate No.
		Plate 012 UZM-C <sub>1</sub> -011

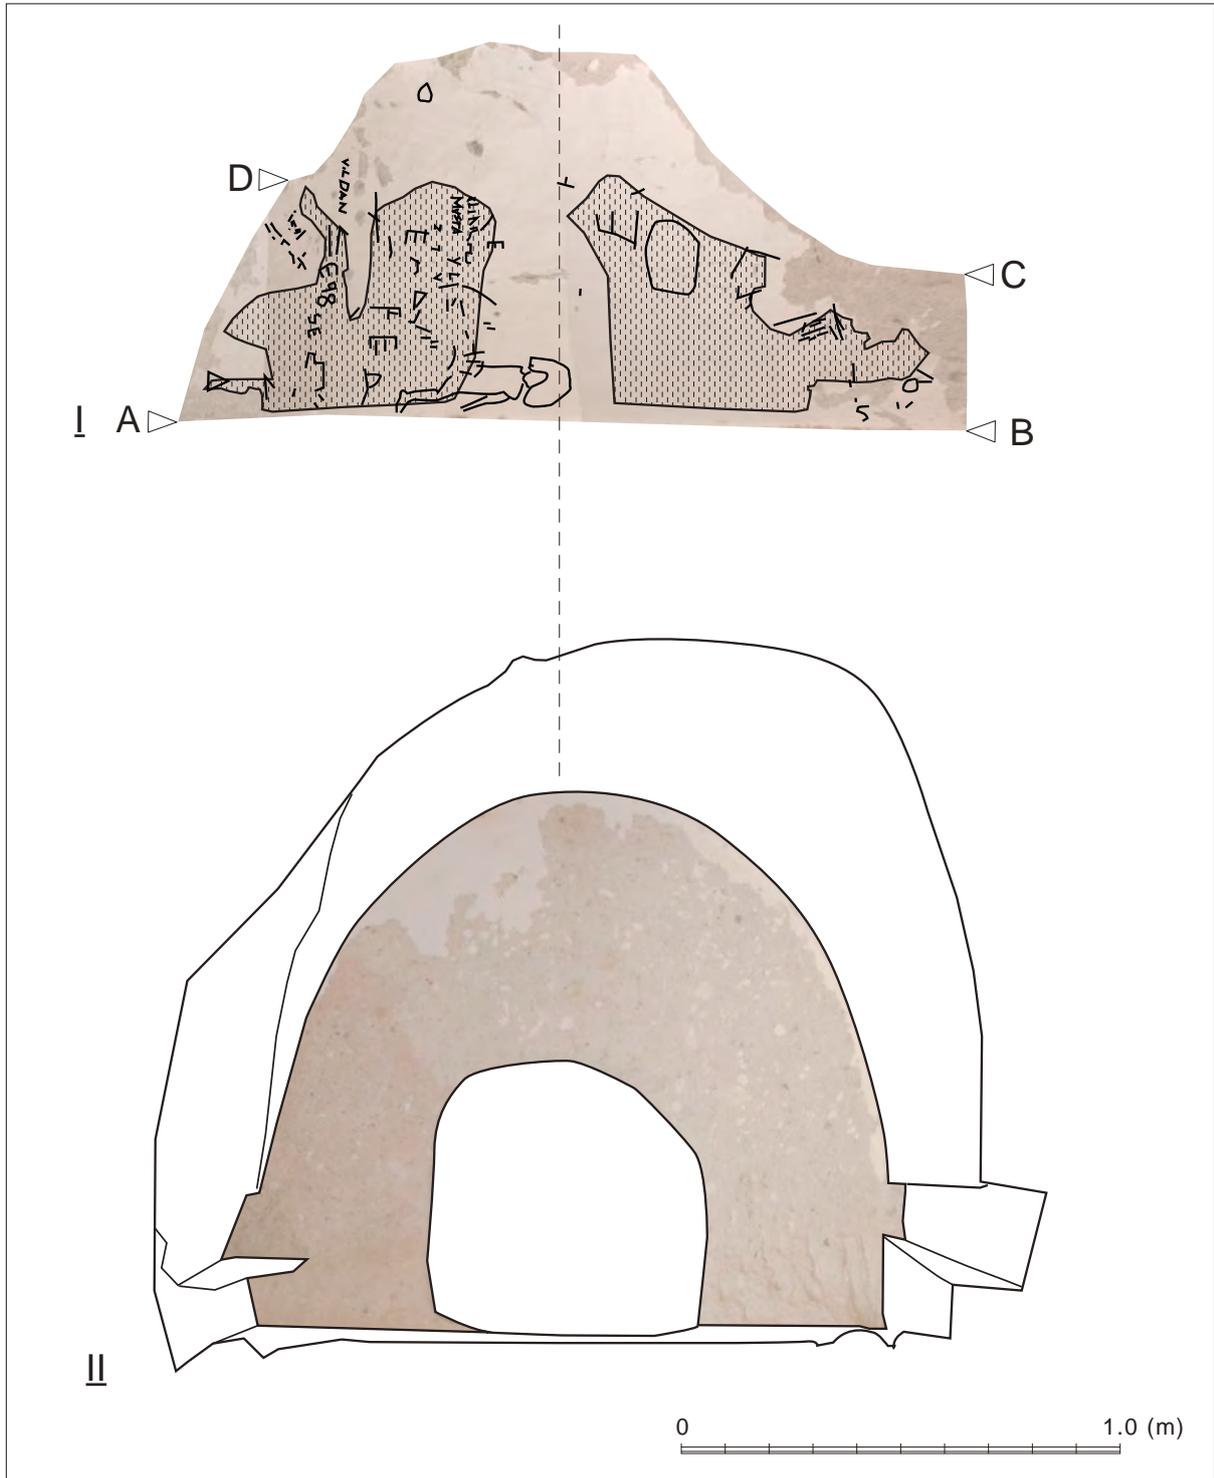
<p><b>Ceiling</b></p>	<p><b>LEGEND</b> C: Paint Deterioration</p> <p> Dark Grey Veil</p> <p> Superficial Graffiti</p>	Church Name (Turkish)
		Üzümlü Kilise
		Church Name (English)
		Chapel of Niketas the Stylite
		Location
		North Arch of Chamber 1
		Subject
		Mural condition map
		Scale
		1/15
		Category
		C
		Plate No.
		Plate 013 UZM-C1-012

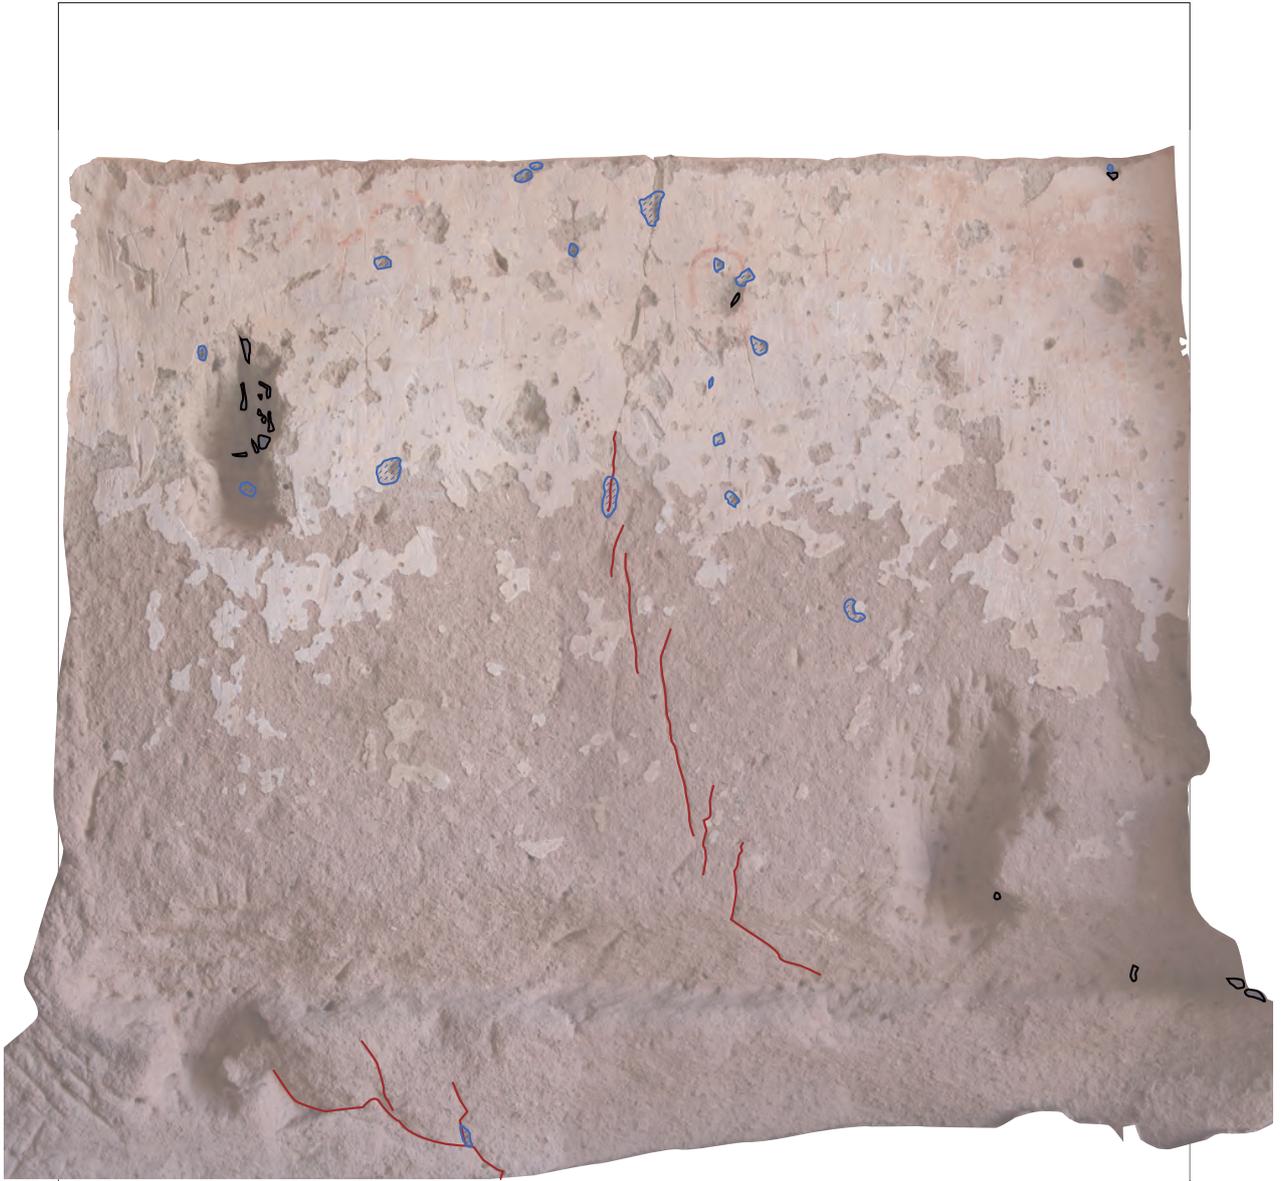
<p><b>Section A-A'</b></p>	<p><b>LEGEND</b> A: Rock Deterioration</p> <p> Deposition of Dark Material</p> <p> Biologic Activity</p>	Church Name (Turkish)
		Üzümlü Kilise
		Church Name (English)
		Chapel of Niketas the Stylite
		Location
		South Wall of Chamber 1
		Subject
		Mural condition map
		Scale
		Category
		1/10
		A
		Plate No.
		Plate015 UZM-C <sub>1</sub> -014

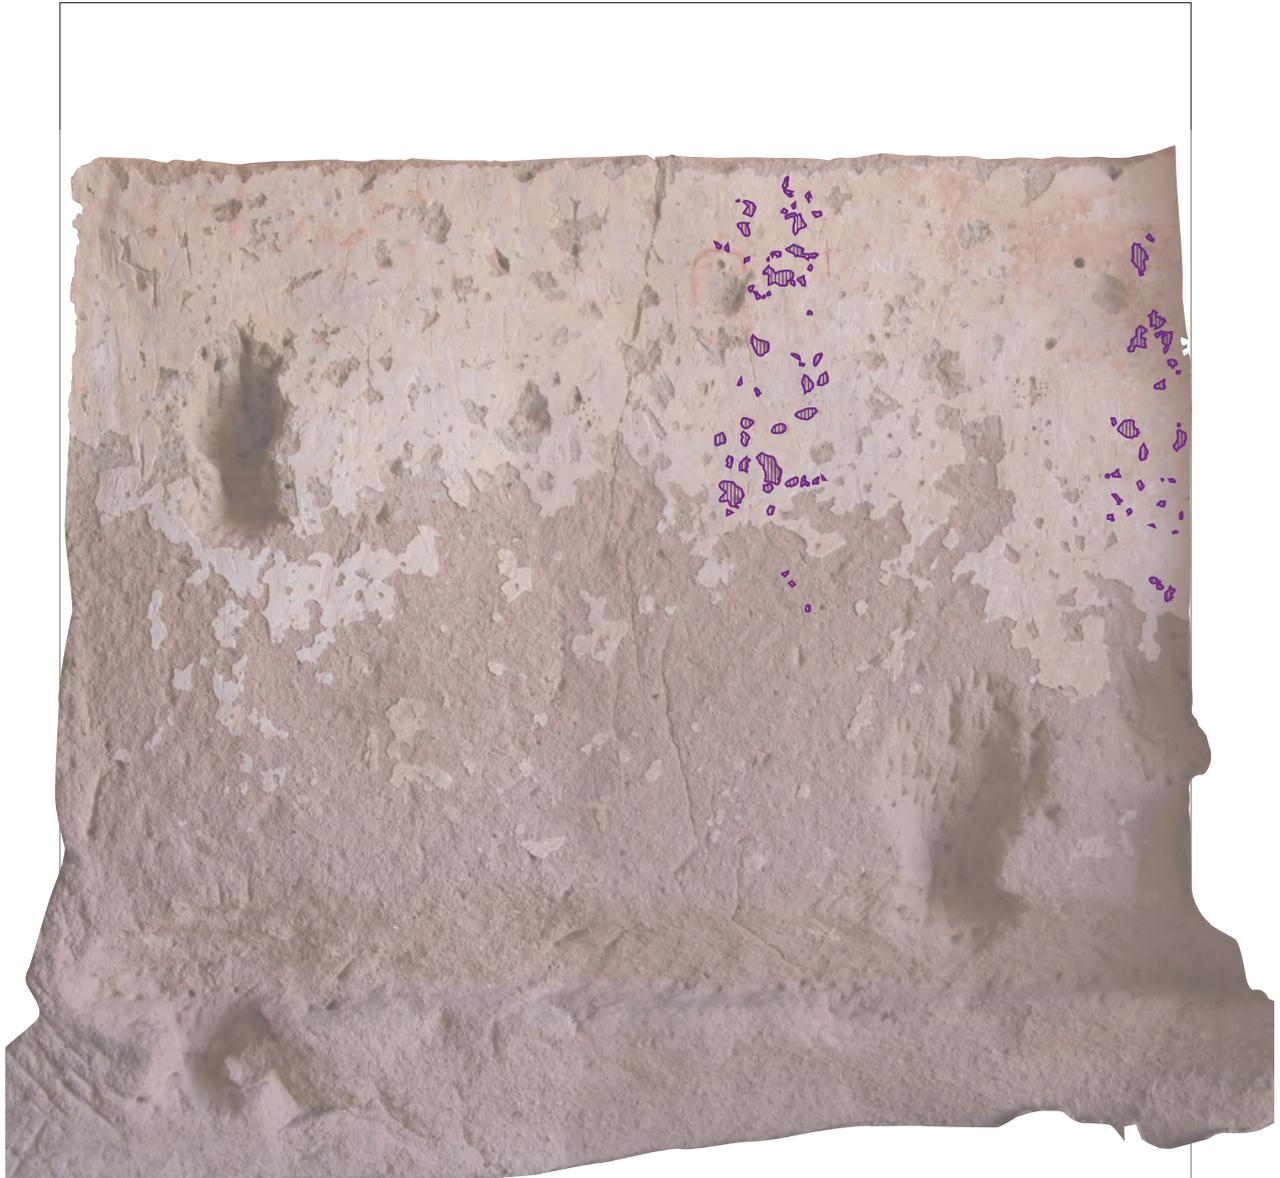
Section A-A'		LEGEND B: Plaster Deterioration		Church Name (Turkish)	
		<ul style="list-style-type: none"> <li> Detachment of Lower Layer</li> <li> Mechanical Damage</li> <li> Cracking</li> <li> Holes</li> </ul>		Üzümlü Kilise	
				Church Name (English)	
				Chapel of Niketas the Stylite	
				Location	
				South Wall of Chamber 1	
				Subject	
				Mural condition map	
				Scale	Category
				1/10	B
				Plate No.	
				Plate016 UZM-C <sub>1</sub> -015

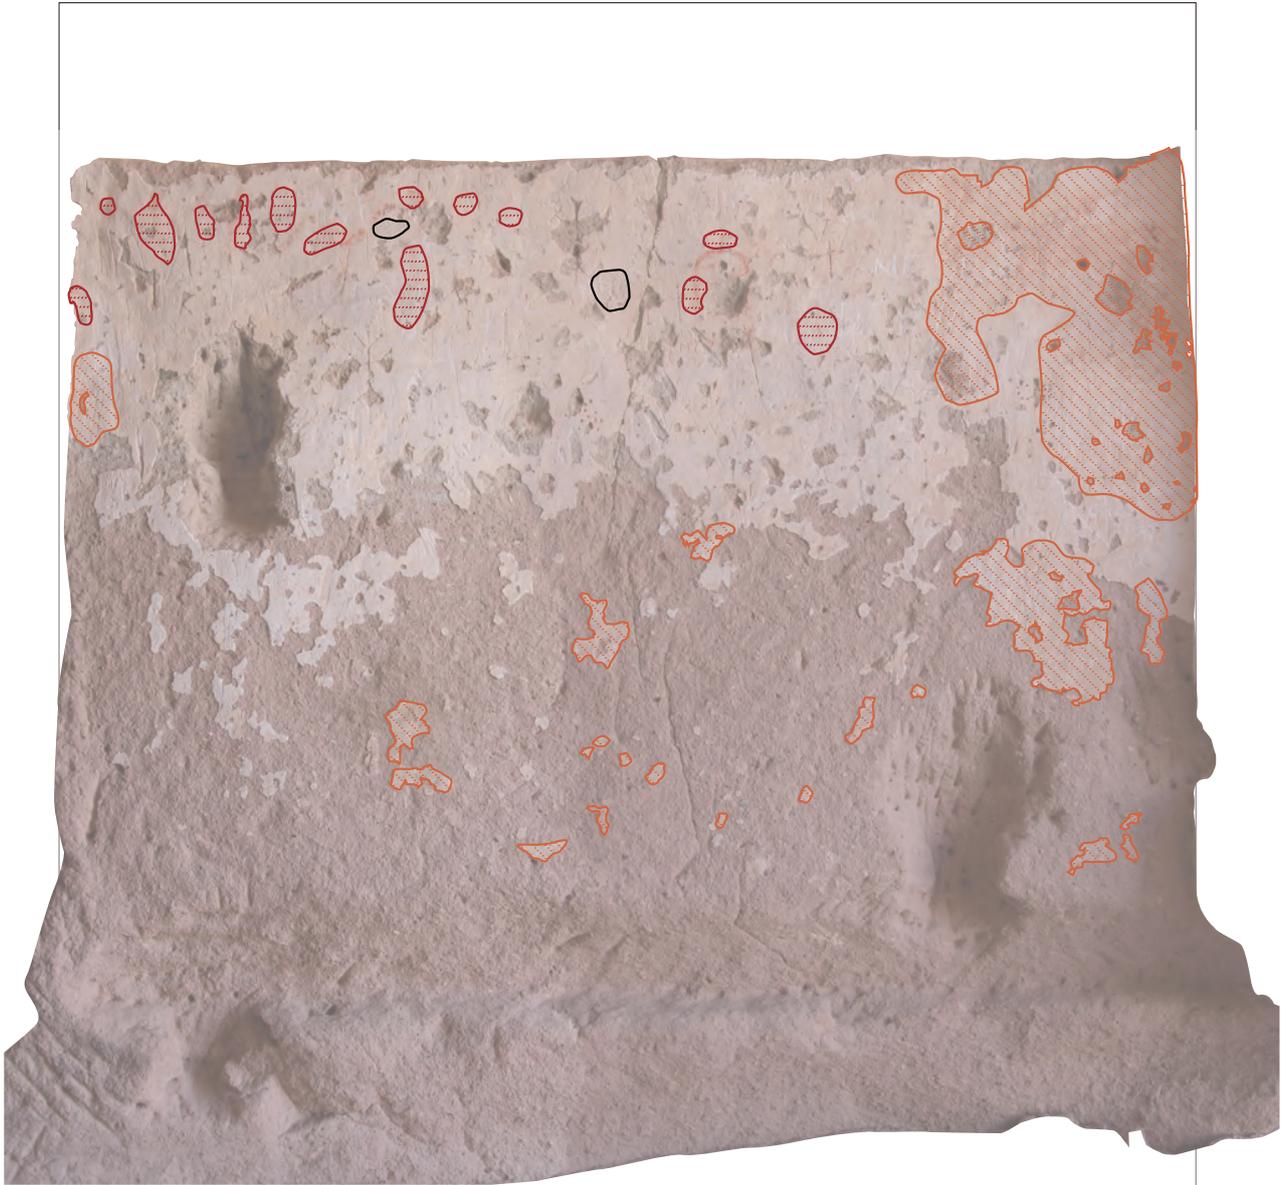
<p><b>Section A-A'</b></p>	<p><b>LEGEND</b> C: Paint Deterioration</p> <ul style="list-style-type: none"> <li> Smearing</li> <li> Surface Deposition</li> <li> Superficial Graffiti</li> </ul>	Church Name (Turkish)
		Üzümlü Kilise
		Church Name (English)
		Chapel of Niketas the Stylite
		Location
		South Wall of Chamber 1
		Subject
		Mural condition map
		Scale
		1/10
		Category
		C
		Plate No.
		Plate017 UZM-C1-016

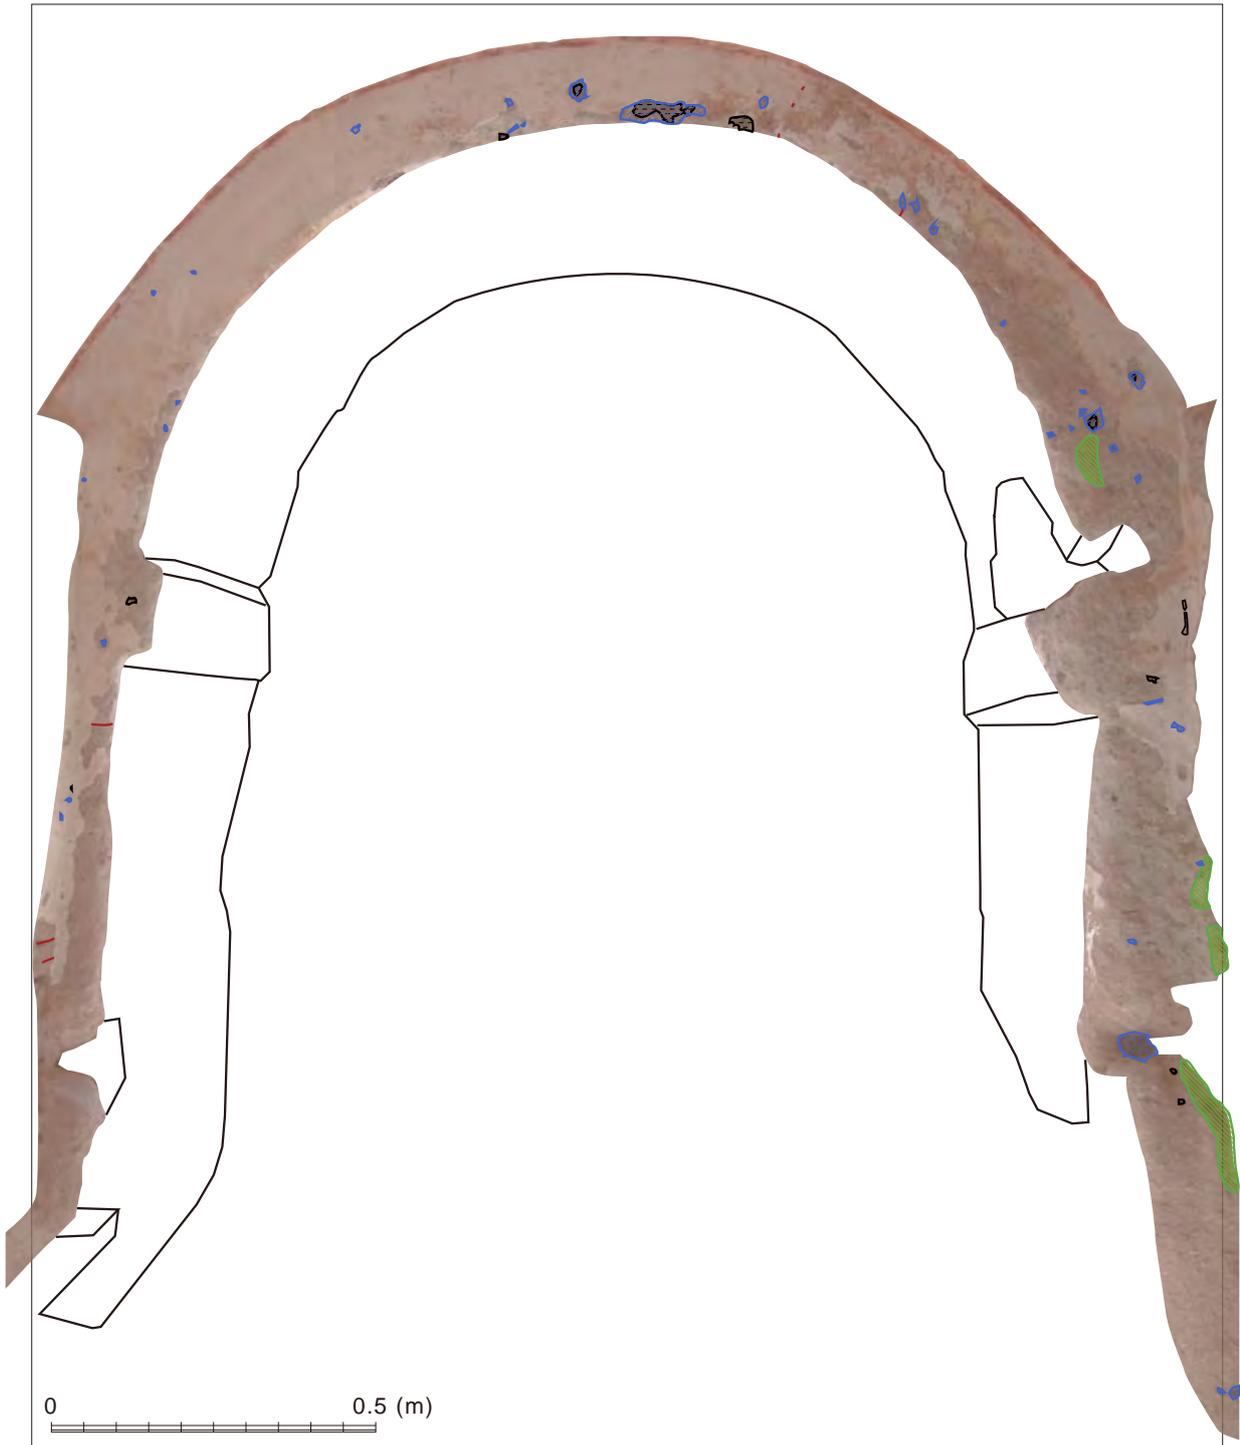
<b>Section G-G'</b>  	<b>LEGEND</b> A: Rock Deterioration  Deposition of Dark Material Biologic Activity Spalling Structural Cracks	Church Name (Turkish)
		Üzümlü Kilise
		Church Name (English)
		Chapel of Niketas the Stylite
		Location
		West Wall of Chamber 1
		Subject
		Mural condition map
		Scale
		Category
		1/10
		A
		Plate No.
		Plate019 UZM-C1-018

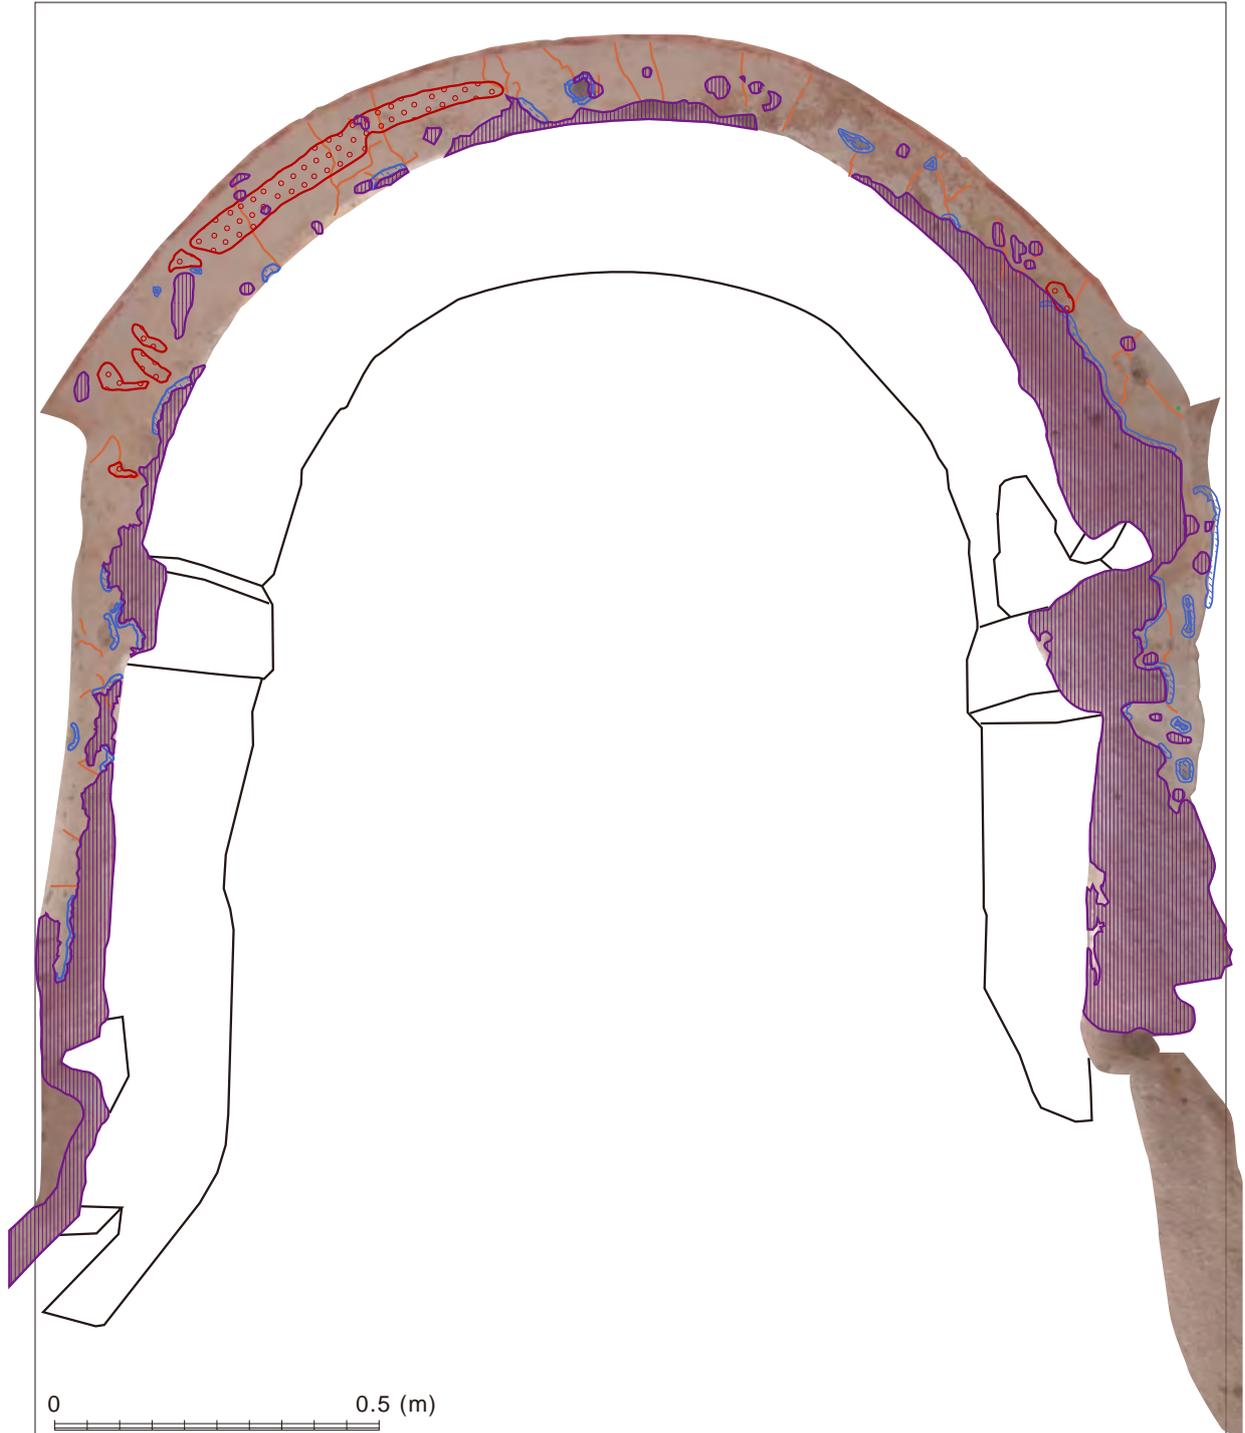
Holes	Church Name (Turkish)	Üzümlü Kilise	
		Church Name (English)	Chapel of Niketas the Stylite	
		Location	West Wall of Chamber 1	
		Subject	Mural condition map	
		Scale	1/10	Category
				B
		Plate No.	Plate020 UZM-C1-019

<b>LEGEND</b> B: Plaster Deterioration

Mechanical Damage

Cracking

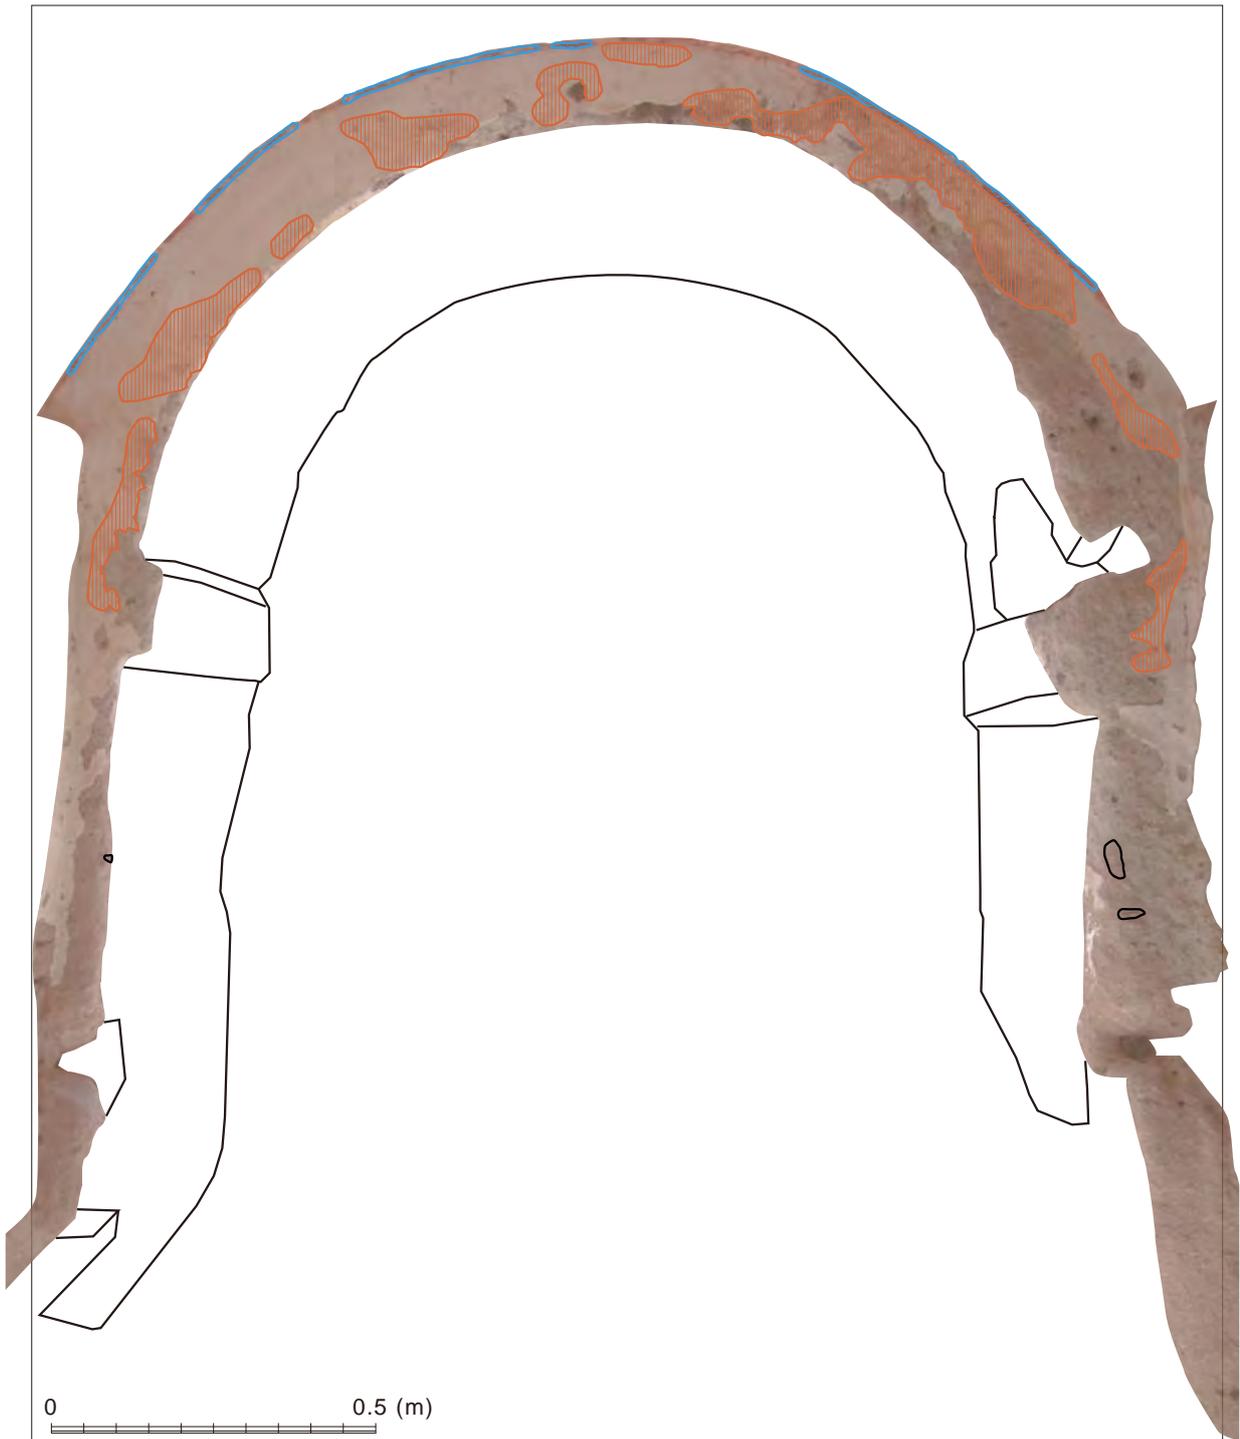
<p><b>Section G-G'</b></p>	<p><b>LEGEND C: Paint Deterioration</b></p>		<p>Church Name (Turkish)</p> <p>Üzümlü Kilise</p>
	<p> Smearing</p> <p> Surface Deposition</p> <p> Superficial Graffiti</p> <p> Biological Deposition</p> <p> Paint Loss due to Biological Activity</p>	<p> Micro Losses</p> <p> Grey Spotting</p> <p> Dark Grey Veil</p>	<p>Church Name (English)</p> <p>Chapel of Niketas the Stylite</p> <p>Location</p> <p>West Wall of Chamber 1</p> <p>Subject</p> <p>Mural condition map</p> <p>Scale</p> <p>1/10</p> <p>Plate No.</p> <p>Plate021 UZM-C1-020</p>

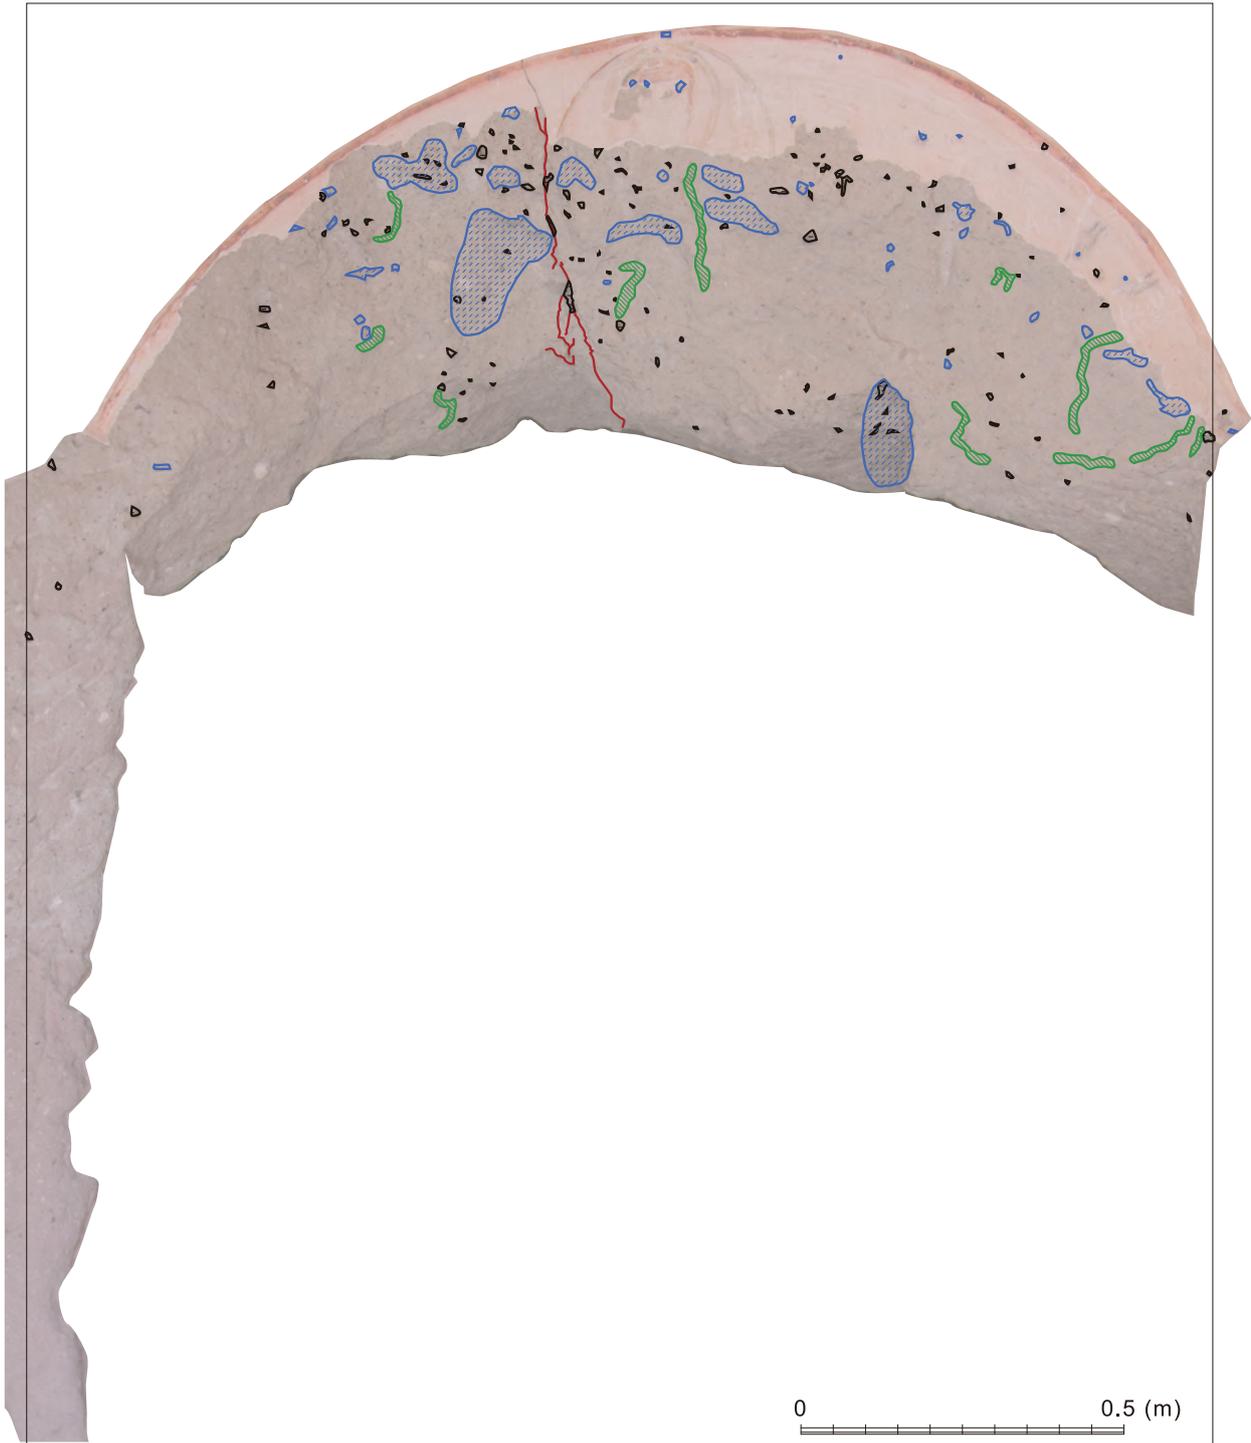
<p><b>Section F-F'</b></p>	<p><b>LEGEND</b> A: Rock Deterioration</p> <ul style="list-style-type: none"> <li> Deposition of Dark Material</li> <li> Biologic Activity</li> <li> Spalling</li> <li> Structural Cracks</li> </ul>	Church Name (Turkish)
		Üzümlü Kilise
		Church Name (English)
		Chapel of Niketas the Stylite
		Location
		East Wall of Chamber 1
		Subject
		Mural condition map
		Scale
		1/10
		Category
		A
		Plate No.
		Plate023 UZM-C1-022

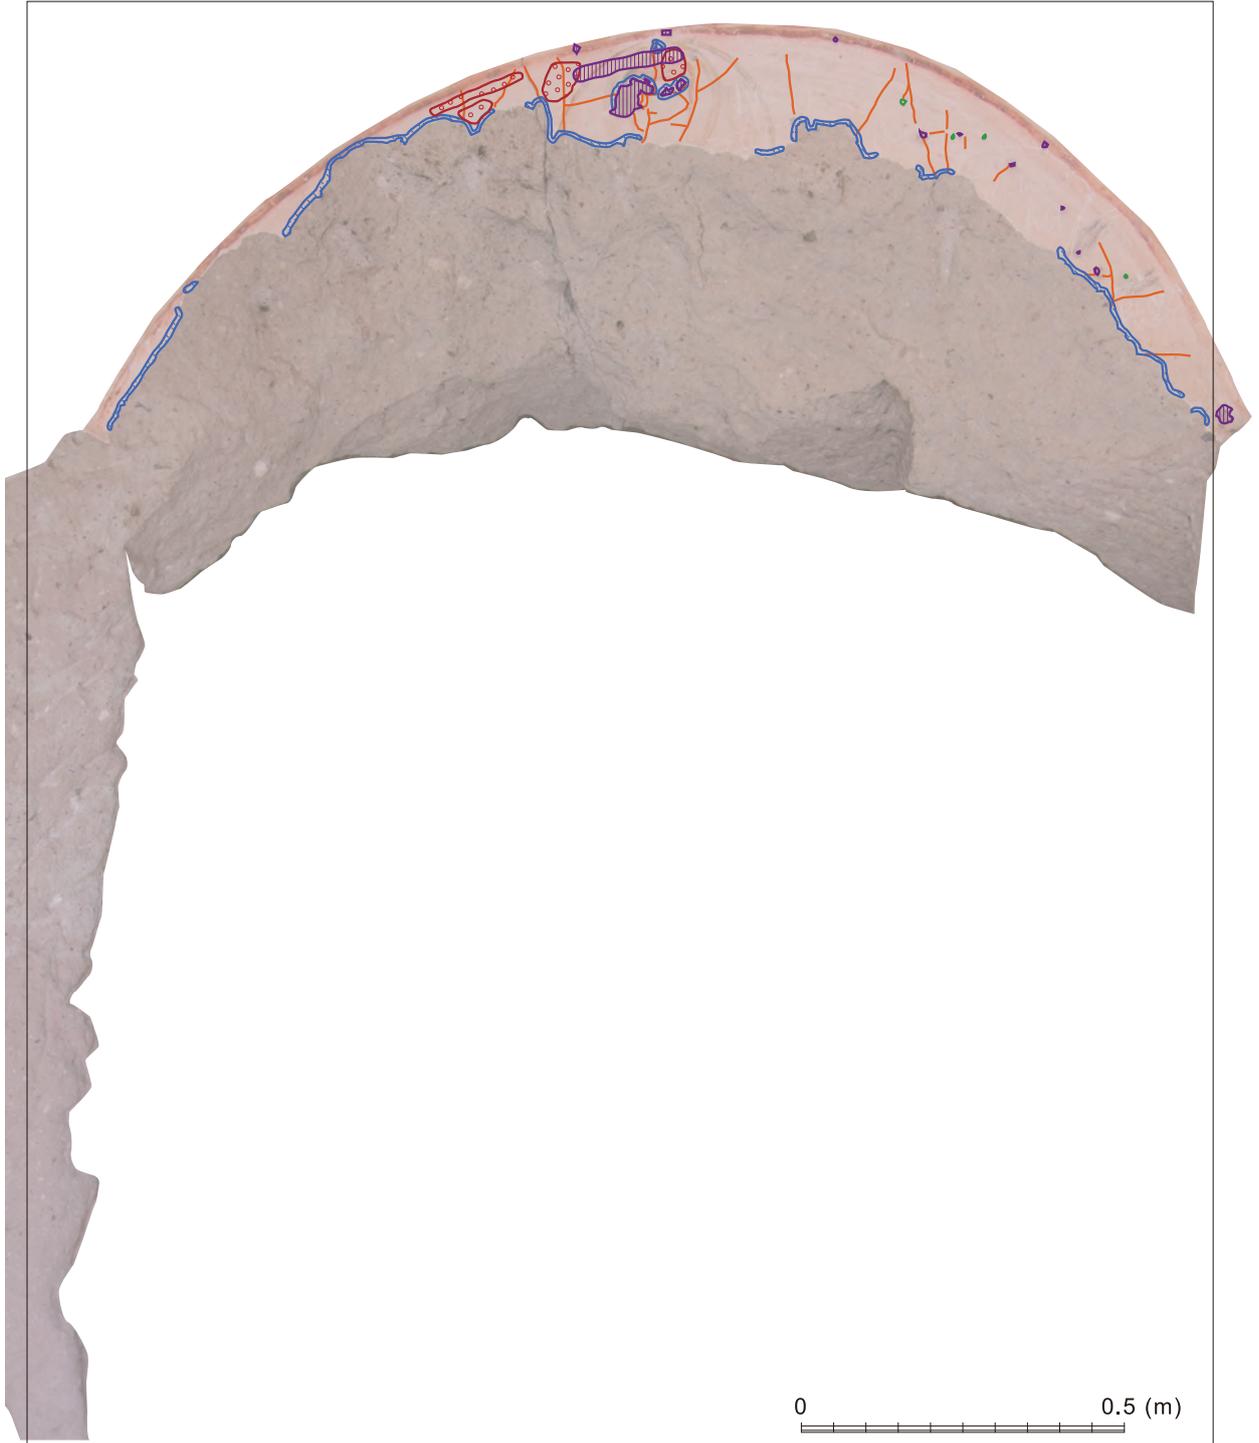
Holes	Subject Mural condition map		
		Scale 1/10	Category B	
		Plate No. Plate024 UZM-C <sub>1</sub> -023

Section F-F'	LEGEND B: Plaster Deterioration	Church Name (Turkish) Üzümlü Kilise

Mechanical Damage	Location East Wall of Chamber 1
