# Scientific Studies on Conservation for Üzümlü Church and its wall paintings in Cappadocia, Turkey

**Vol. 2 (Report on the activities in 2015-2016)**

University of Tsukuba  
2017

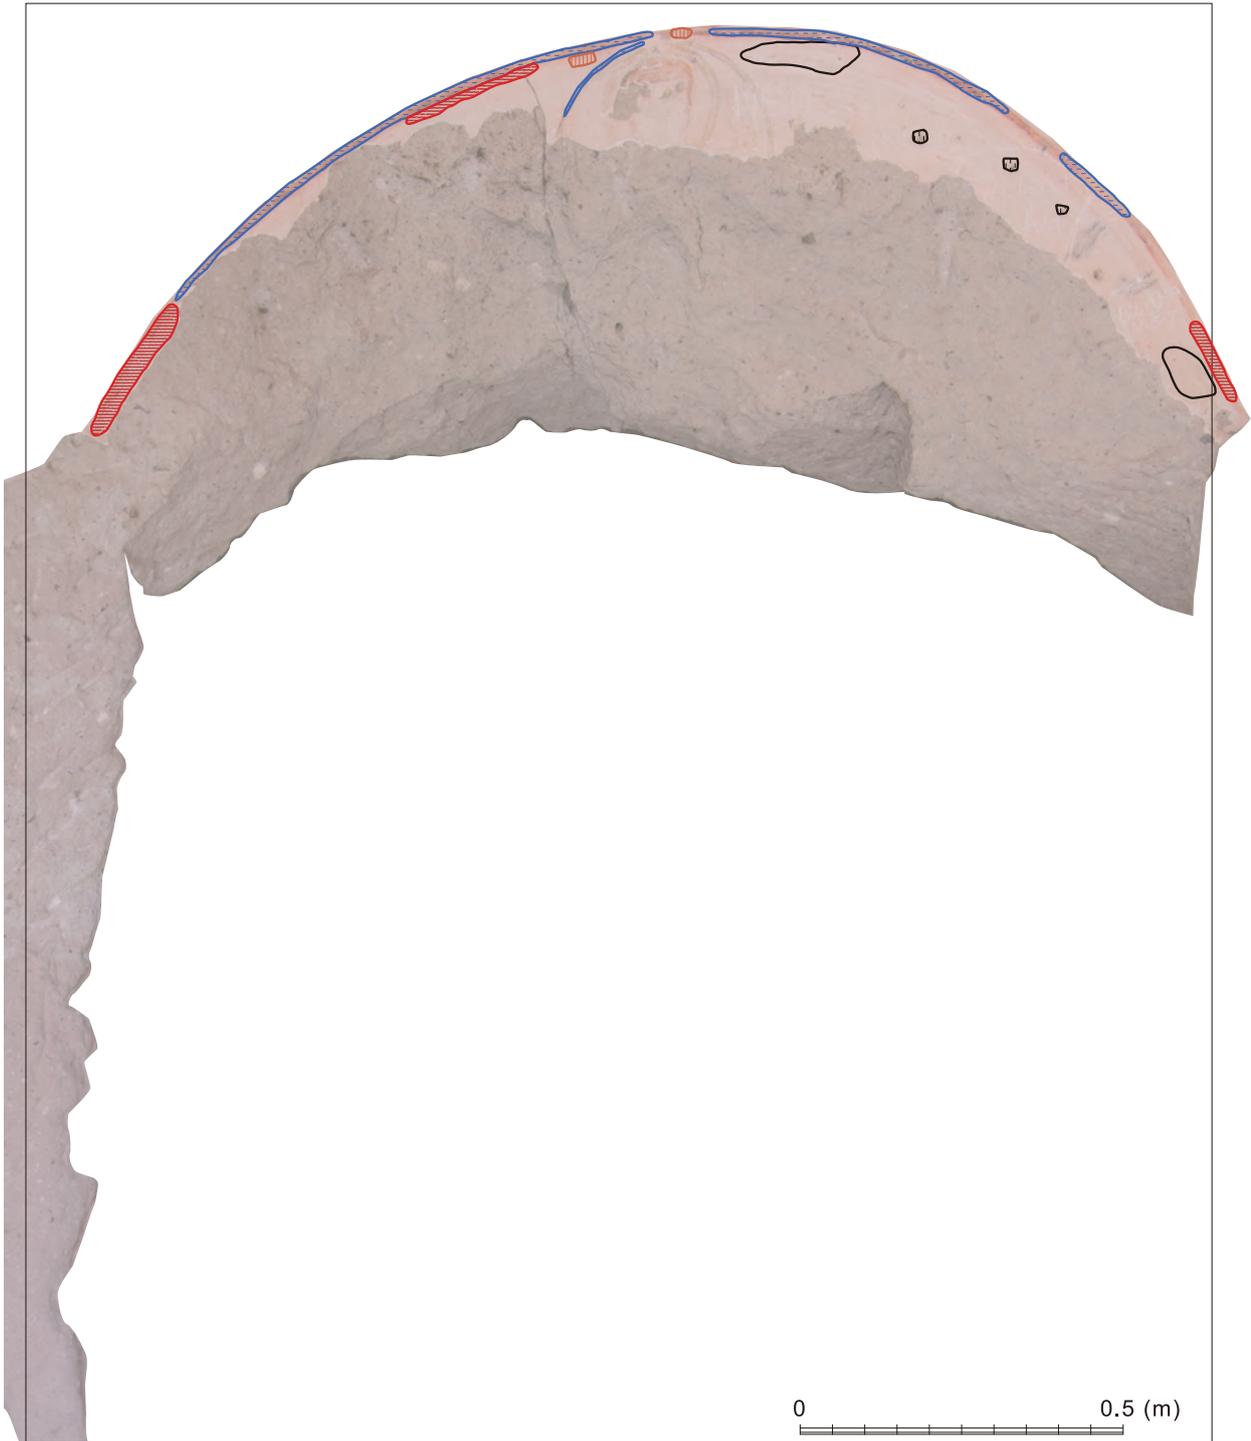
Biological Deposition	Location	
		East Wall of Chamber 1	
	Subject		
	Mural condition map		
	Scale	Category	
	1/10	C	
	Plate No.		
	Plate025 UZM-C <sub>1</sub> -024

Section F-F'	LEGEND C: Paint Deterioration	Church Name (Turkish)

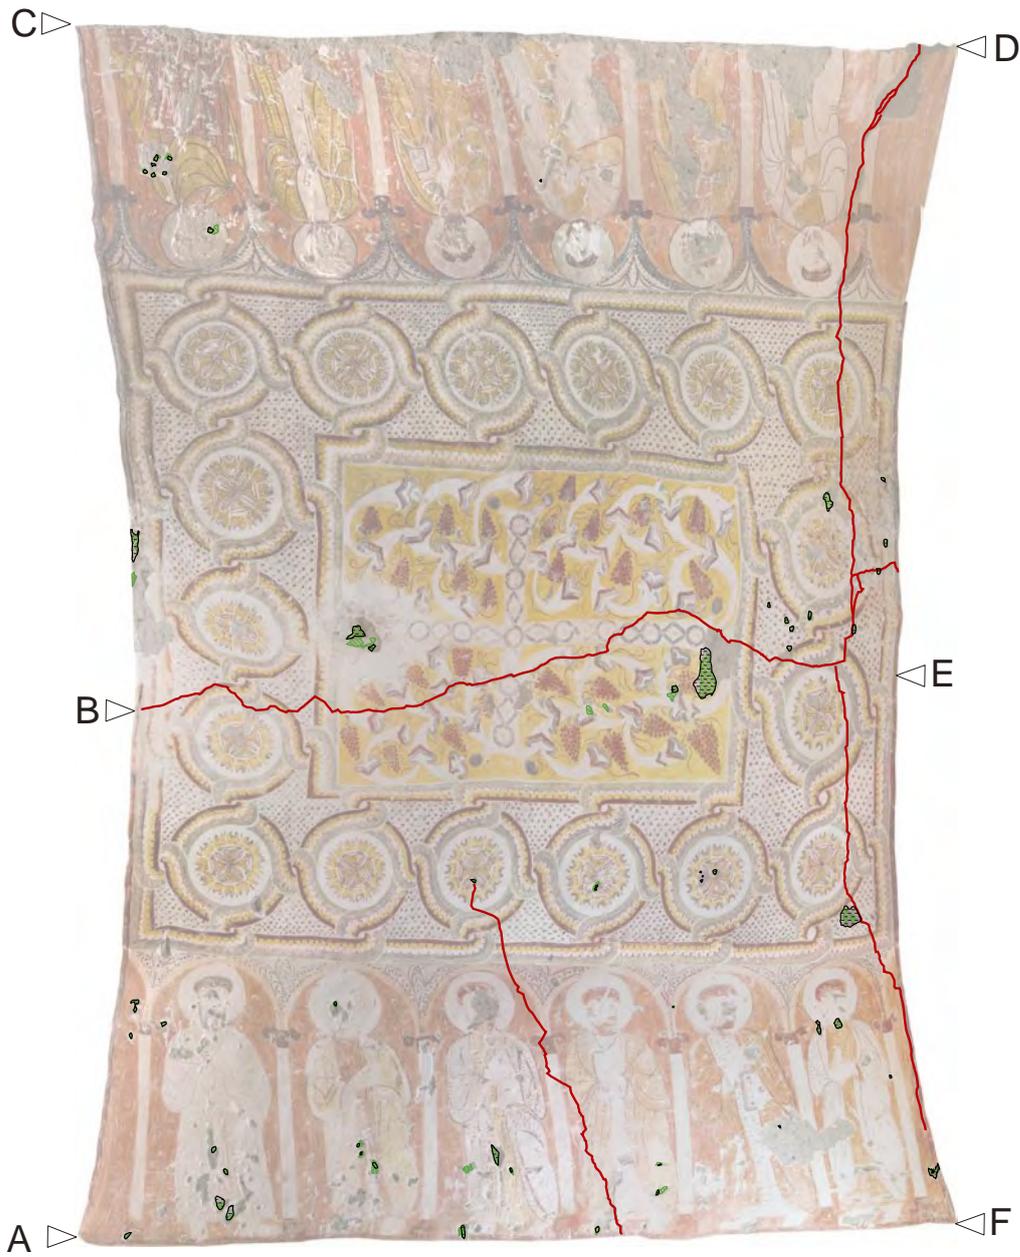
Church Name (Turkish)	
Üzümlü Kilise	
Church Name (English)	
Chapel of Niketas the Stylite	
Location	
Ceiling of Chamber 2	
Subject	
Mural condition map	
Scale	Category
1/20	A
Plate No.	
Plate027 UZM-C <sub>2</sub> -002

**LEGEND** A: Rock Deterioration

Spalling
-

Structural Cracks
-

Biologic Activity

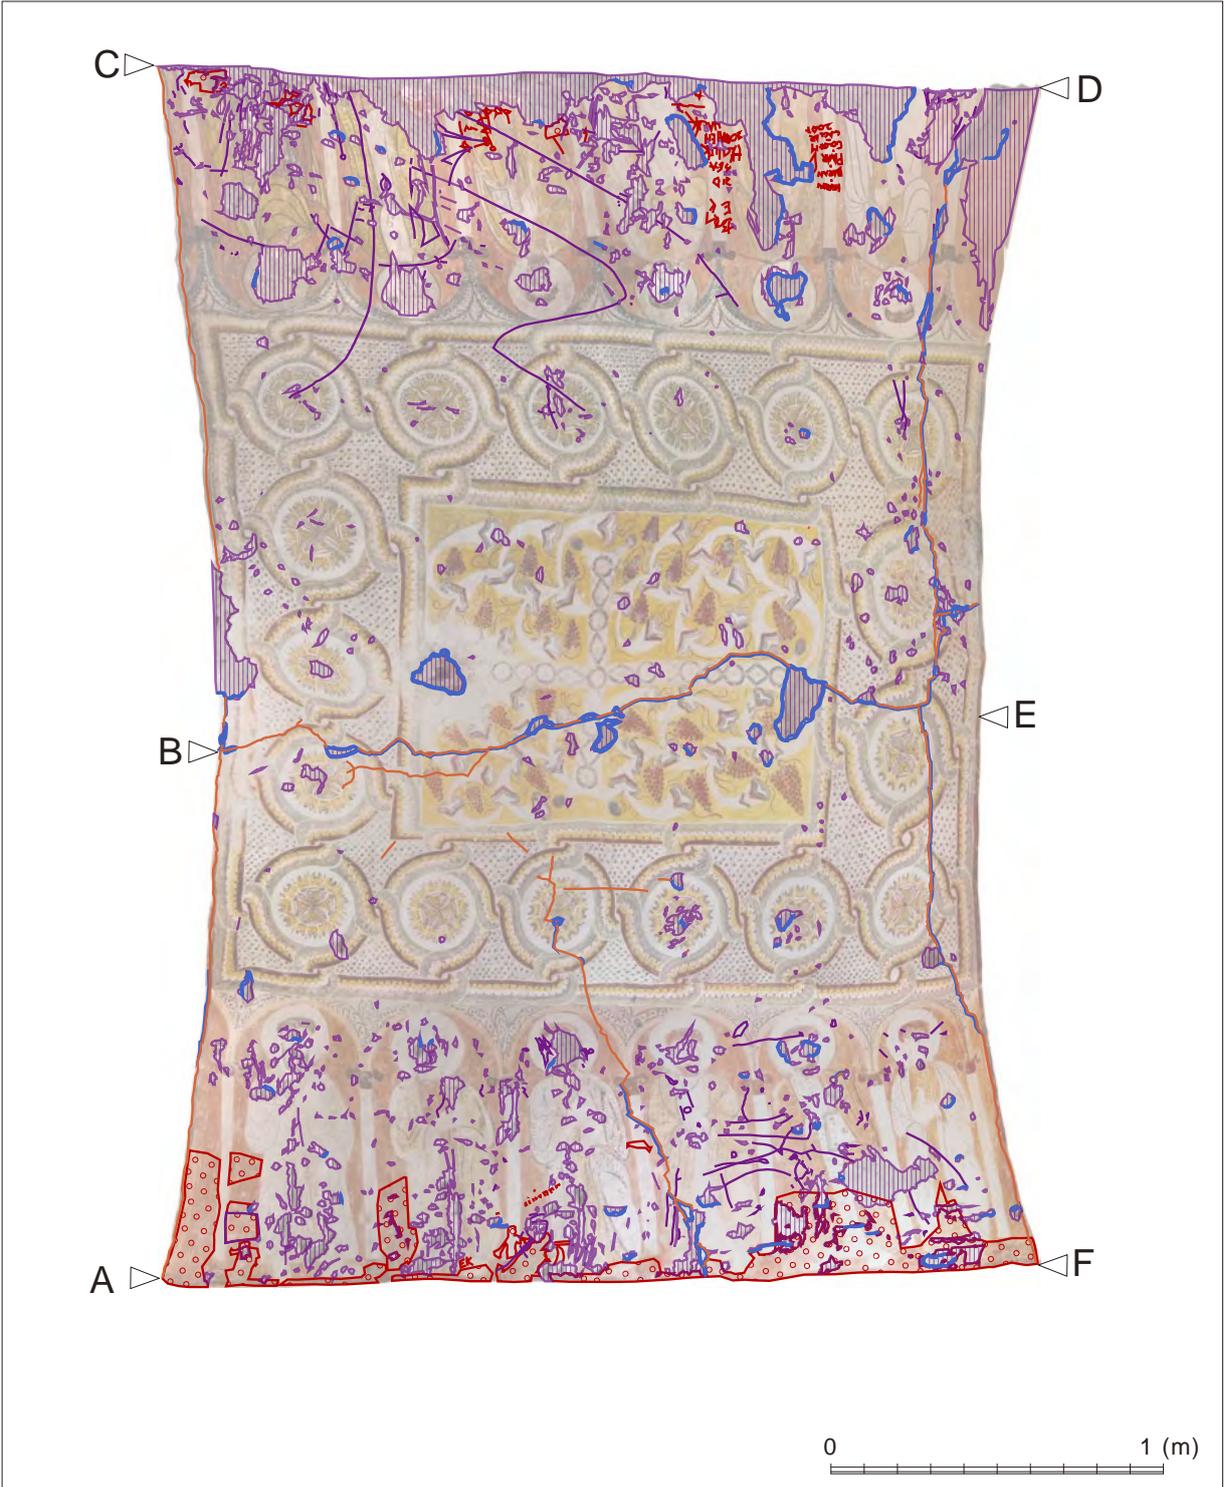
Church Name (Turkish)	
Üzümlü Kilise	
Church Name (English)	
Chapel of Niketas the Stylite	
Location	
Ceiling of Chamber 2	
Subject	
Mural condition map	
Scale	Category
1/20	B
Plate No.	
Plate028 UZM-C <sub>2</sub> -003

**LEGEND** B: Plaster Deterioration

- ○ ○ ○ Incised Graffiti
- Detachment of Lower Layer
- Mechanical Damage
- Cracking
- Holes

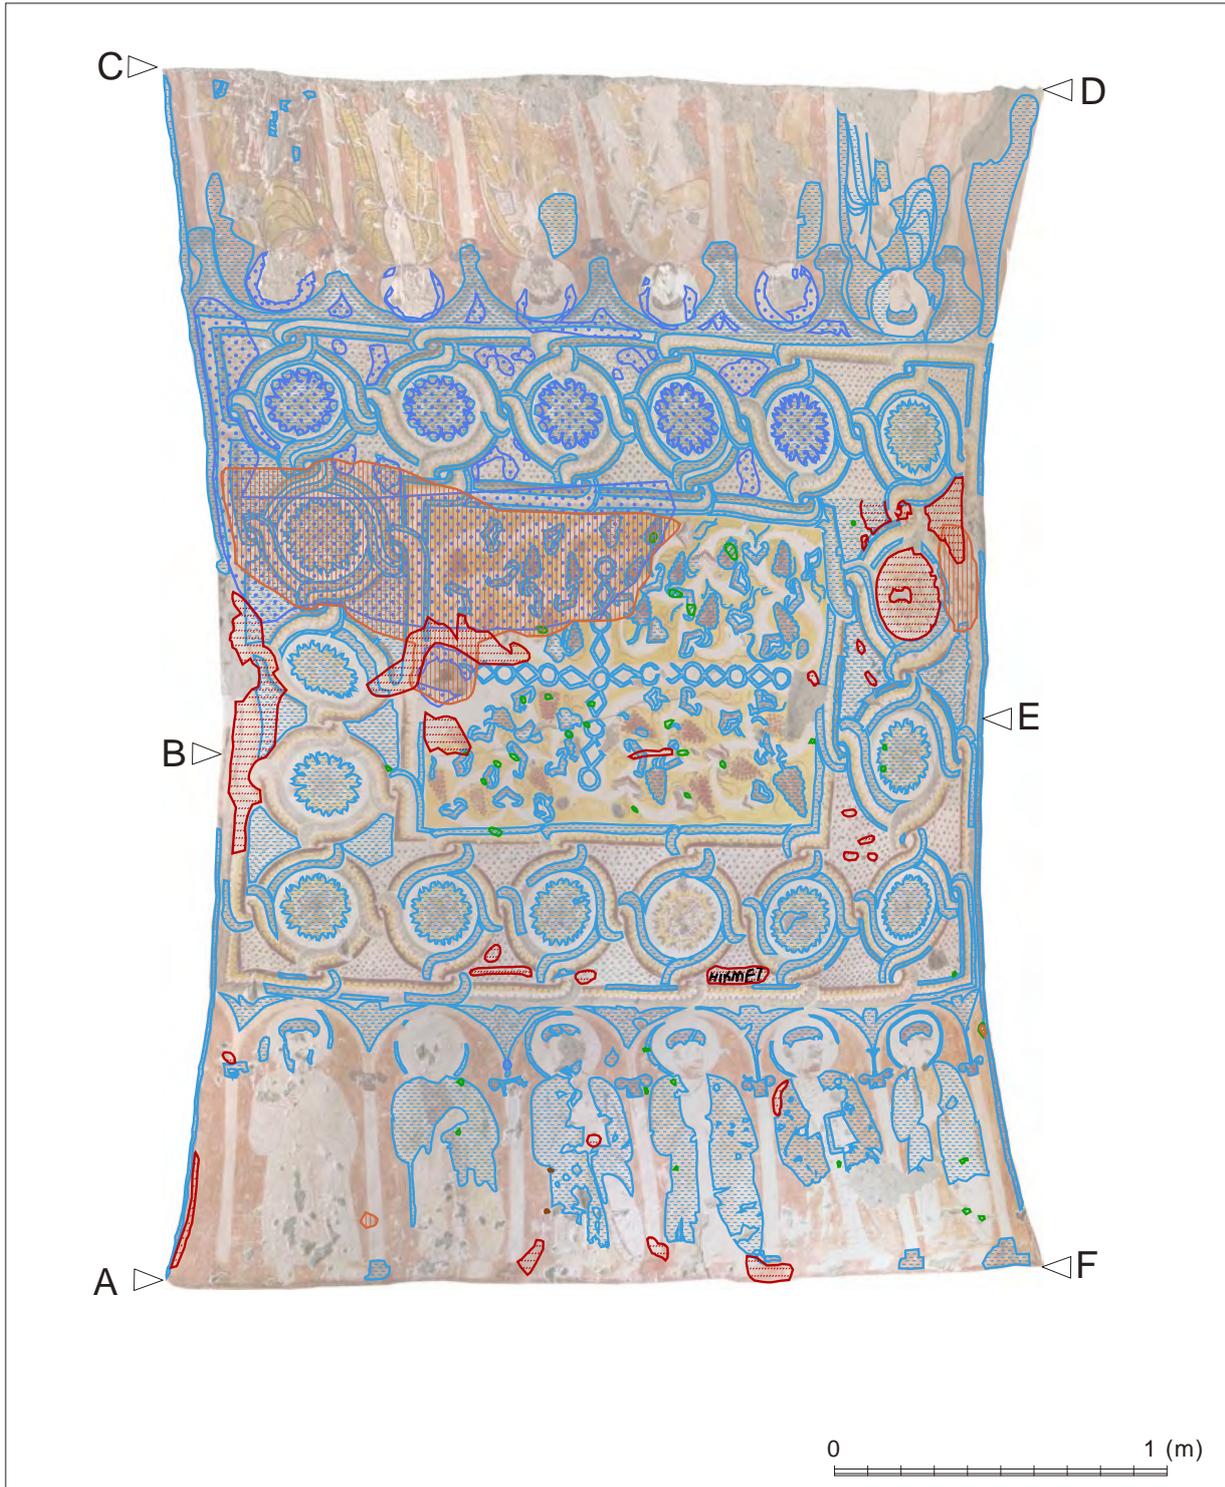
Ceiling		LEGEND		Church Name (Turkish)	
		Smearing		Üzümlü Kilise	
		Dark Grey Veil		Church Name (English)	
		Grey Spotting		Chapel of Niketas the Stylite	
		Biological Deposition		Location	
		Nail		Ceiling of Chamber 2	
		Paint Loss due to Biological Activity		Subject	
		Original Fixing		Mural condition map	
		Superficial Graffiti		Scale	
				Category	
				1/20	
			C		
			Plate No.		
			Plate029 UZM-C <sub>2</sub> -004

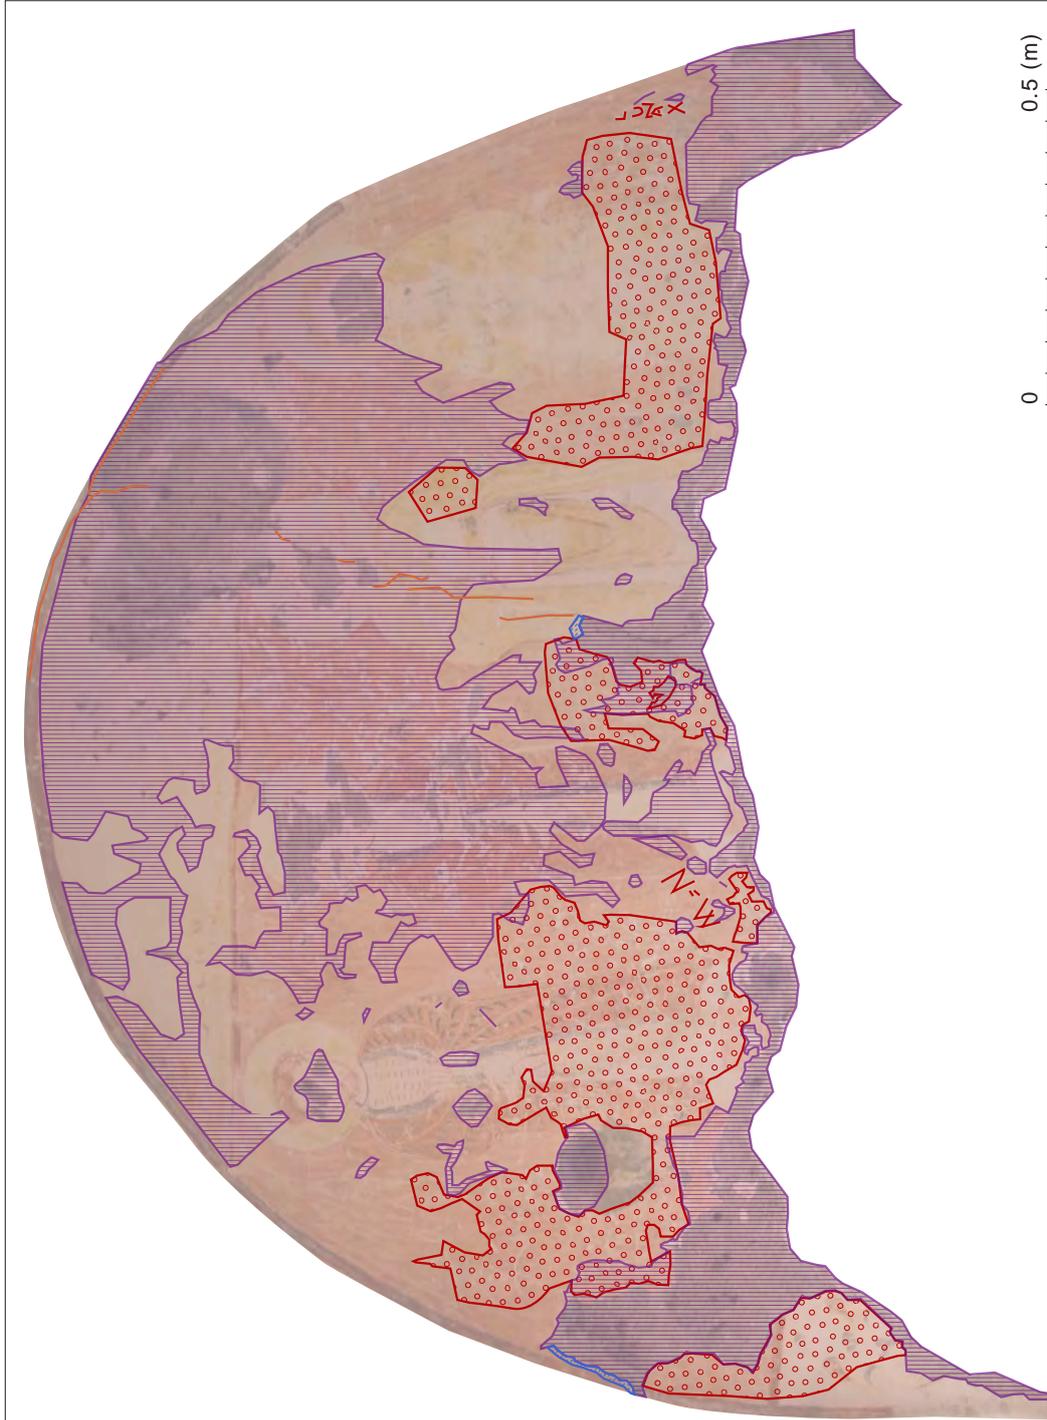
Holes		<b>Subject</b> Mural condition map
<b>Church Name (Turkish)</b> Üzümlü Kilise	<b>Scale</b> 1/10	<b>Category</b> B
<b>Church Name (English)</b> Chapel of Niketas the Stylite	<b>Plate No.</b> Plate036	<b>Uzm No.</b> UZM-C <sub>2</sub> -011
<b>Location</b> West Wall of Chamber 2

<b>LEGEND</b> B: Plaster Deterioration

Mechanical Damage

Cracking

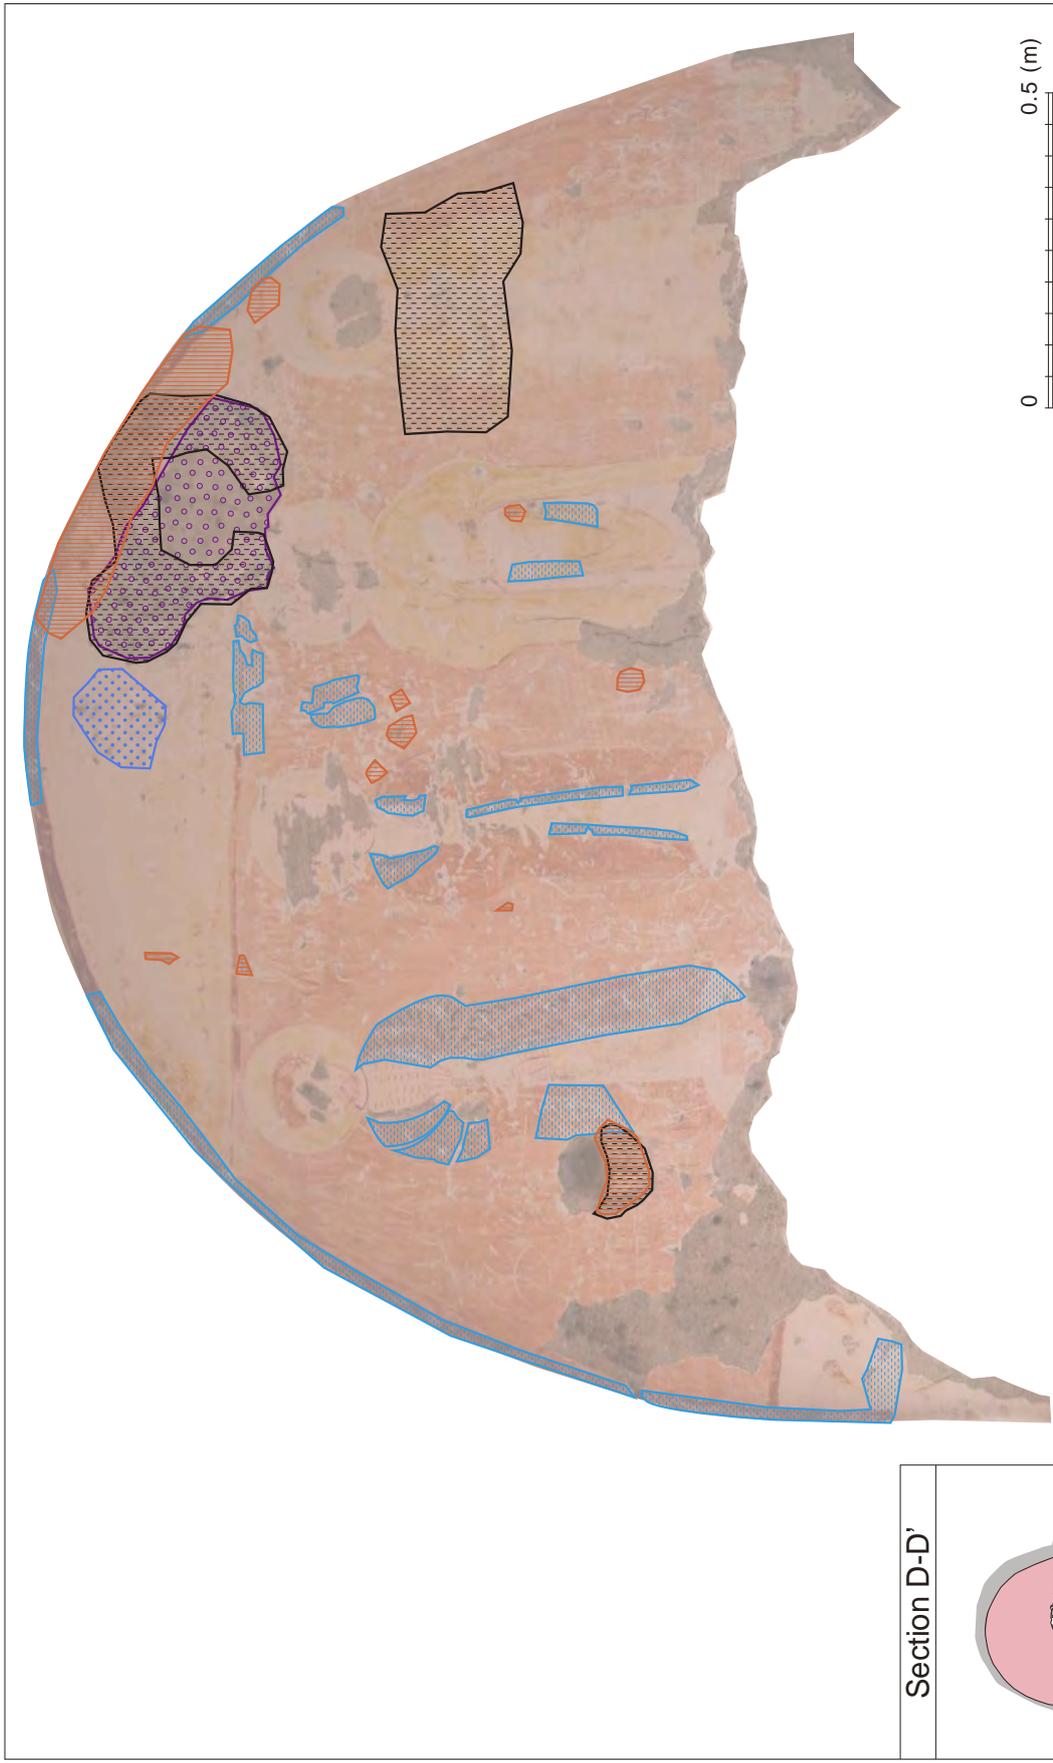
<b>LEGEND</b> C: Paint Deterioration		<b>Subject</b>	
	Micro Losses	<b>Uzümlü Kilise</b>	<b>Mural condition map</b>
	Biological Deposition	<b>Chapel of Niketas the Stylite</b>	Scale
	Grey Spotting	Location	Category
			1/10
			C
			Plate No.
		West Wall of Chamber 2	Plate037 UZM-C-012

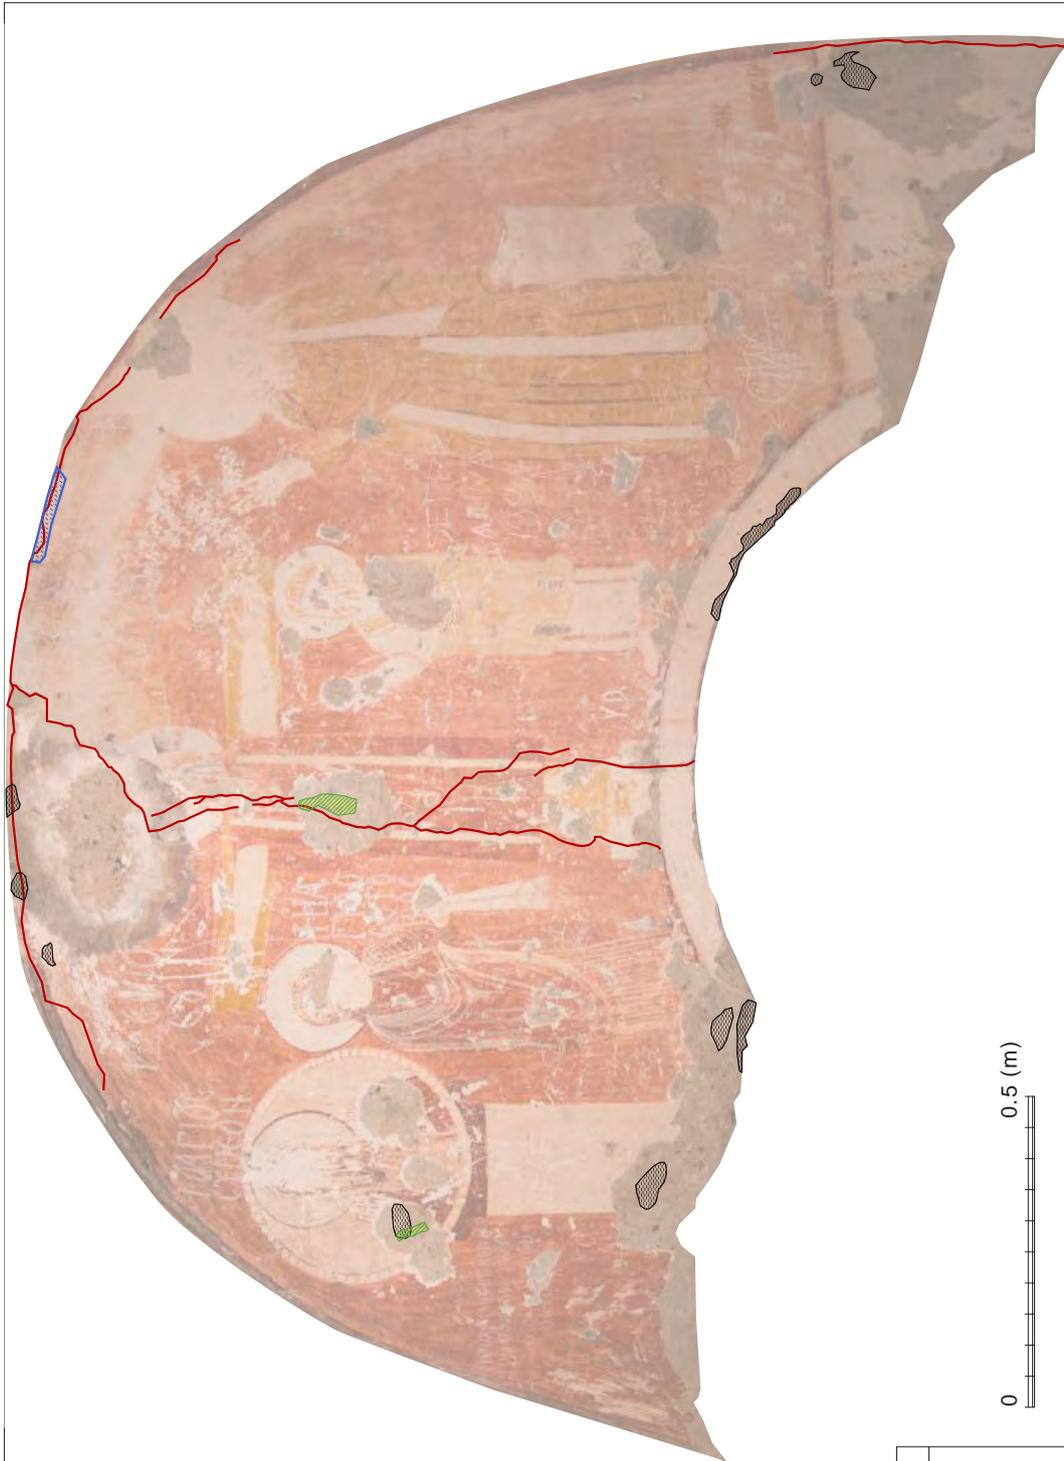
<b>LEGEND</b> A: Rock Deterioration		<b>Subject</b>	
Rock Deterioration	Deposition of Dark Material	Biologic Activity	Church Name (Turkish) <b>Üzümlü Kilise</b>
Spalling	Structural Cracks	Structural Cracks	Church Name (English) <b>Chapel of Niketas the Stylite</b>
			Scale 1/10
			Category A
			Plate No. Plate039 UZM-C2-014
			Location East Wall of Chamber 2

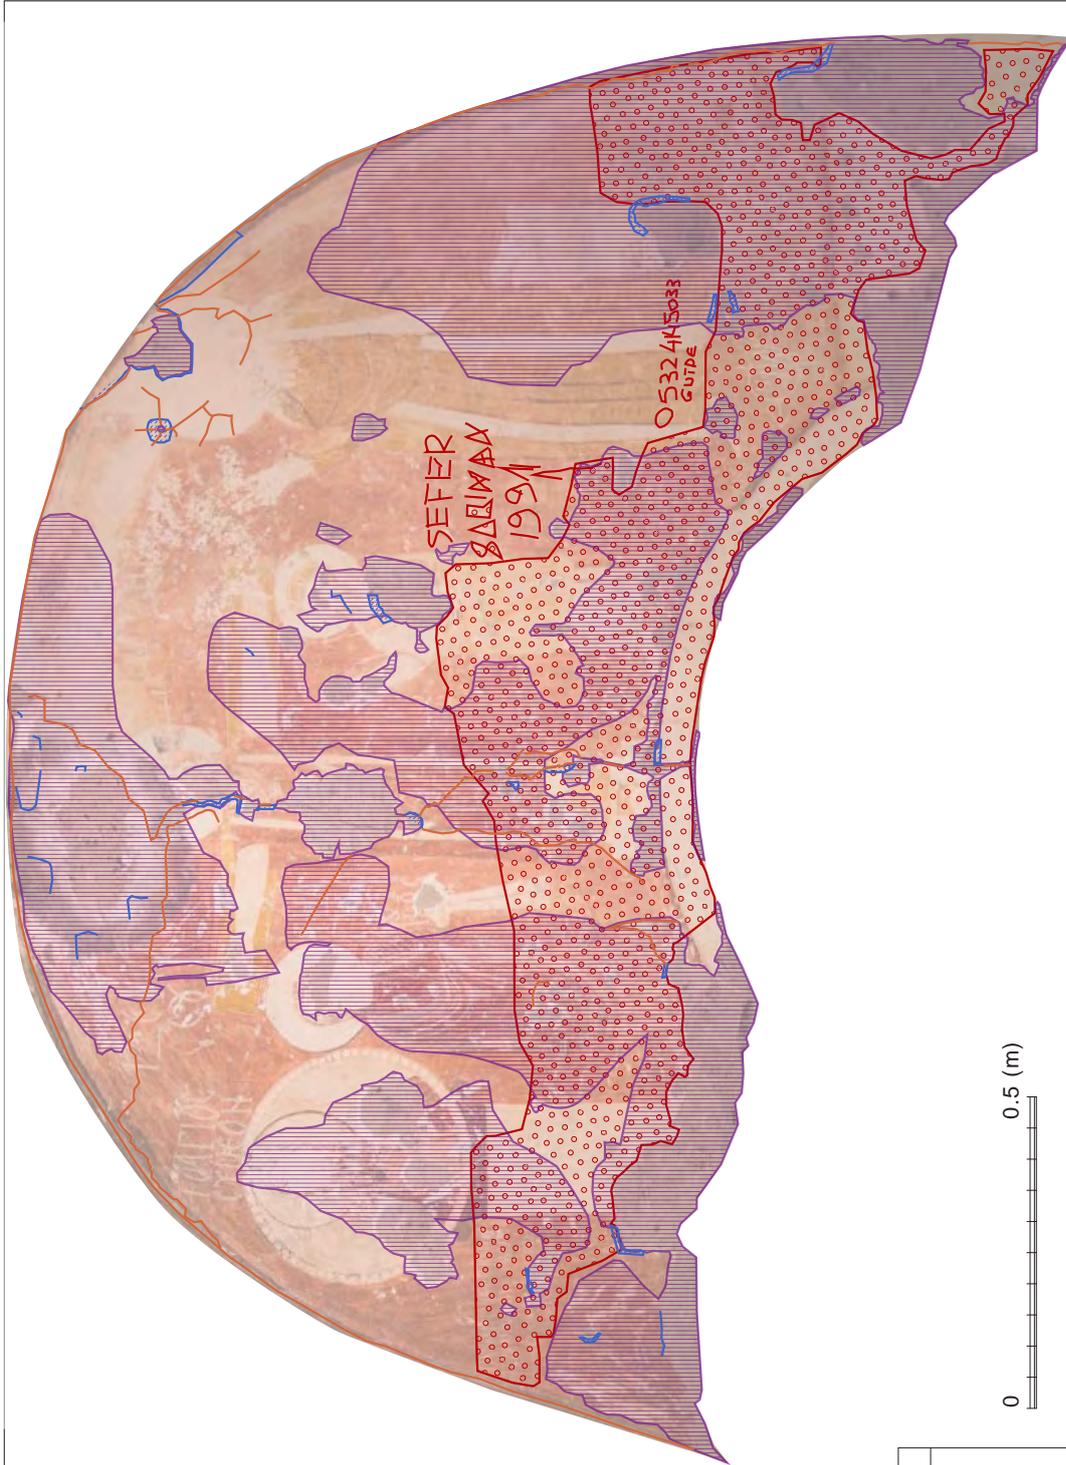
Church Name (Turkish)	Üzümlü Kilise	Subject	Mural condition map
Church Name (English)	Chapel of Niketas the Stylite	Scale	1/10
Location	East Wall of Chamber 2	Plate No.	Plate040 UZM-C <sub>2</sub> -015
		Category	B

LEGEND B: Plaster Deterioration

Mechanical Damage

Cracking

Holes

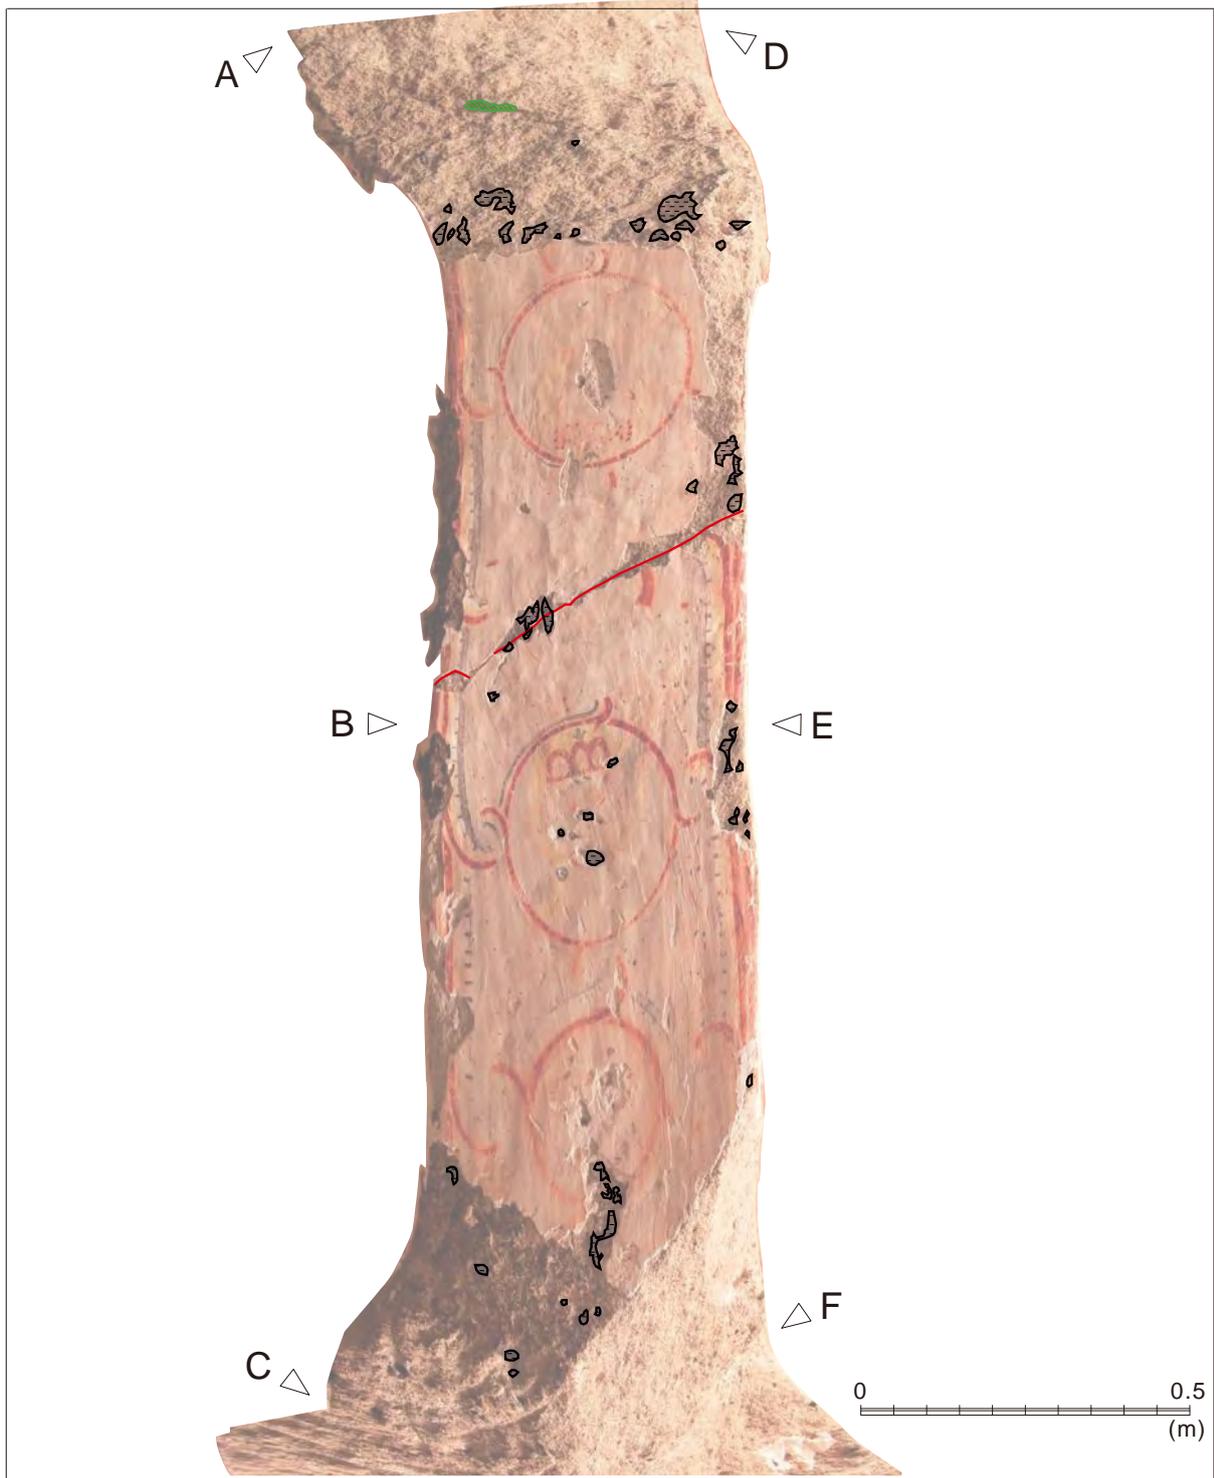
<p><b>Ceiling</b></p>	<p><b>LEGEND</b> A: Rock Deterioration</p>	<p>Church Name (Turkish)</p>
	<p>  Deposition of Dark Material   Spalling   Structural Cracks         </p>	<p>Üzümlü Kilise</p>
		<p>Church Name (English)</p>
		<p>Chapel of Niketas the Stylite</p>
		<p>Location</p>
		<p>Transverse Arch between 2-3</p>
		<p>Subject</p>
		<p>Mural condition map</p>
		<p>Scale</p>
		<p>Category</p>
		<p>1/10</p>
		<p>A</p>
		<p>Plate No.</p>
		<p>Plate043 UZM-C<sub>2</sub>-3-002</p>

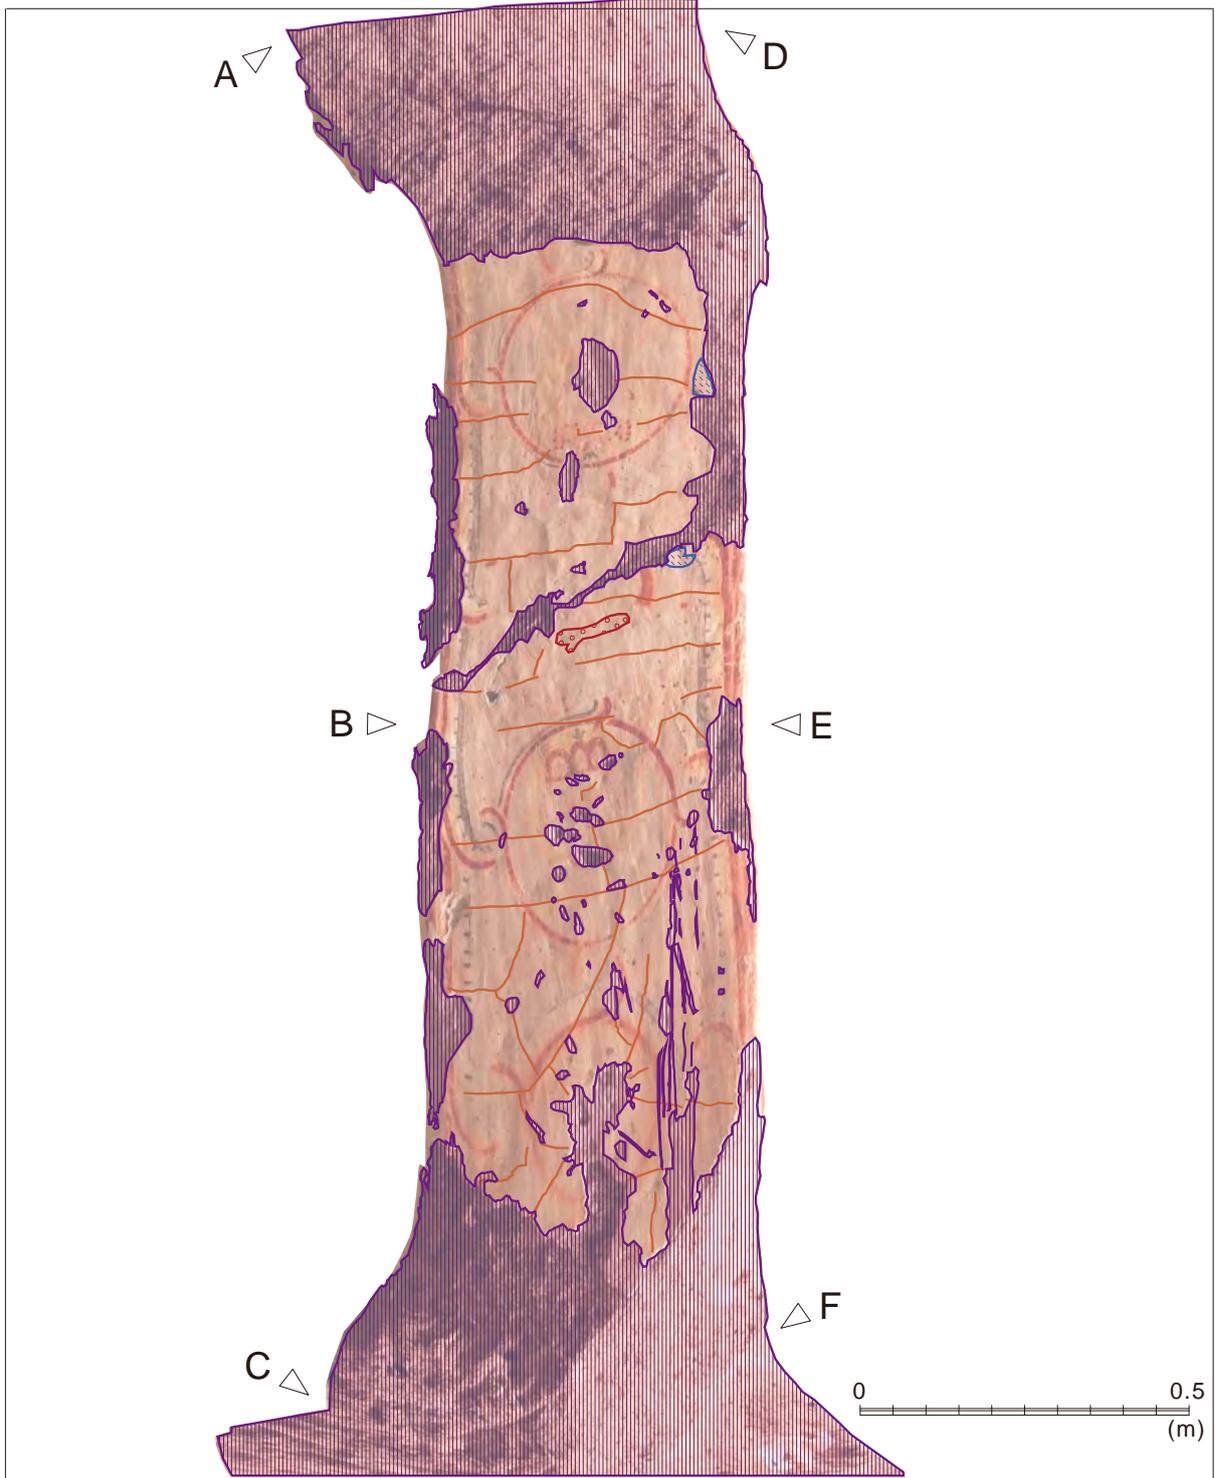
<b>Ceiling</b>		<b>LEGEND</b> B: Plaster Deterioration		Church Name (Turkish)	
		Incised Graffiti		Church Name (English)	
		Detachment of Lower Layer		Üzümlü Kilise	
		Mechanical Damage		Chapel of Niketas the Stylite	
		Cracking		Location	
				Transverse Arch between 2-3	
				Subject	
				Mural condition map	
				Scale	Category
				1/10	B
				Plate No.	
				Plate044 UZM-C <sub>2.3</sub> -003

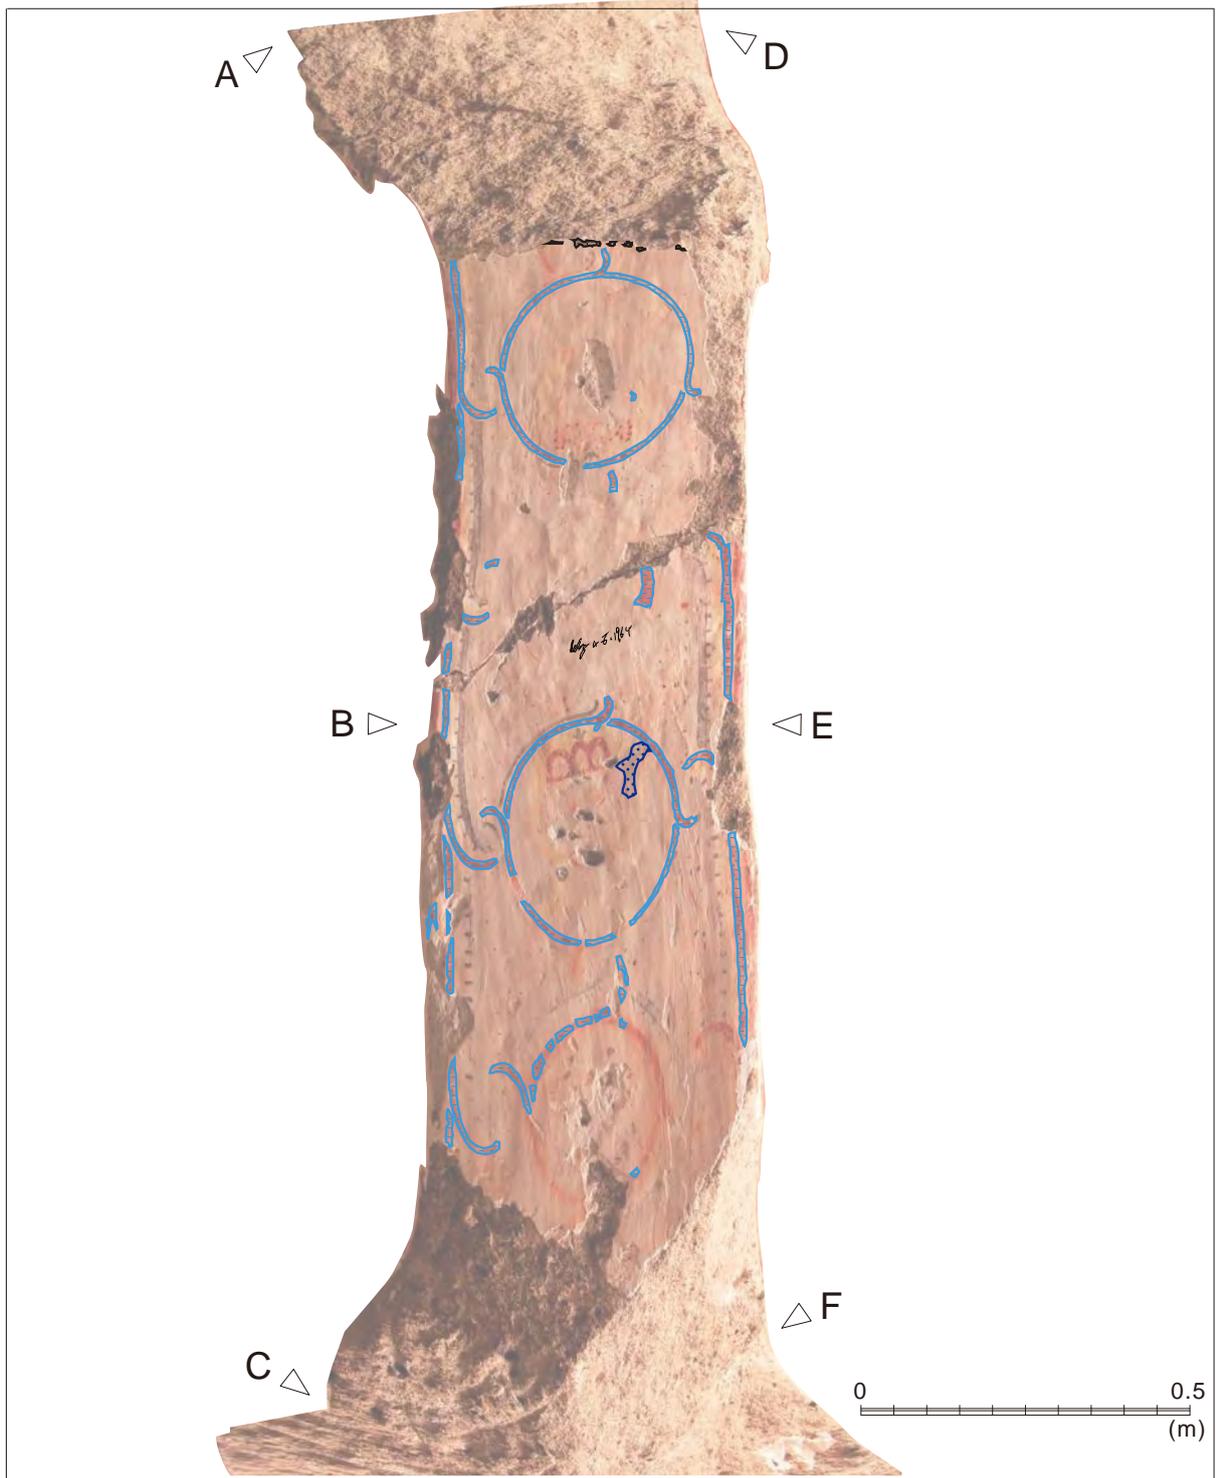
<b>Ceiling</b>	<b>LEGEND</b> C: Paint Deterioration	Church Name (Turkish)	
	<ul style="list-style-type: none"> <li> Micro Losses</li> <li> Dark Grey Veil</li> <li> Grey Spotting</li> <li> Superficial Graffiti</li> </ul>	Üzümlü Kilise	
		Church Name (English)	
		Chapel of Niketas the Stylite	
		Location	
		Transverse Arch between 2-3	
		Subject	
		Mural condition map	
		Scale	Category
		1/10	C
		Plate No.	
		Plate045 UZM-C <sub>2</sub> -3-004

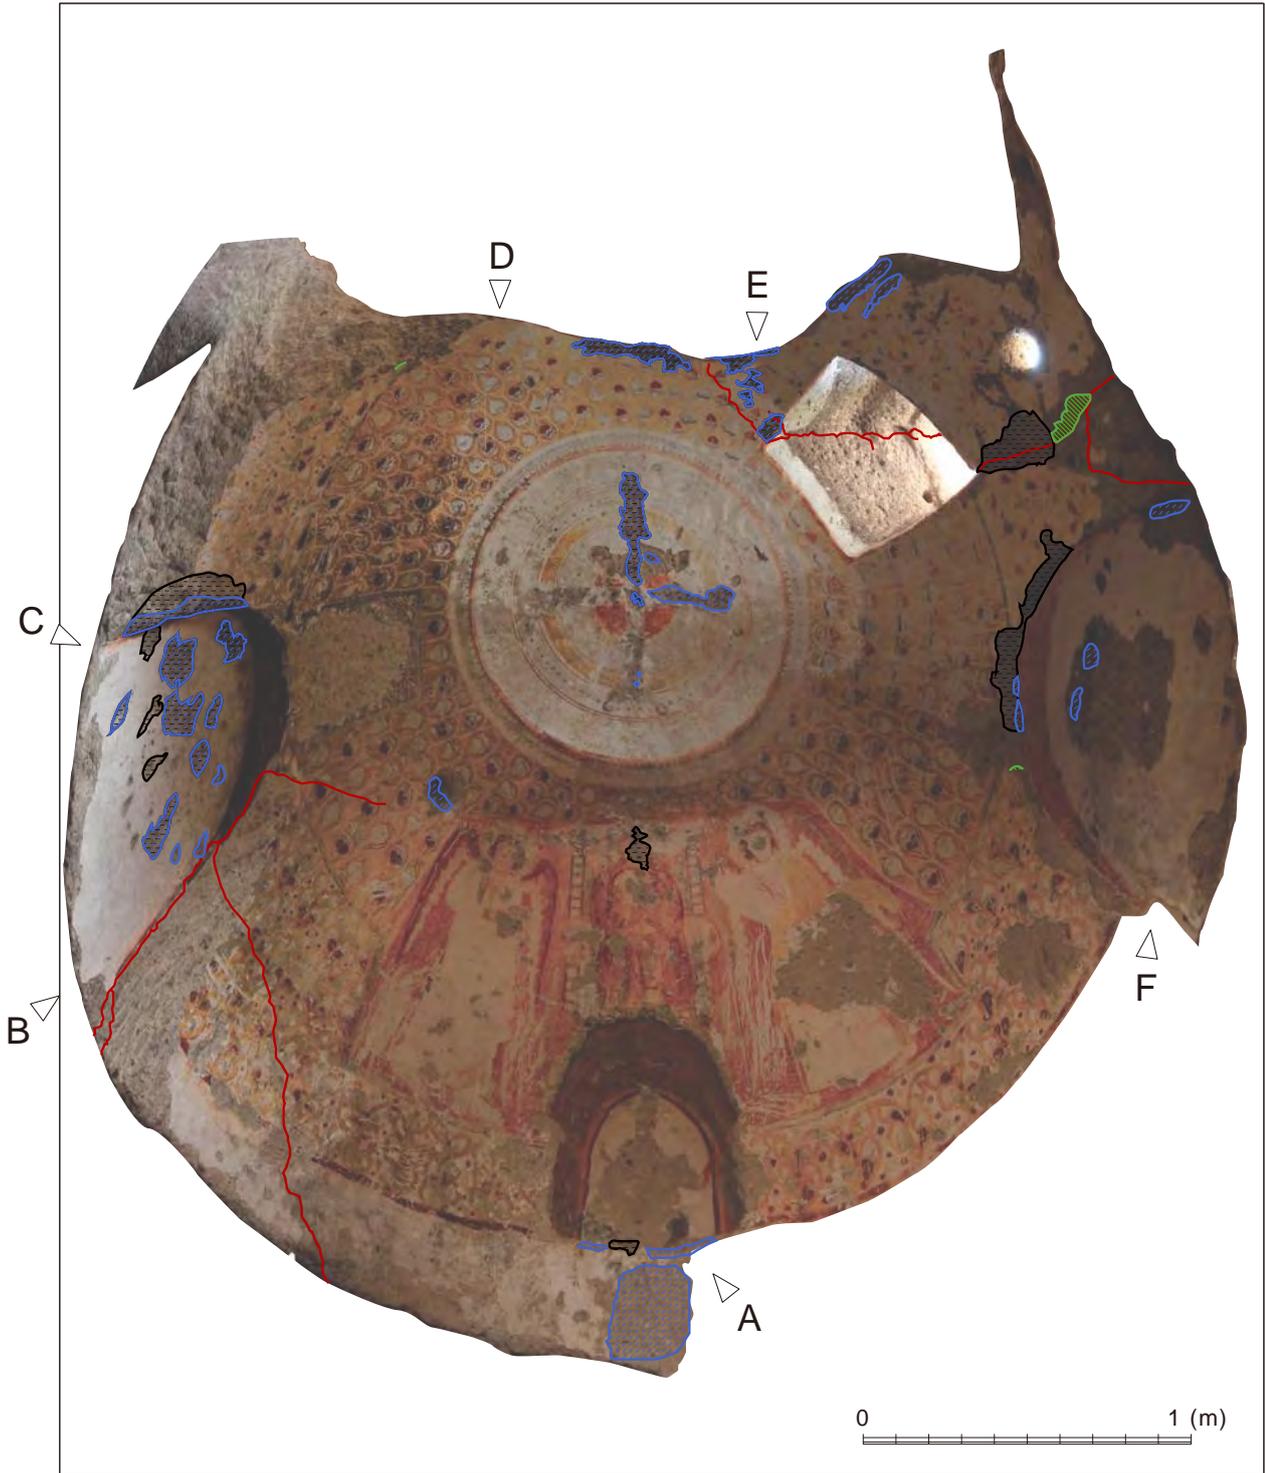
<p><b>Ceiling</b></p>		<p><b>LEGEND</b> A: Rock Deterioration</p> <ul style="list-style-type: none"> <li> Deposition of Dark Material</li> <li> Biologic Activity</li> <li> Spalling</li> <li> Structural Cracks</li> </ul>	Church Name (Turkish)
			Üzümlü Kilise
		Church Name (English)	
		Chapel of Niketas the Stylite	
		Location	
		Ceiling of Chamber 3	
		Subject	
		Mural condition map	
		Scale	
		1/20	
		Category	
		A	
		Plate No.	
		Plate047 UZM-C <sub>3</sub> -002
