# Scientific Studies on Conservation for Üzümlü Church and its wall paintings in Cappadocia, Turkey

**Vol. 2 (Report on the activities in 2015-2016)**

University of Tsukuba  
2017

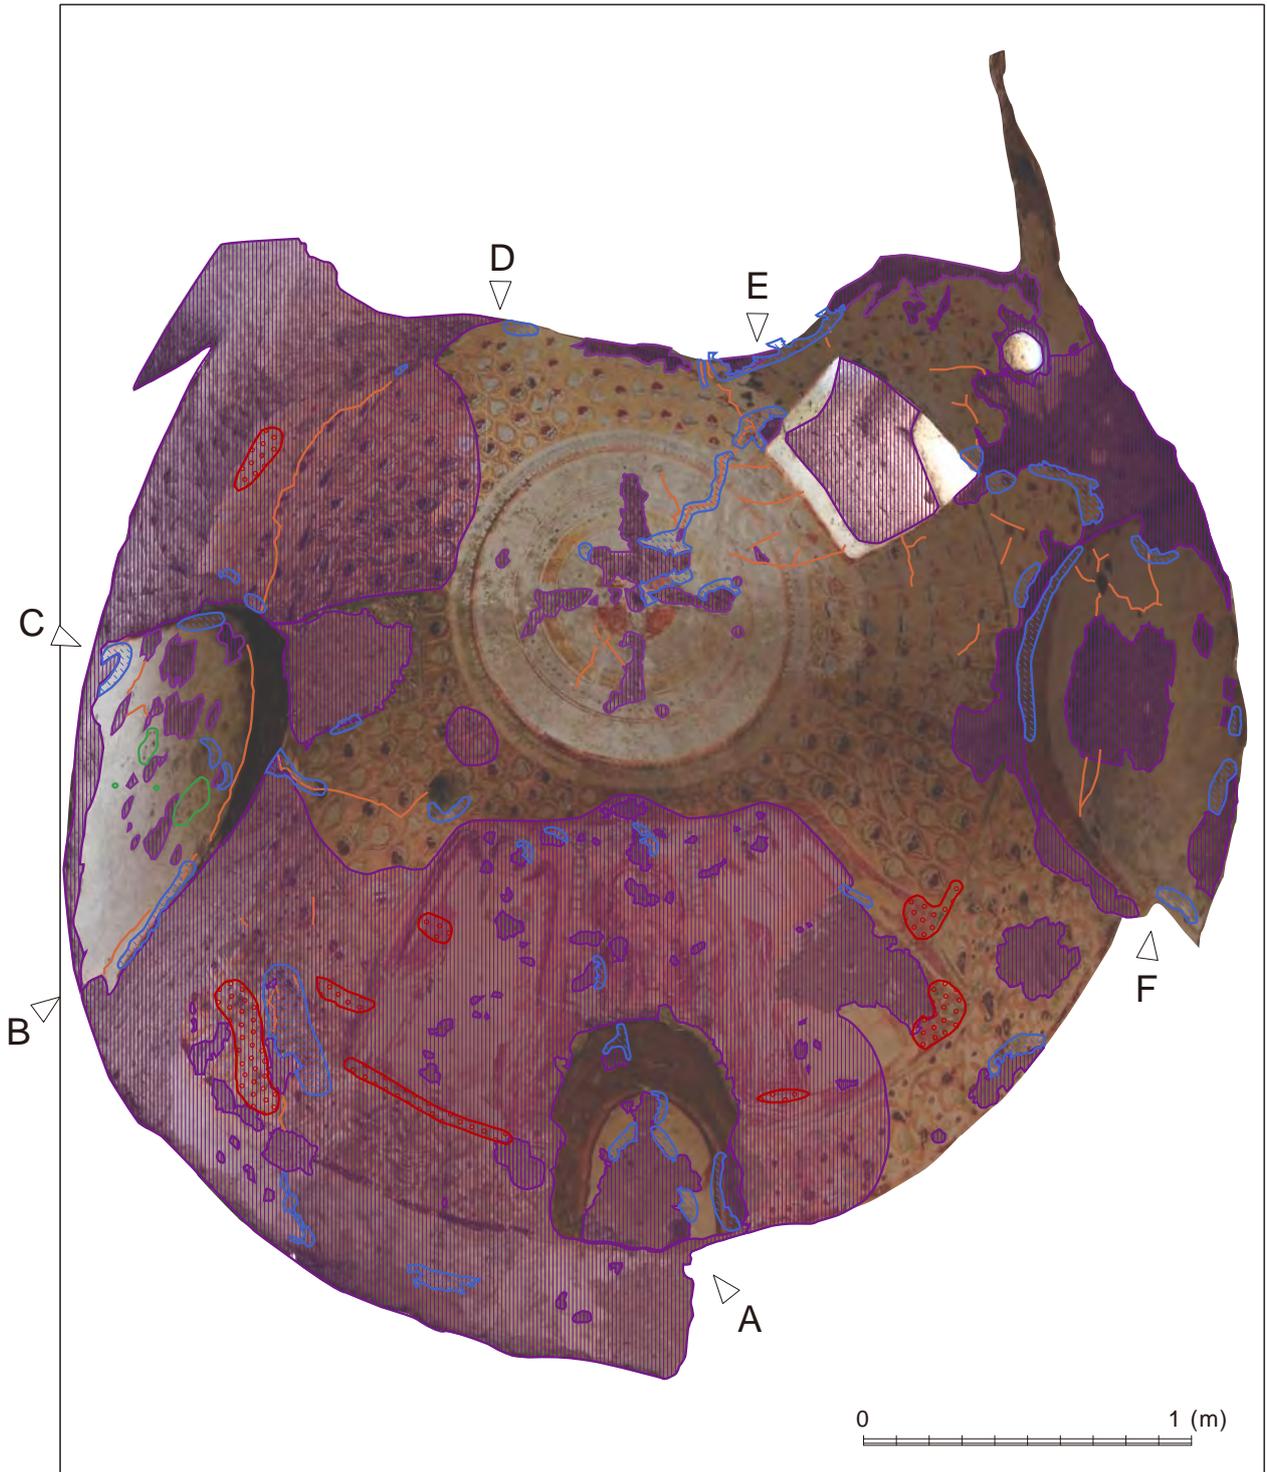
**LEGEND** B: Plaster Deterioration

- Incised Graffiti
- Detachment of Lower Layer
- Mechanical Damage
- Cracking
- Holes

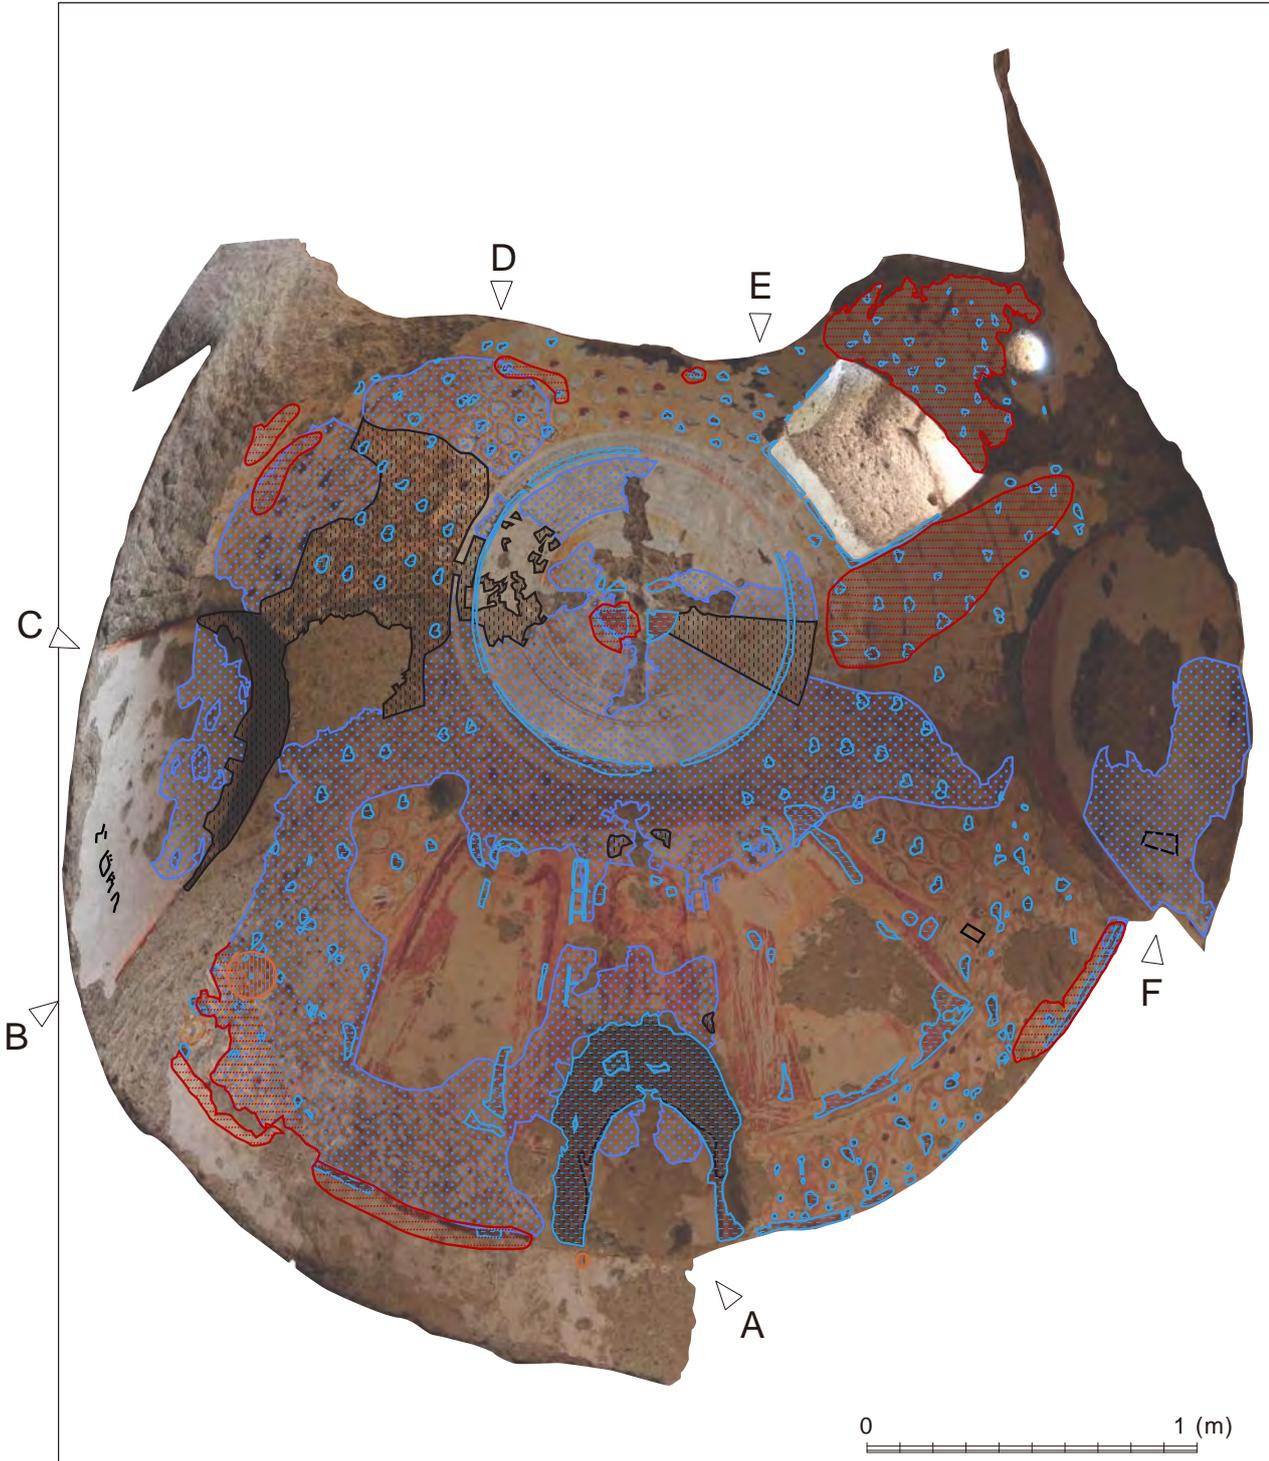
<p><b>Ceiling</b></p>	<p><b>LEGEND</b> C: Paint Deterioration</p> <table border="0"> <tr> <td></td> <td>Smearing</td> <td></td> <td>Micro Losses</td> </tr> <tr> <td></td> <td>Biological Deposition</td> <td></td> <td>Grey Spotting</td> </tr> <tr> <td></td> <td>Superficial Graffiti</td> <td></td> <td>Dark Grey Veil</td> </tr> </table>		Smearing		Micro Losses		Biological Deposition		Grey Spotting		Superficial Graffiti		Dark Grey Veil	<p>Church Name (Turkish)</p> <p>Üzümlü Kilise</p> <p>Church Name (English)</p> <p>Chapel of Niketas the Stylite</p> <p>Location</p> <p>Ceiling of Chamber 3</p> <p>Subject</p> <p>Mural condition map</p> <table border="1"> <tr> <td>Scale</td> <td>Category</td> </tr> <tr> <td>1/20</td> <td>C</td> </tr> </table> <p>Plate No.</p> <p>Plate049 UZM-C<sub>3</sub>-004</p>	Scale	Category	1/20	C
			Smearing		Micro Losses													
	Biological Deposition		Grey Spotting

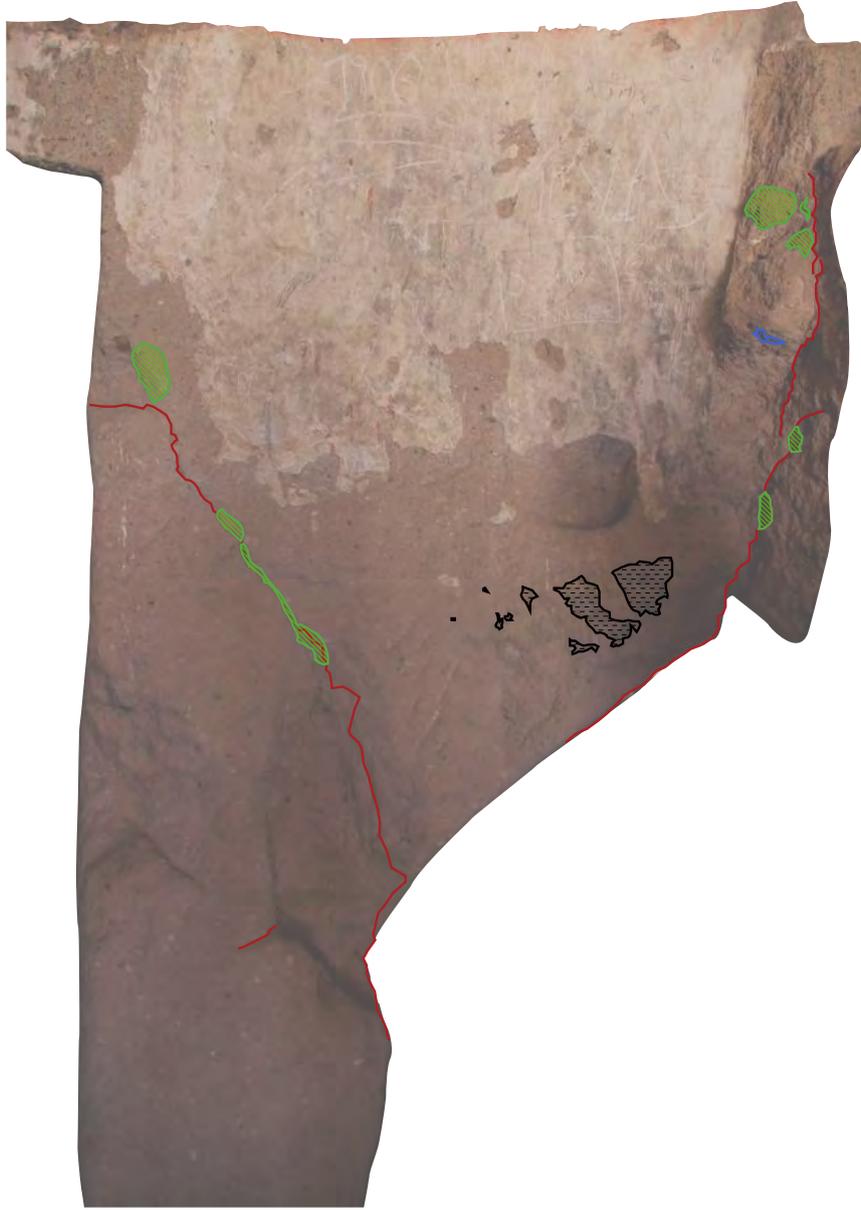
LEGEND A: Rock Deterioration

Spalling
-

Structural Cracks

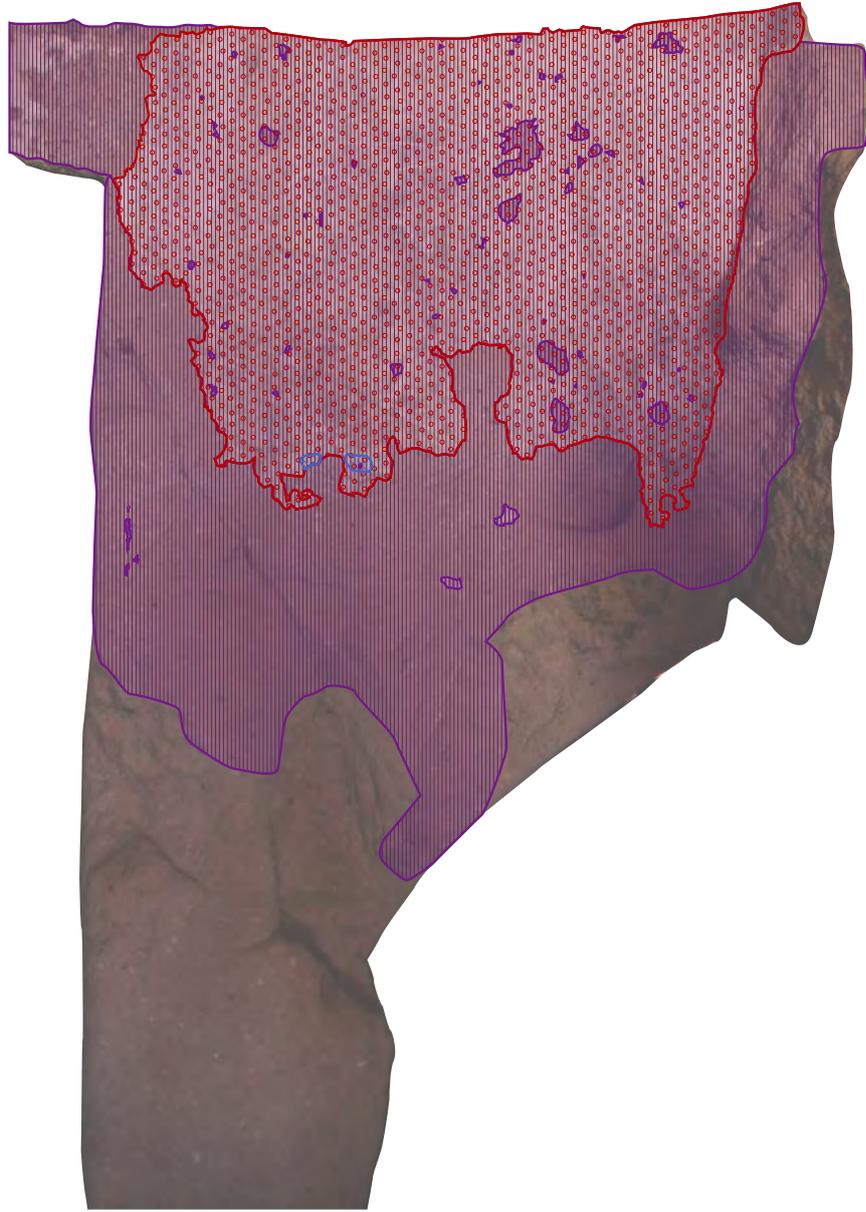
<p><b>Section A-A'</b></p>	<p><b>LEGEND</b> B: Plaster Deterioration</p> <ul style="list-style-type: none"> <li> Incised Graffiti</li> <li> Detachment of Lower Layer</li> <li> Mechanical Damage</li> </ul>	Church Name (Turkish)
		Üzümlü Kilise
		Church Name (English)
		Chapel of Niketas the Stylite
		Location
		South East Wall of Chamber 3
		Subject
		Mural condition map
		Scale
		Category
		1/10
		B
		Plate No.
		Plate052 UZM-C <sub>3</sub> -007

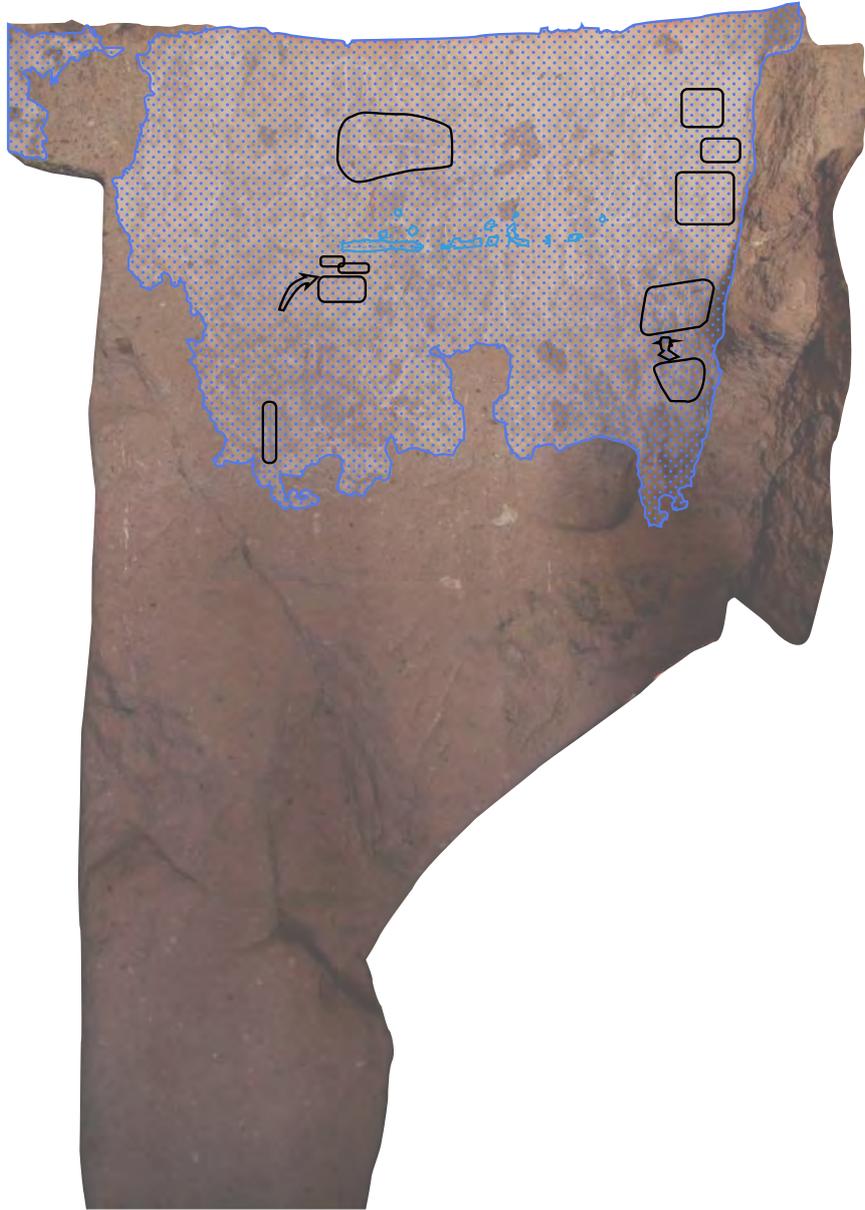
LEGEND C: Paint Deterioration
