Scientific Studies on Conservation for Üzümlü Church and its wall paintings in Cappadocia, Turkey

Vol. 1 : Annual report on the activities in 2014

**University of Tsukuba
2014**

Yoko Taniguchi, University of Tsukuba

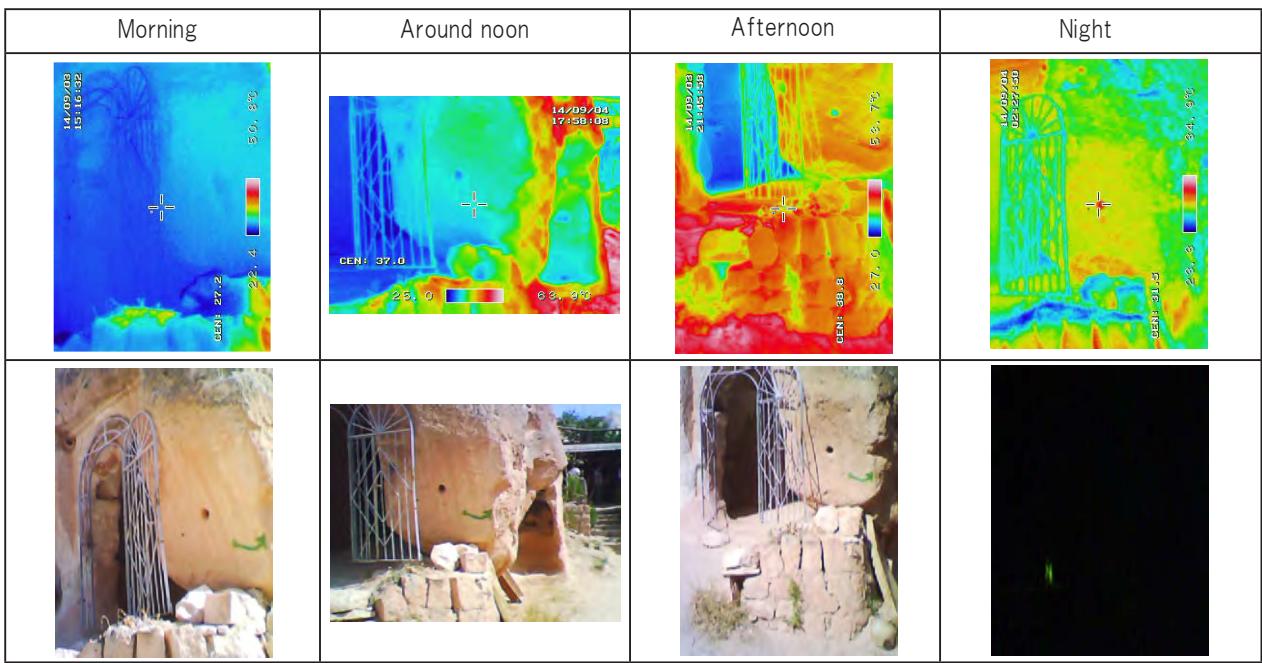
Figure 7. Thermography of the entrance (southwest side)

Saha araştırması sırasında, sabah (9:00), öğle, öğleden sonra (15:30) ve gece (20:00) termografi çekildi. Bu fotoğraflardan bazıları Şekil 7, 8 ve 9'da gösterilmektedir. Gölgedeki sıcaklık dış ortam sıcaklığıyla neredeyse aynı kalırken, kilisenin güneşli tarafında yüzey sıcaklığı yaklaşık 50 °C'ye yükseldi. Güneşli tarafın yüzeyinde büyük bir günlük sıcaklık farkı olduğu teyit edildi.

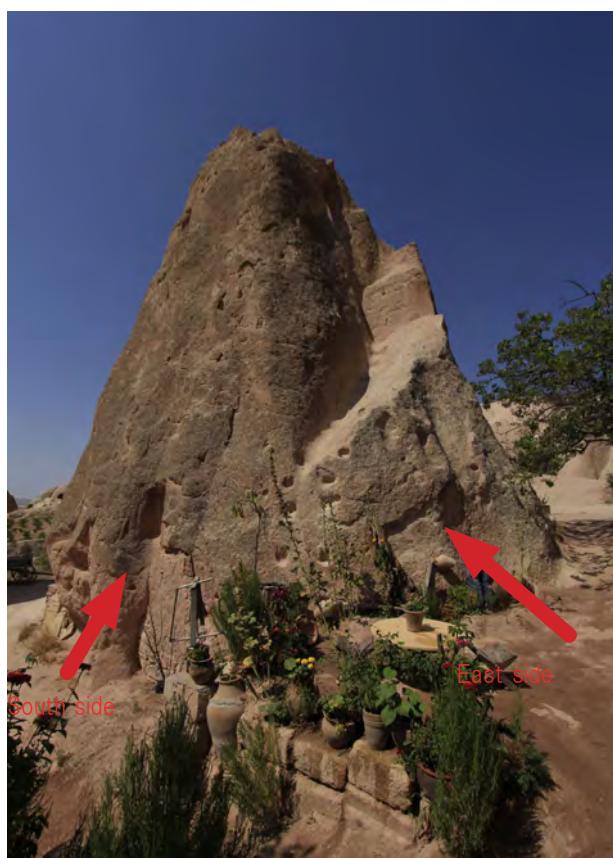
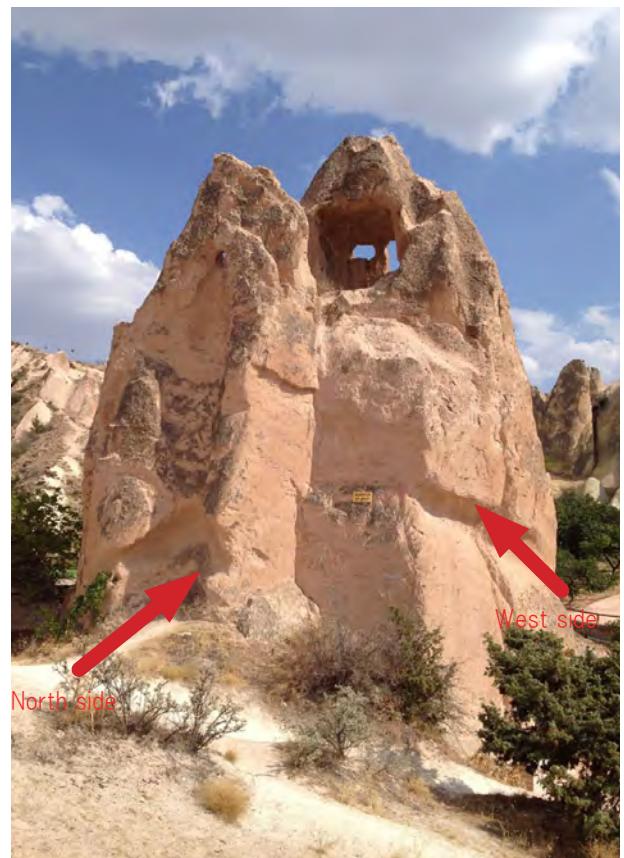
Figure 3. each side conditions of the church

As a result, we confirmed that the north side was higher and the west side was lower in intensity than the other sides. However, each side was highly variable in intensity. Because the test points were chosen randomly, it was not possible to grasp the influence of the gravel particles inside the foundation, tuff rock. It was not clear which side suffered heavier weathering conditions. In order to assess this in detail, further in-situ testing is required.

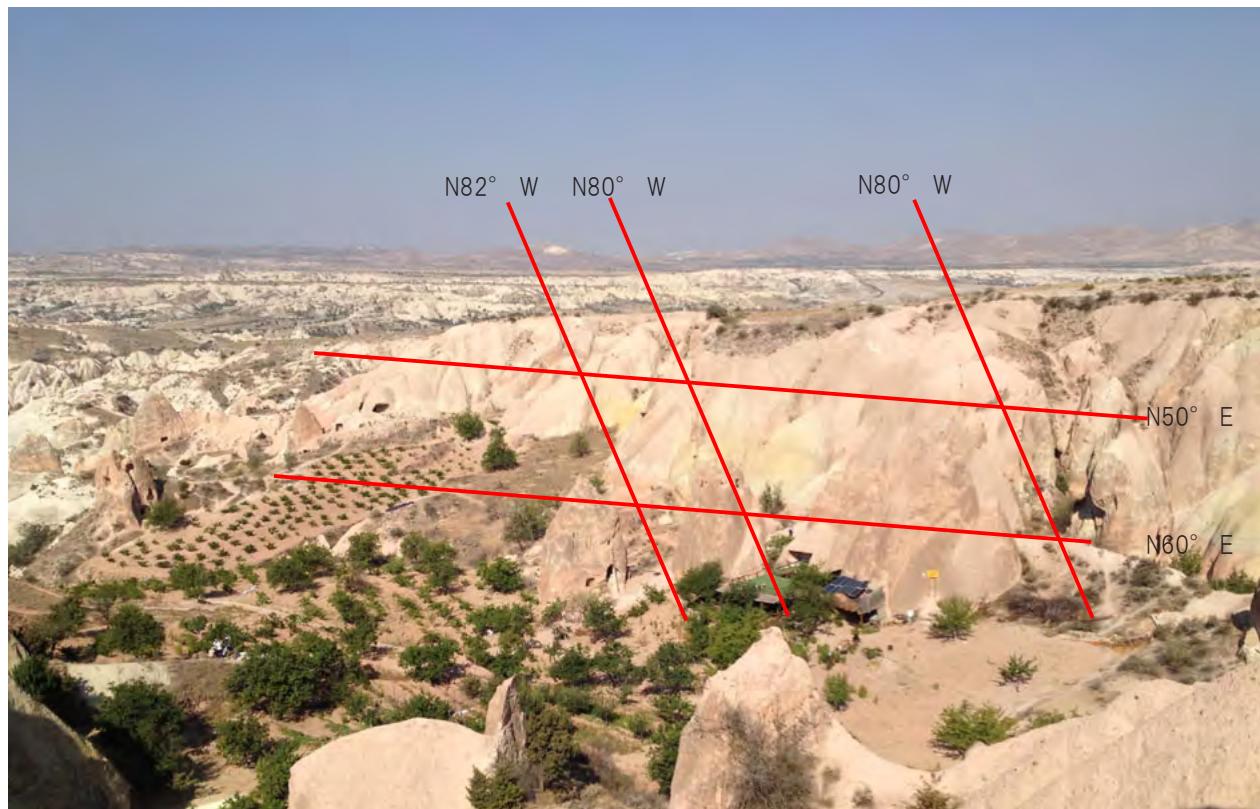
Figure 4. the lineament conditions around church

In order to study the geological environment around the Üzümlü Church, we have carried out a geological reconnaissance within the range of 1km around the church. The area is a big catchment basin, from east to west, the ground level showing a trend from high to low. Around the area, there are two representative directions of major faults, which are caused by tectonic movement. They form a network showing two sets of parallel lineaments that control the geological formation. One runs almost parallel to the riverbed in front of the church, and the other crosses the riverbed at about N80W. The faulting and jointing govern the form of the church (Fig.4, Fig.5, Fig.6). The movement of water flow was seen throughout the rock formations.

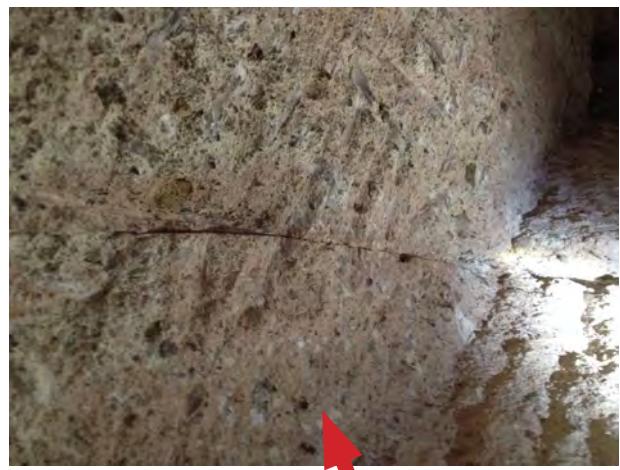
In fact, we have confirmed that a large crack passes completely through to the other side of the church's foundation, and also detected the presence of free lime crystals which formed inside the crack due to water flow.

The crack passes completely through to the other side of the church's foundation, and free lime detected inside of the crack indicates water flow.

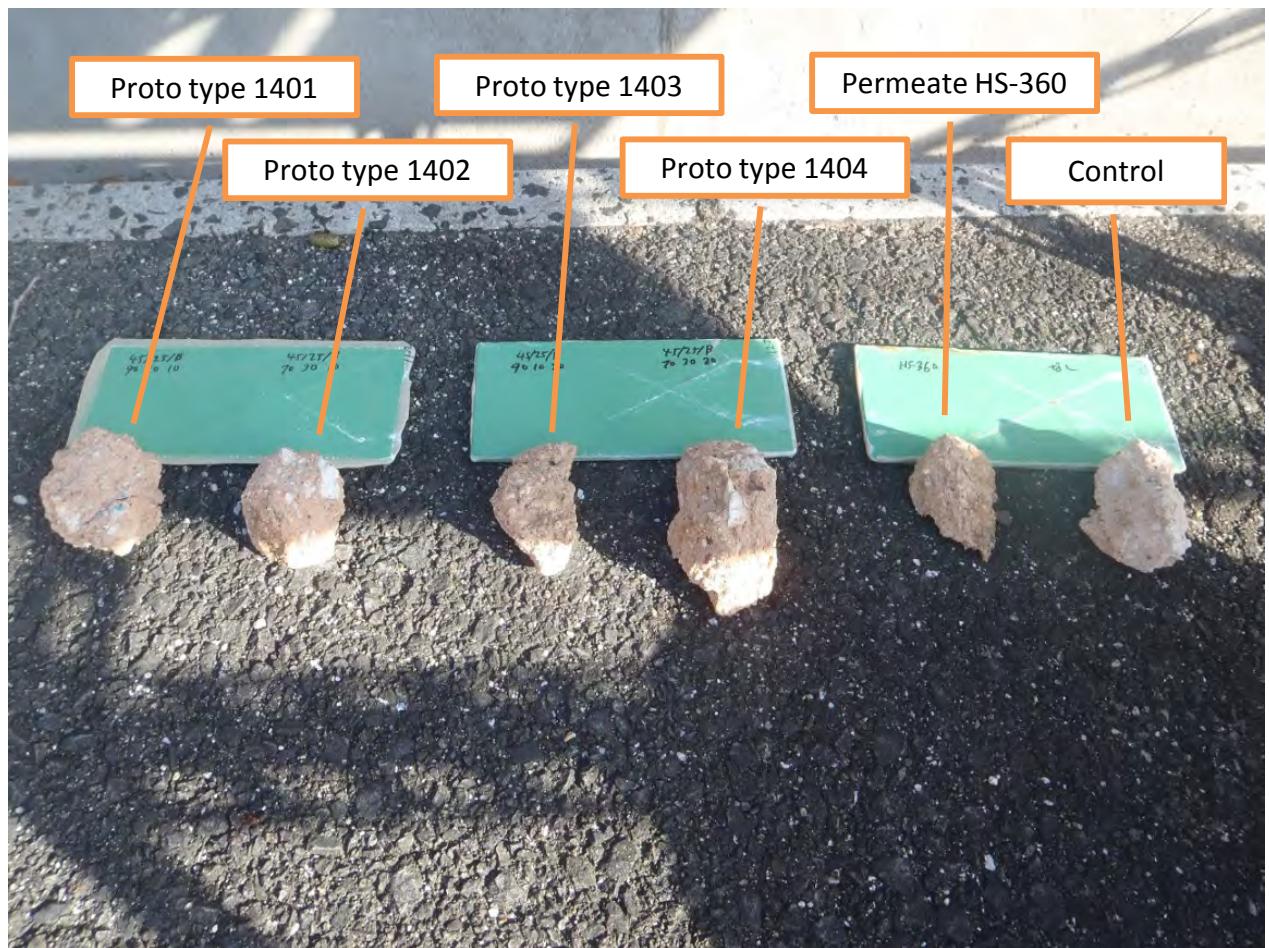
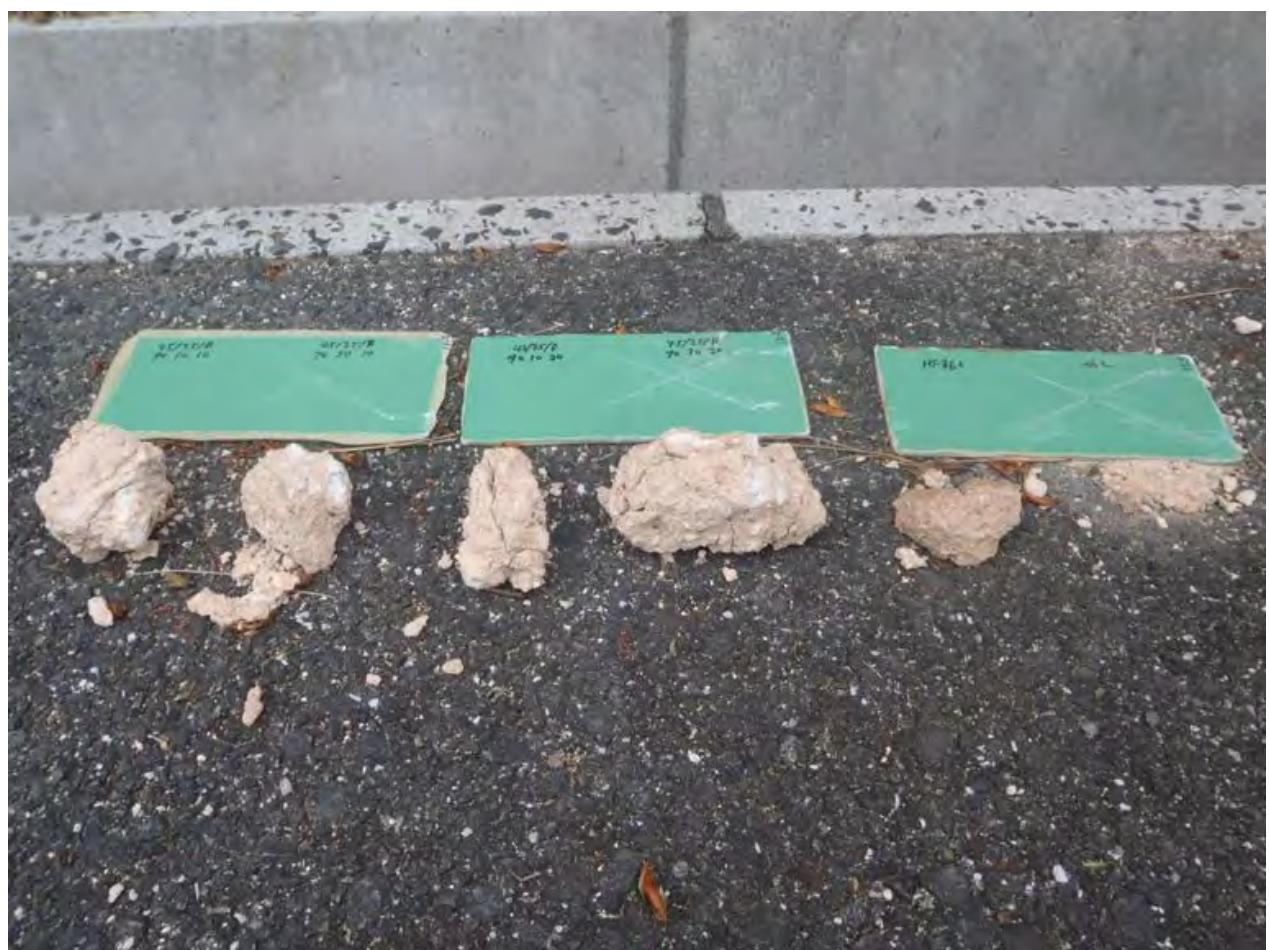
The control sample began to decay after 1 week of exposure, and after two weeks, it became fragile, and crumbled. It had deteriorated extremely quickly, and after 3 months of exposure, It had almost completely deteriorated.

The samples coated with the Permeate HS-360 prototype derivatives mostly kept their shapes, however severe cracks and surface deterioration were observed, especially at their corners.

As a preliminary test in an outdoor environment, Permeate HS-360 showed the most reasonable effect. It did not produce excess saturation after a week of exposure in conditions similar to the winter-spring weather of Cappadocia region. In such an environment, with freezing and thawing, the Permeate HS-360 treated sample showed the best durability. None of the treated samples deteriorated completely after 3 months.

Proto type 1401	Proto type 1402	Proto type 1403
Before Exposure			
2 weeks Exposure			
4 weeks Exposure			
2 months Exposure			
3 months Exposure

Proto type 1404	Permeate HS-360	Control (non treatment)
Before Exposure			
2 weeks Exposure	 Decay Crack		
4 weeks Exposure	 Decay Crack expand		
2 months Exposure	 Decay Crack expand		
3 months Exposure	 Decay Crack expand

Further tests shall be carried out with rock samples from Red Valley of Cappadocia, with redefined environmental settings to simulate actual conditions in Cappadocia.

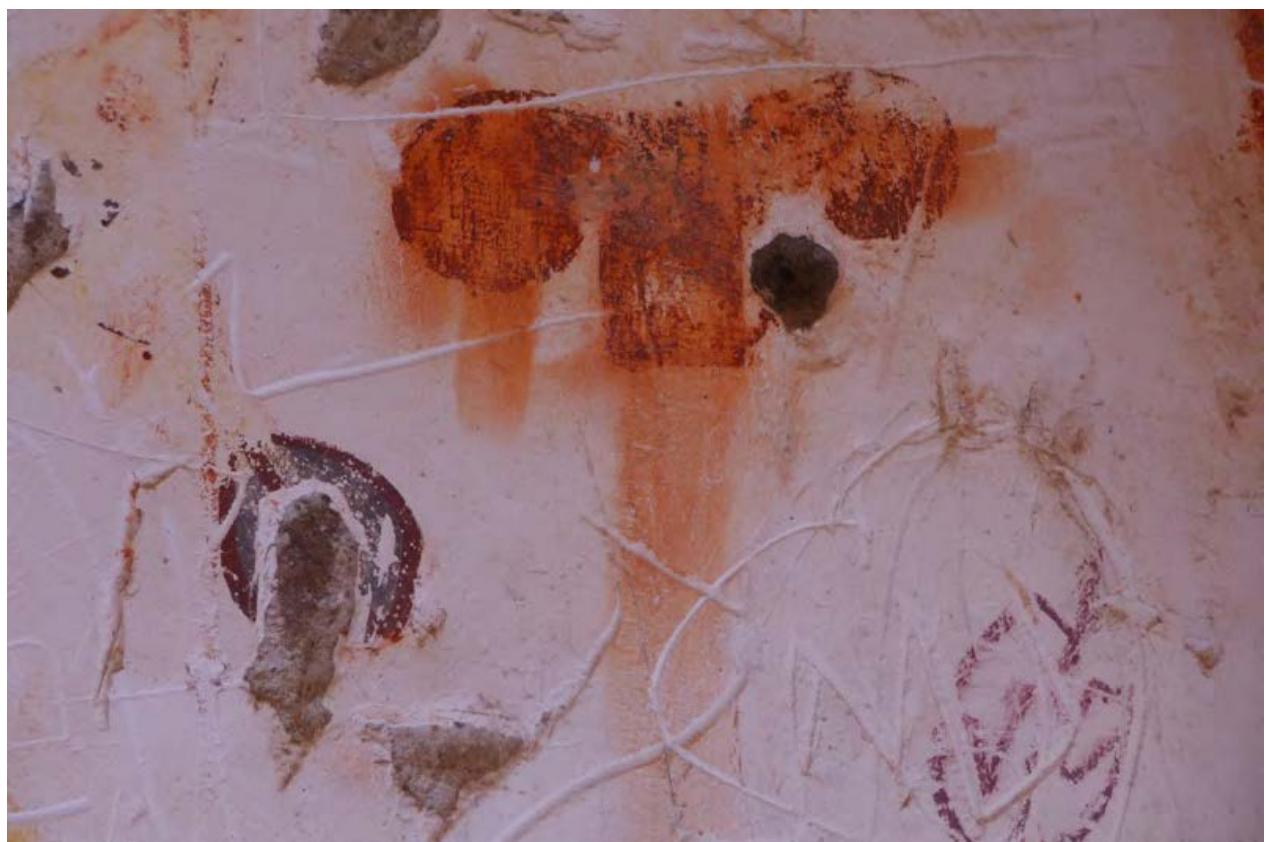
Figure 12. Smearing of the paint layers suggests that the pigments are bound with an organic medium

The paints often appear to have been applied in quite liquid, medium-rich preparations, resulting in some areas in thin, glaze-like effects (though this appearance may in part be due to deterioration, as discussed further below) (fig. 11). The smearing of layers in some areas, either due to mechanical action, dry or in the presence of water, also indicates that the paint layers were originally applied a secco, and further supports the hypothesis that the plaster layers are gypsum-based (fig. 12). Though Cappadocian paintings have often been reported as true frescoes (ex. Schwartzbaum 1986), there is also ample evidence that organic (often proteinaceous) binders were commonly used (Pelosi et al. 2013, Andaloro 2008).

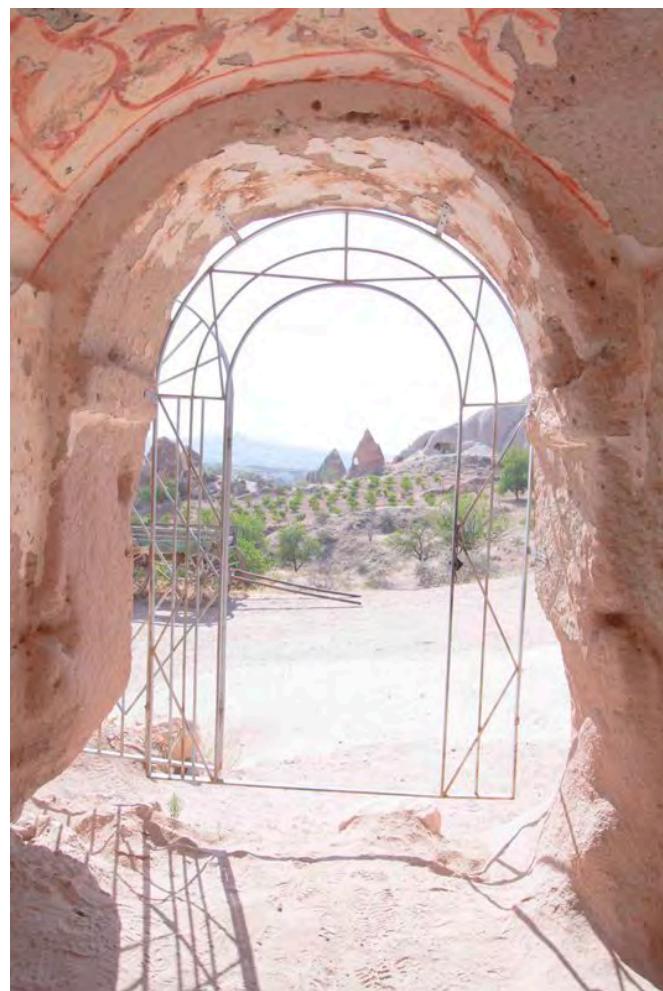
Figure 13. Metal door which secures the entrance to the church

The entrance to the church is currently closed by an ill-fitted metal door, composed of widely-spaced metal bars (Fig. 13). It seems that this door is generally kept locked, but when open, visitation to the church is often unaccompanied and unsupervised.

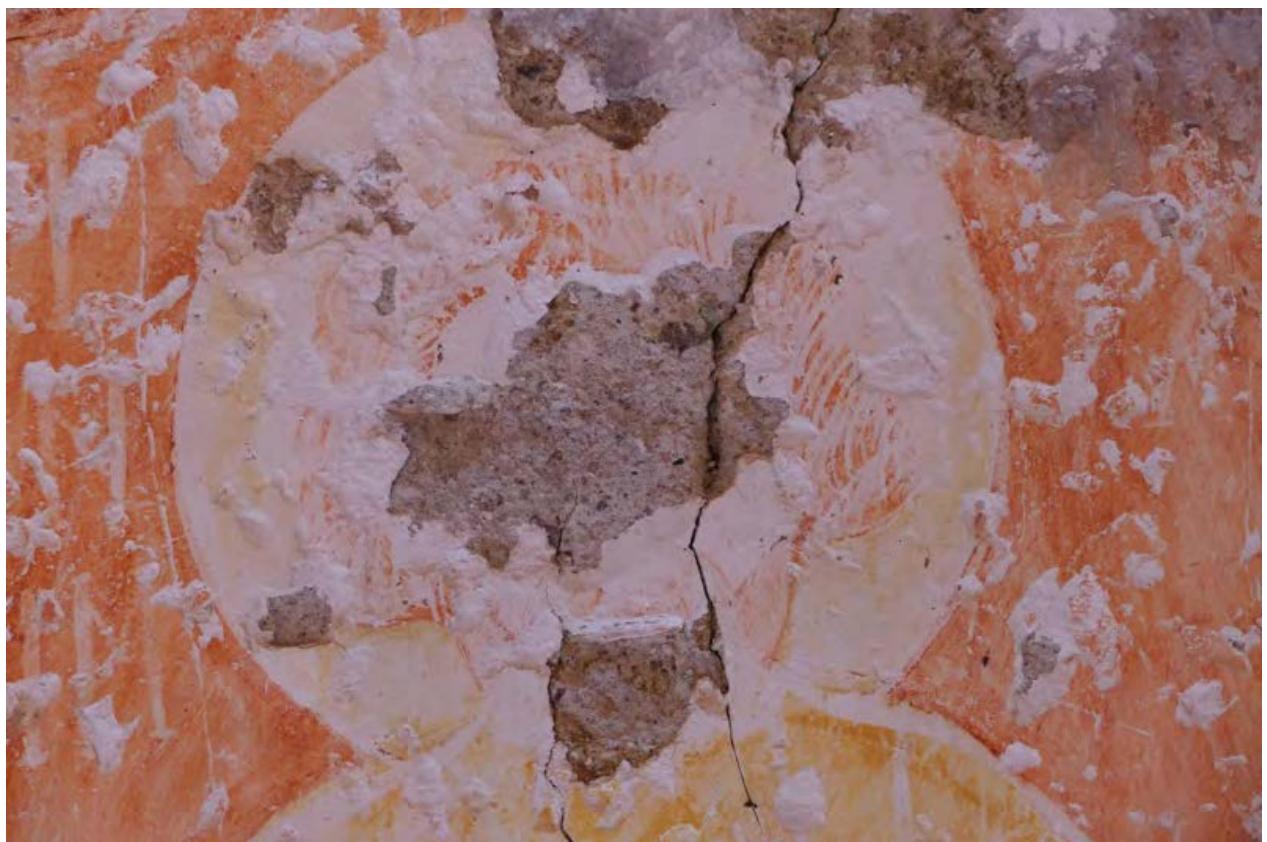
Figure 22. Example of vandalism directed at specific iconographic elements

by iconoclasm or other differences in religious belief (fig. 22). The vandalism was inflicted by scratching, hitting, scraping and gouging (fig. 23 & 24). Generally, the damage cuts through the paint layer and into the plaster layers, but sometimes has caused the loss of all three layers, revealing the bare stone beneath. In some cases, impact has caused the compaction, deformation and cracking of the paint and plaster layers, but the stratigraphy remains intact (fig. 25). Like the graffiti, human-inflicted damage occurs mainly in the lower 1.5-2 m of the painting, but does extend to the height of the ceiling in some areas, in which cases it appears that sticks, rocks or other implements were used.

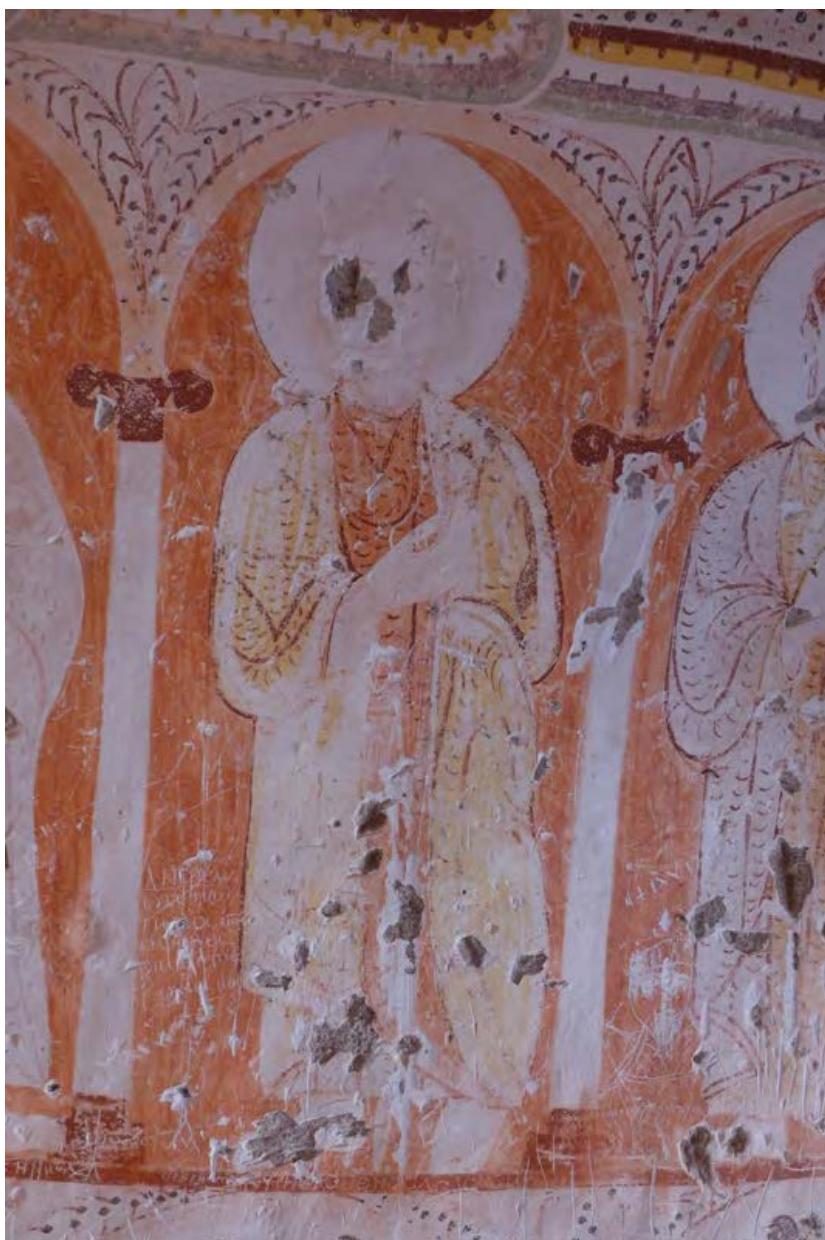
Figure 27. Some paint layers in the face and robe of the figure have been completely lost, while others remain

No powdering or flaking of the paint layers was observed, though they do appear to be friable, based on smearing observed in various locations. There are also areas of preferential loss, the mechanism of which is as yet unexplained, and may vary from area to area (fig. 27). It also does not affect paint layers in the same way across the painting, further confounding explanation. Loss could be due to chemical or physical changes within the paint layer, possibly a failure of the binder. The process is not yet clear, and will need to be investigated further. Preferential loss of paint layers has also been observed in other sites (Andaloro 2008), but further work would have to be done to determine if there are consistent patterns or causes between sites.

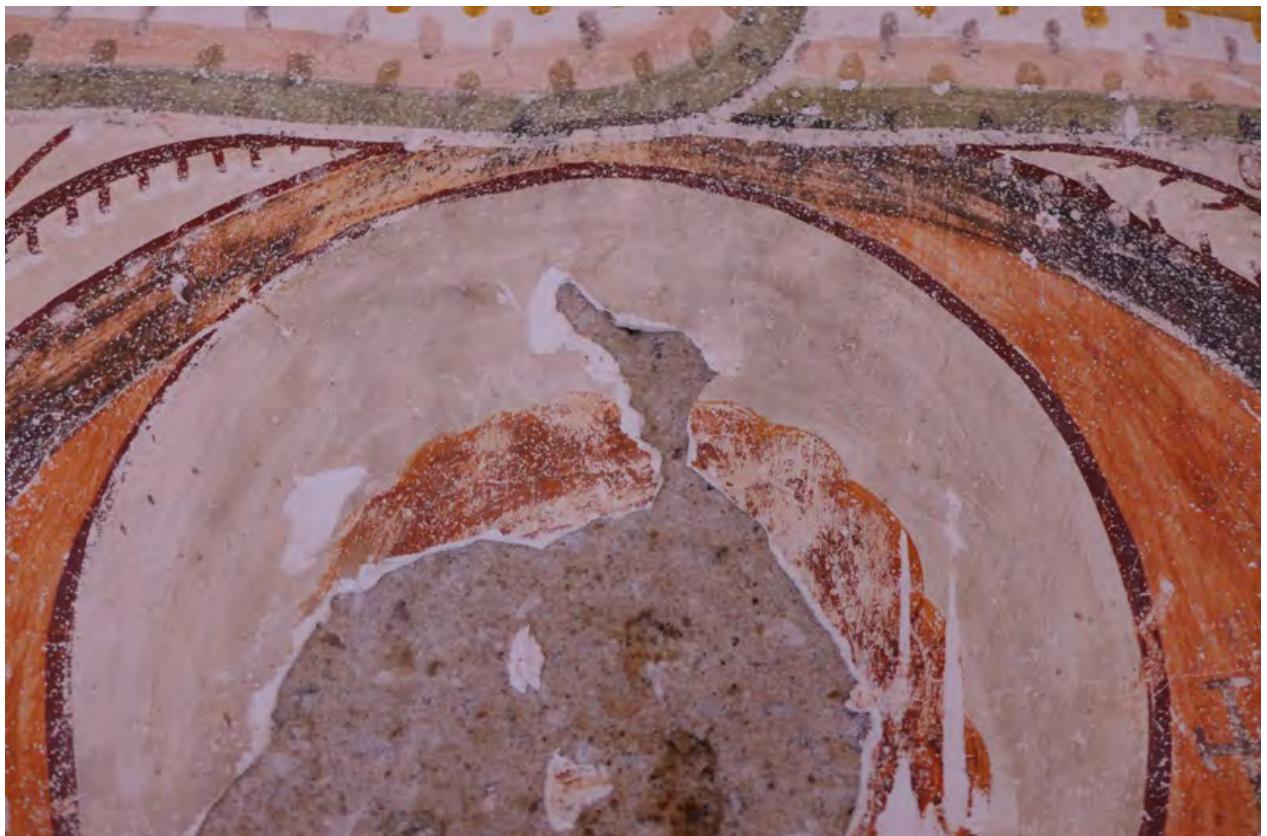
Figure 28. The paint layer in the halo appears to have altered to a grayish white hue

Pigment alteration was also observed, mainly as a shift from pink to grey, white to grey, and red to grey (fig. 28 & 29). Alteration of some type may also explain the current appearance of some of the other paint layers, but this cannot be understood without further examination and/or analysis.

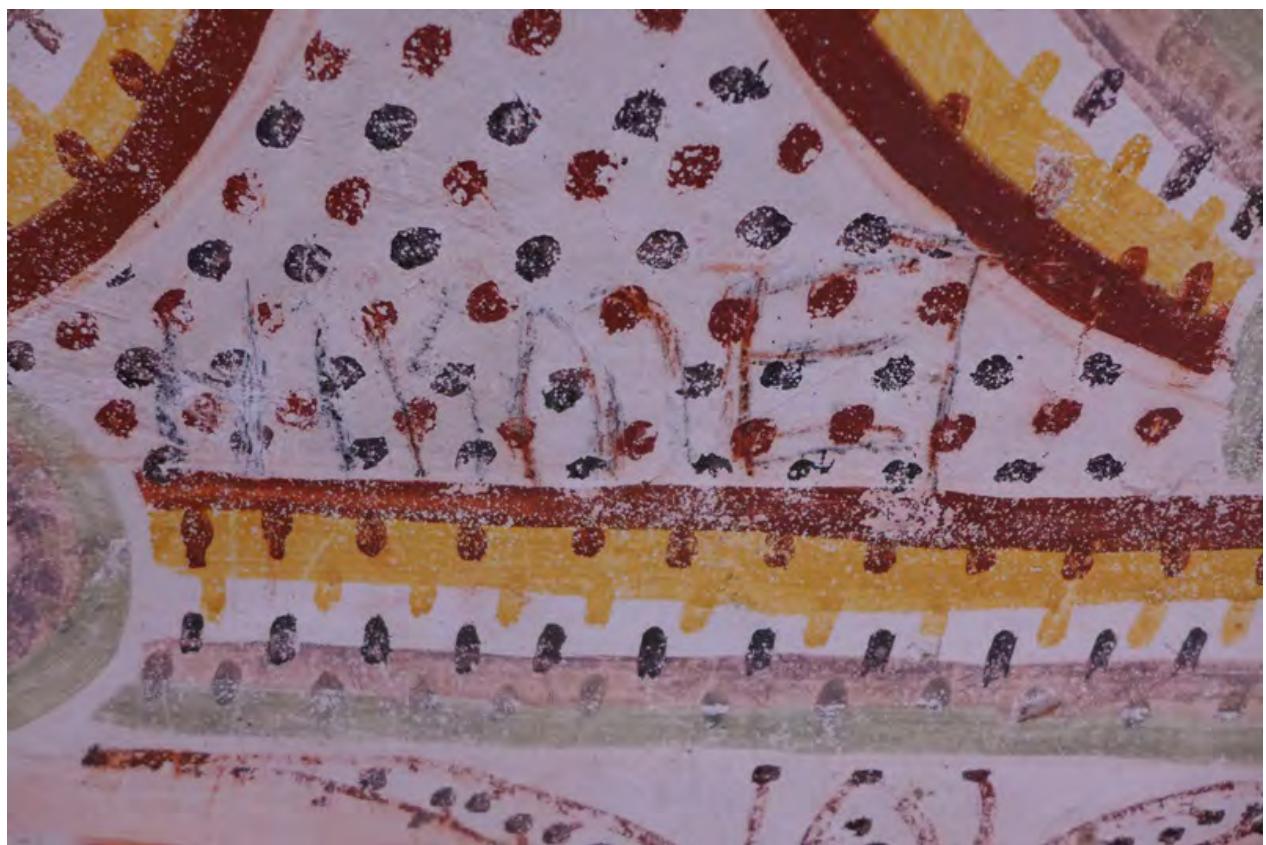
Figure 30. Superficial graffiti (in blue)

The paint layers have suffered the same mechanical damage as that described above for the plaster layers. The paint layers have additionally suffered from superficial graffiti (fig. 30), and smearing, a condition which has been exploited in a number of instances for the writing of graffiti (fig. 31).

Yukarıda alçı tabakalarındaki tarifte olduğu gibi, boyabakaları da aynı mekanik hasara uğramıştır. Boya tabakaları buna ek olarak, çok sayıda graffiti örneği ile istismar edilmiş yüzeysel duvar yazısı (Şekil 30) ve karalama olayına maruz kalmıştır (Resim 131).

- The stabilization of some areas of detached or cracked plaster is recommended in order to prevent their loss over time. Partial treatment with fills, edge repairs and grouting should be applied only to the extent deemed necessary to ensure the paintings' stability, i.e. this should be designed as a partial treatment only, limiting the intervention to the minimum necessary to secure the paintings.
- Modern graffiti should be toned down in order to increase

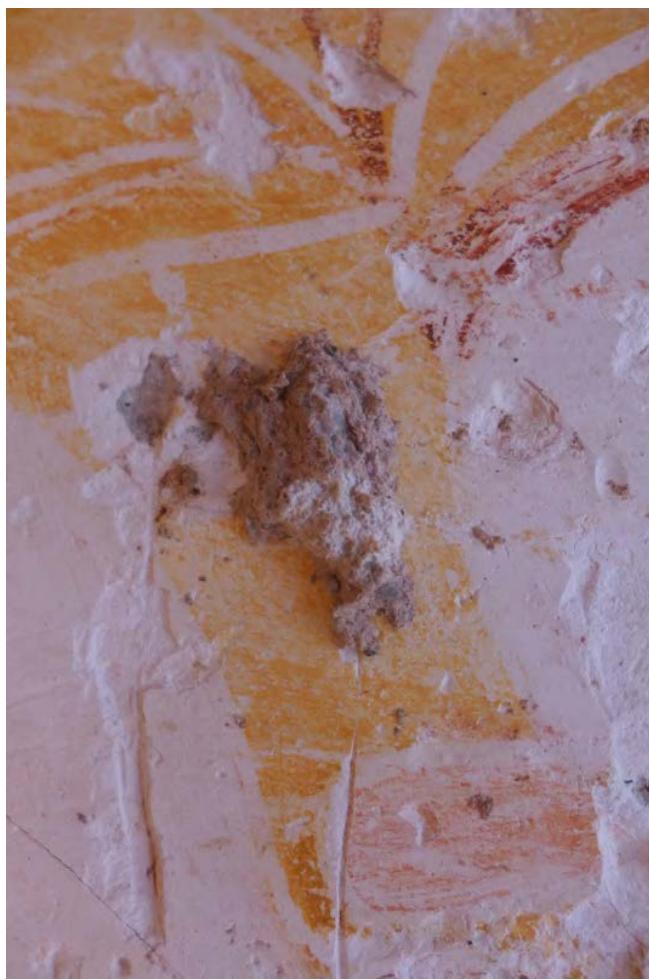
Figure 31. Graffiti created by smearing the original paint layers

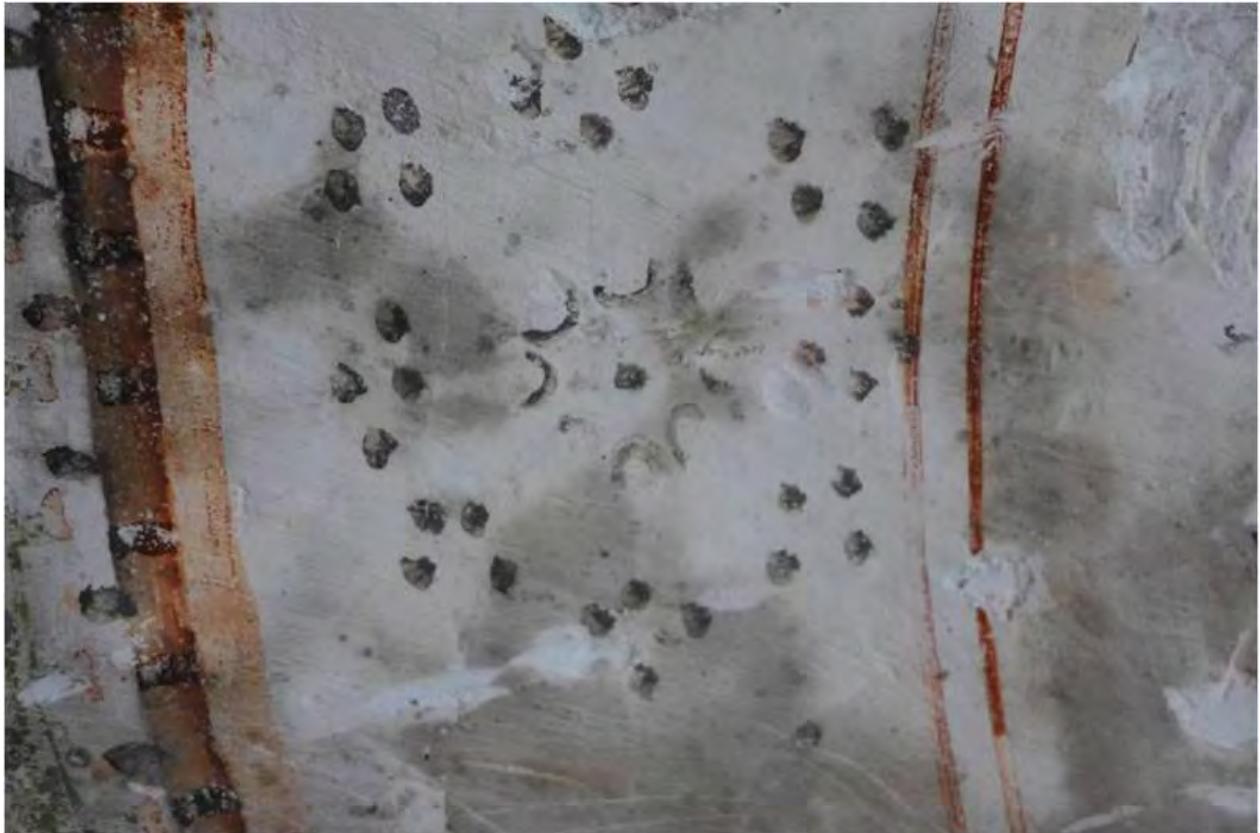
Figure 33. Remains of earthen nest material, and loss of the paint layer where it has been removed

The presence of animals has affected the paint layers through the deposition of material on the surface (ex. mud from nests, excreta), and the loss of paint when these materials have been removed (fig. 32 & 33). Contact with the animals has also resulted in the loss of paint layers in the form of scratching and other types of mechanical damage. Animals appear to have roosted mainly in Chamber 2.

Hayvanların varlığı, yüzeydeki materyal çökelmesi (Or: Yuvaların çamuru, dışkı) ve bu materyallerin kaldırılması sonucu boyanın kaybı yoluyla boyabakasını etkilemiştir (Şekil 32, 33). Hayvanlarla temas da, kazıma ve diğer mekanik hasar tipleri şeklinde boyabakalarının kaybıyla sonuçlanır. Hayvanların genelde 2 No'lu odada tünedikleri görüldü.

- Continuing mechanical damage should be controlled through the installation of a well-fitted door with a narrower grid. This would prevent the entrance of humans and animals, greatly reducing the incidence of damage, though the visitation policy still leaves the paintings in danger of some amount of ongoing vandalism;
- There is unfortunately little which can be done to limit the structural failure of the church, since it is caused by the movement of the underlying fault line. However, cracking should certainly be monitored, and external cracks filled and maintained as necessary to prevent water infiltration to the church interior;
- Controlling or reducing ongoing external erosion is of course also fundamental to the long term preservation of the paintings, but is the subject of a separate report.

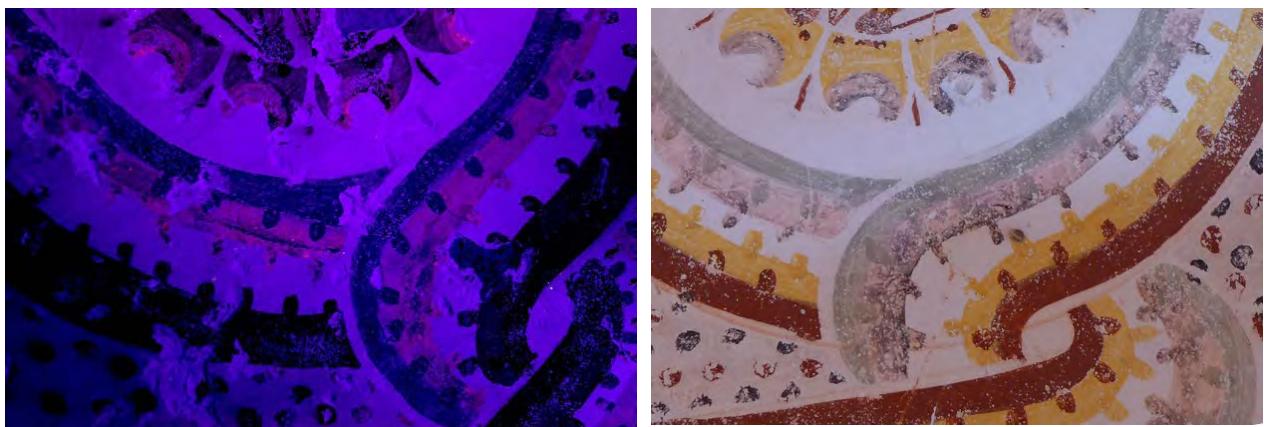
Photographs: 365nm-UV excited fluorescence visible photograph (left), and visible photograph (right) showing strong pinkish fluorescence of pale pink painted area with darkened alteration phenomena.

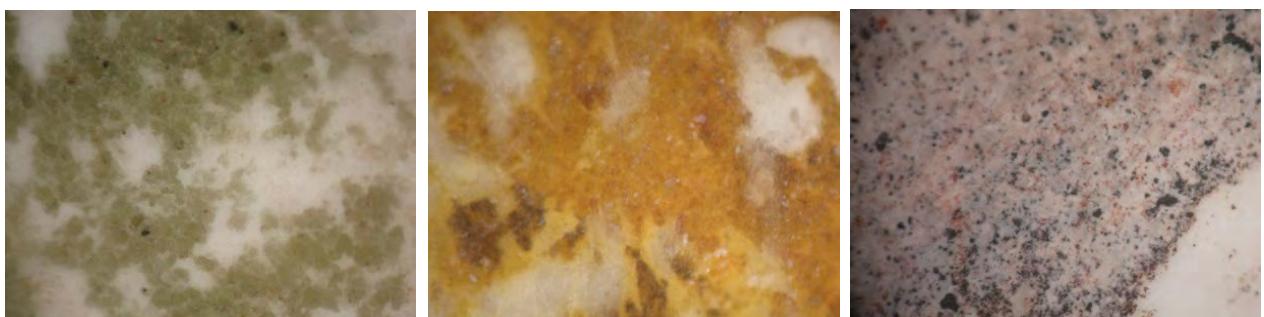
Microphotographs: (from left) 3rd chamber, main niche, greenish shade (3234), 3rd chamber, flower (3224), 2nd chamber, flower petal, altered (blackened) pink area (3208) [1.5mm in the long side]

Visible micro photographs and microphotographs of wall painting surfaces were obtained using a digital camera-attached microscope (®Microadvance) for detailed observation. Particular metal-based pigment alterations probably caused by exposure to outdoor environment were observed. Infra-red and Ultra-violet photographs (365nm excitement wavelength) were also taken to assess specific types of painting materials.

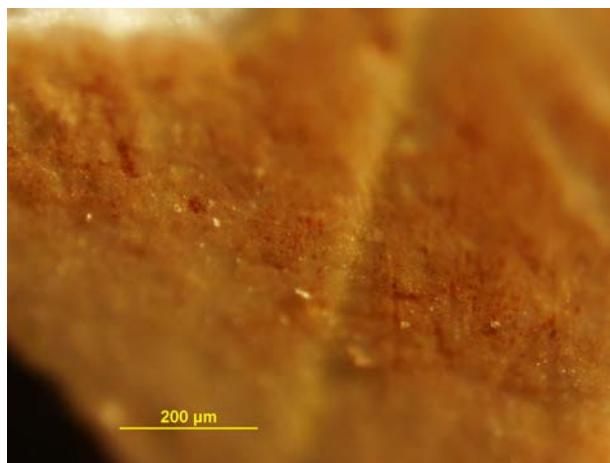
UZM_003, Oda 1’deki kırmızımsı yüzeyden alındı. Daha önceleri bu alanda üzüm figürleri olduğunu düşünmektediyiz (UZM007’nin alındığı alanda olduğu gibi). Üzümleri betimleyen resim muhtemelen su ile ilgili nedenlerden ötürü büyük ölçüde kaybolmuş. Reçineye batırılmamış örneğin yüzeyinde üzümlerin özgün rengine işaret edebilecek birkaç kırmızı parçacık gözlendi (Şekil 1). Kesitte, zemin tabakasının üst kısmında sadece birkaç demir içeren parçacık gözlendi (Şekiller 2, 3). Şu an için üzüm figürlerinin kaybolma nedeni bilinmiyor. Bu konu organik incelemenin sonuçlarına göre

Figure 1. Light microscopic image of unembedded UZM_003
A few red particles are dispersed on pink surface.

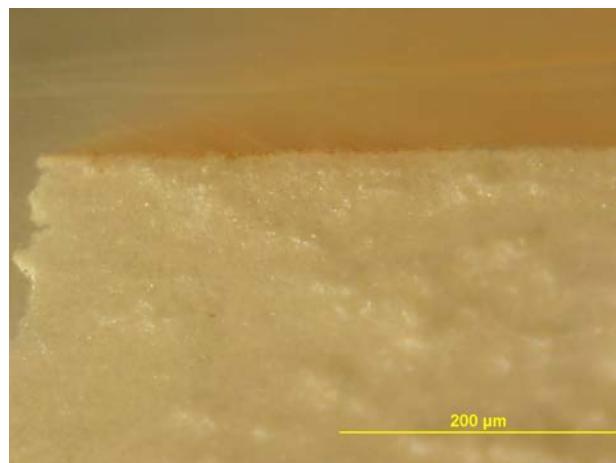
Figure 2. Light microscopic image of the cross-section UZM_003
A very thin layer of red paint; small number of red particles are found at the surface of the white ground.

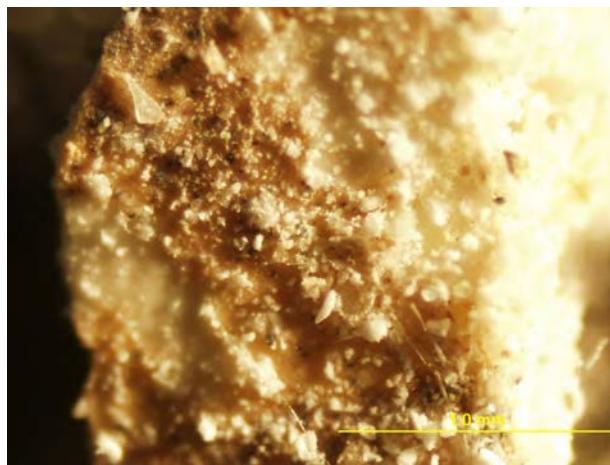
Figure 4. Light microscopic image of unembedded UZM_004

Rough surface with red, black and white particles

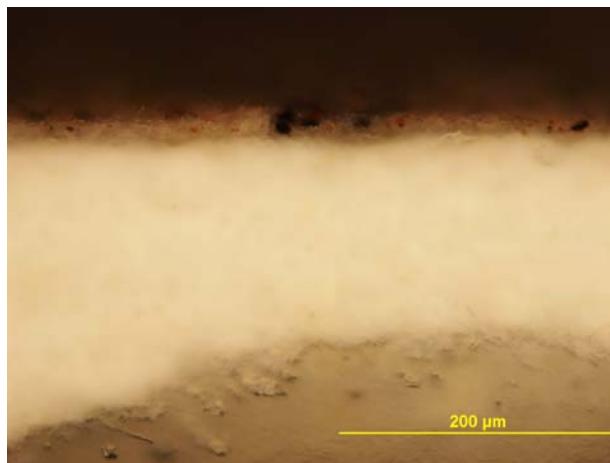
Figure 6. Light microscopic image of the cross-section UZM_004

Fine red particles and relatively large size of black particles

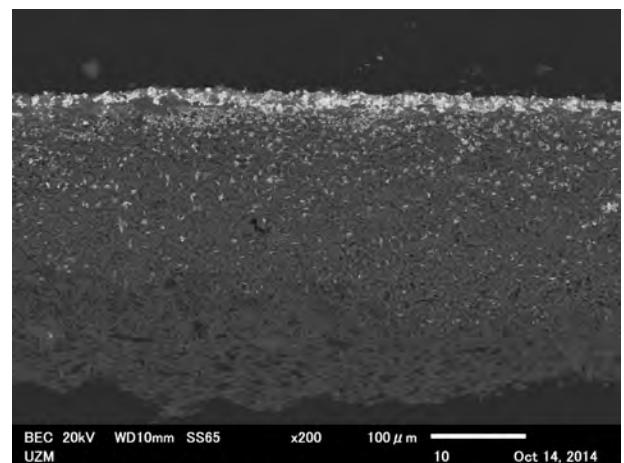
The darker area in the top layer contained calcium (Ca) and sulphur (S), which means that the ground and paint materials were somehow mixed. Brighter spots in the ground layer also contained lead (Pb) and chlorine (Cl) (Figure 8). Since there was no red or black particles in the ground layer, it suggested that decomposed red lead has somewhat impregnated into the ground layer. This could be related to a source of chlorine (Cl). A source of chlorine could be water soluble salts such as sodium chloride (NaCl).

Figure 8. SEM-BSE image of cross-section of UZM_004
Bright spots containing Pb and Cl are spread in the white ground layer.

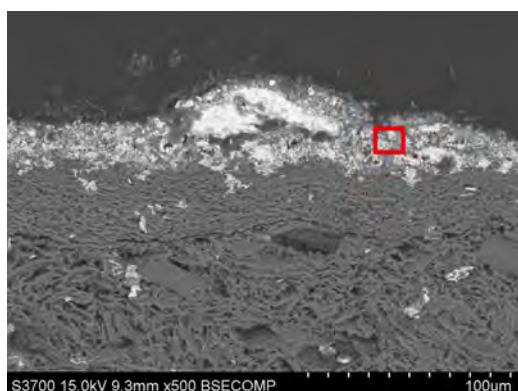
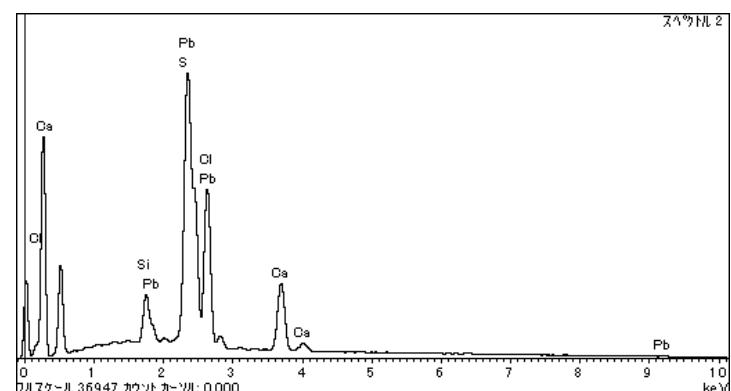
Figure 7. EDS area analysis result of the paint layer of UZM_004

lead. Considering the brightness in contrast in the SEM-BSE images, the number of red and black particles in the top layer were very small, and it suggested the white particles could be degradation/alteration product of red lead (Figure 7).

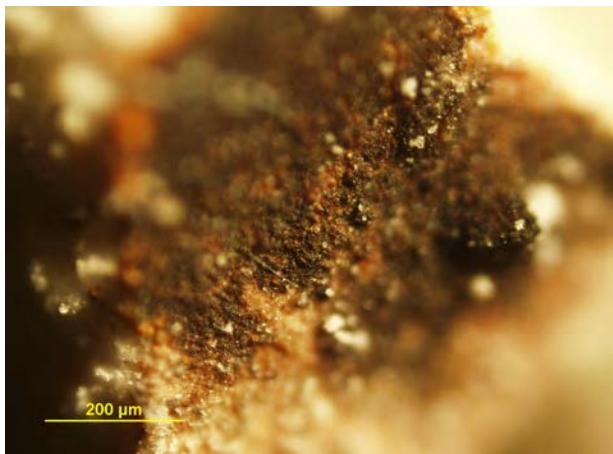
UZM_005 is a darkened red paint sample from the ceiling of Chamber 2. Observation with the light microscope indeed reveals the presence of red and black particles. The surface was darkened while the red colour was preserved underneath the darkened particles (Figure 9). In the cross-section, however, this observation was not obvious probably because of that only surface particles were altered.

Figure 9. Light microscopic image of unembedded UZM_005

The red particles are visible under the surface dark particles.

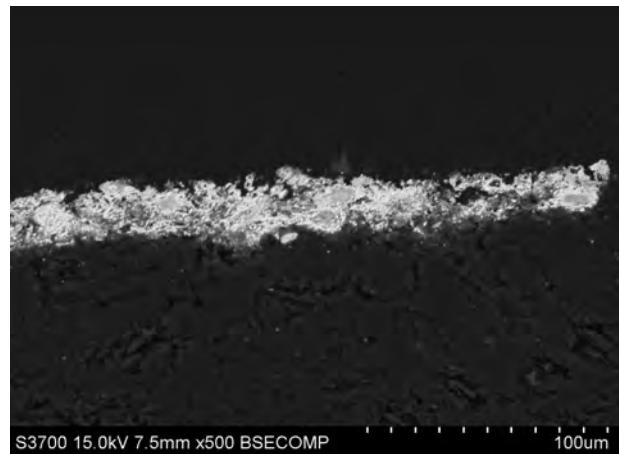
Moreover, in the SEM-BSE image the top layer was highly X-ray reflective that did not correspond to the locations of the red and black particles (Figure 10). As it was seen in UZM_004, both black and white particles in the top layer were assumed to be alteration products of red lead. Based on the EDS analysis, a difference from UZM_004 was the top layer which does not contain chlorine (Cl) and also no migration of lead (Pb), which was observed in UZM_005. Reasons for the differences between two samples should be examined further in the future.

Figure 10. SEM-BSE image of cross-section of UZM_005

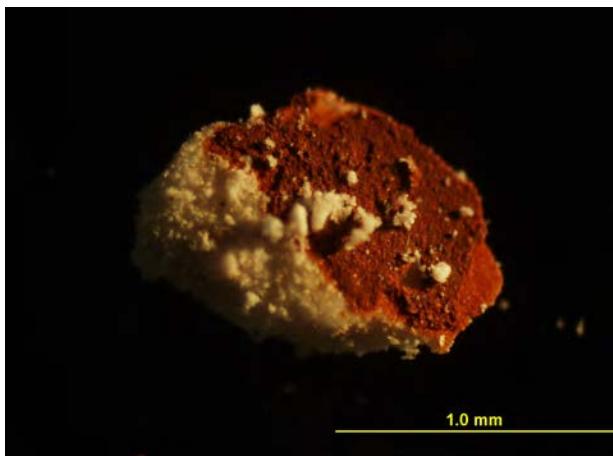
UZM_007 is a red paint sample taken from grape images depicted area on the ceiling of Chamber 2. The surface appeared darker than underlying material in the light microscopic image of the unembedded sample (Figure 11). However this difference was not obvious in the cross-section, and the light microscope and SEM-BSE examinations suggested that the dark surface was due to accretion of dirt

UZM_007, Oda 2'nin tavanındaki üzüm figürlerinin betimlendiği bölümünden alınan bir kırmızı boyalarının örnekidir. Reçineye batırılmamış örneğin ışık mikroskopu görüntüsünde yüzey, alt kısmından daha koyu göründü (Şekil 11). Ancak bu farklılık, kesitte ne ışık mikroskopu ne de SEM-BSE kullanıldığından belirgindi ve bu durum koyu yüzeyin kir birikmesinden kaynaklandığını düşündürdü (Şekil 12).

Figure 11. Light microscopic image of unembedded UZM_007

Surface is darker than the red particles underneath.

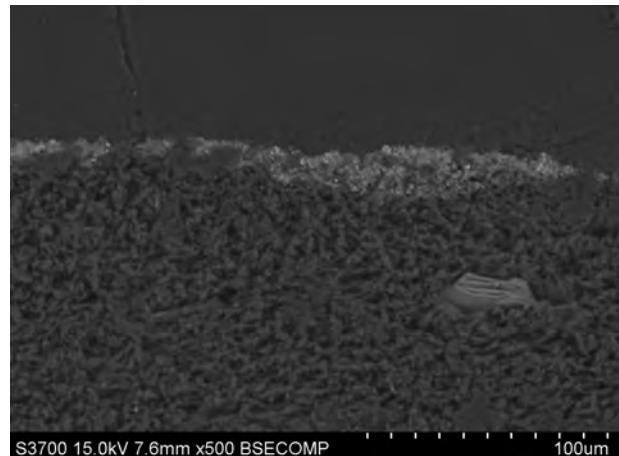
Figure 12. SEM-BSE image of cross-section of UZM_007

(Figure 12). EDS analysis detected iron (Fe) with silicon (Si) in the red paint layer indicating the use of red ochre (Figure 13).

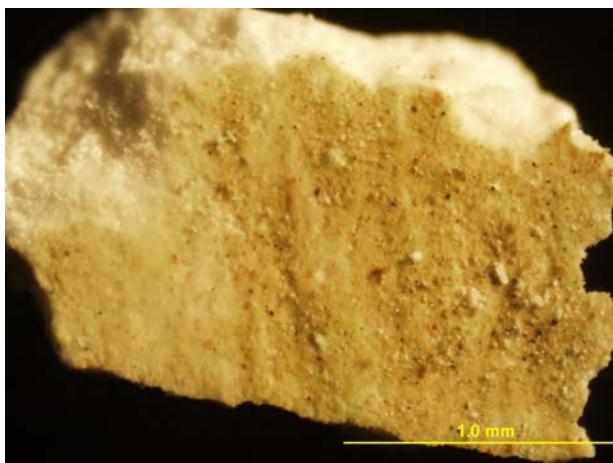
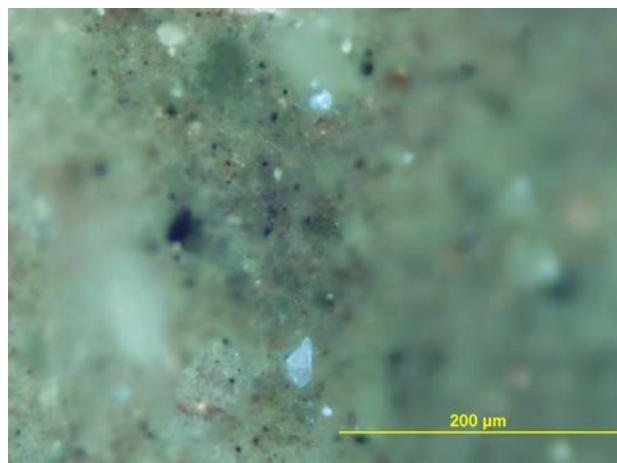
UZM_008 was taken from a green area on the ceiling of Chamber 2. In the light microscopic image the green colour was very pale and the top layer contains various types of particles shown under UV-light (Figures 14, 15). The top layer is distinguishable from the ground in the SEM-BSE images as the crystal structure was slightly different. EDS detected silicon (Si), aluminum (Al), magnesium (Mg), potassium (K), and iron (Fe) which are typical elemental compositions of green earth (Figure 16). In order to identify a type of green earth (glauconite or celadonite) further analysis with XRD and/or FTIR is required.

Figure 14. Light microscopic image of unembedded UZM_008

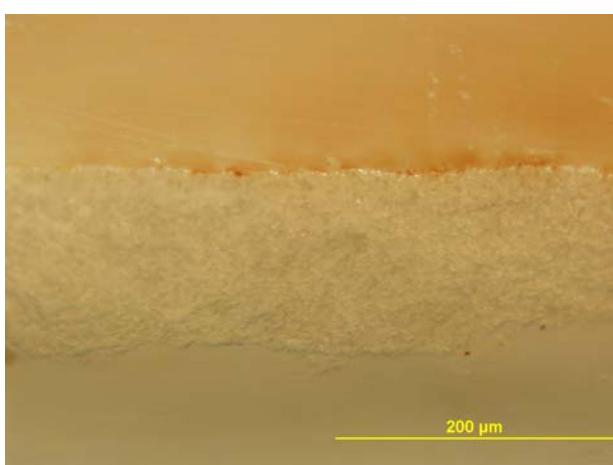
UZM_010 is a pale pink paint taken from the west wall of Chamber 2. The layer was extremely thin and only small numbers of red particles were dispersed on the ground (Figure 17). The red particles contain iron (Fe) detected with EDS indicating the use of red ochre, probably refined in a specific way.

Figure 17. Light microscopic image of the cross-section UZM_010 with the square.

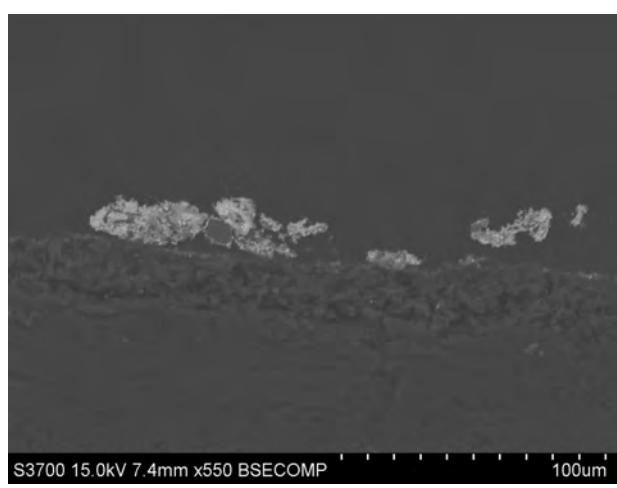
UZM_011 was taken from a darkened red area of the west wall of Chamber 2. The surface condition was close to the UZM_005. As expected, EDS detected lead (Pb) in the red paint layer. Again there was no difference observable between intact red particles and altered black particles in the SEM-BSE images. In this sample, delamination of the paint layer was clearly shown in the SEM-BSE image (Figure 18).

Figure 18. SEM-BSE image of cross-section UZM_011
