Scientific Studies on Conservation for Üzümlü Church and its wall paintings in Cappadocia, Turkey

Vol. 1 : Annual report on the activities in 2014

**University of Tsukuba
2014**

Yoko Taniguchi, University of Tsukuba

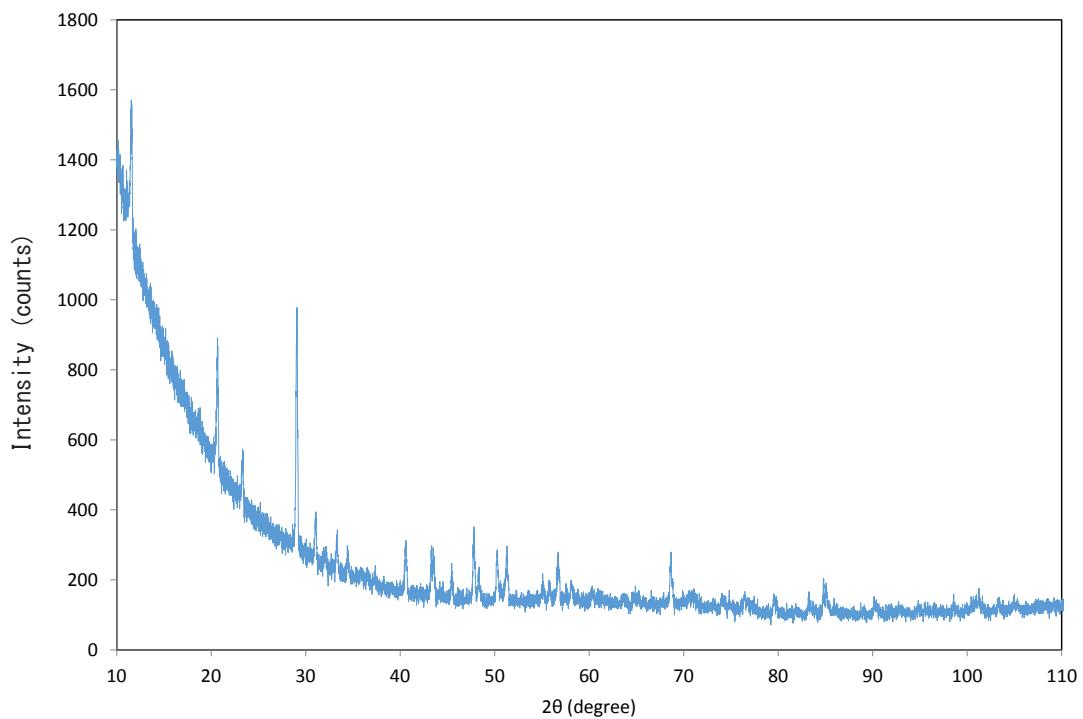
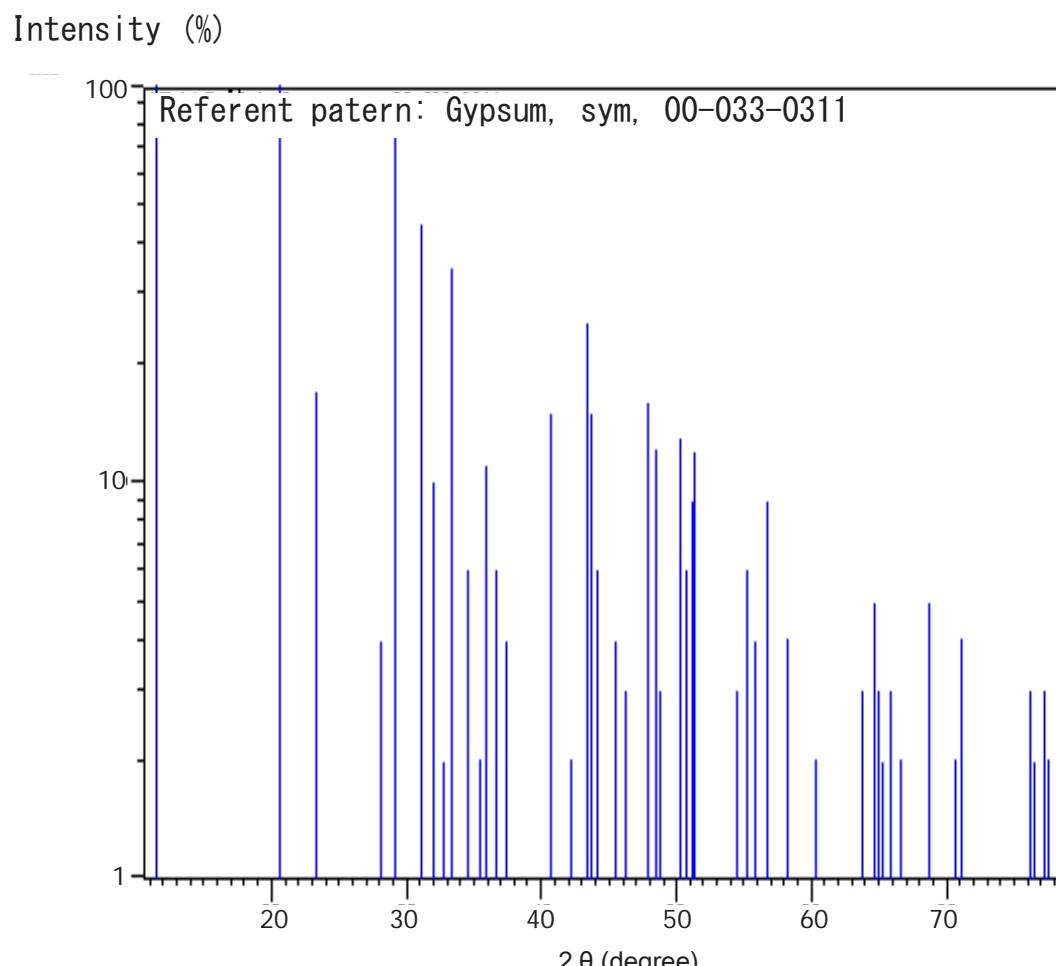
Figure 19. XRD diffractogramme of UZM_002 white ground and a reference diffractogramme of gypsum [JCPDS: 00-033-0311]

The samples UZM_002 and UZM_013, which were taken for identification of the white ground, were analyzed by the XRD. Gypsum was identified in both samples. The XRD diffractogramme is shown in Figure 19 (JCPDS: 00-033-0311). In addition, crystal structure of the two samples (unembedded) showed characteristic shapes of gypsum crystals (Figure 20). Detections of calcium (Ca) and sulphur (S) with EDS in the all samples supported the XRD results (Figure 21) as calcium sulphate hydrate; gypsum ($\text{CaSO}_4 \cdot 2\text{H}_2\text{O}$).

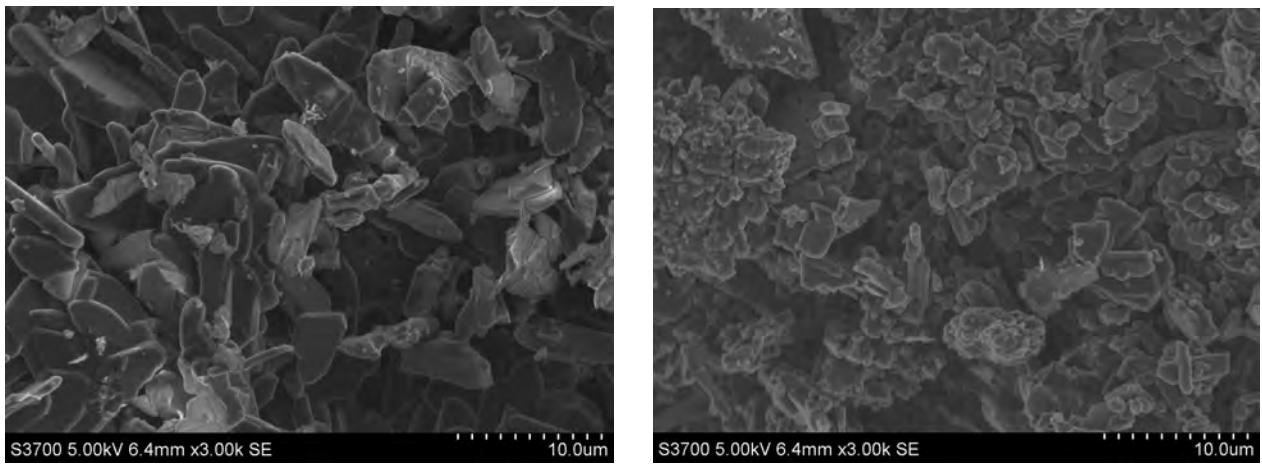
Figure 20. SE(secondry electron) images of UZM_002 and UZM_013 (both white ground samples) showing typical gypsum crystalline shapes (UZM_013 might be a little degraded)

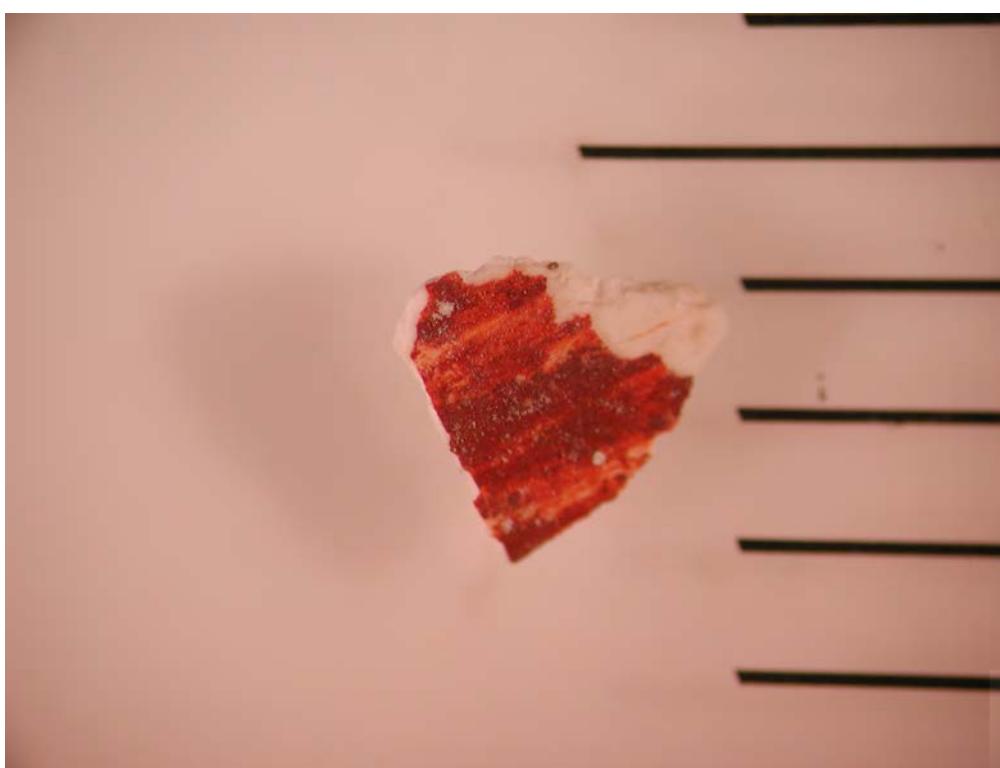
Duvar resimlerinden alınan 2 numune ELISA testi kullanılarak incelendi. Numunelerden biri yalnızca toprak tabakası (Numune: 1), diğer ise toprak ve ince kırmızı boyalı tabakası içeriyordu (Numune: 2, Fotoğraf: 1). Numune 2'de, toprak ve boyalı tabakalarını birbirinden ayırmak zordu ve bu sebeple birlikte incelendiler.

Photo 1 Sample 2 contained ground and thin red paint layer (The scale on the ruler is millimeters)

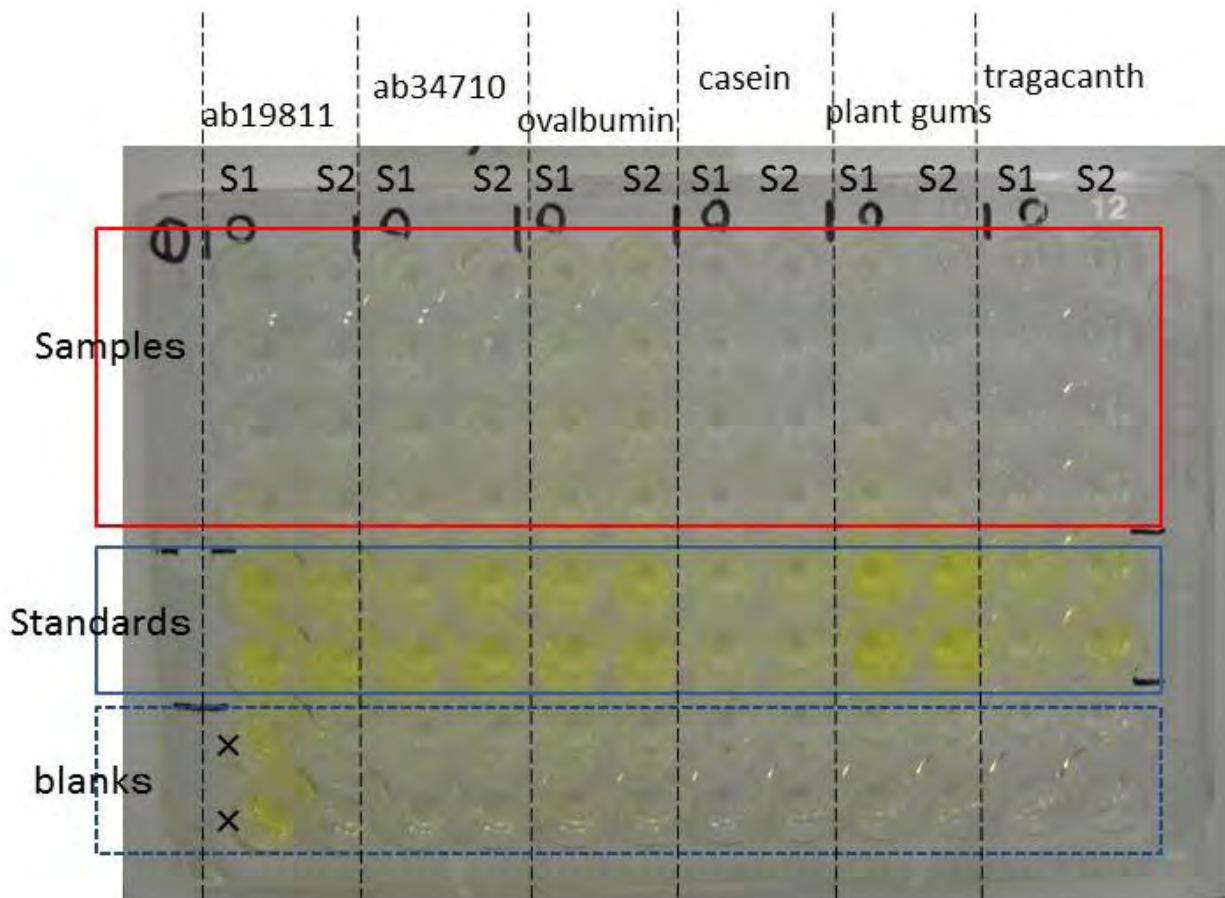
Figure 1. ELISA micro-plate. 4 dilutions for each sample and 4 dilutions for each standard, and 4 blanks were prepared for use with each antibody (S1 and S2 means sample 1 and 2). Standards turned yellow, while samples did not, meaning the antibodies did not recognize proteins.

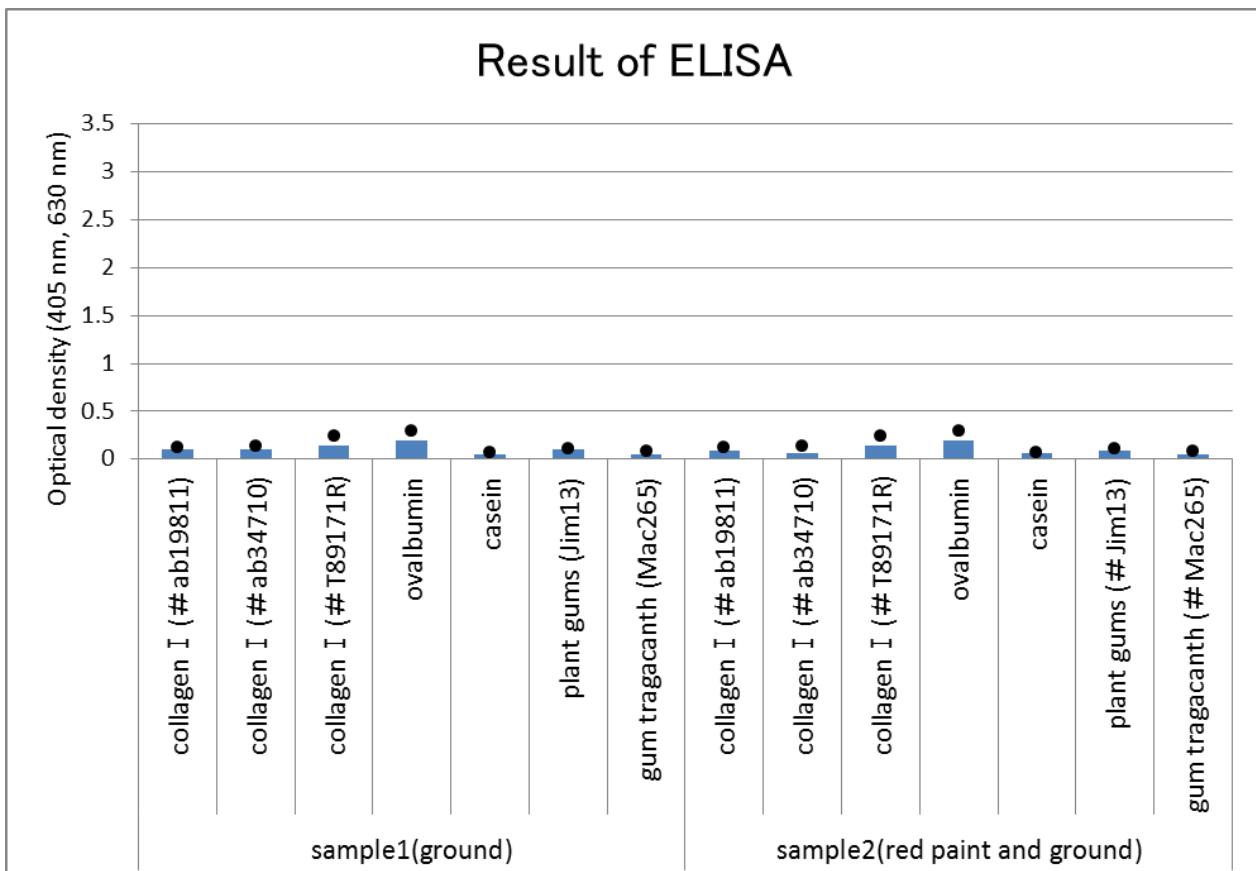
Figure 2. ELISA result for the identification of the binding medium of sample 1 (ground) and sample 2 (red paint and ground). 4 dilutions were prepared from each sample, one for each antibody and the average absorbance of 4 dilutions are shown (bar chart). No collagen I , ovalbumin, casein, plant gums and gum tragacanth were detected in the both sample. The dots indicate the cut-off values.

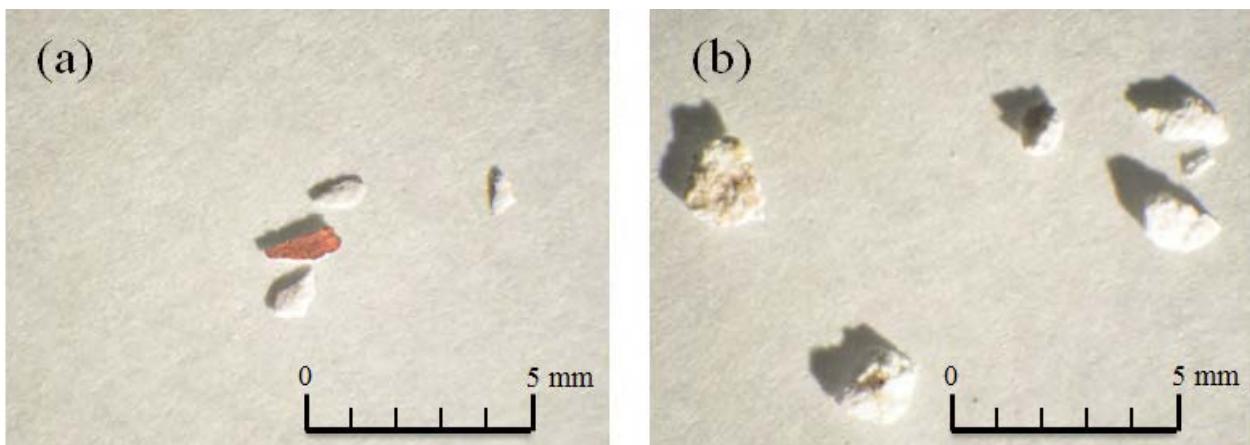
Kırmızı duvar resmi parçaları veritabanı ile birleştirilen Nano-LC-ESI-MS/MS analizi, Tablo 1'de listelendiği gibi bir seri insan keratini ve güvenilir eşleşmeli tripsini (önemli eşik $p < 0.05$, iyon sayısı cut-off 50) teşhis etmiştir. Bununla birlikte, bu proteinler (peptitler) genellikle bir protein kirlenmesi ile ilişkilidir ve muhtemelen numunelerin çevresel maruziyeti ve protein sindirimini prosedürü için kullanılan tripsinin oto sindiriminden kaynaklanır (2). Bu sonuç aynı zamanda, boyasız zeminden alınan numuneden de tespit edilen hemen hemen aynı protein setleri gerçeğe de desteklenir.

Figure 1. Small fragments sampled from the Üzümlü wall paintings. Fragments with red painting layer and white ground material (UZM_012: a) and those of ground material (UZM_013: b).

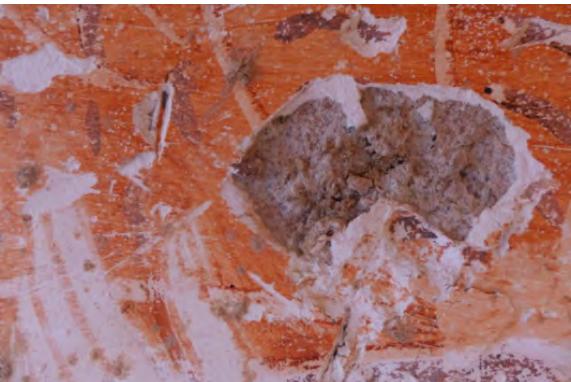
BIYOLOJIC BOZULMA	BIOLOGIC ACTIVITY Evidence of animal inhabitation (insects, spiders). Often, they appear to have inhabited pre-existing fractures in the rock, possibly exacerbating deterioration

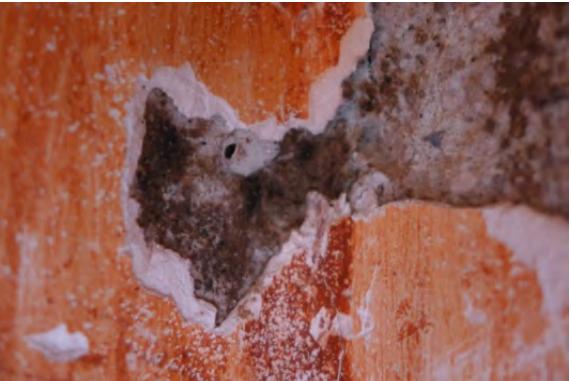
SIYAHLAŞMA	DEPOSITION OF DARK MATERIAL Deposits of dark brown or blackish material on the surface of the rock. Its origin is unclear, but it may be caused by biologic activity (ex. insects, bats). It appears to have been deposited on the stone after a loss of plaster, but this is uncertain – similar deposits do not appear on the surface of the plaster or paint layers. Could it have formed under the plaster and contributed to detachment? If of insect or animal origin, what caused the depopulation?

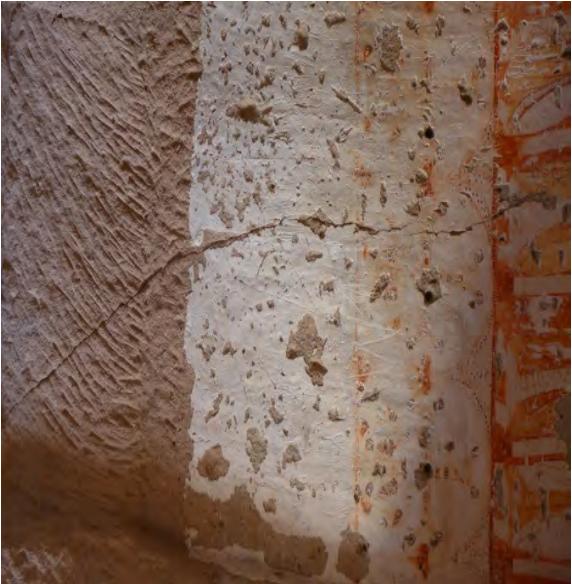
<p>YAPISAL ÇATLAH</p>	<p>STRUCTURAL CRACKS</p> <p>Large cracks which run through the body of the rock, caused by faulting</p>

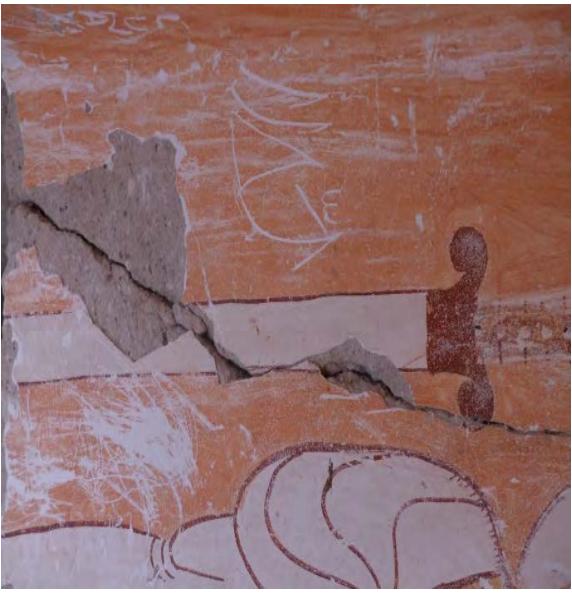
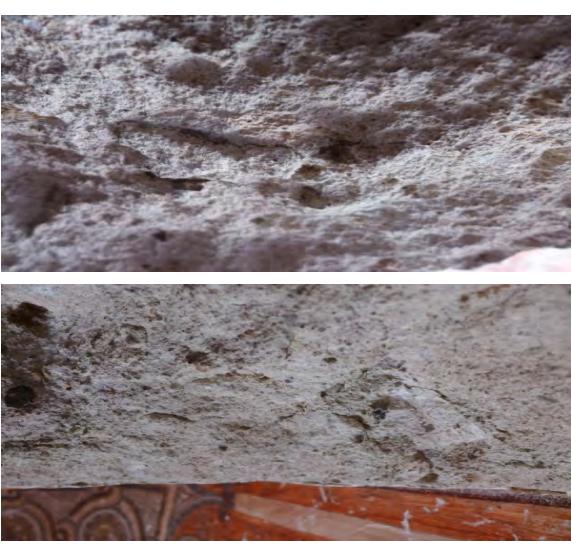
<p>YÜZEYDE KÜÇÜK ÇATLAK</p>	<p>SPALLING</p> <p>Detachment of the rock on a small scale, in parallel to the surface of the rock, probably more due to internal failure of the rock itself than macro-failure of the structure, though the two factors may be inter-related</p>

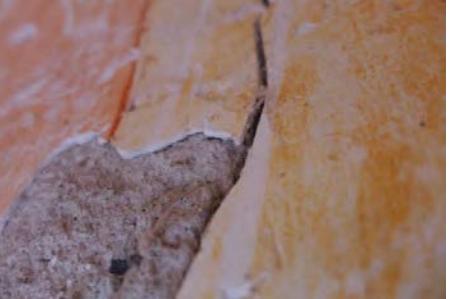
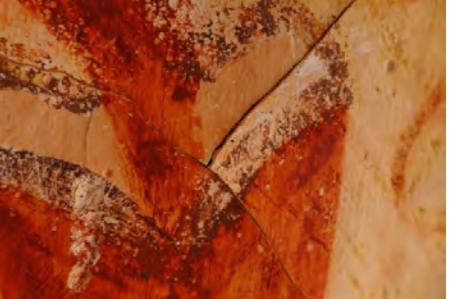
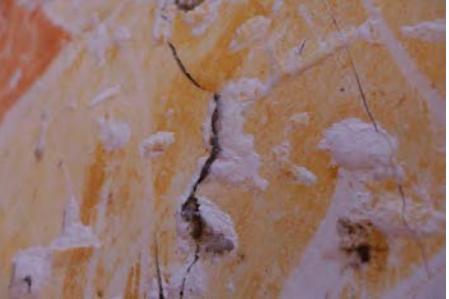
SIVA TOBAKASINDA AYRILMA	DETACHMENT OF LOWER PLASTER LAYER Loss of adhesion between the lower plaster layer and rock substrate, as assessed by visual evidence alone. In general, the observed detachment appears to result from mechanical damage to the surrounding areas, or structural cracking, though it may be more extensive

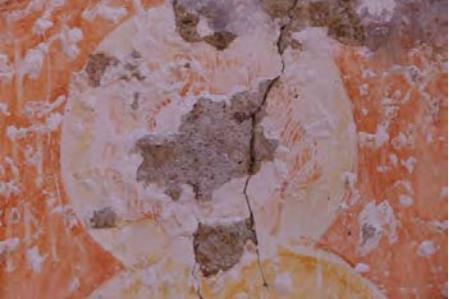
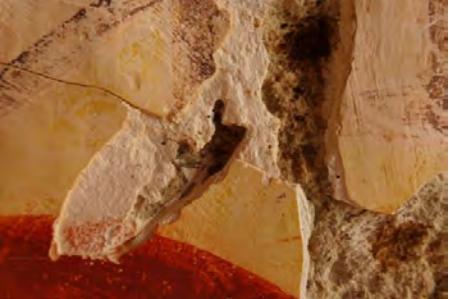
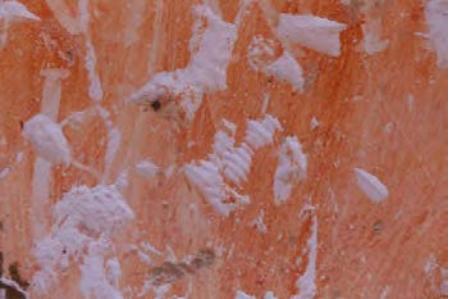
MEKANİK HASARLAR (insan eliyle yapılan hasar)	MECHANICAL DAMAGE Rupture of the painting stratigraphy by human or animal action, causing a variety of damage types: loss of the entire stratigraphy, revealing the underlying rock substrate; loss of the paint layer, ground and part of the lower plaster layer, leaving the interior of the lower plaster layer exposed; loss of only the upper plaster ground, leaving the surface of the lower plaster layer intact; deformation of the painting stratigraphy, which otherwise remain intact. Often appears as scratching, gouging, or denting. Damage was often directed at specific iconographic elements (ex. faces, hands, books).

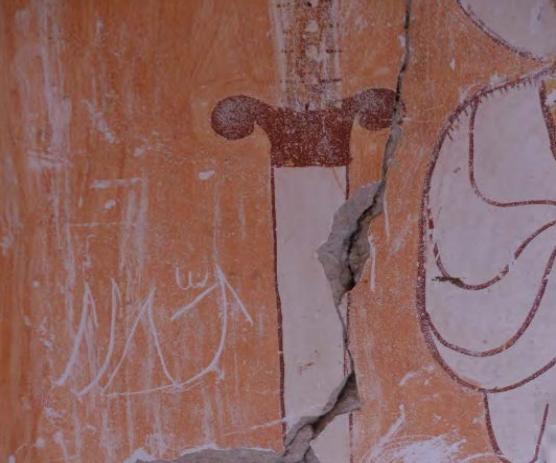
BÜTÜN ÇATLAKLAR	CRACKING Cracking of the plaster layer most often resulting from cracking of the rock structure and mechanical damage, though there may be other causes

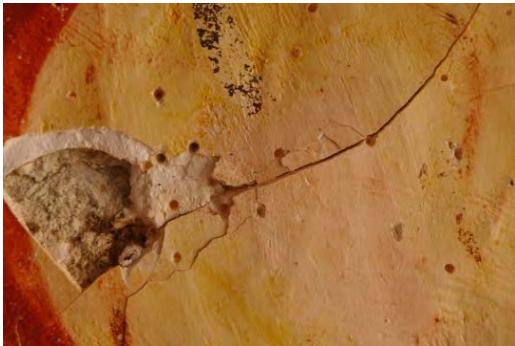
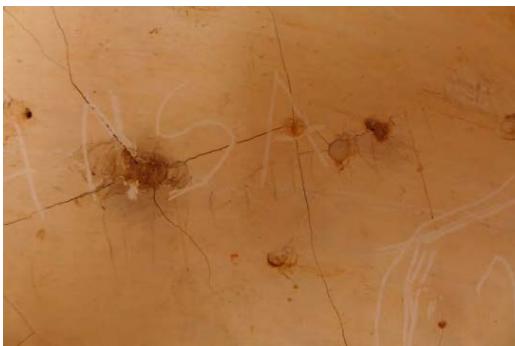
DELİKLER (5mm Ø)	HOLES Very circular, small holes of approximately 5 mm Ø, which enter into the plaster layer and generally do not reach the substrate. Cause is unknown as of yet.

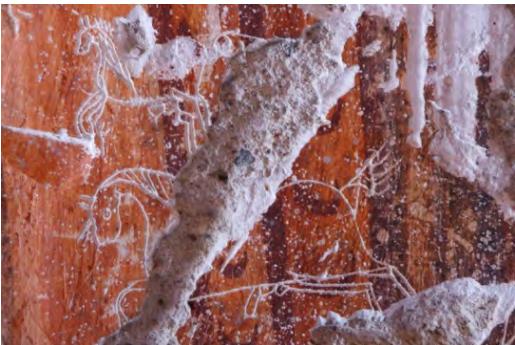
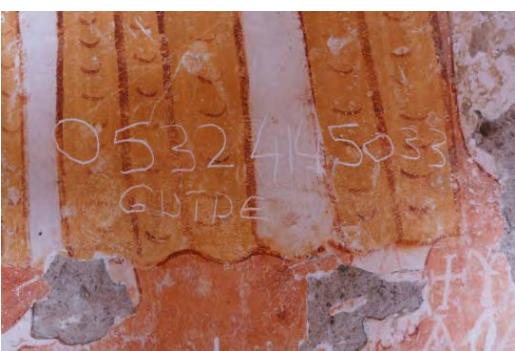
GRAFİTİ	INCISED GRAFFITI Inscriptions and drawings incised into the surface of the painting, affecting the paint layer, ground and plaster layer. Some graffiti appears to be ancient (written in Greek; imagery of horses, monks etc), but a significant proportion is modern (based on writing, dates, phone numbers ...).

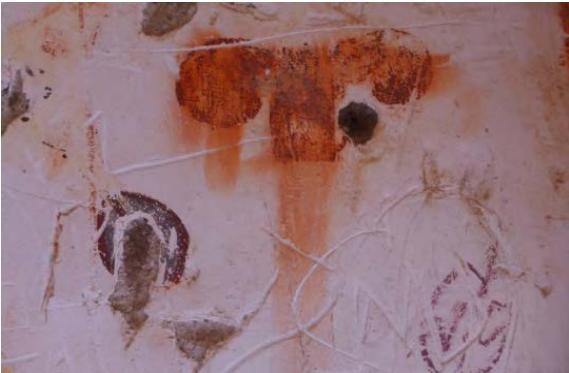
LEKELENMELER	SMEARING Displacement of the paint layer by mechanical action beyond its original location, seen as a spreading of the paint across the surface of the plaster. Generally appears to have been caused by contact with the paint layer, perhaps in combination with the presence of water

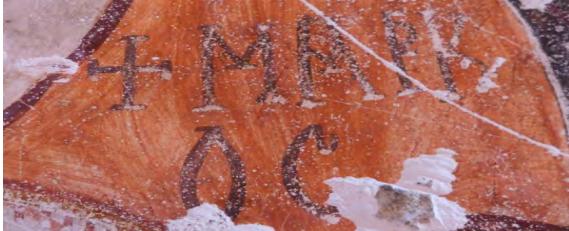
MIKRO KAYIPLAR	MICRO LOSSES Extremely small, rounded losses of the paint layer generally on the order of 0.5-1 mm Ø. Not always confined to specific paint layers, but does appear to be somewhat location-specific

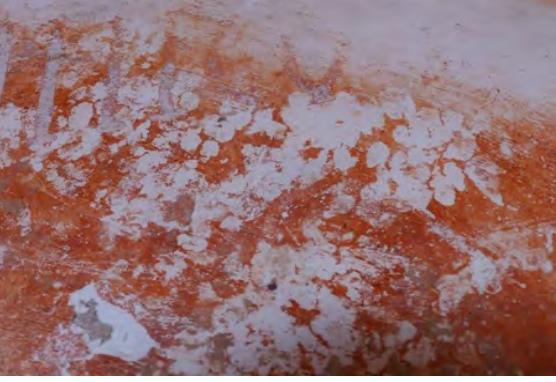
BİYOLOJİK NEDENLERLE BOYA TABAKASINDA KAYIP	PAINT LAYER LOSS DUE TO BIOLOGIC ACTIVITY Loss of the paint layer due to the former presence of birds' nests (primarily) which, when separated from the painting surface, removed part of the paint layer

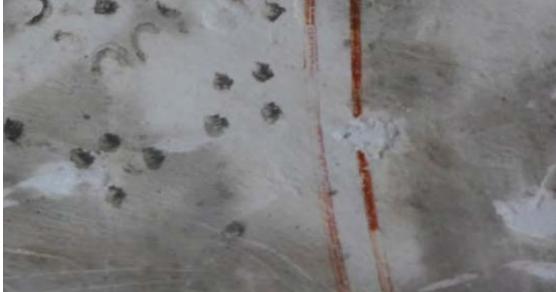
KOYU GRI LEKELENMELER	DARK GREY VEIL Veil extending over the surface of the painting, dark grey in color, somewhat patchy, and of unclear origin. Does not appear to be soot.

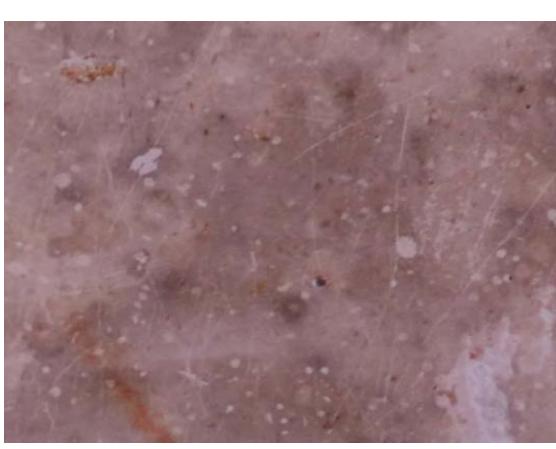
GRI LEKELENMELER	GREY SPOTTING Faint, circular grey spots, 0.5-3 mm Ø, on the surface of the painting. Origin unclear, but often generally occurs in the same vicinity as the grey veil

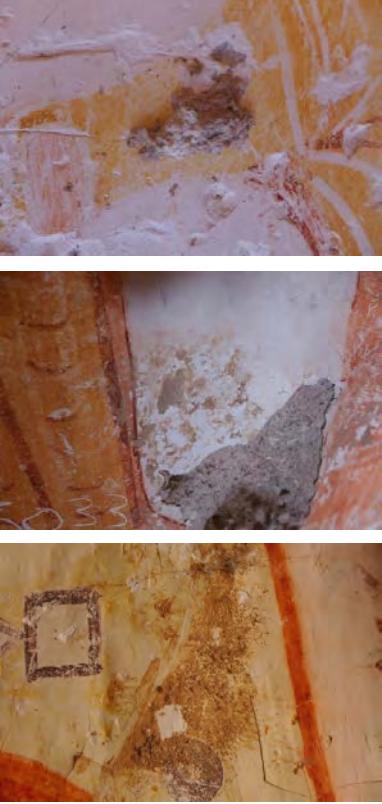
YÜZEY BİRİKİNTİLERİ	SURFACE DEPOSITION Deposition of material on the surface of the painting, such as mud from birds' nests or from later construction in the church (ex. mud plaster)

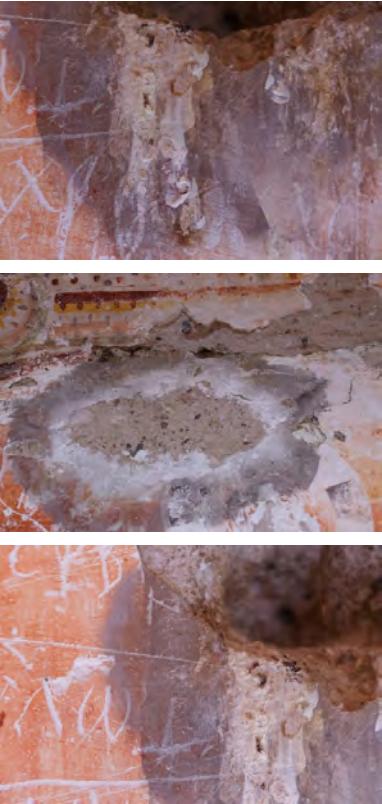
BİYOLOJİK BOZULMA	BIOLOGIC DETERIORATION Discoloration (generally dark grey) of certain areas of painting due to animal inhabitation. Has also resulted in the peeling and detachment of the plaster layer in certain areas

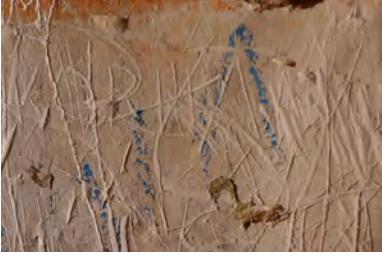
YÜZEYSEL GRAFİTİ	SUPERFICIAL GRAFFITI Graffiti applied to the surface of the painting using a medium such as paint, ink, or graphite. At times the original paint layer used as a medium by taking advantage of its friability/water sensitivity

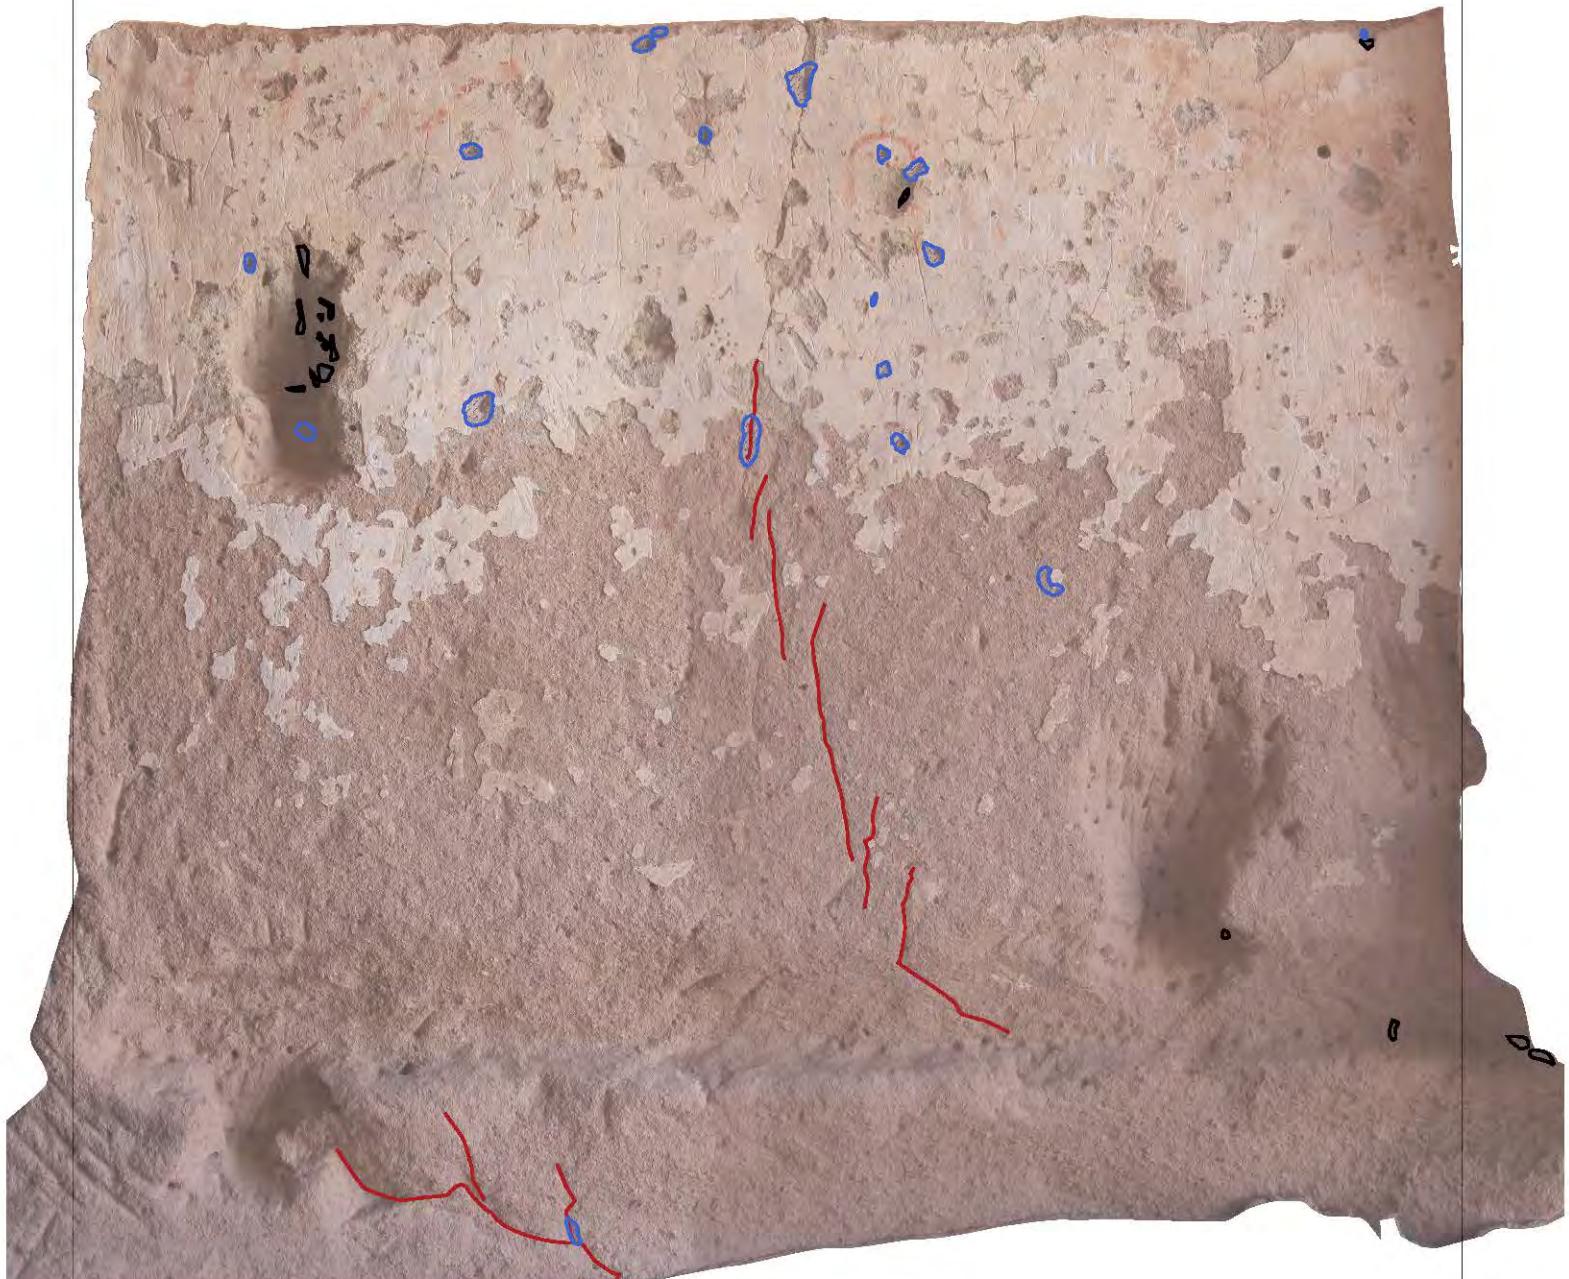
Section A-A'		LEGEND A: Rock Deterioration	Church Name (Turkish)
		Deposition of Dark Material	Üzümlü Kilise
		Biologic Activity	Church Name (English)
		Structural Cracks	Chapel of Niketas the Stylite
		Location	South Wall of Chamber 1
		Subject	Mural condition map
		Scale	Category
		1/10	A
		Plate No.	Plate015 UZM-C1-014

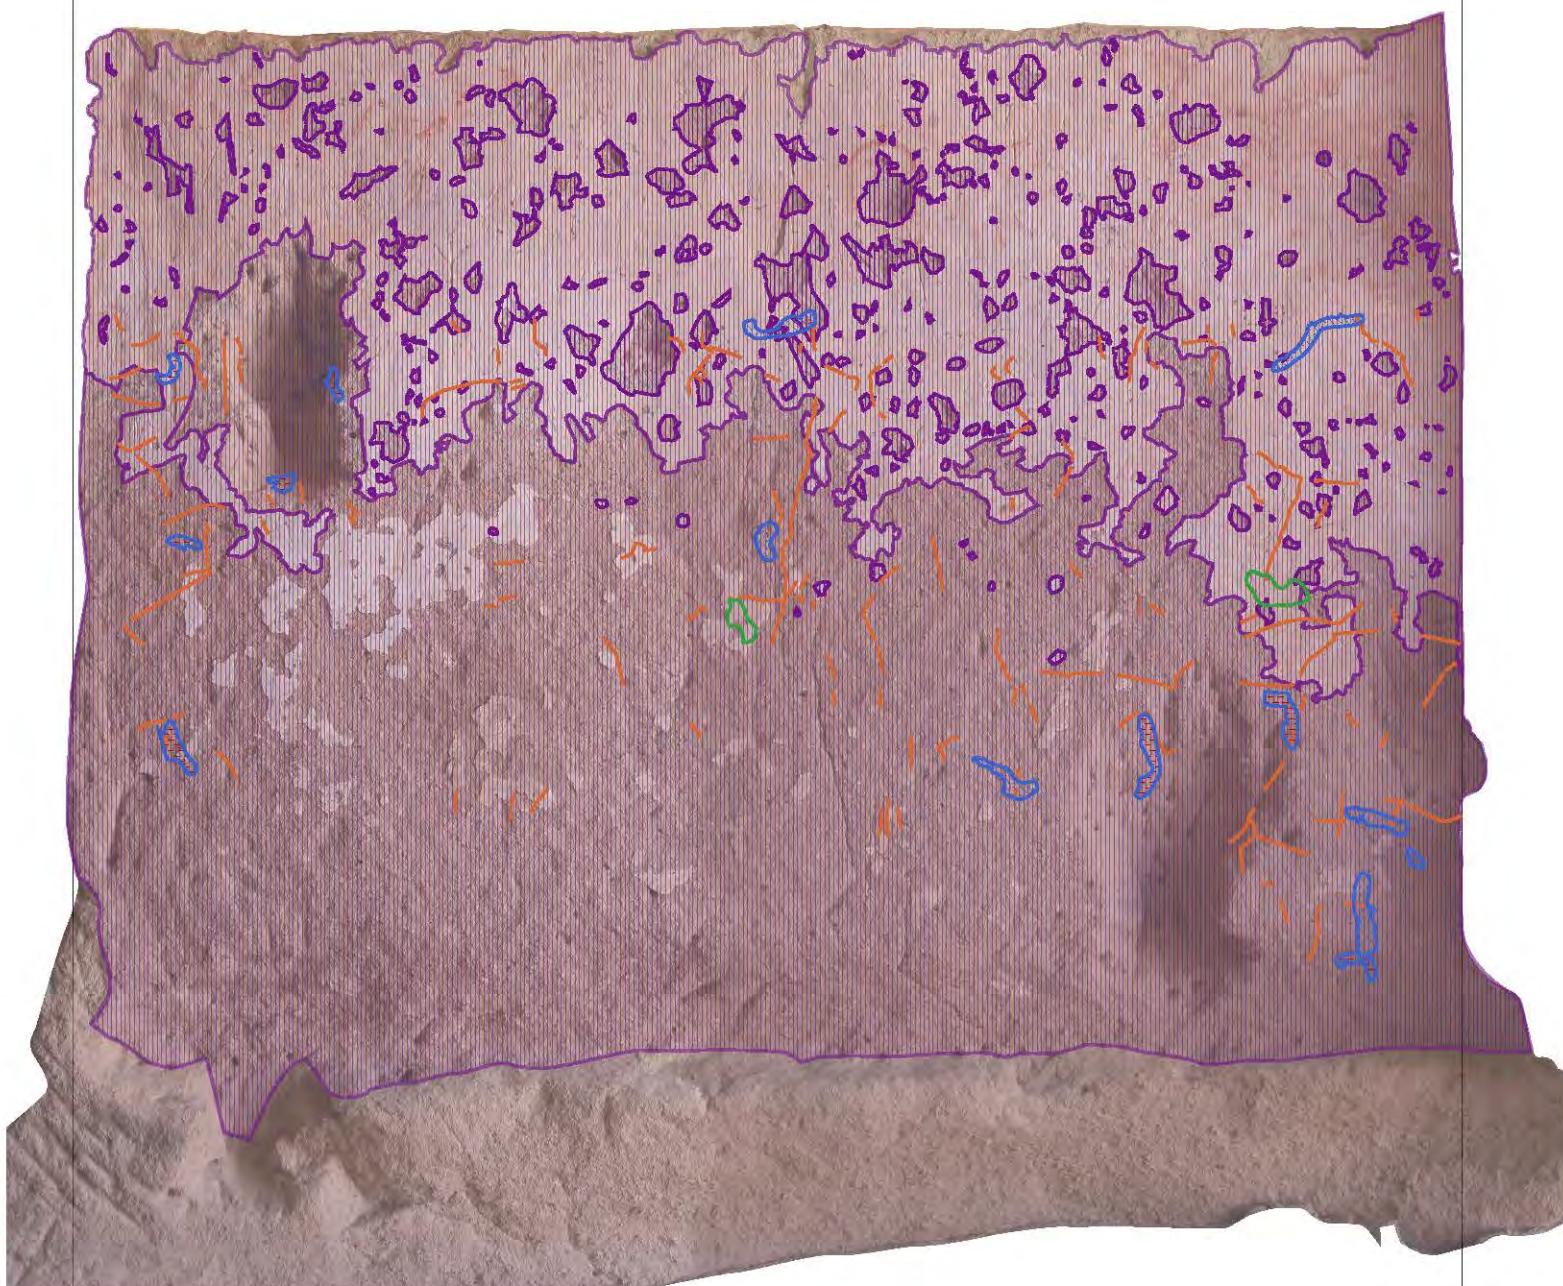
Section A-A'	LEGEND B: Plaster Deterioration	Church Name (Turkish)
	<ul style="list-style-type: none"> Detachment of Lower Layer Mechanical Damage Cracking Holes 	Üzümlü Kilise
		Church Name (English)
		Chapel of Niketas the Stylite
		Location
		South Wall of Chamber 1
		Subject
		Mural condition map
		Scale Category
	1/10	B
	Plate No.	
		Plate016 UZM-C1-015

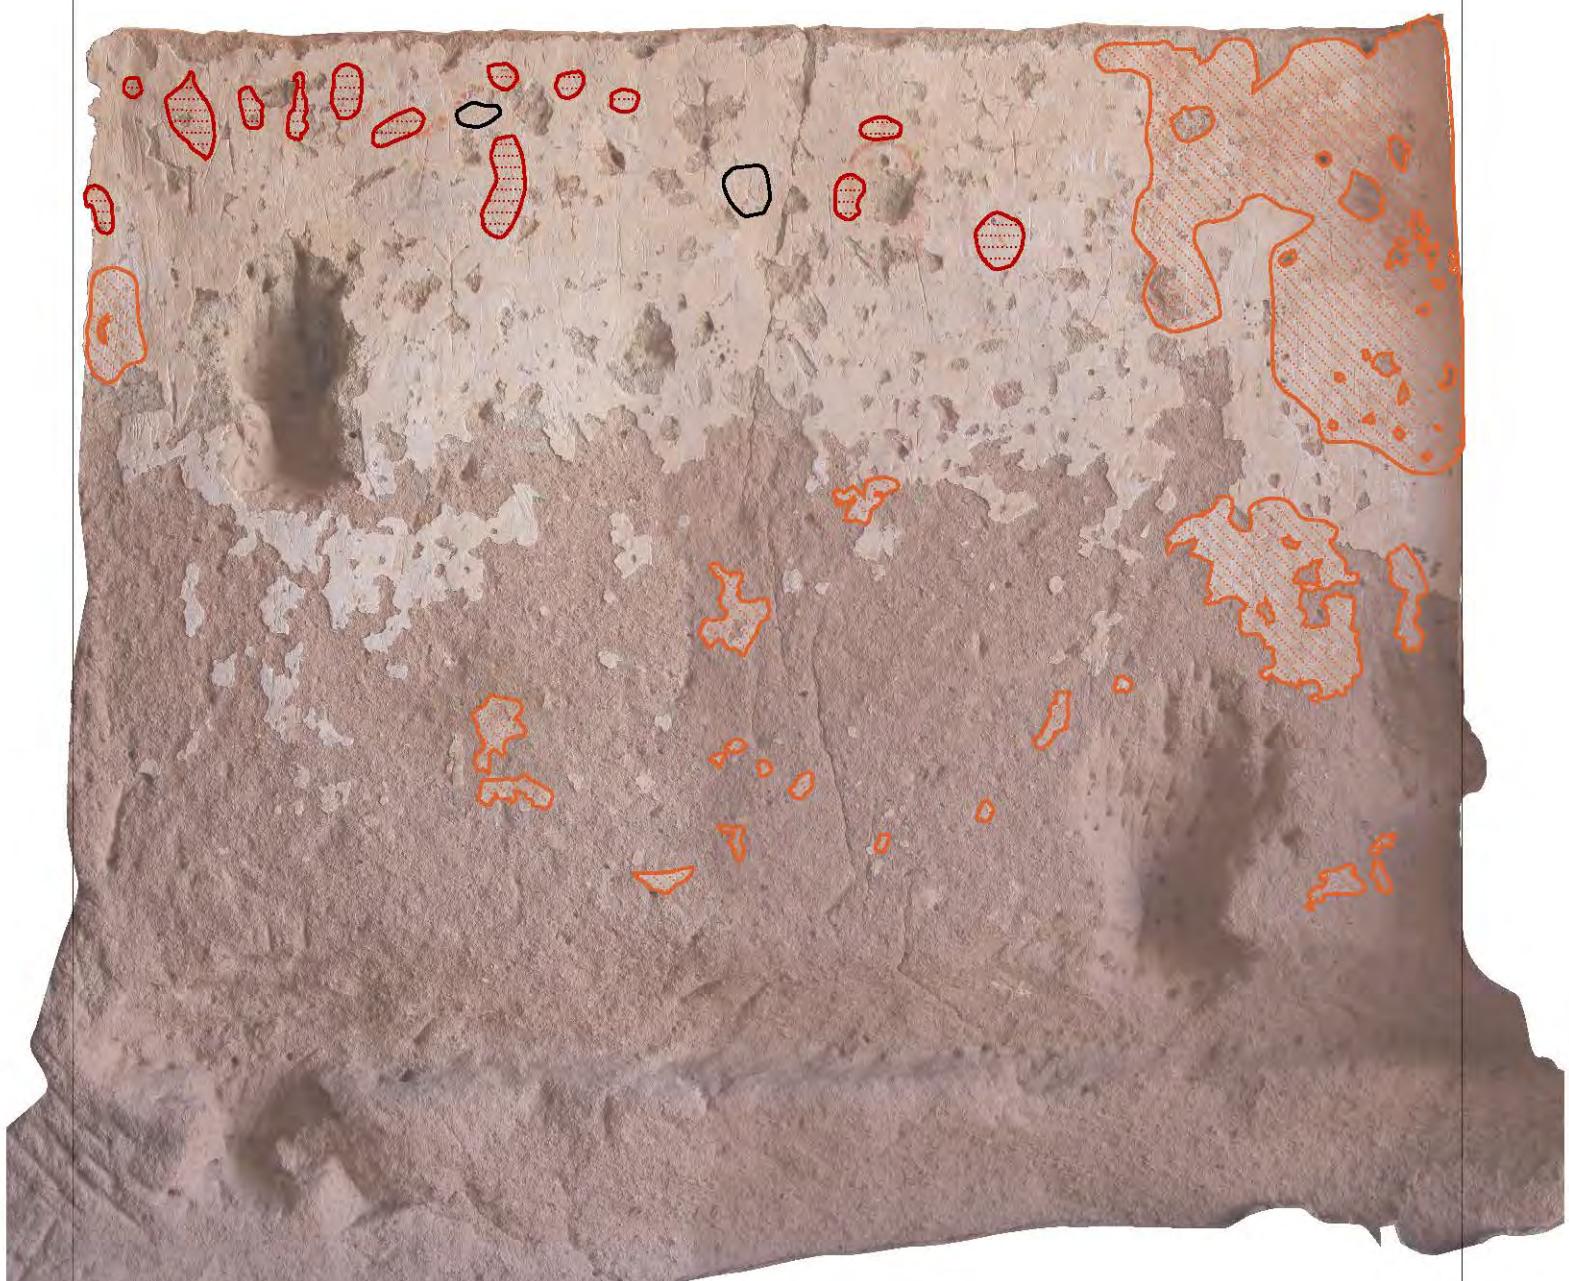
Section A-A'	LEGEND C: Paint Deterioration	Church Name (Turkish)
	<ul style="list-style-type: none"> █ Smearing █ Surface Deposition — Superficial Graffiti 	Üzümlü Kilise
		Church Name (English)
		Chapel of Niketas the Stylite
		Location
		South Wall of Chamber 1
		Subject
		Mural condition map
		Scale
		1/10
		Category
		C
		Plate No.
		Plate017 UZM-C1-016

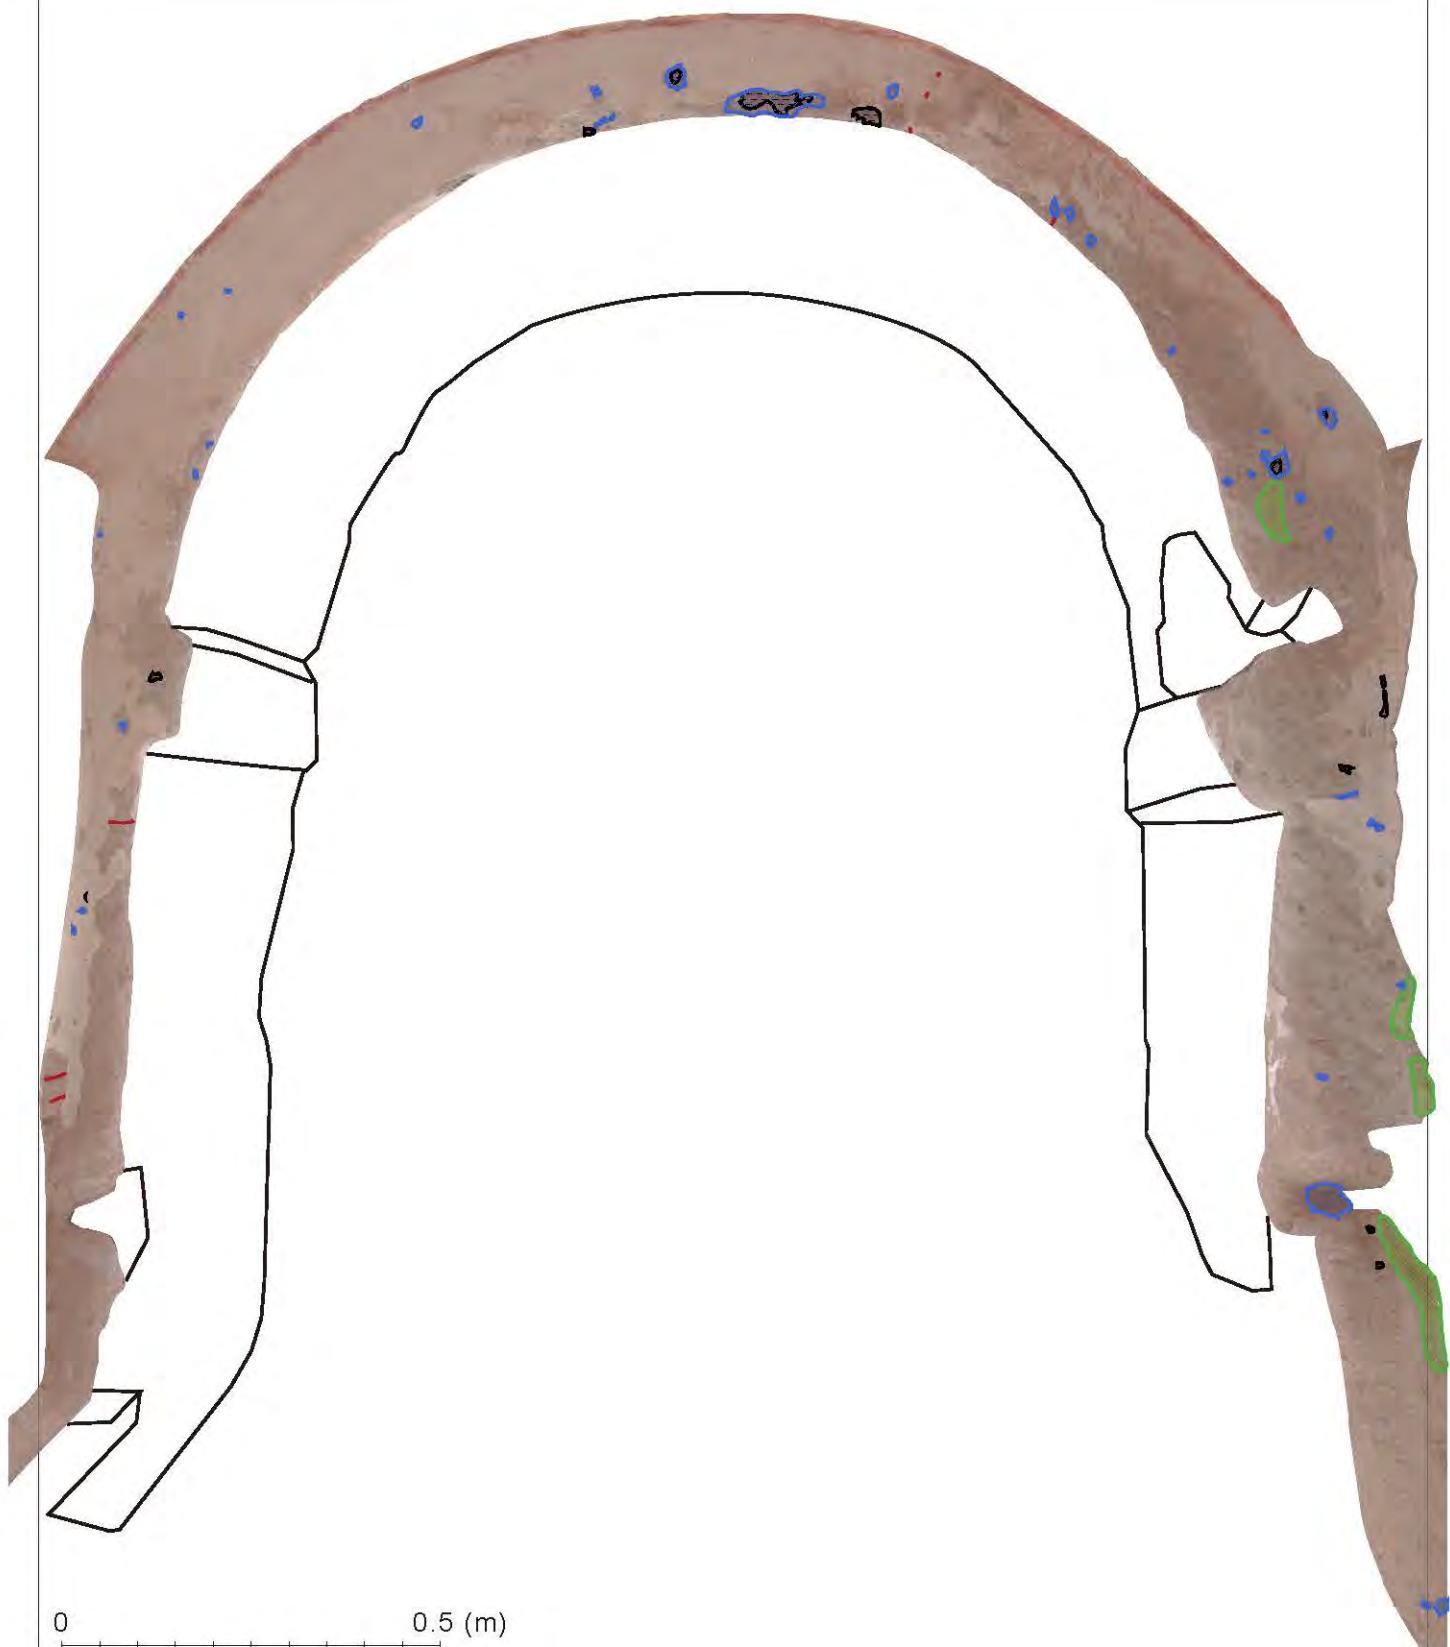
Section G-G'	LEGEND A: Rock Deterioration	Church Name (Turkish) Üzümlü Kilise
	<ul style="list-style-type: none"> Deposition of Dark Material Biologic Activity Spalling Structural Cracks 	Church Name (English) Chapel of Niketas the Stylite
G		Location West Wall of Chamber 1
G'		Subject Mural condition map
		Scale Category 1/10 A
		Plate No. Plate019 UZM-C1-018
