Scientific Studies on Conservation for Üzümlü Church and its wall paintings in Cappadocia, Turkey

Vol. 1 : Annual report on the activities in 2014

**University of Tsukuba
2014**

Yoko Taniguchi, University of Tsukuba

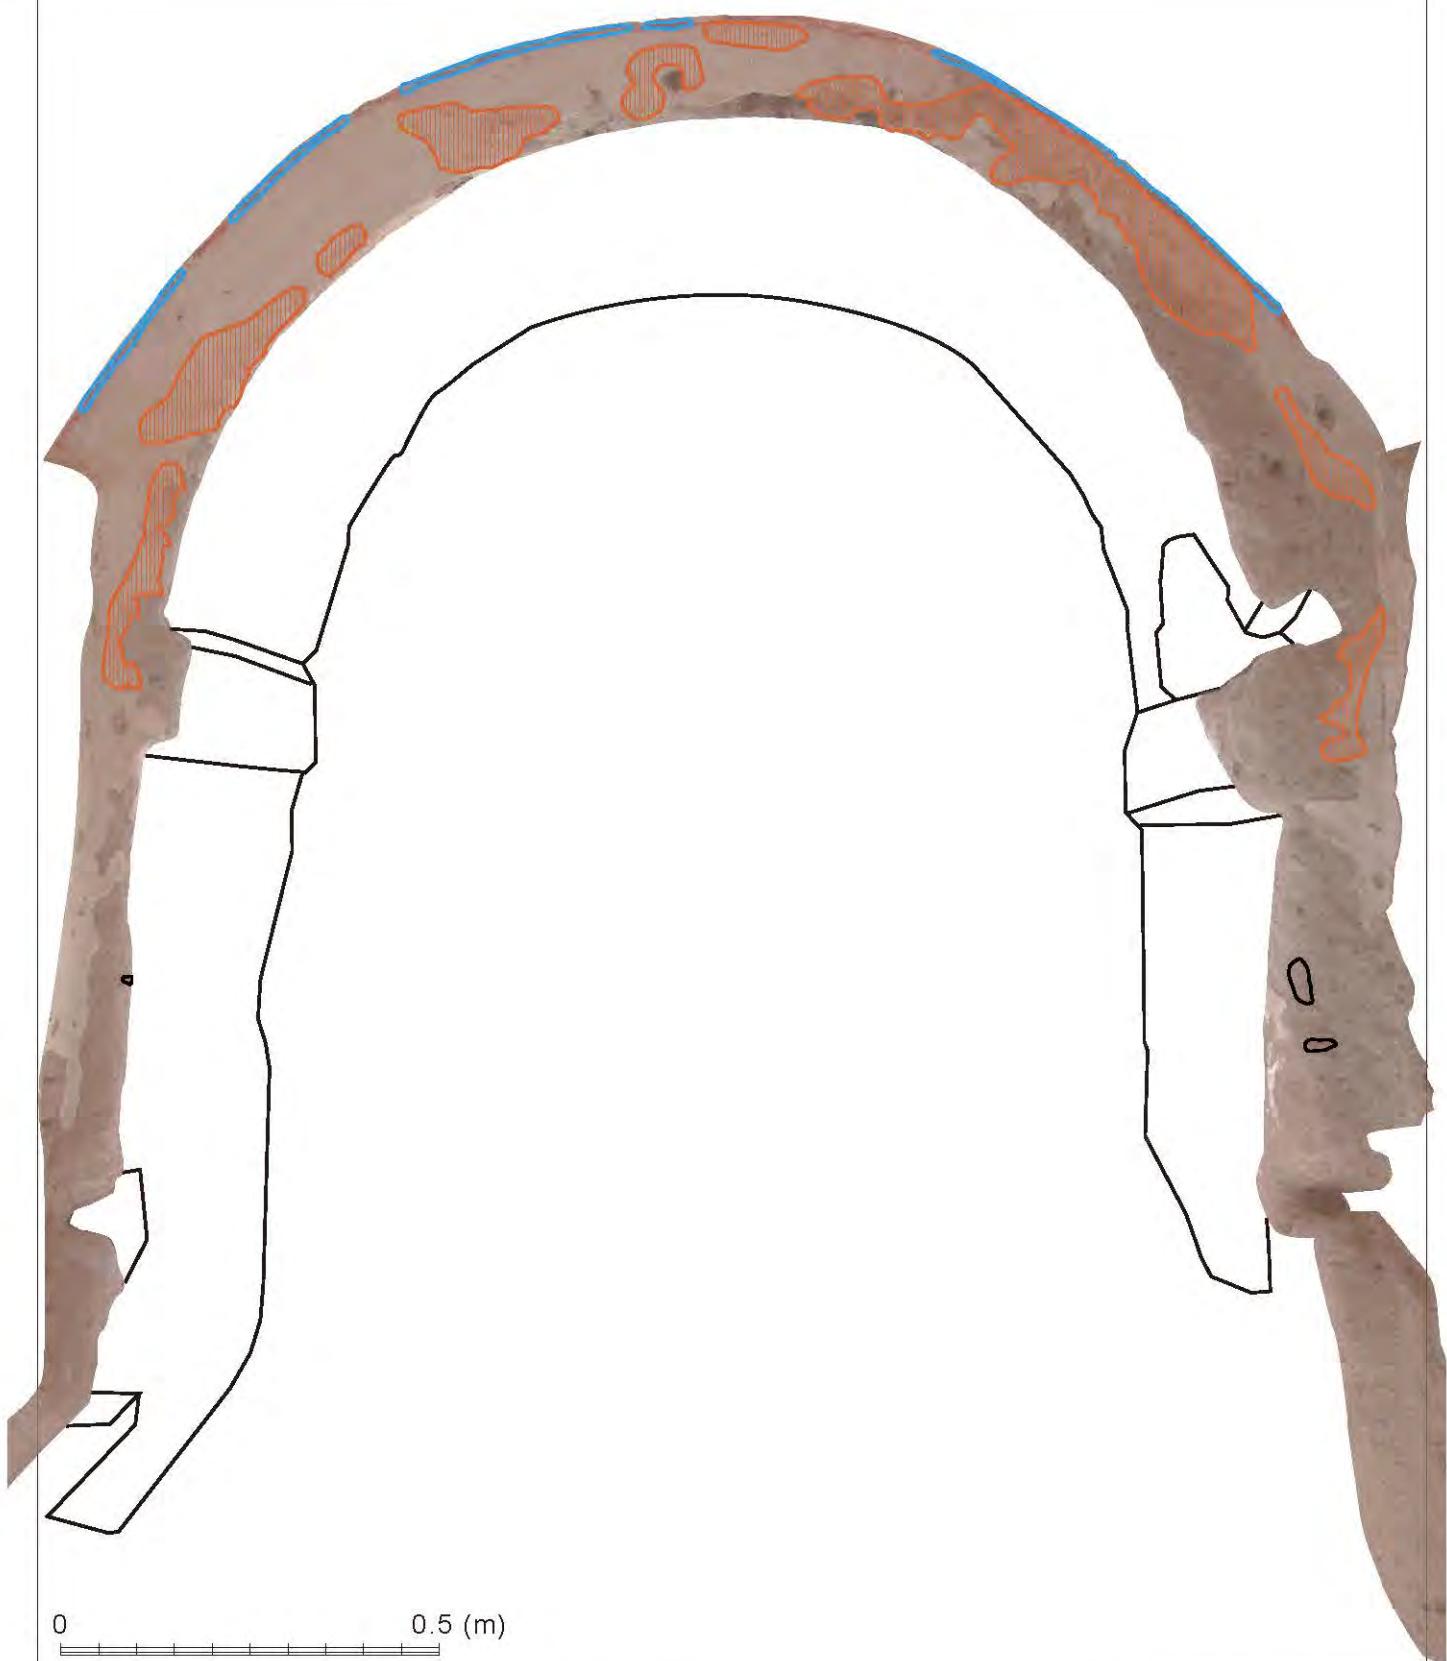
Section G-G'	LEGEND C: Paint Deterioration	Church Name (Turkish) Üzümlü Kilise
	Smearing Micro Losses Surface Deposition Grey Spotting Superficial Graffiti Dark Grey Veil Biological Deposition Paint Loss due to Biological Activity	Church Name (English) Chapel of Niketas the Styliste
G		Location
G		West Wall of Chamber 1
		Subject
		Mural condition map
		Scale Category
		1/10 C
		Plate No.
		Plate021 UZM-C1-020

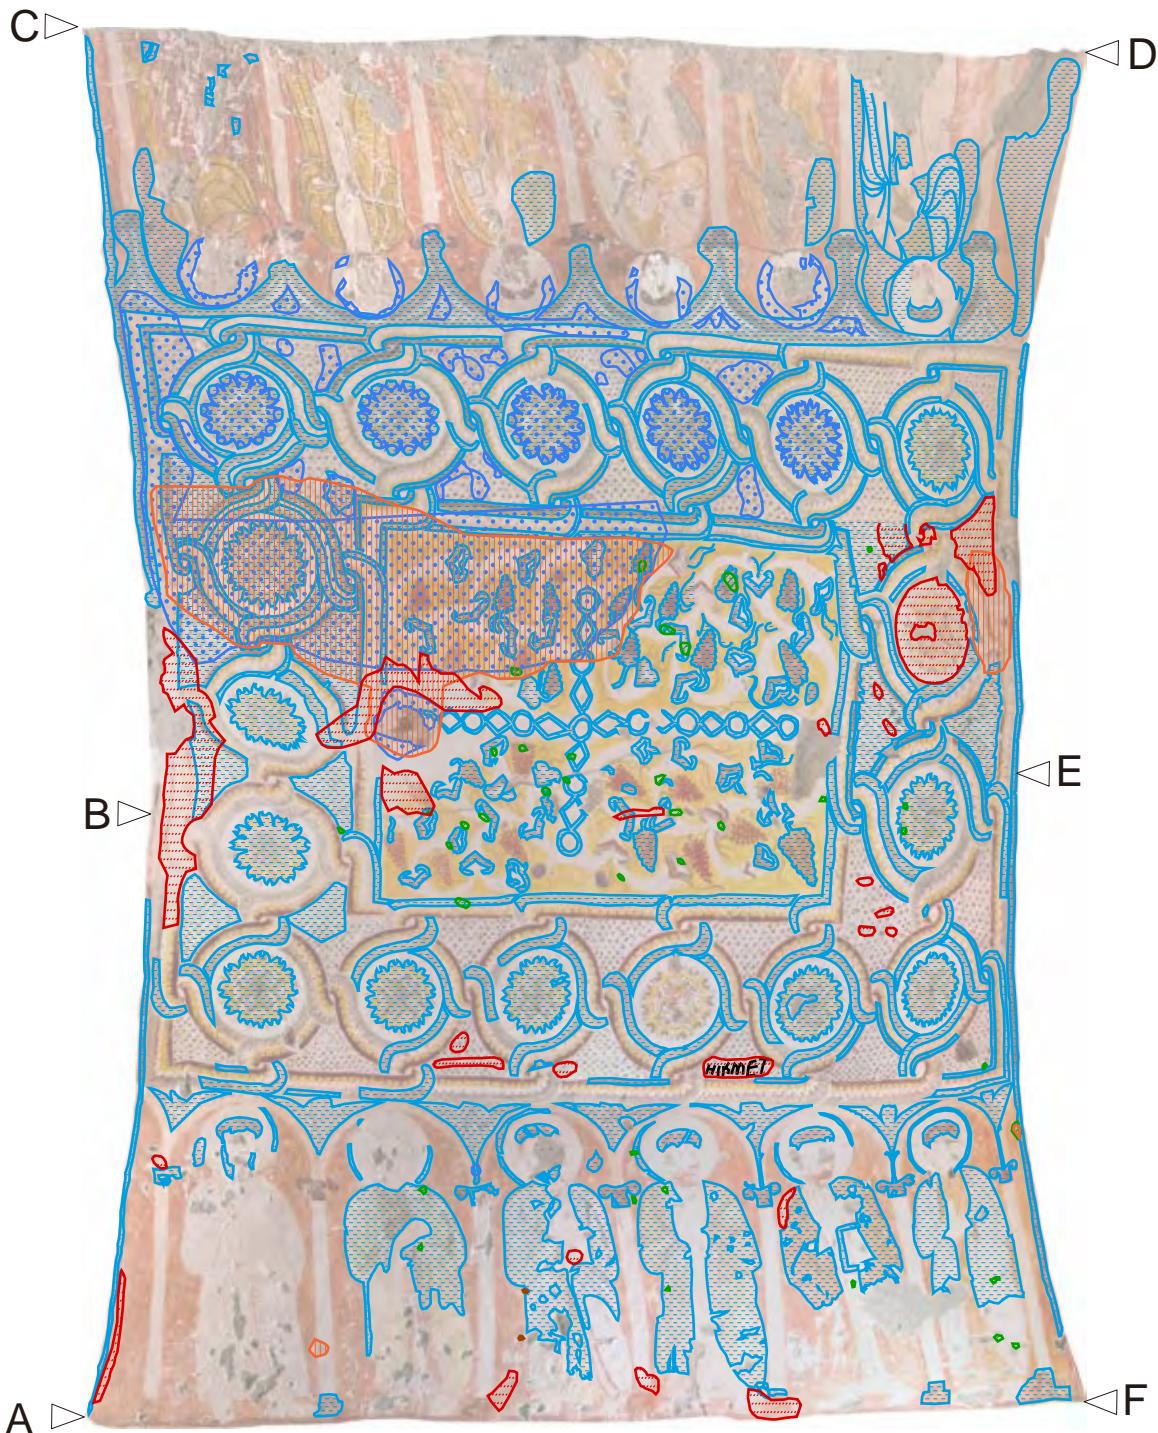
Ceiling	LEGEND C: Paint Deterioration		Church Name (Turkish)
	Smearing	Surface Deposition	Üzümlü Kilise
	Dark Grey Veil	Micro Losses	Church Name (English)
	Grey Spotting	Original Fixing	Chapel of Niketas the Stylite
	Biological Deposition	Superficial Graffiti	Location
	Nail	Paint Loss due to Biological Activity	Ceiling of Chamber 2
			Subject
			Mural condition map
			Scale Category
			1/20 C
			Plate No.
			Plate029 UZM-C ₂ -004
			168

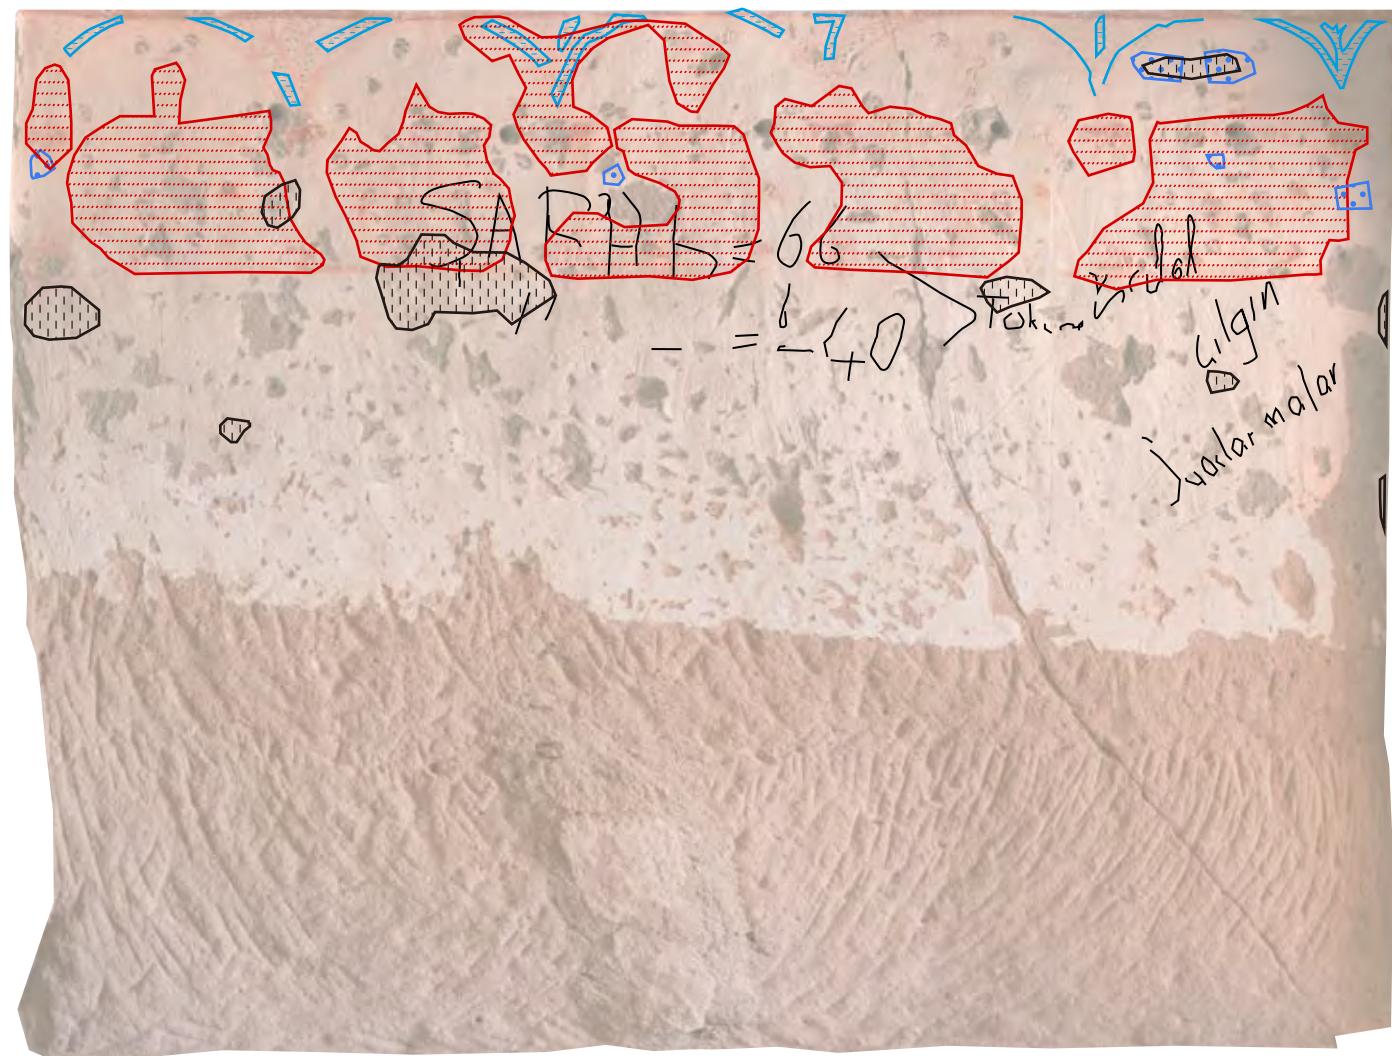
Church Name (Turkish)	Subject	
Üzümlü Kilise	Mural condition map	
Church Name (Turkish)	Scale	Category
Chapel of Niketas the Stylite	1/15	C
Location	Plate No.	
South Wall of Chamber 2	Plate033 UZM-C ₂ -008

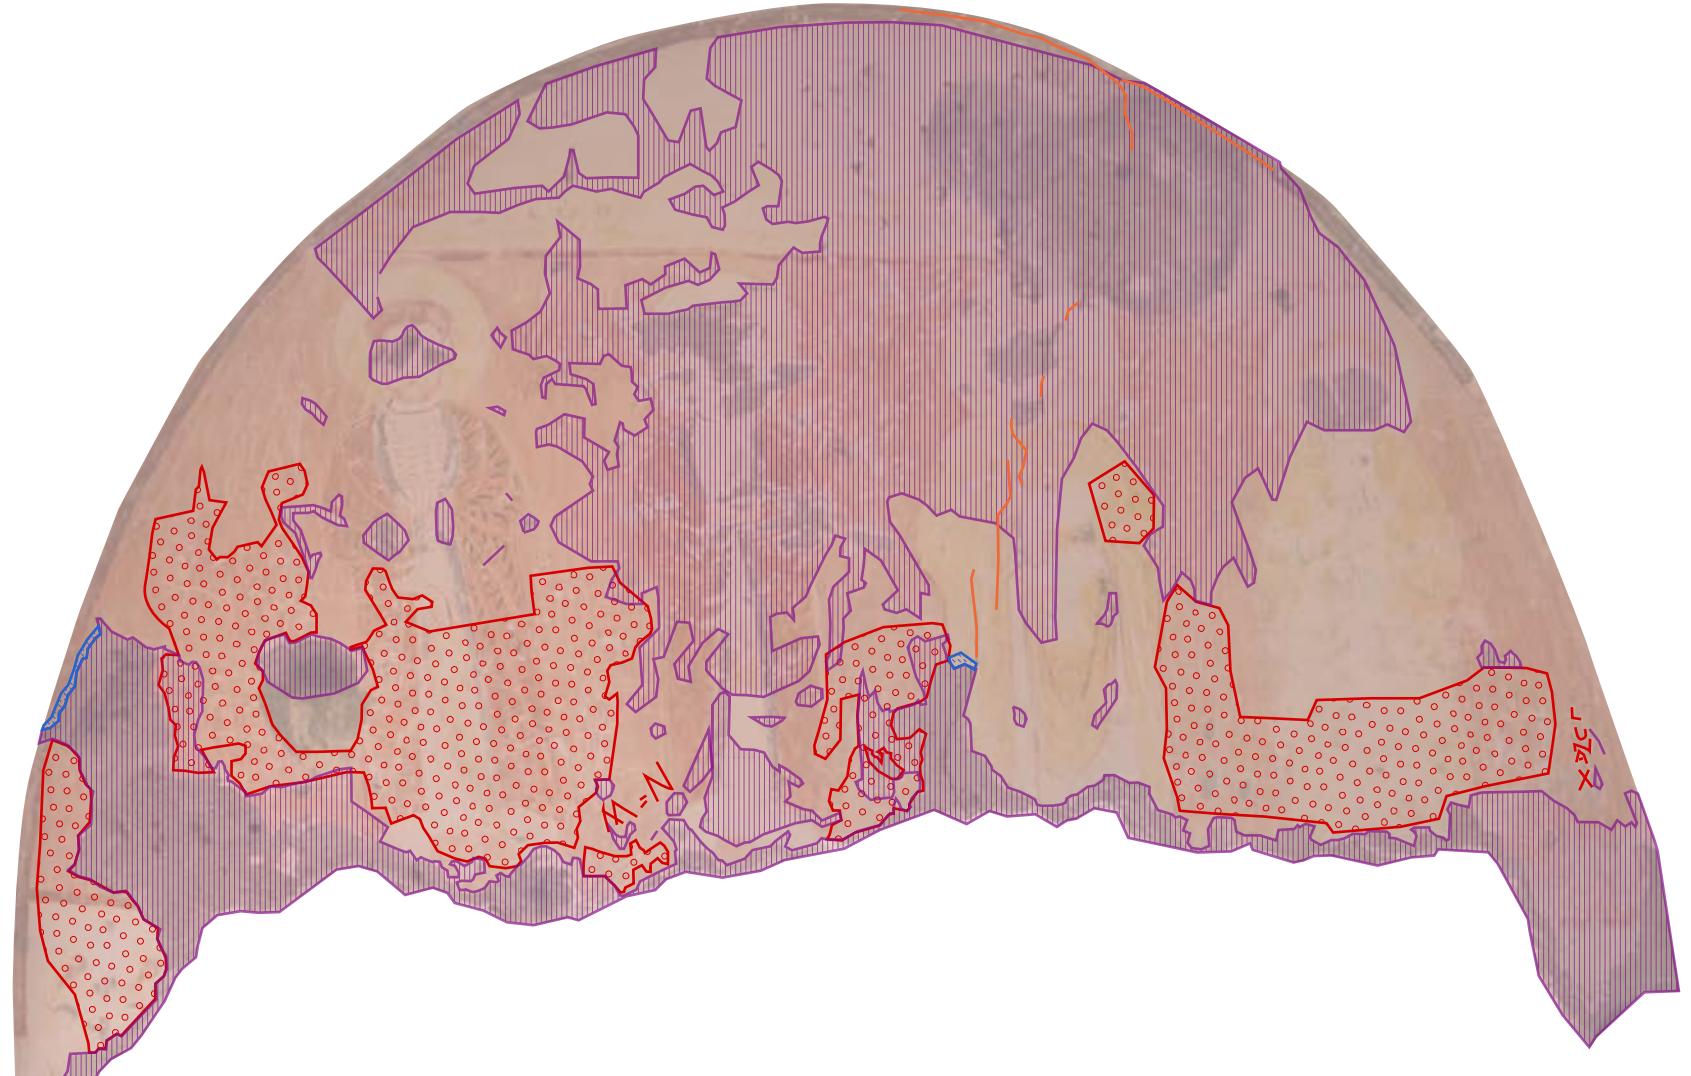
Plate035 UZM-C₂-010

LEGEND A: Rock Deterioration

Spalling

Structural Cracks

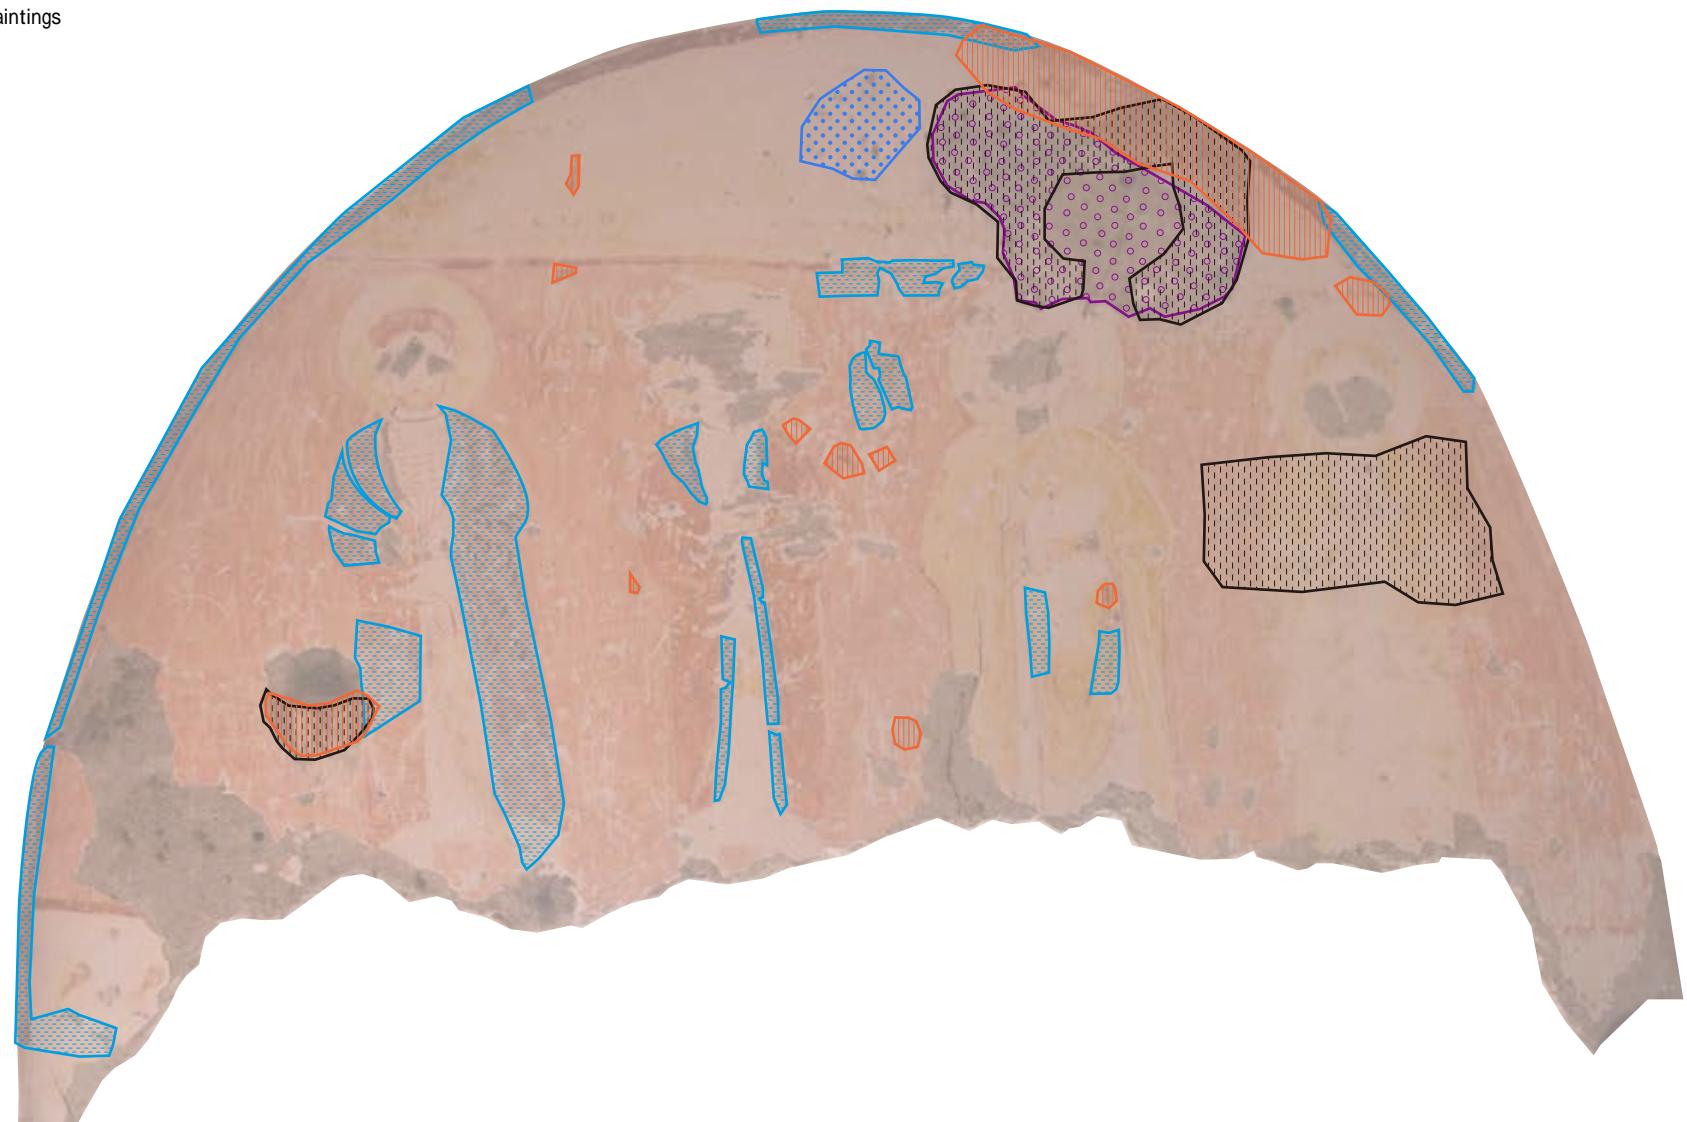
LEGEND C: Paint Deterioration

| Grey Spotting | Paint Loss due to Biological Activity | |

Church Name (Turkish)	Subject
Üzümlü Kilise	Mural condition map
Church Name (English)	Scale Category
Chapel of Niketas the Stylite	1/10 C
Location	Plate No.
West Wall of Chamber 2	Plate037 UZM-C ₂ -012

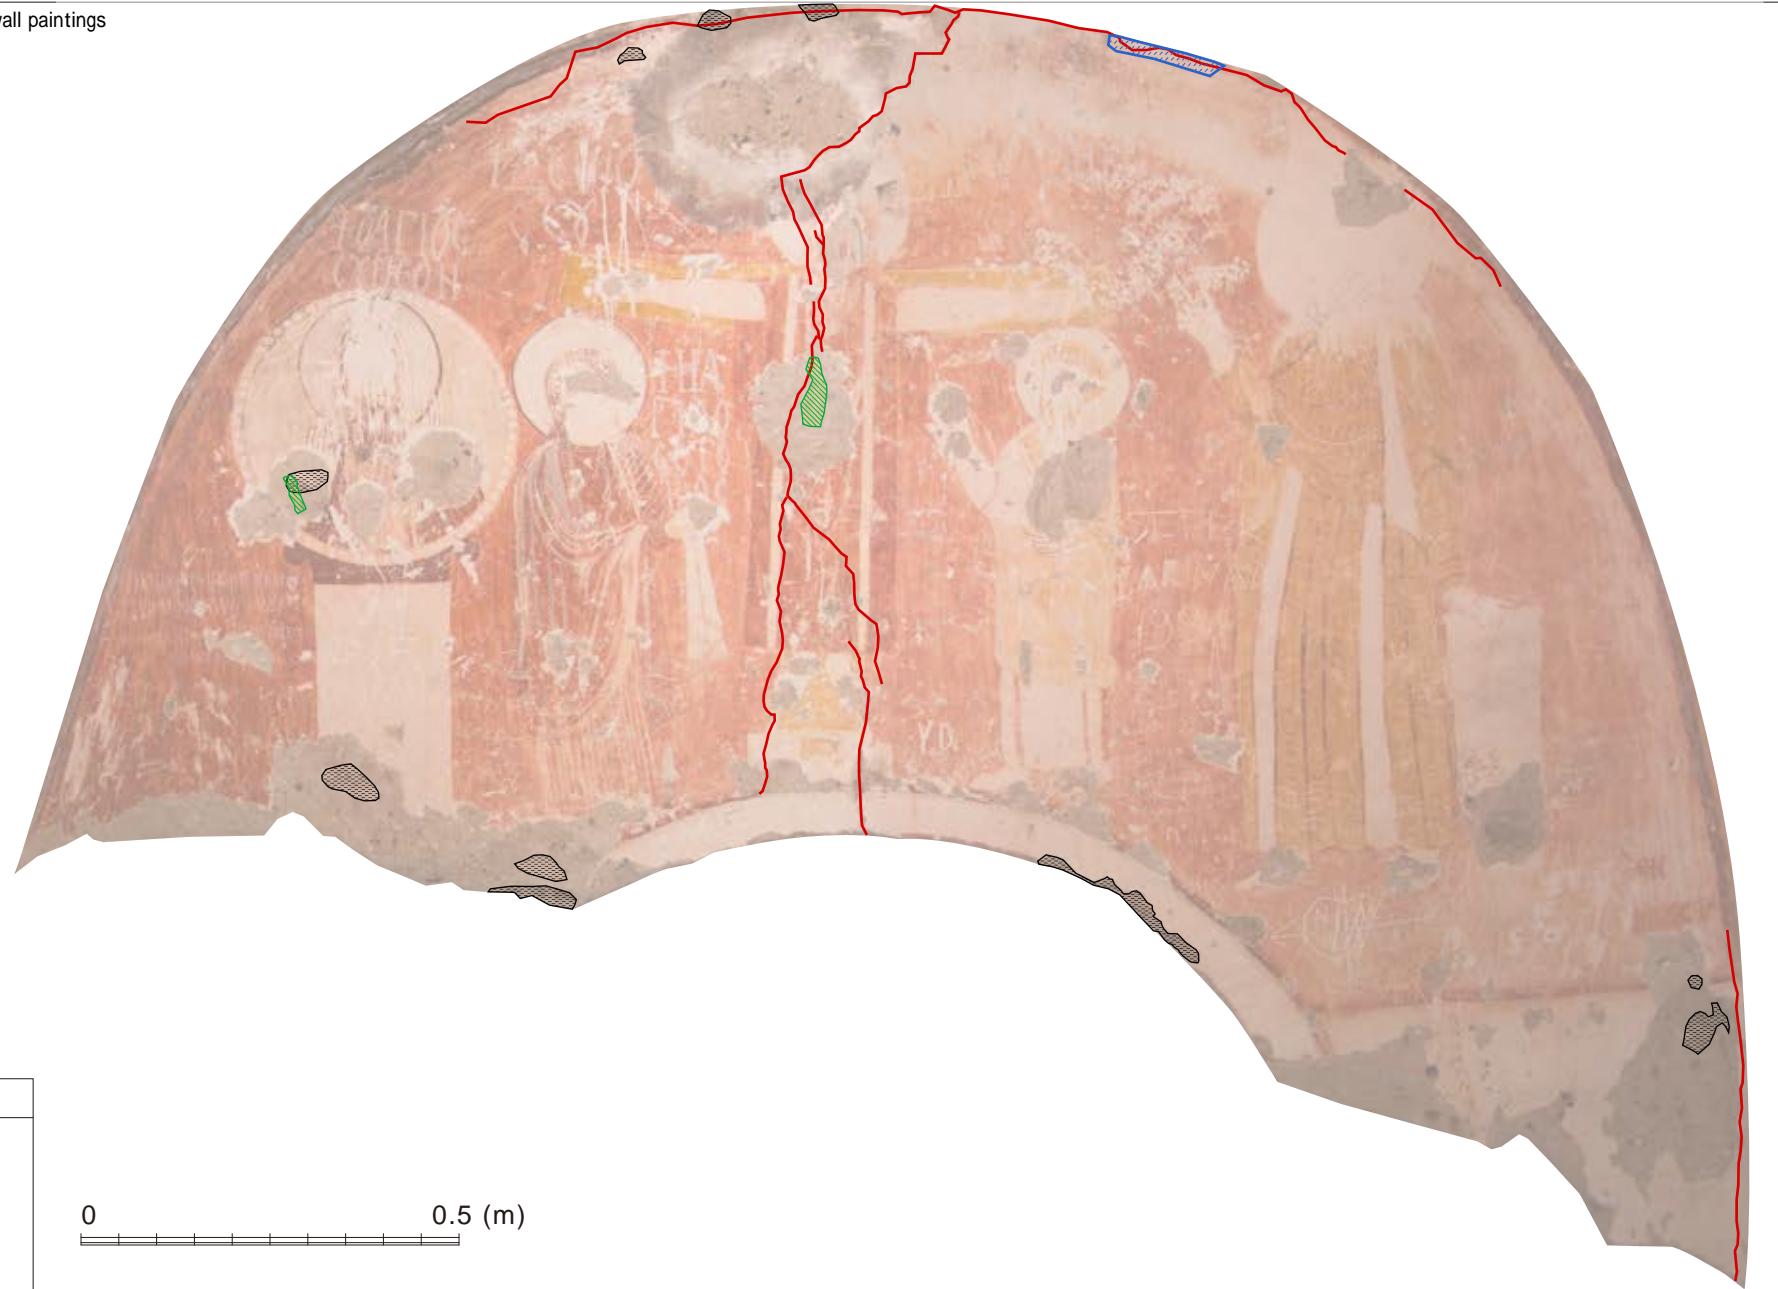
LEGEND A: Rock Deterioration

Spalling

Structural Cracks

Church Name (Turkish)	Subject
Üzümlü Kilise	Mural condition map
Church Name (English)	Scale
Chapel of Niketas the Stylite	1/10
Location	Category
East Wall of Chamber 2	A
Plate No.	
Plate039 UZM-C ₂ -014

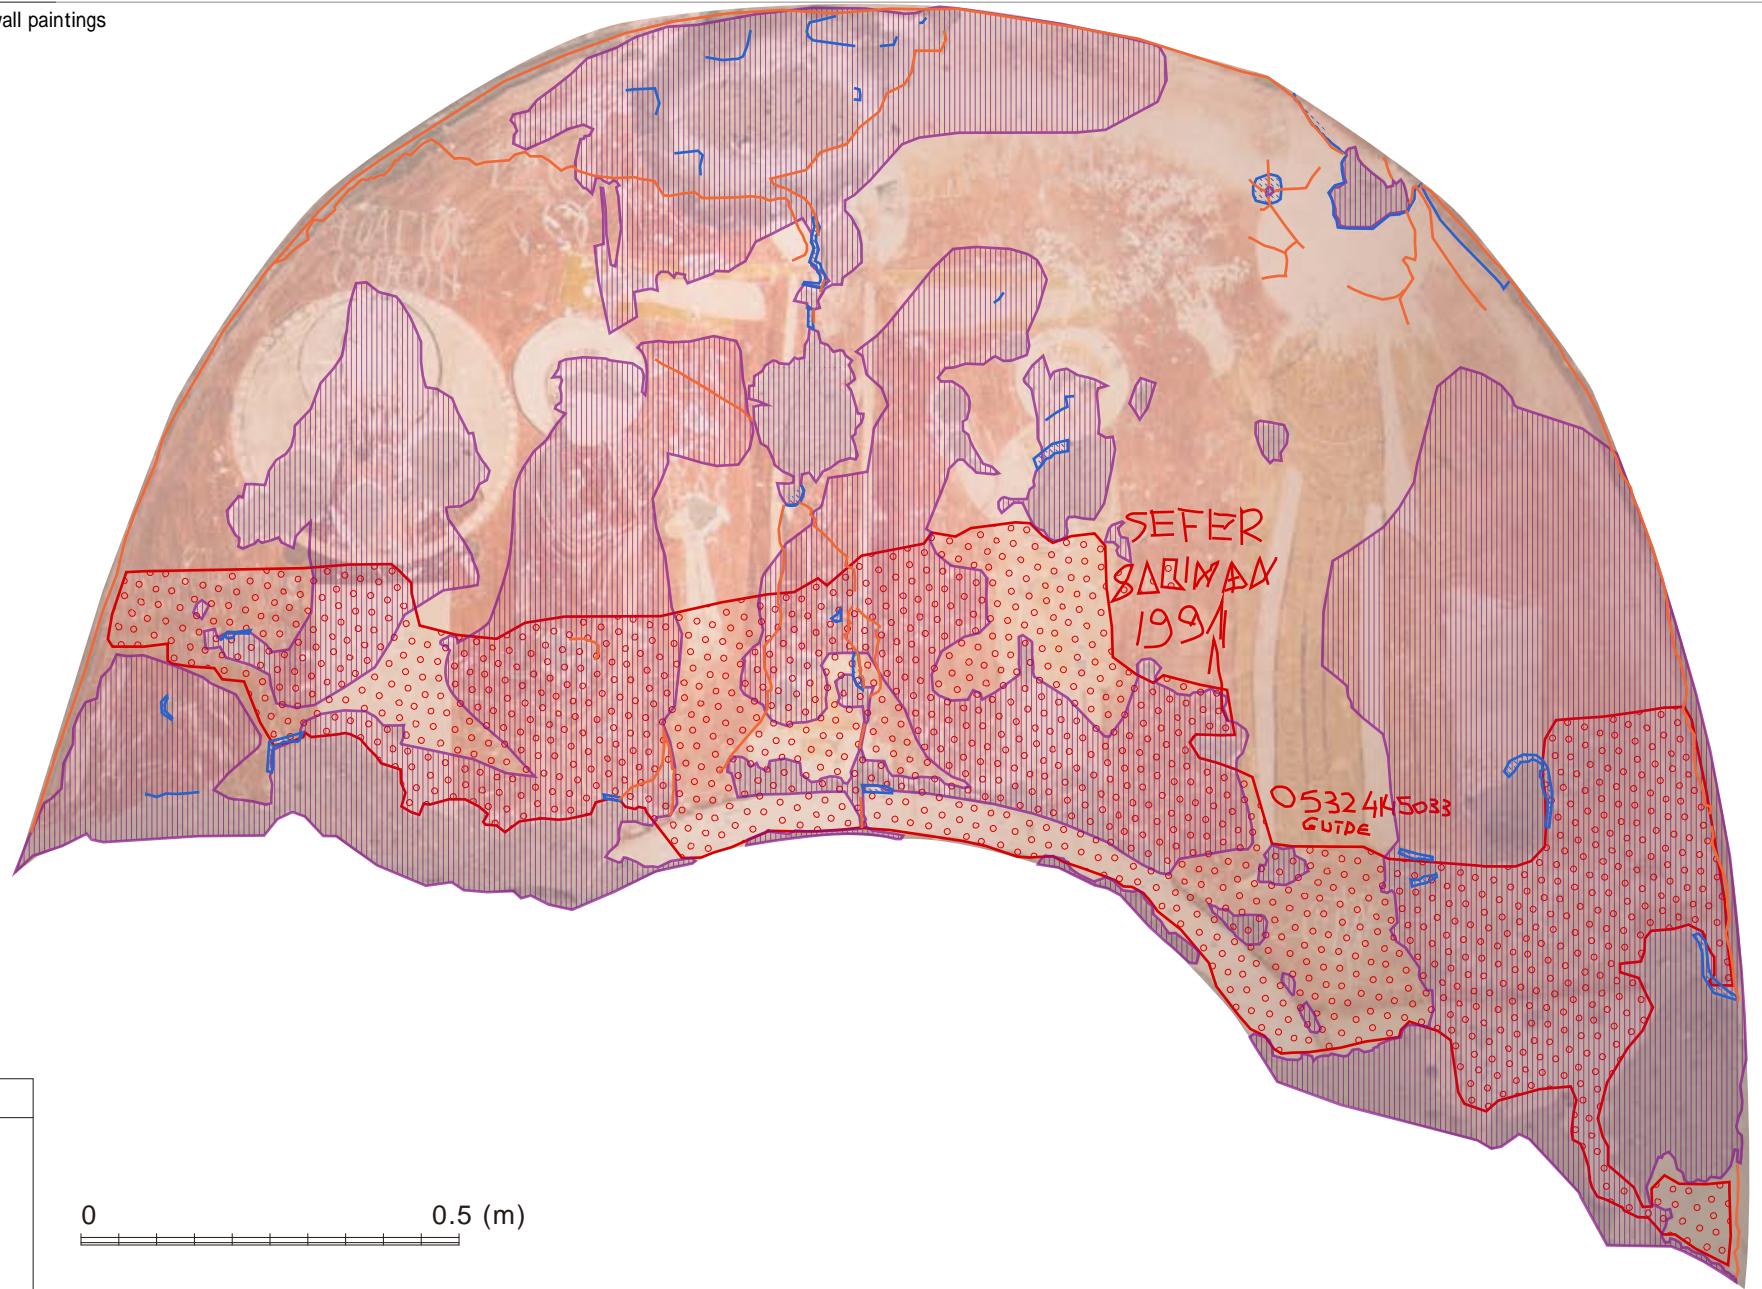
LEGEND B: Plaster Deterioration

Mechanical Damage

Cracking

Church Name (Turkish)	Subject
Üzümlü Kilise	Mural condition map
Church Name (English)	Scale
Chapel of Niketas the Stylite	Category
Location	1/10
East Wall of Chamber 2	Plate No.
	Plate040 UZM-C ₂ -015

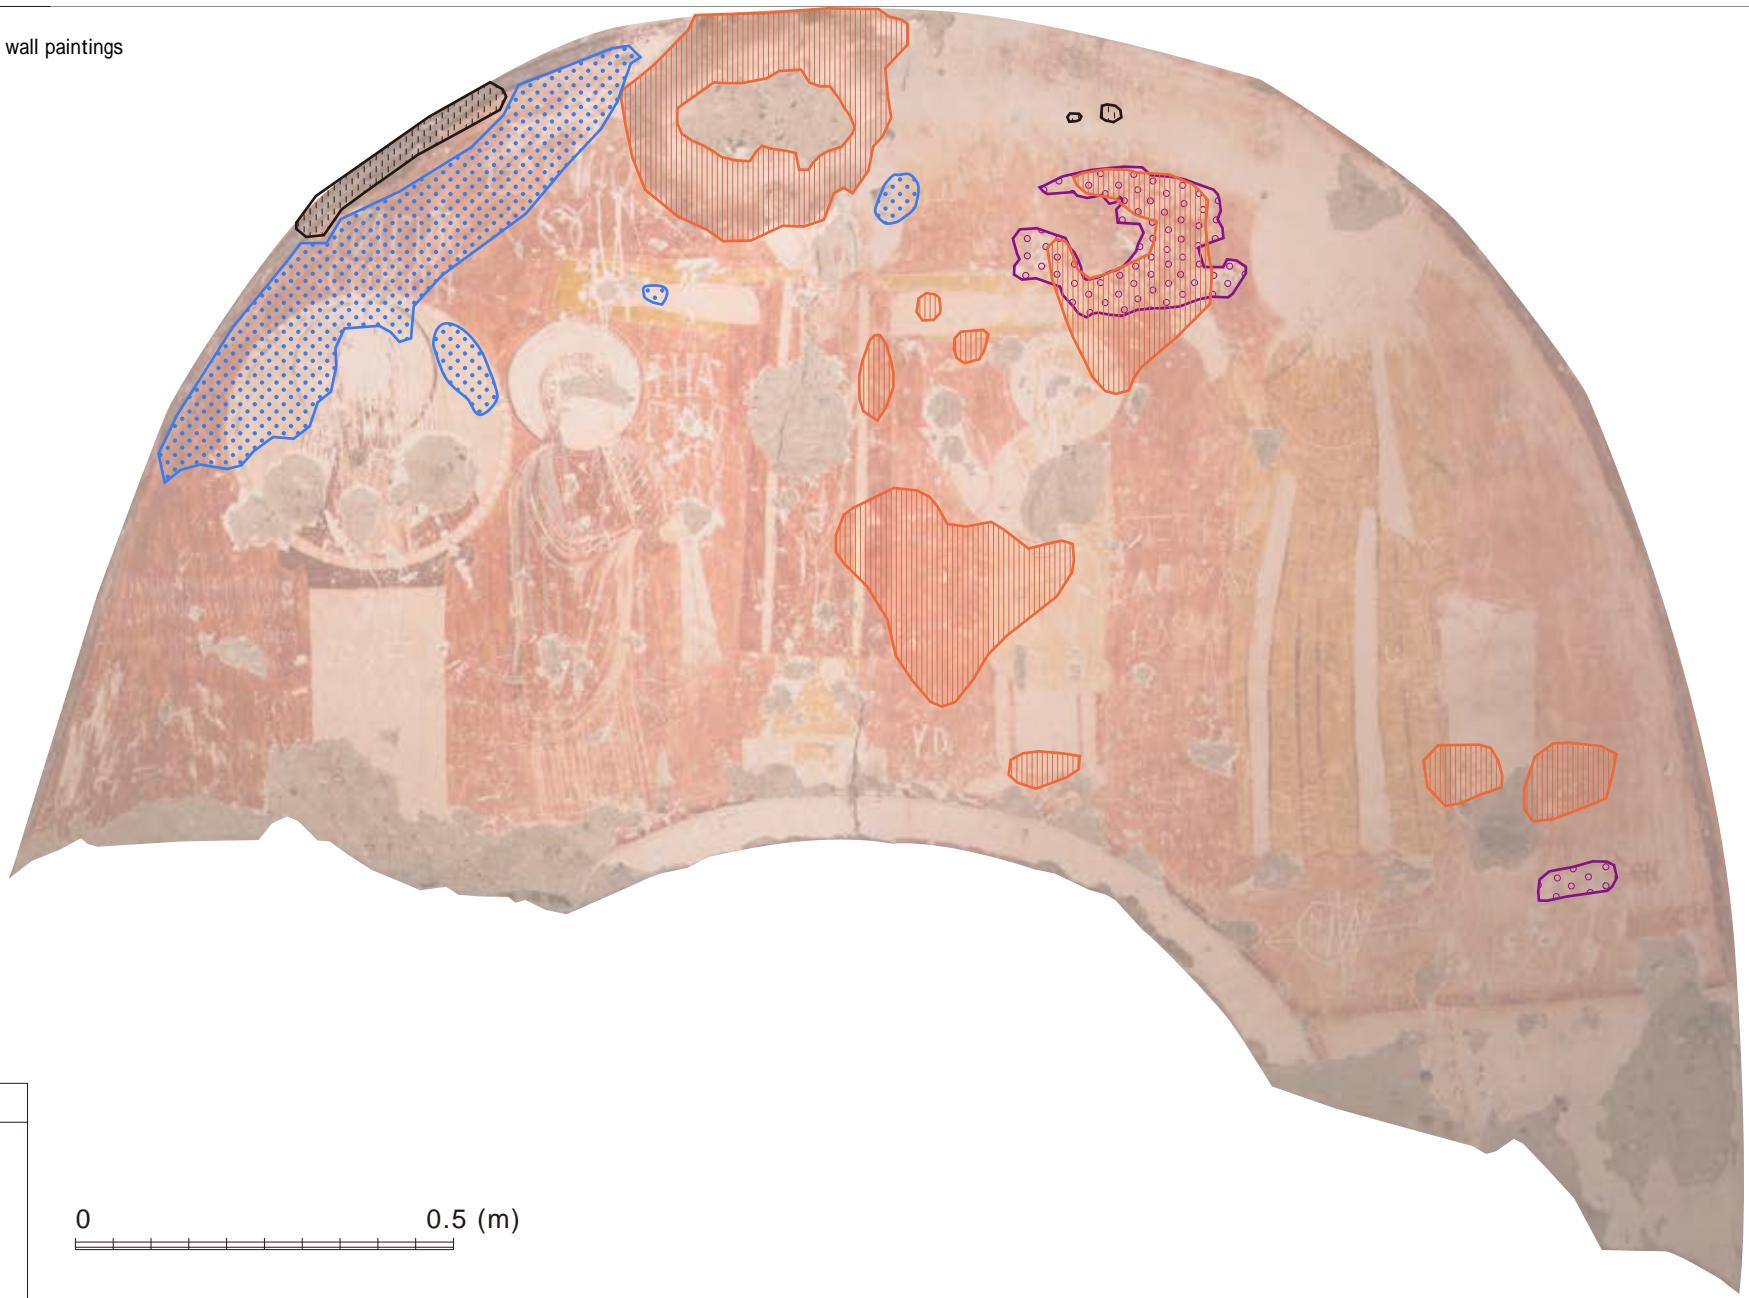
LEGEND C: Paint Deterioration

Church Name (Turkish)	Subject	Mural condition map
Üzümlü Kilise		
Church Name (English)	Scale	Category
Chapel of Niketas the Stylite	1/10	C
Location	Plate No.	
East Wall of Chamber 2	Plate041	UZM-C ₂ -016

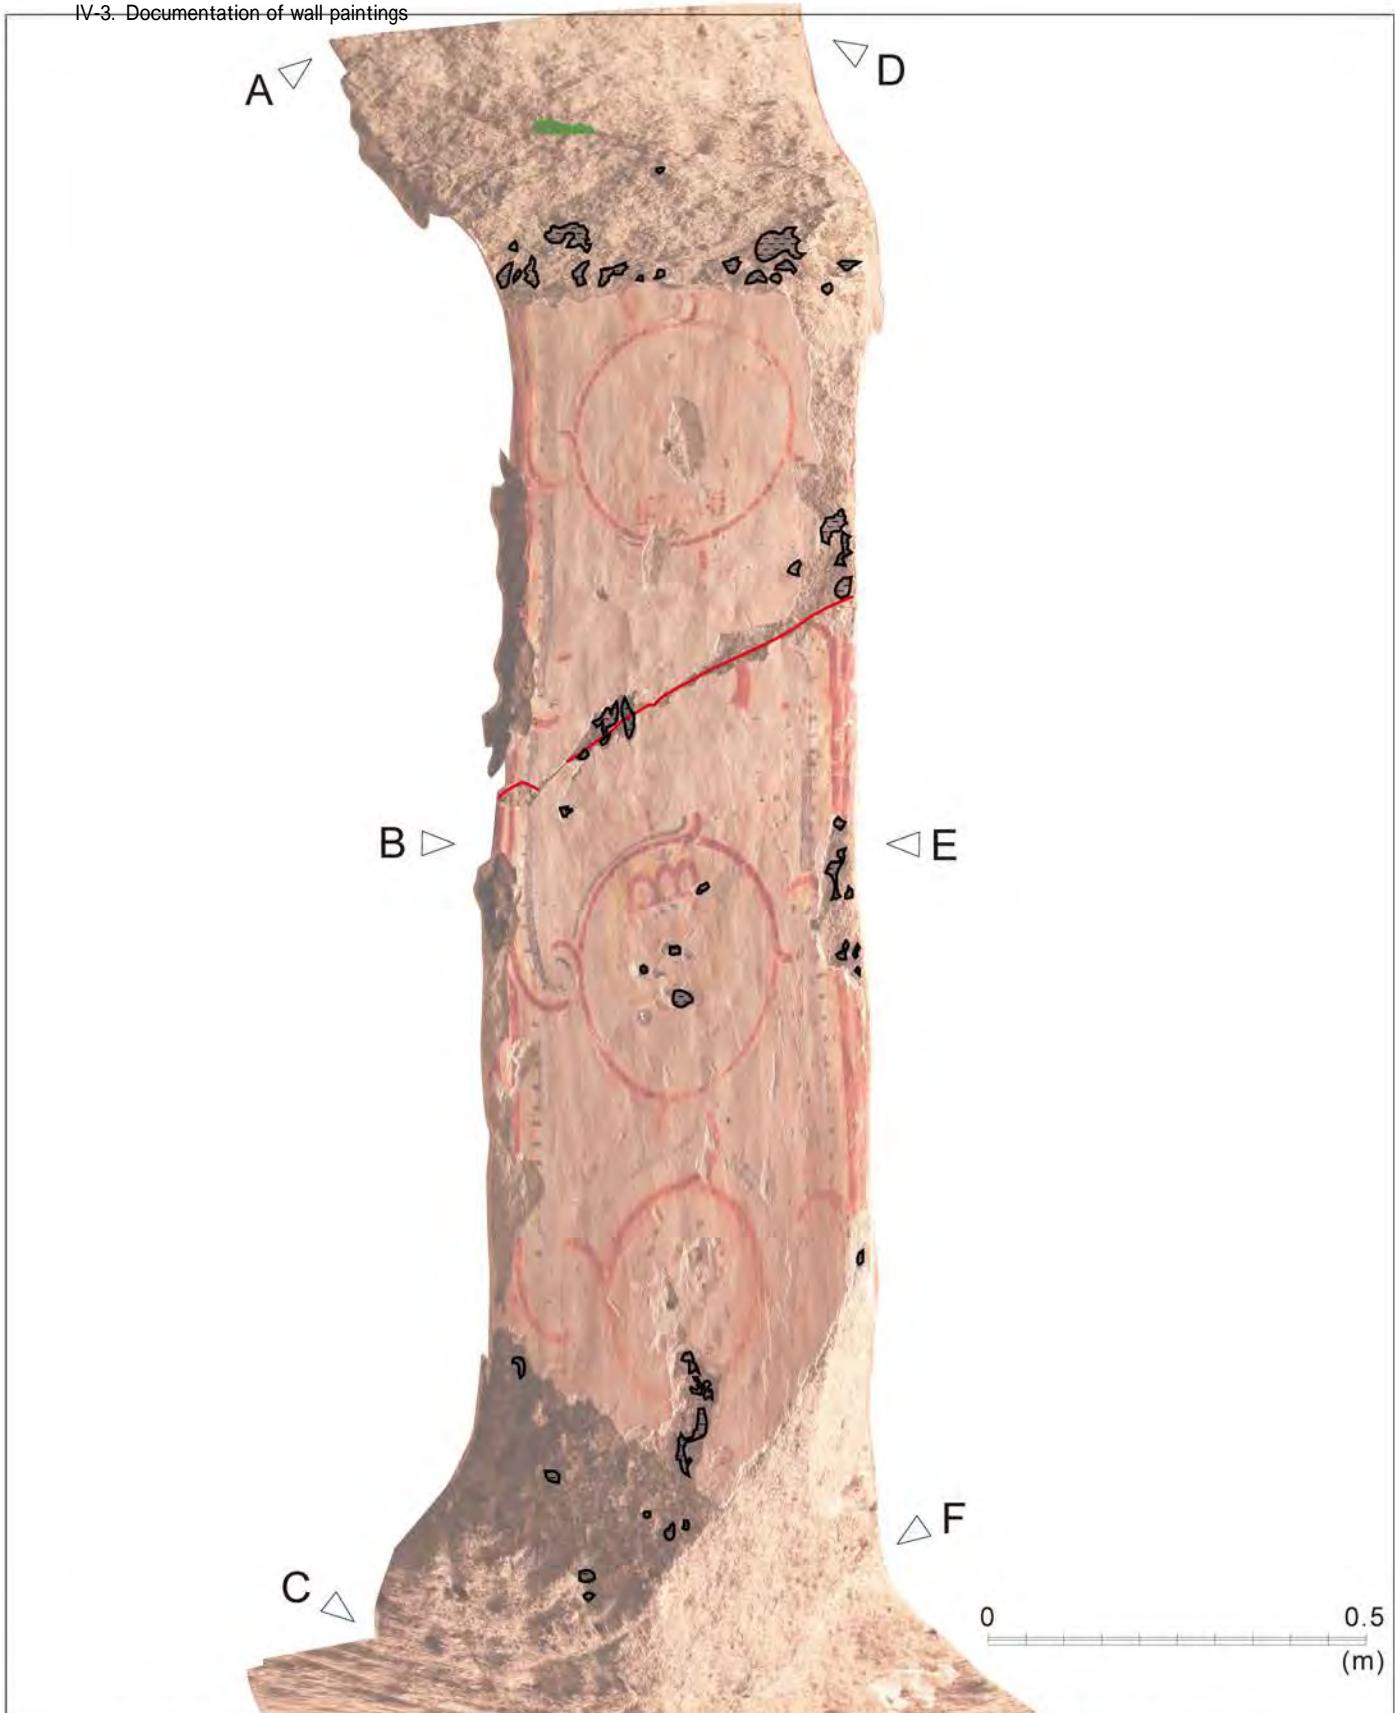
Ceiling	LEGEND A: Rock Deterioration	Church Name (Turkish) Üzümlü Kilise

<ul style="list-style-type: none"> Deposition of Dark Material Spalling Structural Cracks 	Church Name (English) Chapel of Niketas the Styliste
		Location Transverse Arch between 2-3
		Subject Mural condition map
	Scale	Category
	1/10	A
	Plate No.	
	Plate043 UZM-C ₂₋₃ -002

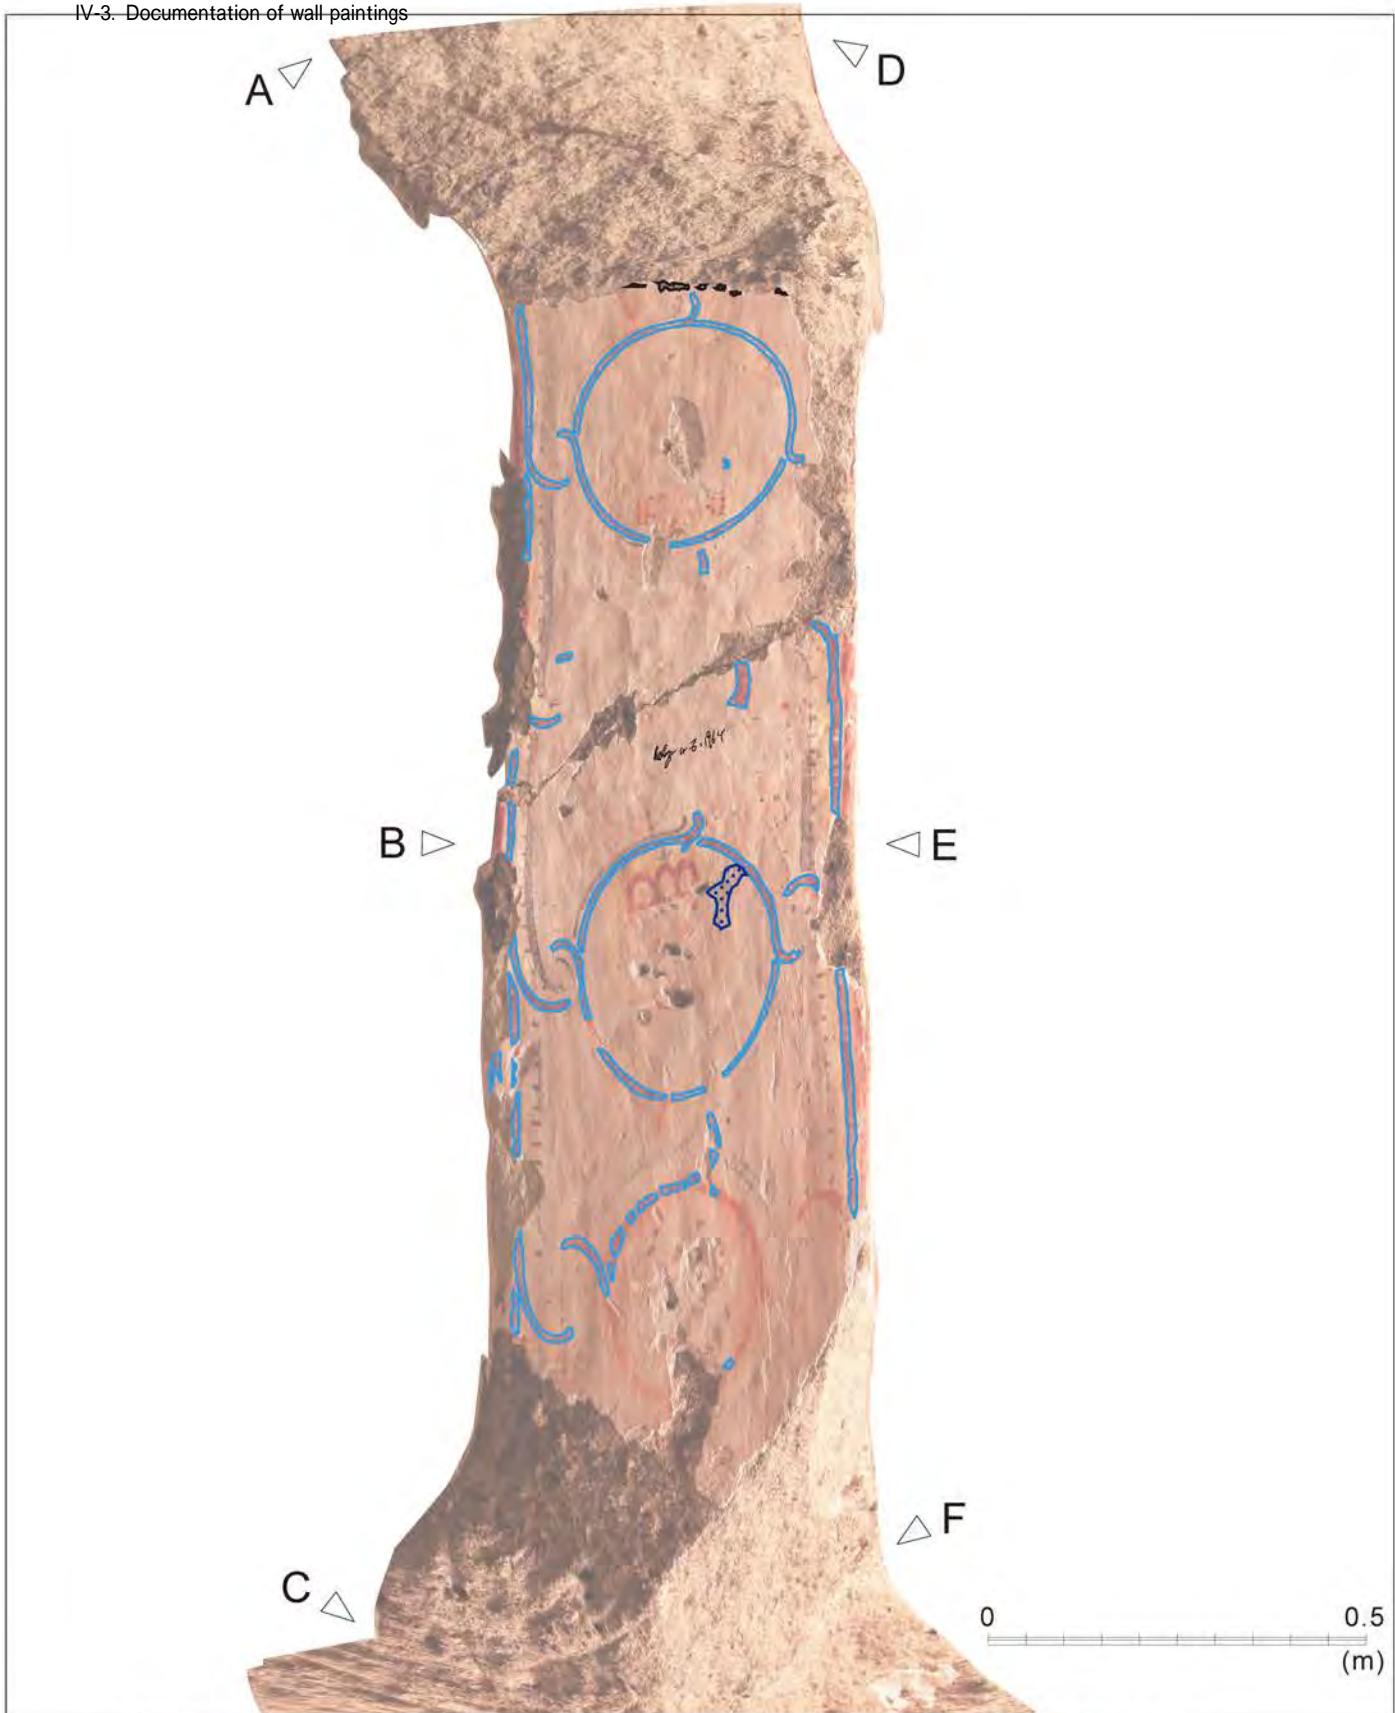
Ceiling	LEGEND C: Paint Deterioration	Church Name (Turkish) Üzümlü Kilise
	<ul style="list-style-type: none"> Micro Losses Dark Grey Veil Grey Spotting Superficial Graffiti 	Church Name (English) Chapel of Niketas the Styliste
		Location Transverse Arch between 2-3
		Subject Mural condition map
		Scale Category 1/10 C
		Plate No. Plate045 UZM-C ₂₋₃ -004
