Scientific Studies on Conservation for Üzümlü Church and its wall paintings in Cappadocia, Turkey

Vol. 1 : Annual report on the activities in 2014

**University of Tsukuba
2014**

Yoko Taniguchi, University of Tsukuba

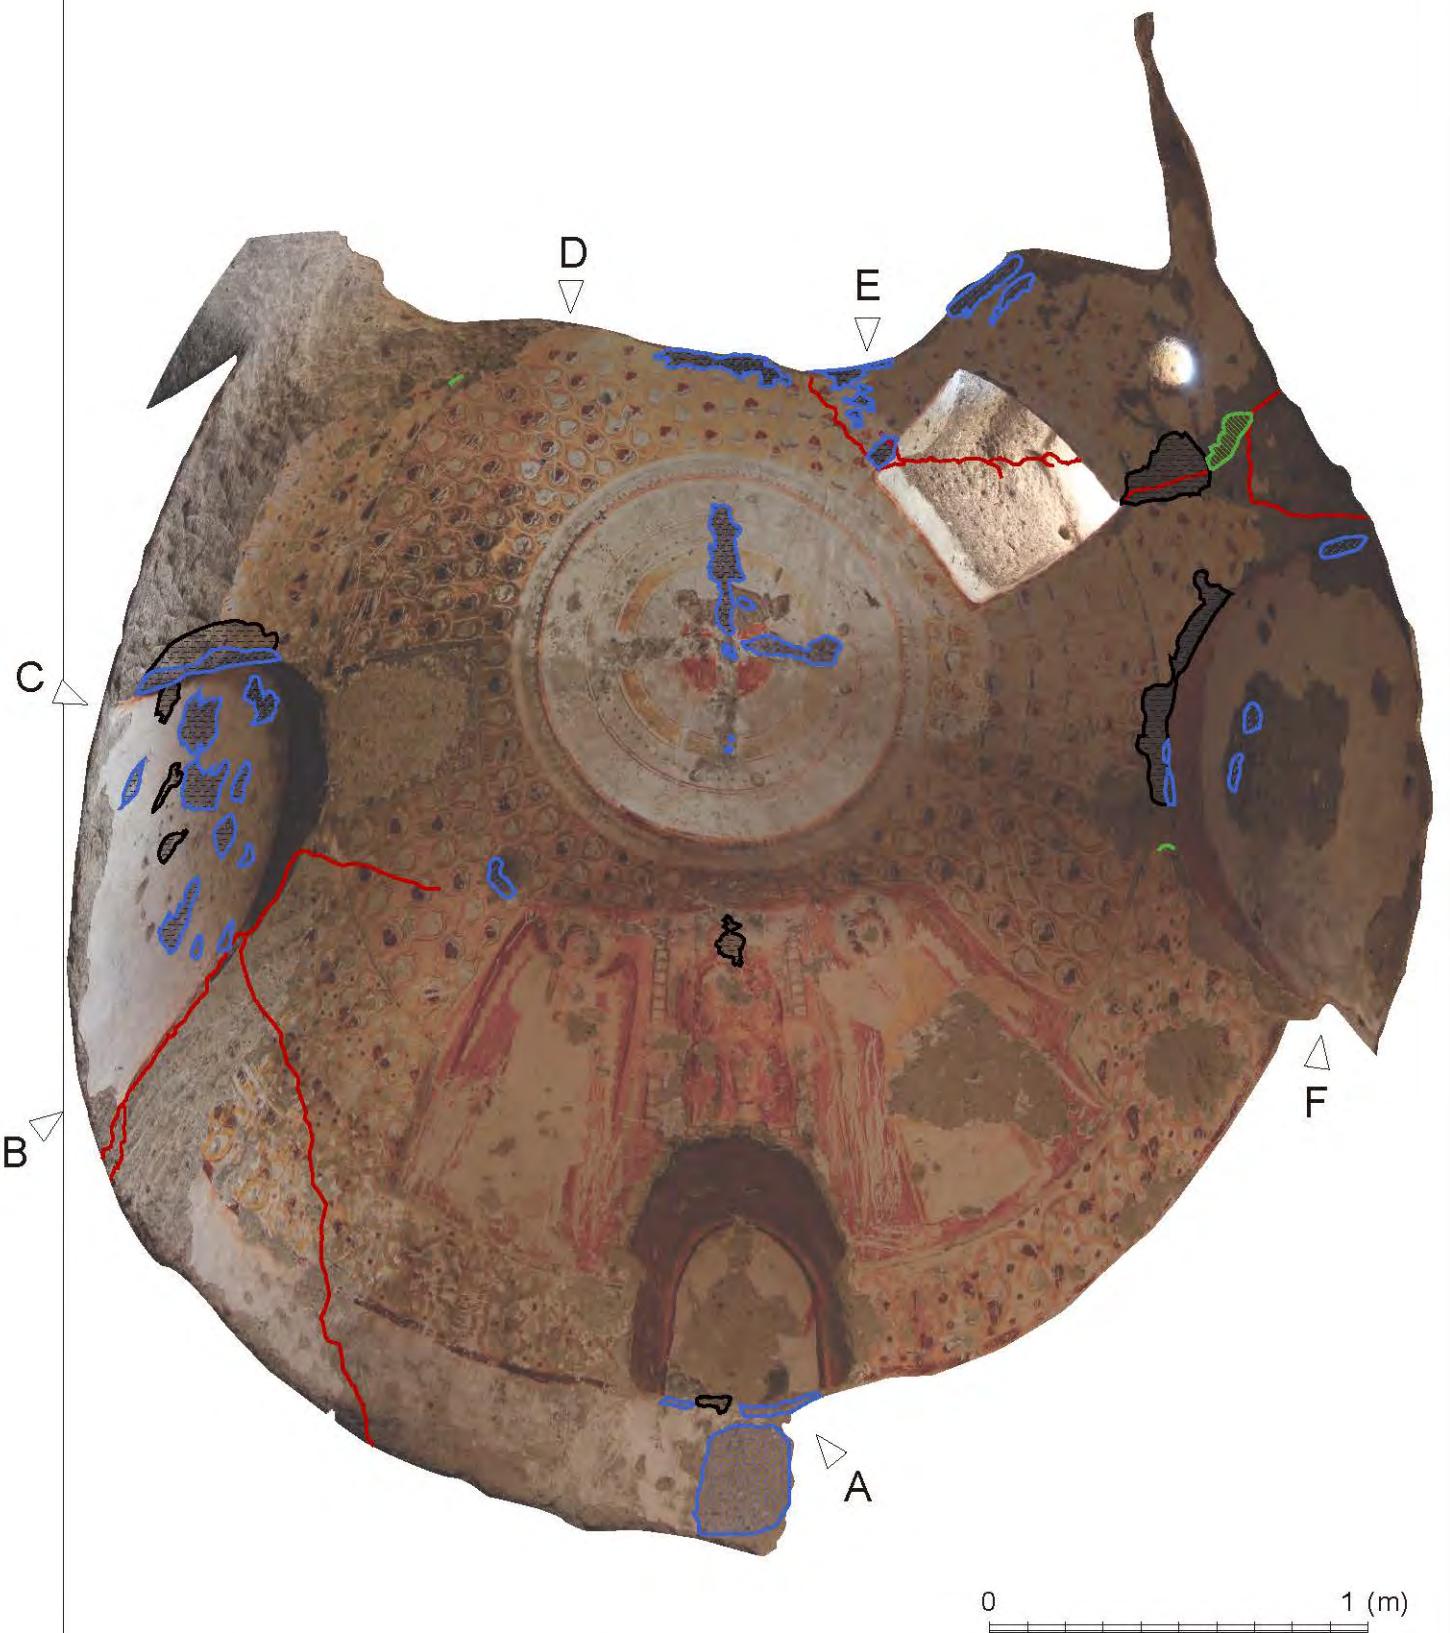
Ceiling	LEGEND	A: Rock Deterioration	Church Name (Turkish)

Üzümlü Kilise
		Deposition of Dark Material	Church Name (English)
		Biologic Activity	Chapel of Niketas the Styliste
		Spalling	Location
		Structural Cracks	Ceiling of Chamber 3
			Subject
			Mural condition map
			Scale
			1/20
			Category
			A
			Plate No.
			Plate047 UZM-C ₃ -002

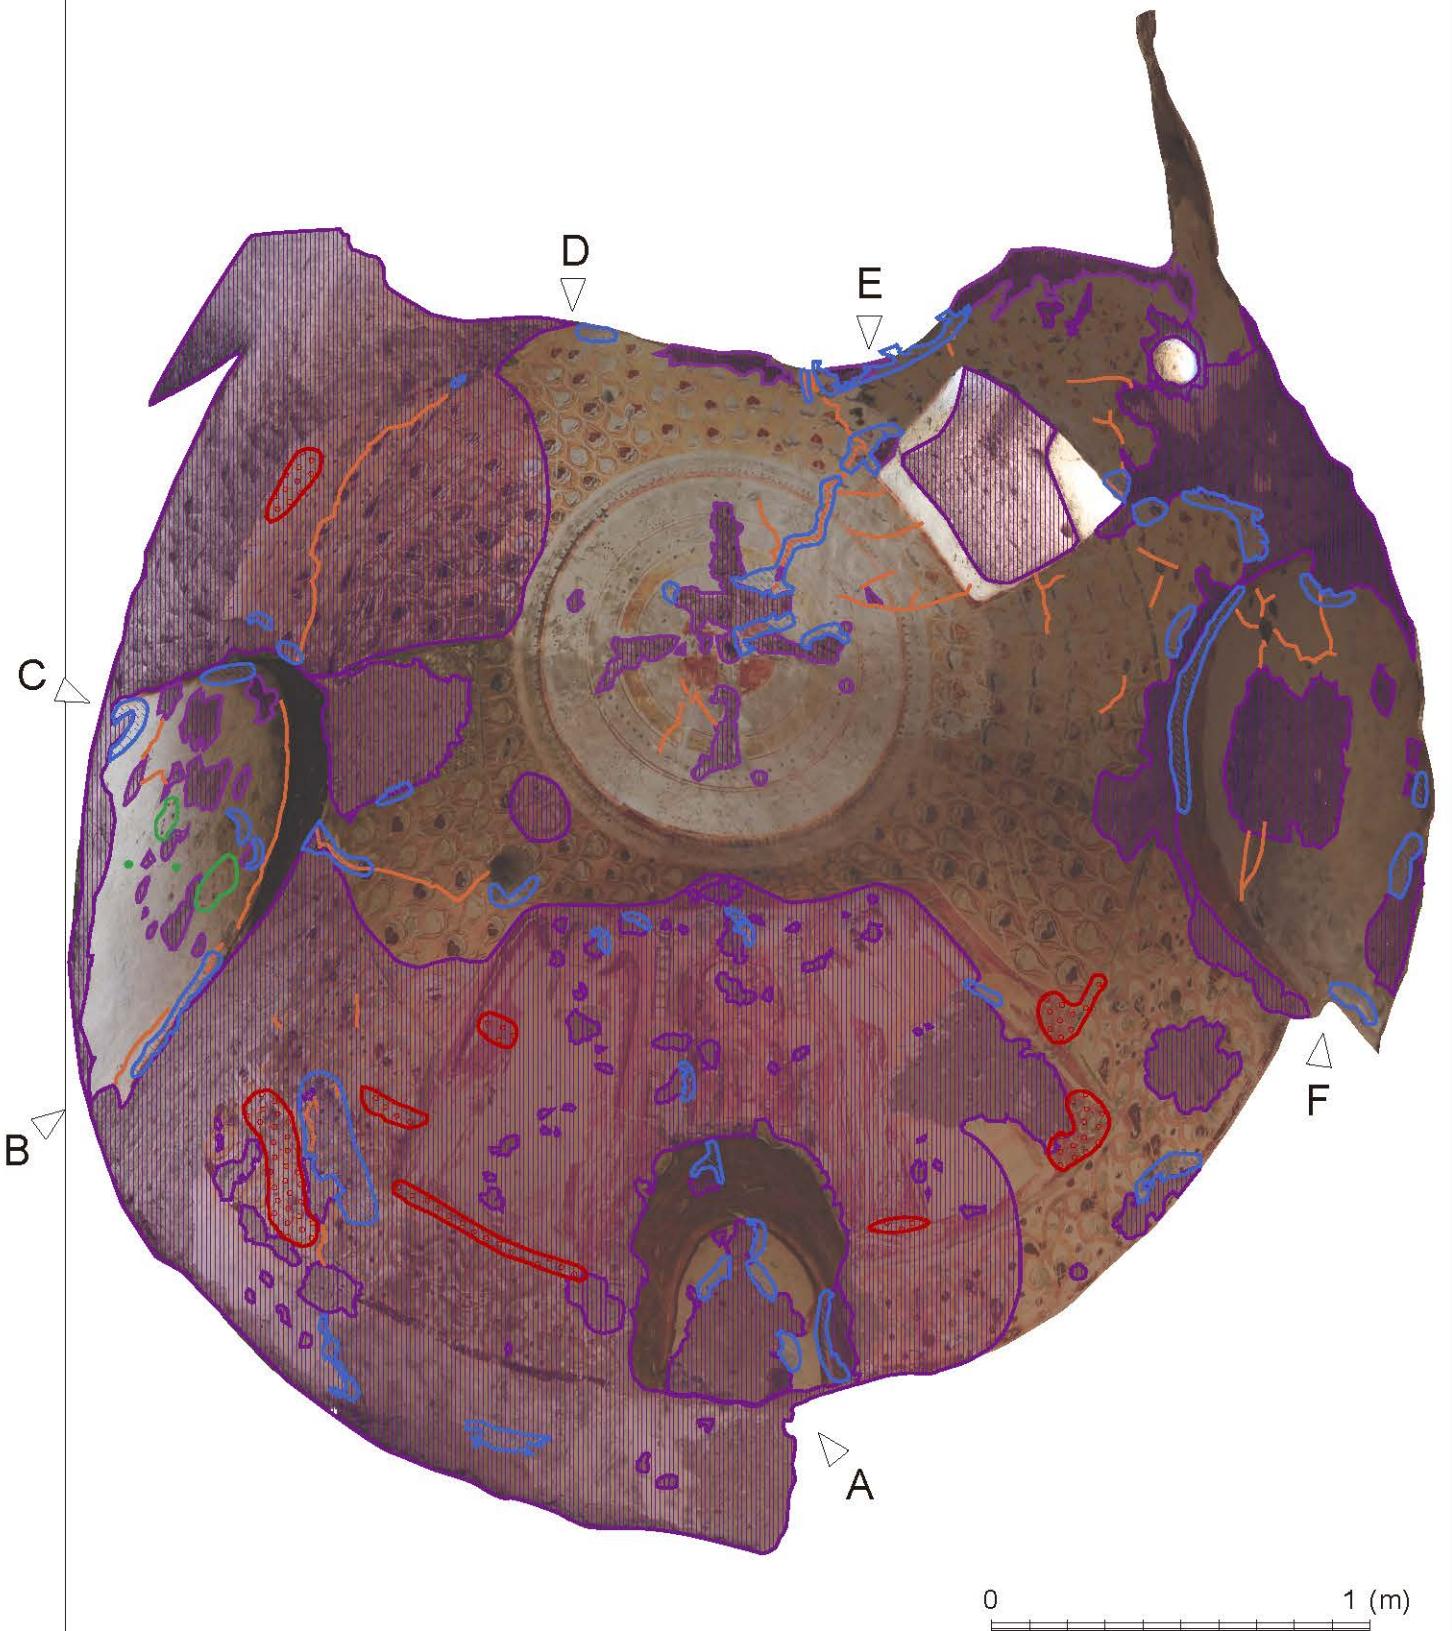
Ceiling	LEGEND	B: Plaster Deterioration	Church Name (Turkish)
			Üzümlü Kilise
			Church Name (English)
			Chapel of Niketas the Styliste
			Location
			Ceiling of Chamber 3
			Subject
			Mural condition map
			Scale
			1/20
			Category
			B
			Plate No.
			Plate048 UZM-C ₃ -003

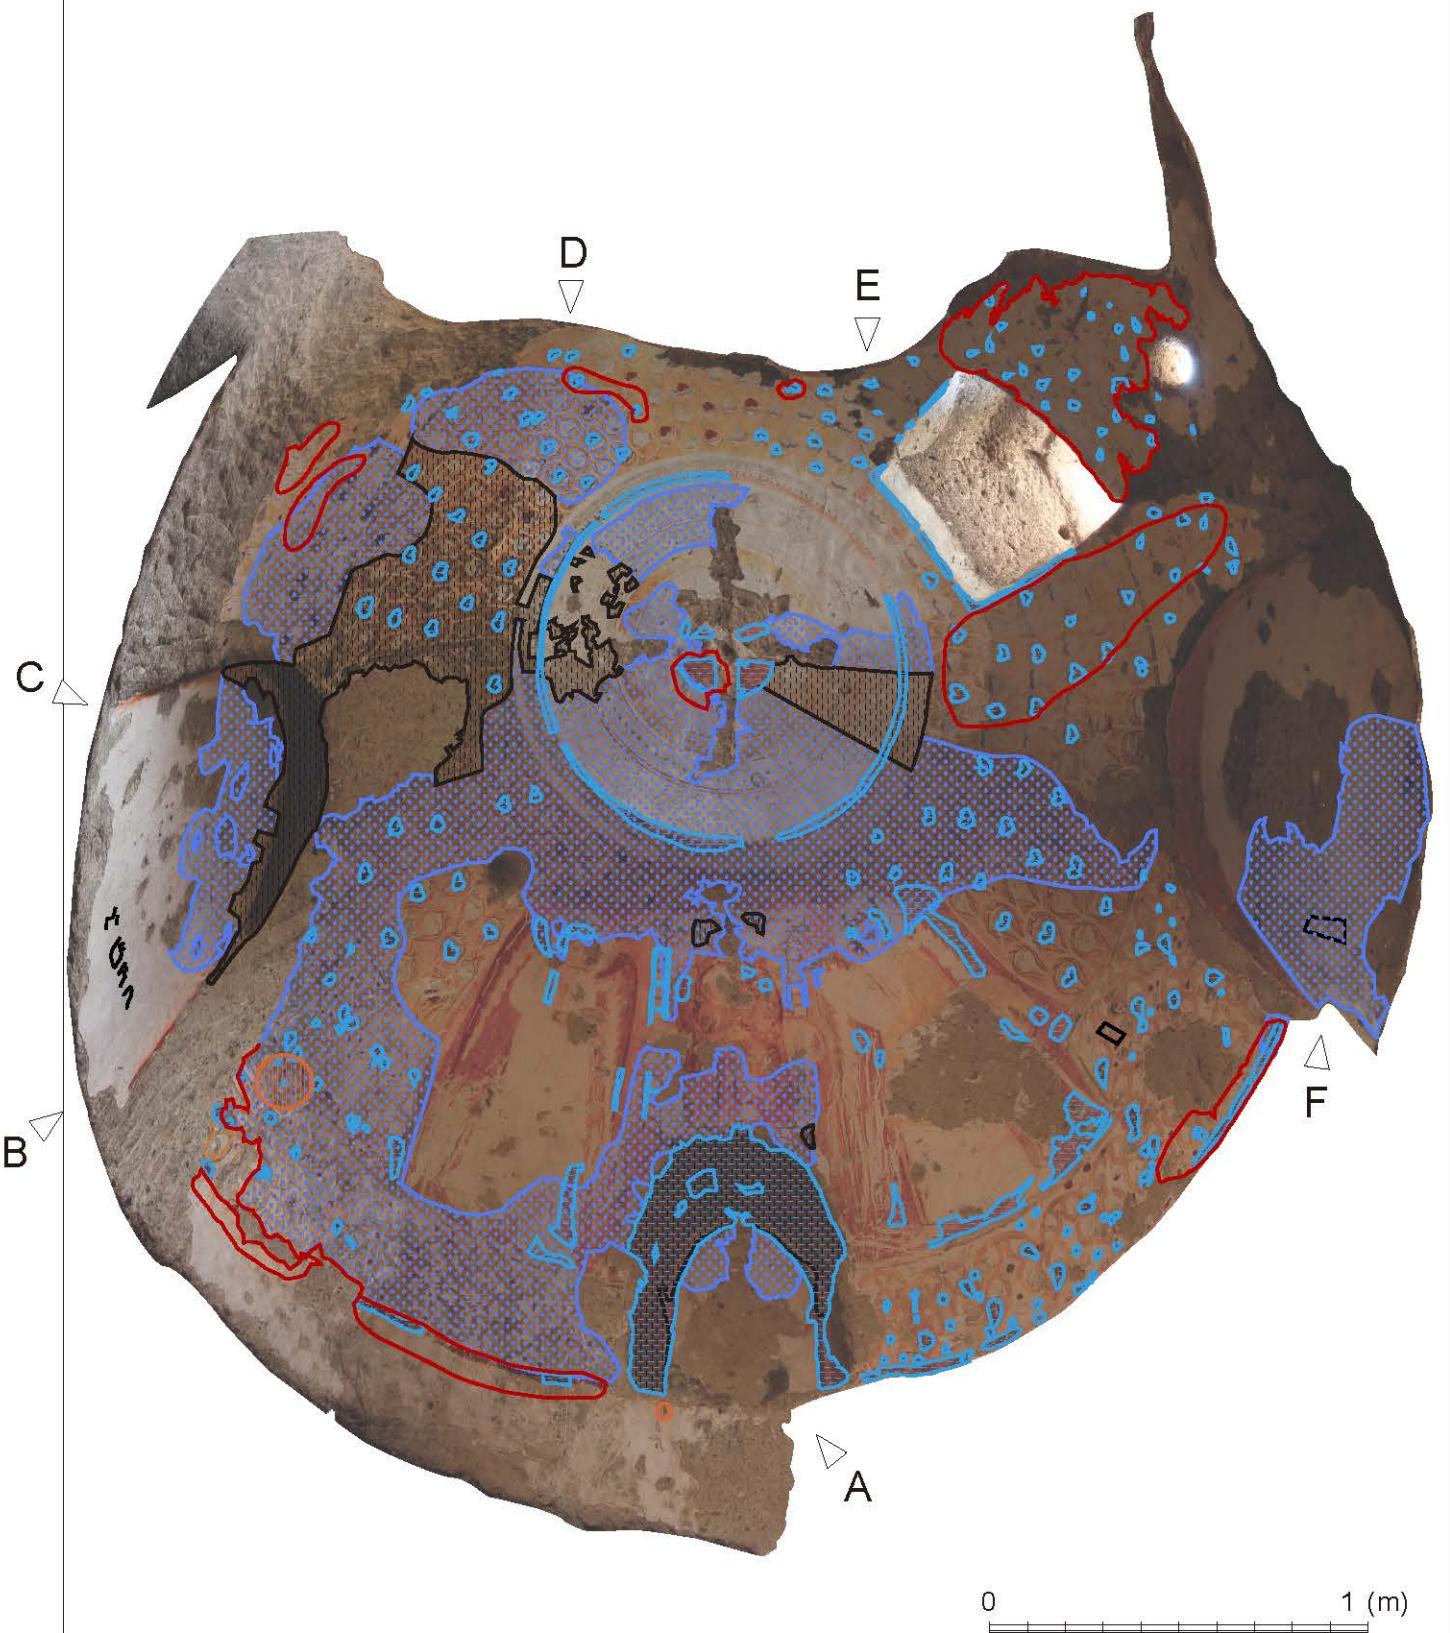
Ceiling	LEGEND C: Paint Deterioration	Church Name (Turkish) Üzümlü Kilise
		Church Name (English) Chapel of Niketas the Styliste
		Location Ceiling of Chamber 3
		Subject Mural condition map
		Scale Category 1/20 C
		Plate No. Plate049 UZM-C ₃ -004

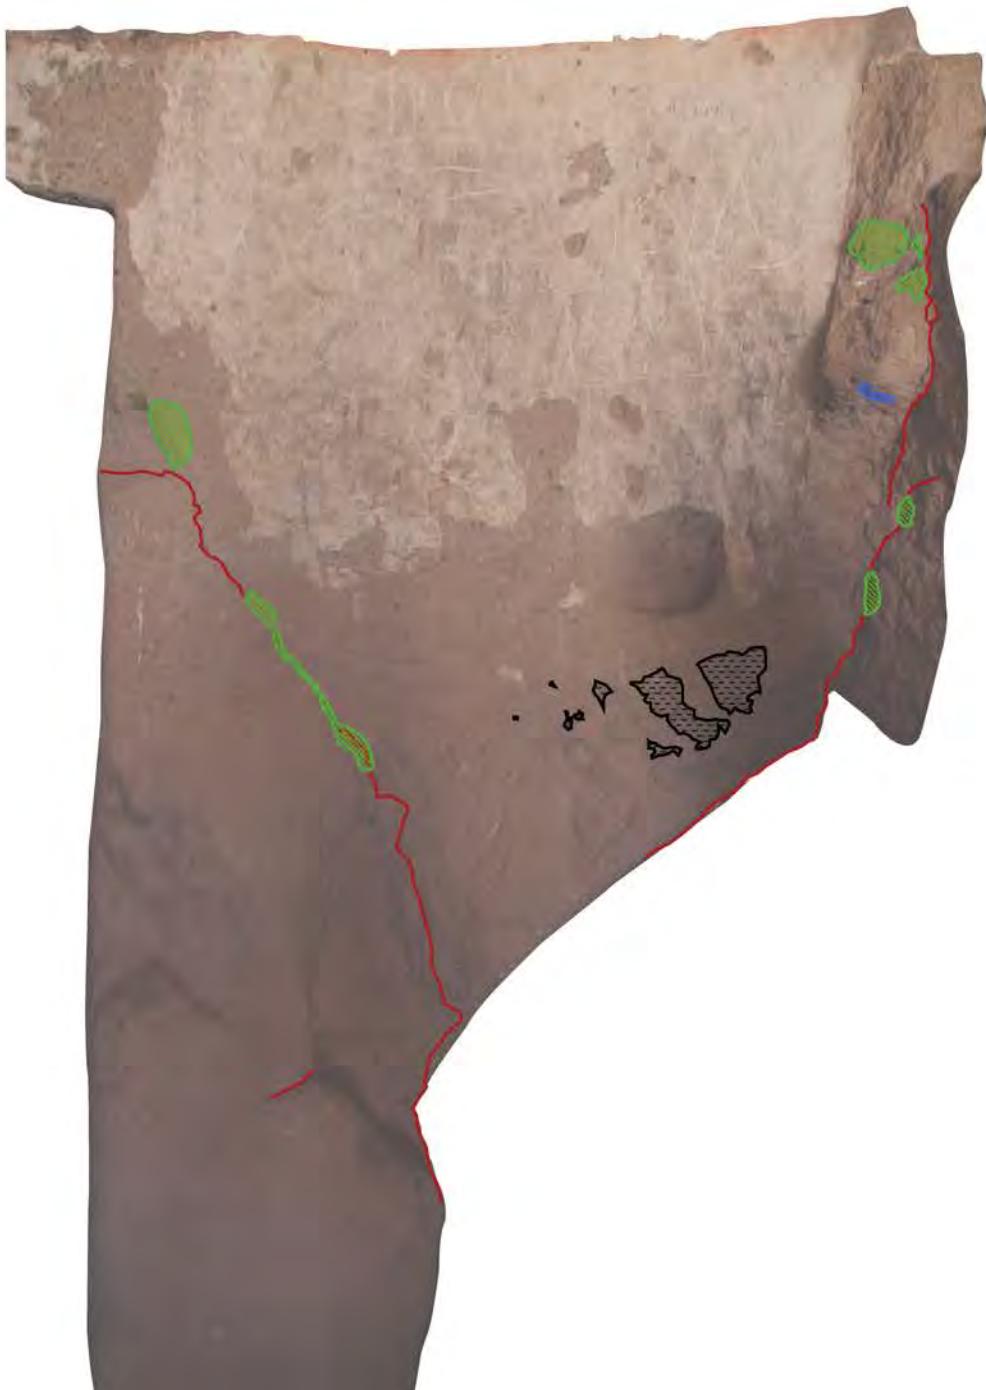
Section A-A'	LEGEND A: Rock Deterioration	Church Name (Turkish) Üzümlü Kilise
	<ul style="list-style-type: none"> Deposition of Dark Material Biologic Activity Spalling Structural Cracks 	Church Name (English) Chapel of Niketas the Styliste
		Location South East Wall of Chamber 3
		Subject Mural condition map
		Scale 1/10 Category A
		Plate No. Plate051 UZM-C ₃ -006

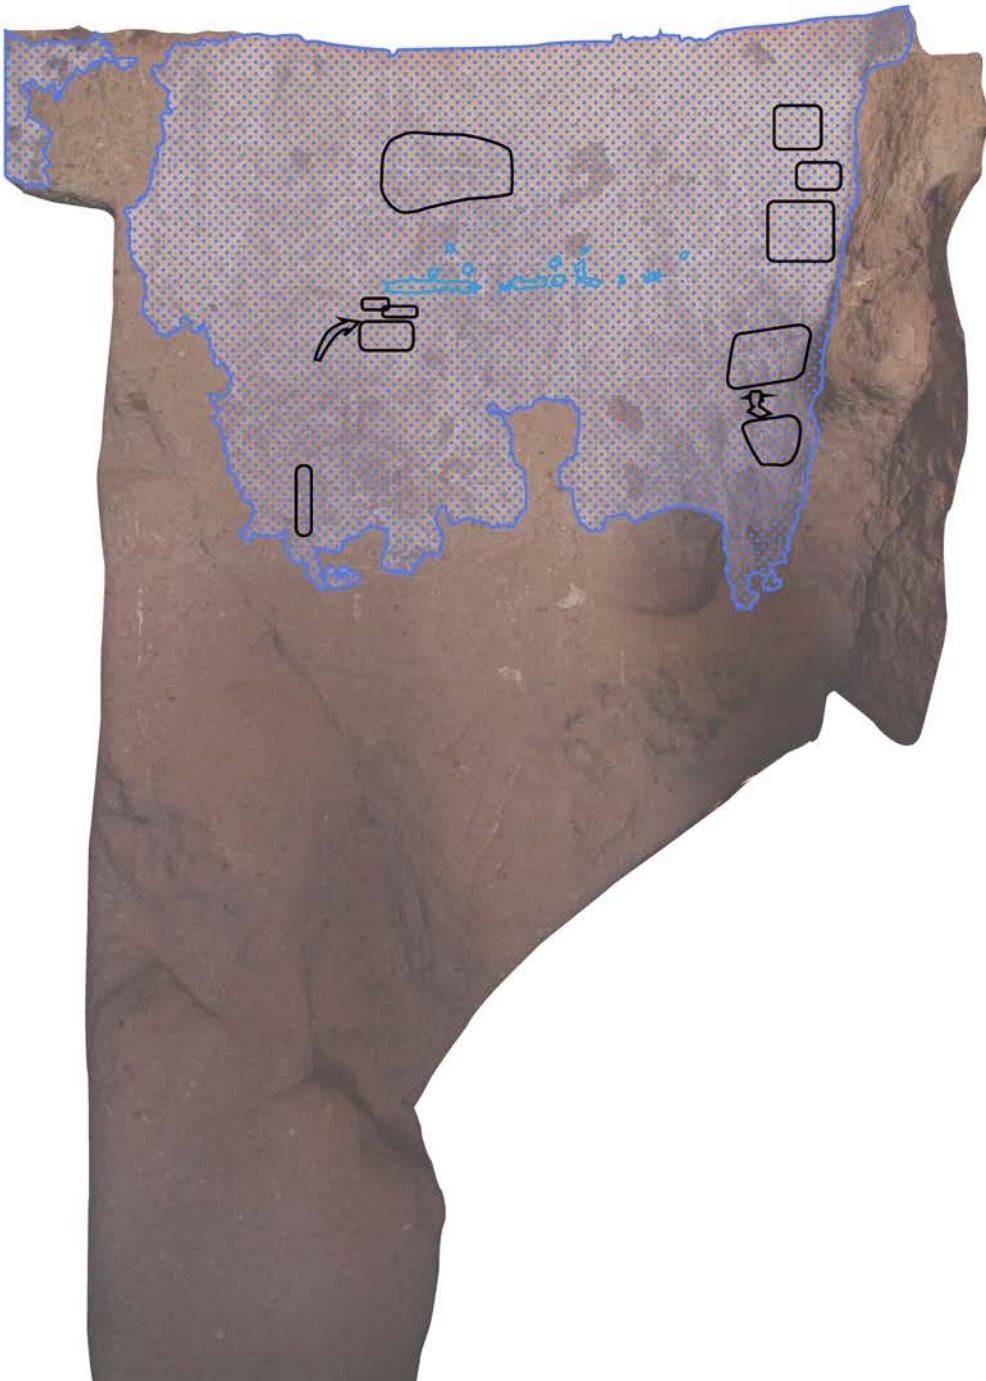
LEGEND C: Paint Deterioration

- Micro Losses
- Grey Spotting
- Superficial Graffiti

Church Name (Turkish)	Üzümlü Kilise
Church Name (English)	Chapel of Niketas the Styliste
Location	South East Wall of Chamber 3
Subject	Mural condition map
Scale	Category
1/10	C
Plate No.	
Plate053 UZM-C ₃ -008
